High Falls Parking Garage

240 State Street
Rochester, New York 14614

October 1st, 2021

EXECUTIVE SUMMARY

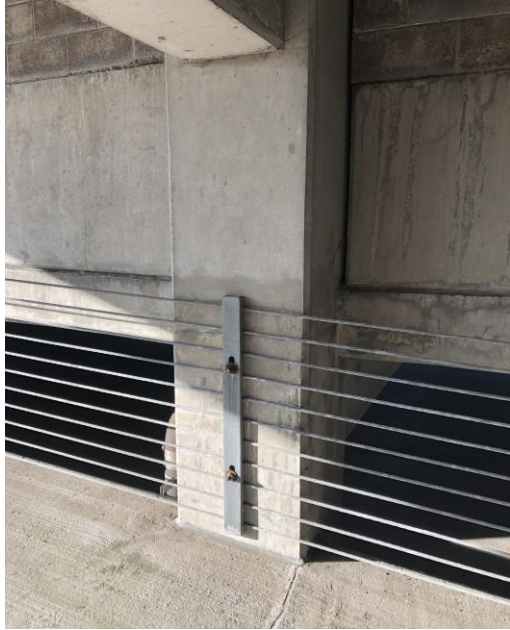
<p>Photo #1</p>
--	---

<p><u>Typical Column Condition</u> Minor hairline cracks and light efflorescence common among columns in the garage. Vehicle barriers moved to external attachment for most columns with previous cable issues, as shown in the picture.</p>

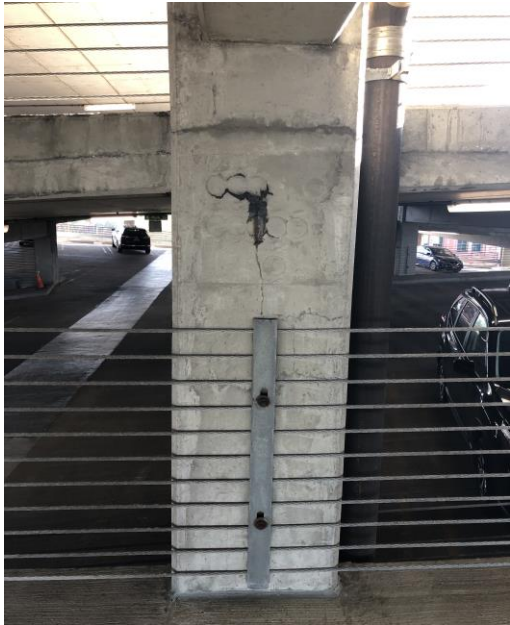
<p>Photo #2</p>
--	--

<p><u>Column Case 1</u> Heavy grease stains from beam post tensioning tendons.</p>

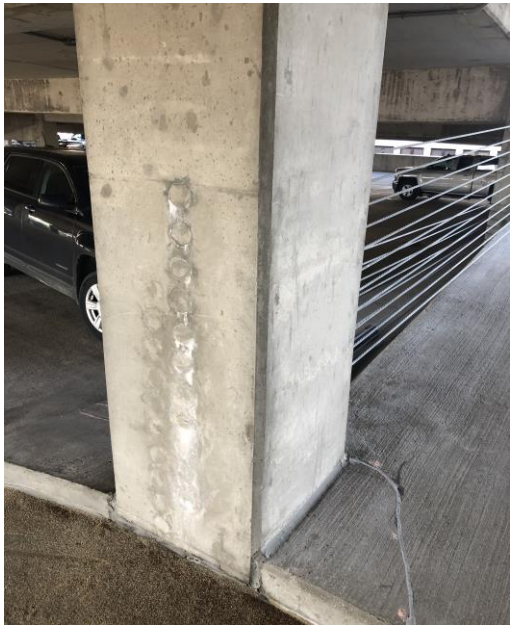
Photo #3

<p><u>Column Case 2</u></p> <p>Heavy efflorescence at cable vehicle barrier caps, common where cable barriers are mounted as the picture shows.</p>

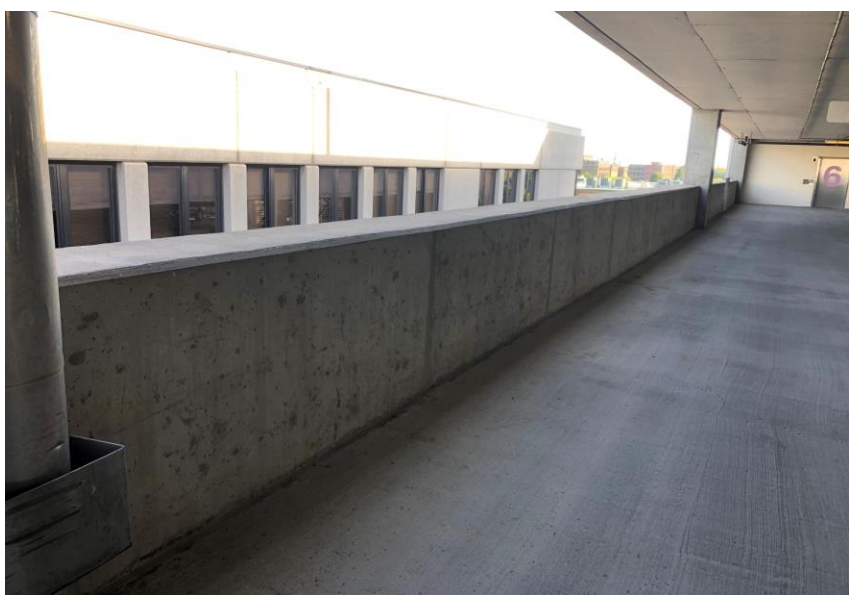
Photo #4

<p><u>Typical Upturned Beam Condition</u></p> <p>Very minor deficiencies if any at all, good condition overall.</p>

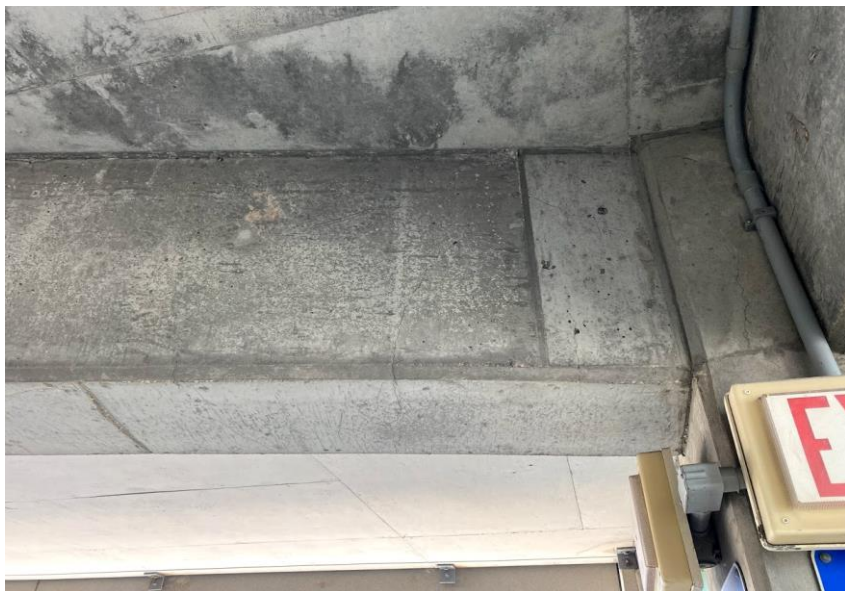
Photo #5

Typical Standard Beam Condition

Minor hairline cracks at column ends. Overall condition good.

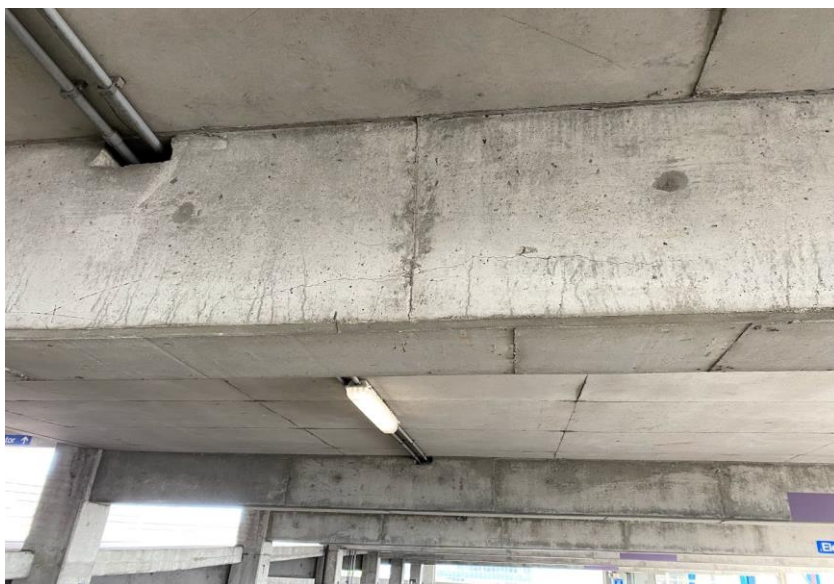
Photo #6

Standard Beam Case 1

Wide cracks at mid span of beam, about 6' long.

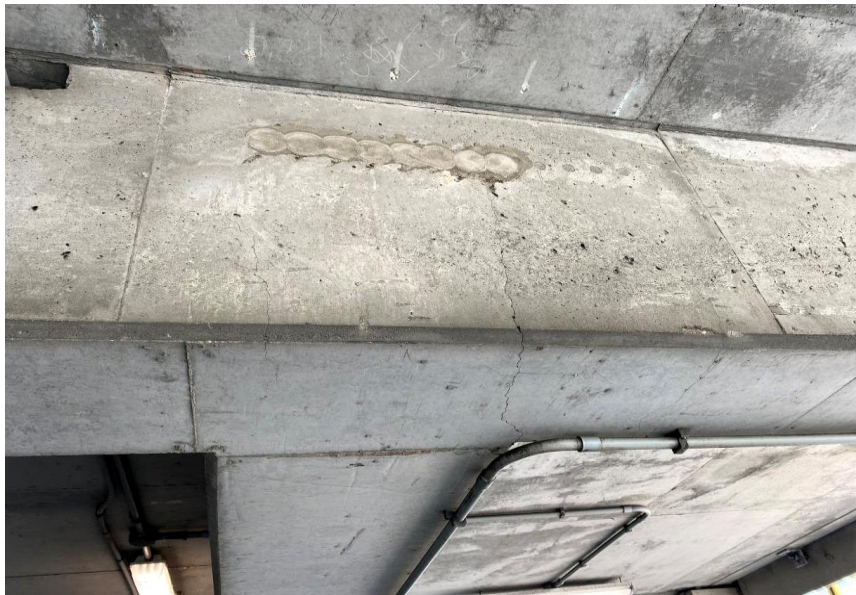
Photo #7

Standard Beam Case 2

Wide cracks at beam intersection, monitoring recommended. Cracks align with the sides of the perpendicular intersecting beam.

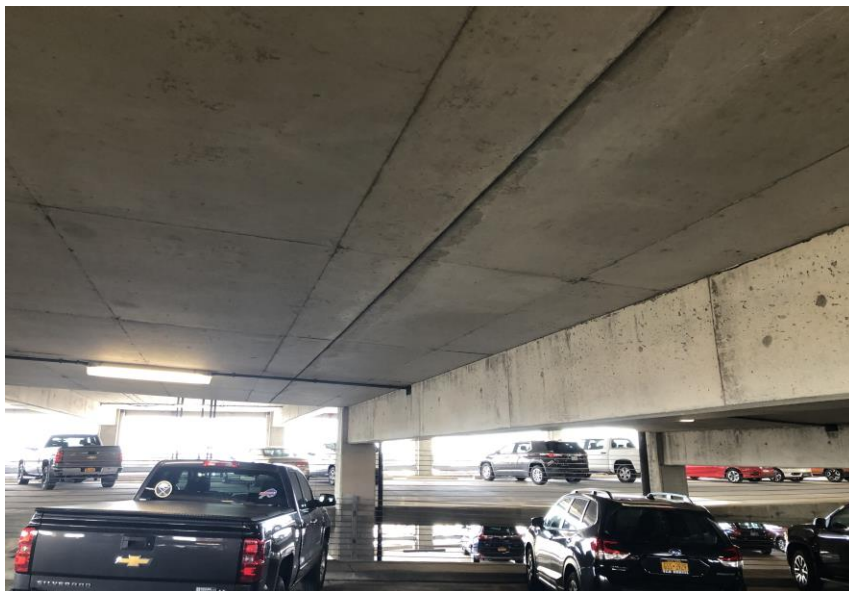
Photo #8

Typical Deck Condition

Overall condition good of most decks, minor efflorescence, hairline cracks, and spalls common.

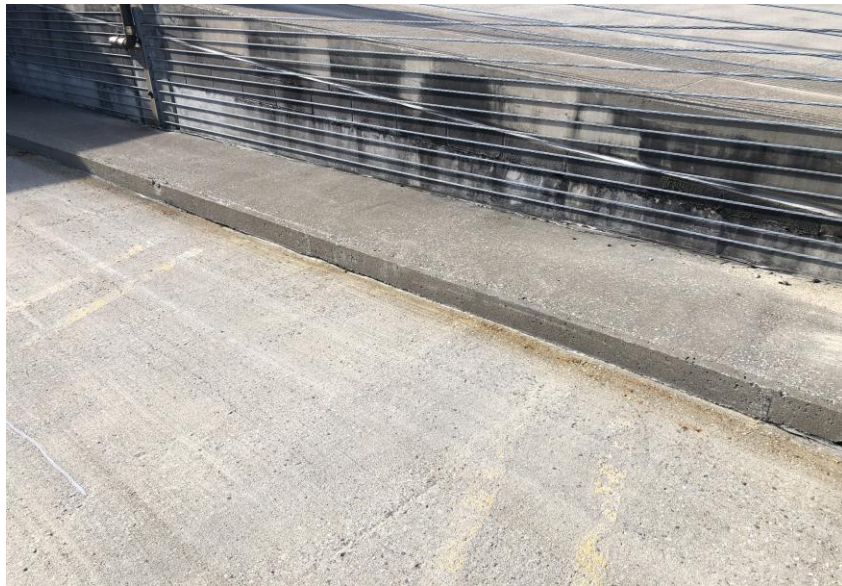
Photo #9

Sealants

Cove sealant failure, common for the garage, worse for the upper levels. This can be addressed whenever the deck sealer is applied.

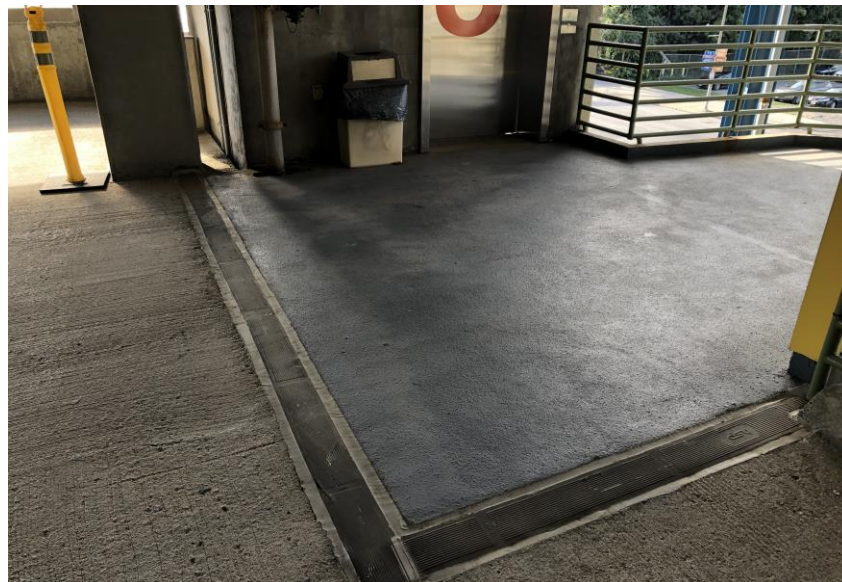
Photo #10

Typical Isolation Joint Condition

Joints are worn and small rips in sealant common. Rips in the joints are typically in the corner.

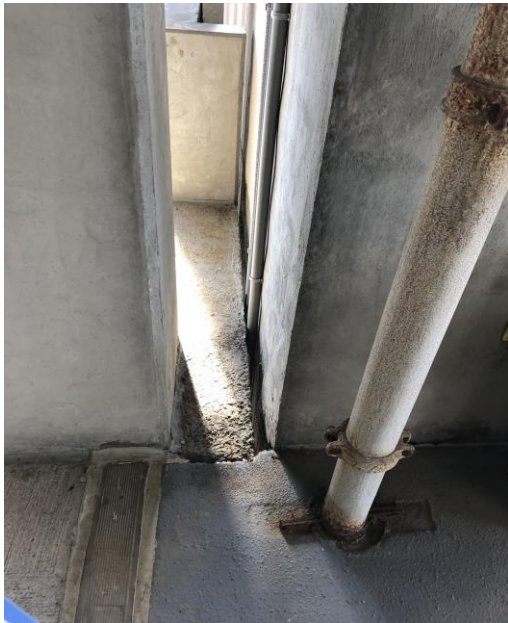
<p>Photo #11</p>
--	--

<p><u>Isolation Joint Case 1</u> Isolation joint missing at Southwest elevator. Joint is typical for that elevator and is not present on the 3rd through 6th floor.</p>

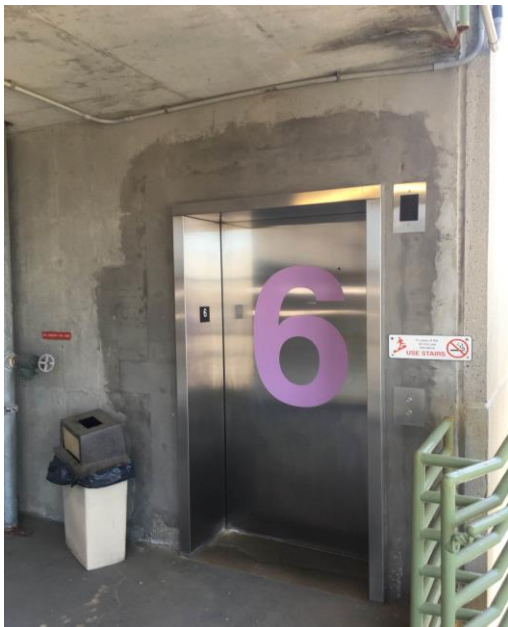
<p>Photo #12</p>
---	---

<p><u>Typical Elevator Enclosure</u> <u>Condition</u> Both elevators enclosures recently fixed and generally in good condition.</p>

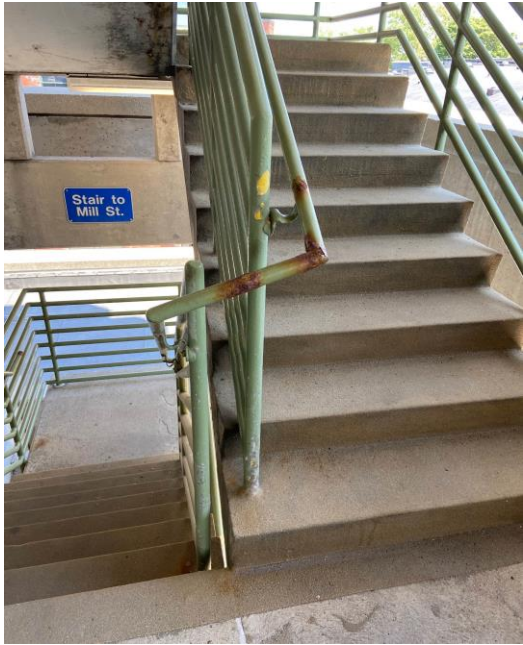
<p>Photo #13</p>
---	--

<p><u>Typical Stairs Condition</u> Stairs covered with traffic topping, rust stains common on the steps. Hairline cracks under the stairs common. Paint failure on the railings and misc metals, including stair supports are prevalent throughout.</p>

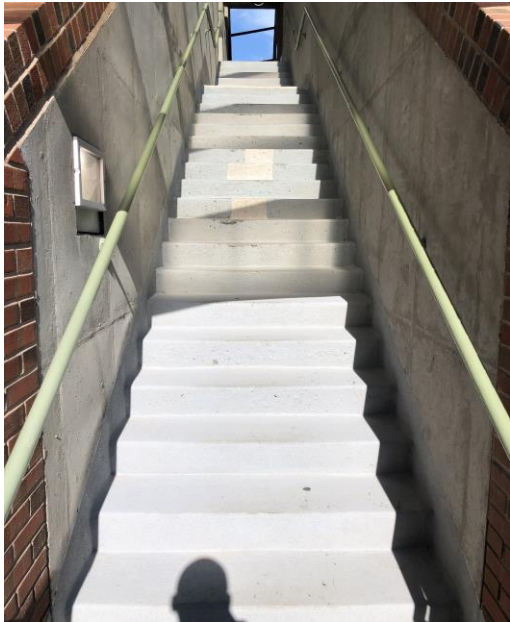
<p>Photo #14</p>
---	---

<p><u>Stairs Case 1</u> Waterproofing on stair nosings are worn through, isolated spots of delaminations/rust stains at the nosing.</p>

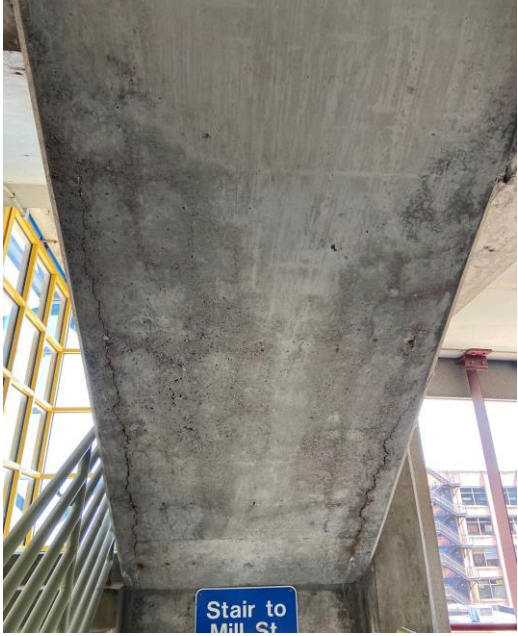
Photo #15

<p><u>Stairs Case 2</u></p> <p>A couple stairs have open/wide cracks on the bottom of the stair risers, but condition has not changed appreciably. These riser sections should be repaired when other significant work is being performed.</p>
