### **Midtown Building Assessment**

### Building Assessment

The City of Rochester

*December 8, 2006*

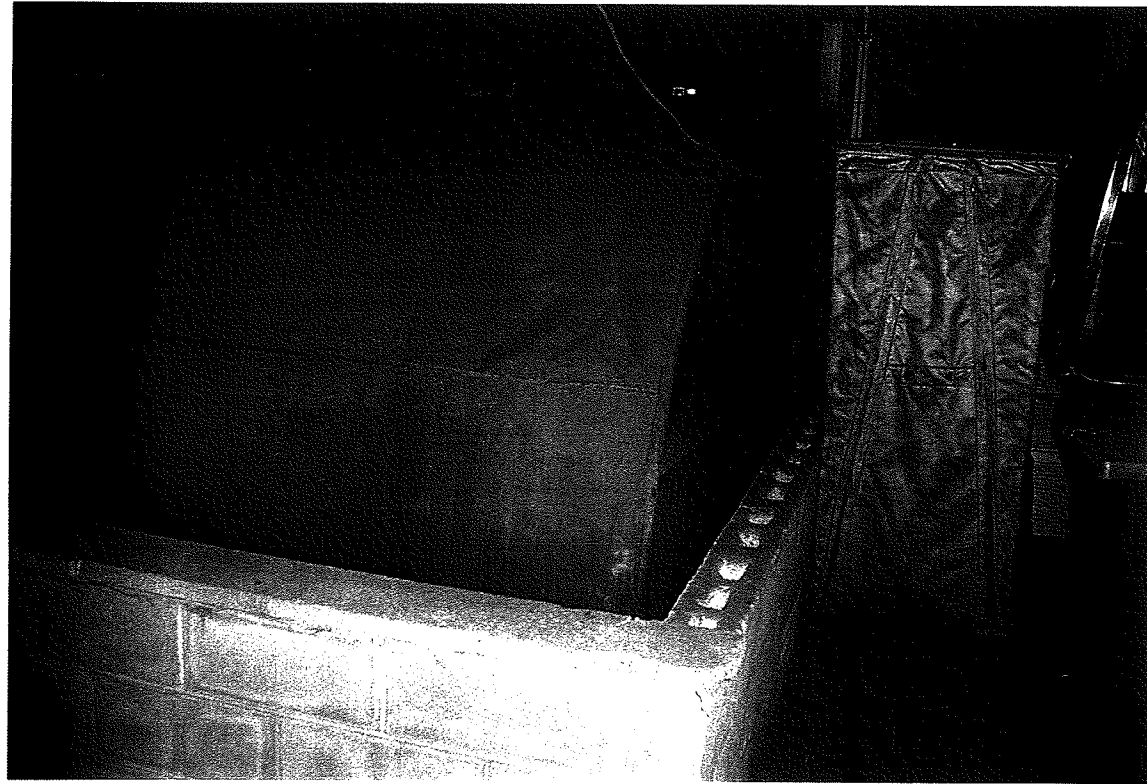
Photo 1  
Photo Date  
11/21/06

View of the 6,000 gallon fuel oil storage tank located in the McCurdy's Building basement. The tank was reportedly installed in 1975 and consists of single wall steel construction. The tank was surrounded by a masonry block retaining wall for spill containment.

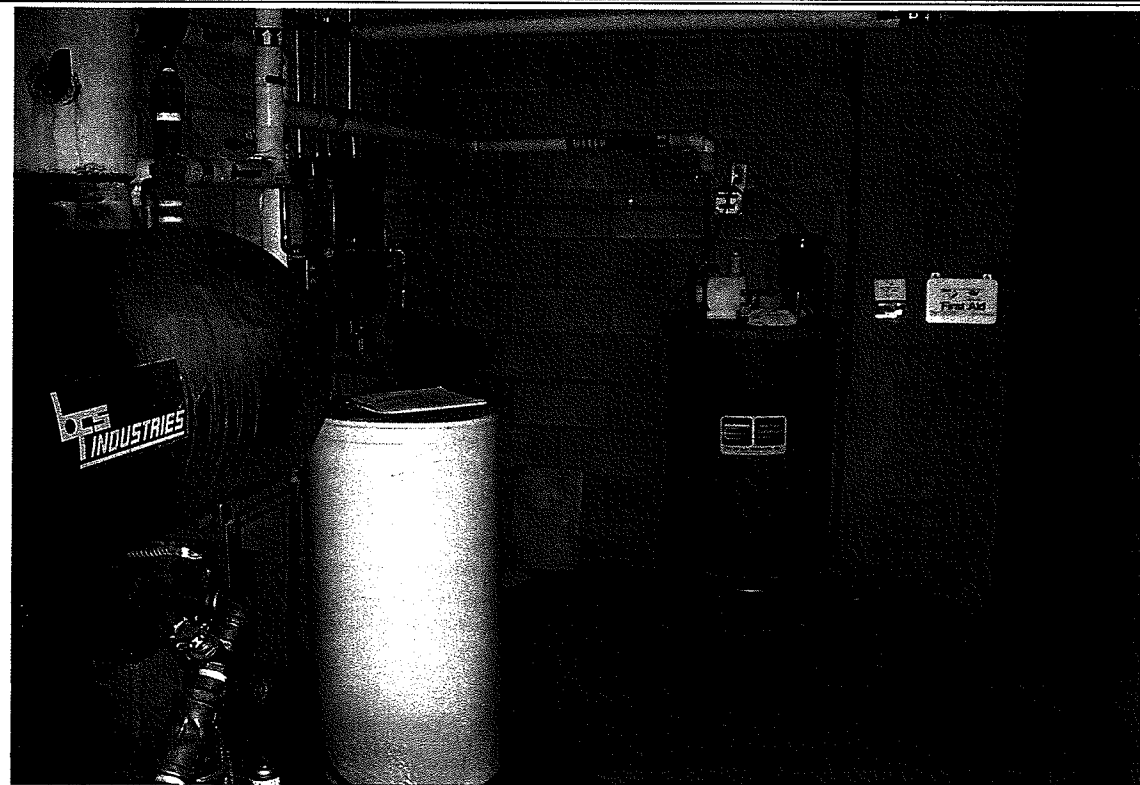
Photo 4 View of the boiler room in the McCurdy's Building.  
 Photo Date 11/21/06 Containers of chemical treatment for the boiler system.

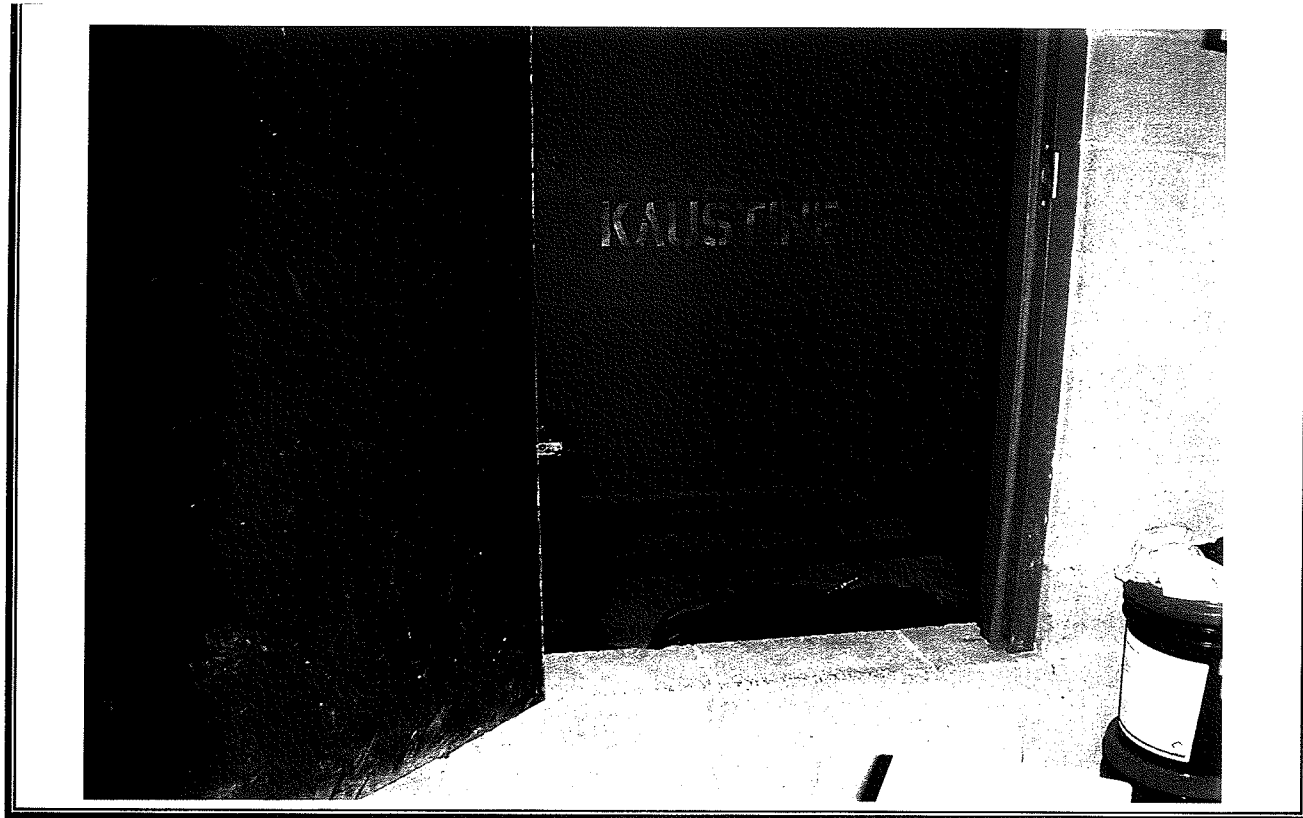
Photo 5  
Photo Date  
11/21/06

A 6,000 gallon No. 2 fuel oil aboveground storage tank is in service at the Midtown Tower Building (PBS registration #8-503479). The tank was installed in 1975 and consists of single wall steel construction. The tank is located in a small masonry block building. The block walls and raised door provides for secondary containment and overfill protection. The tank services a dual natural gas-oil boiler located in the third floor of the Midtown Plaza-Tower building complex. Visual observations conducted in November 2006 did not indicate evidence of on-going releases or leaks from the tank, which contained approximately 1,300 gallons of fuel oil. Conveyance piping is single wall steel. The piping may need upgrading for secondary containment/spill containment purposes. Based on site observations, the AST may be adequate for near-term use but require replacement as part of a long-term management program.

View of the 6,000 gallon fuel oil storage tank located at the Midtown Tower building.  
The tank was reportedly installed in 1975 and consists of single wall steel construction.  
The tank was located in a separate masonry block building with a raised door for spill containment.

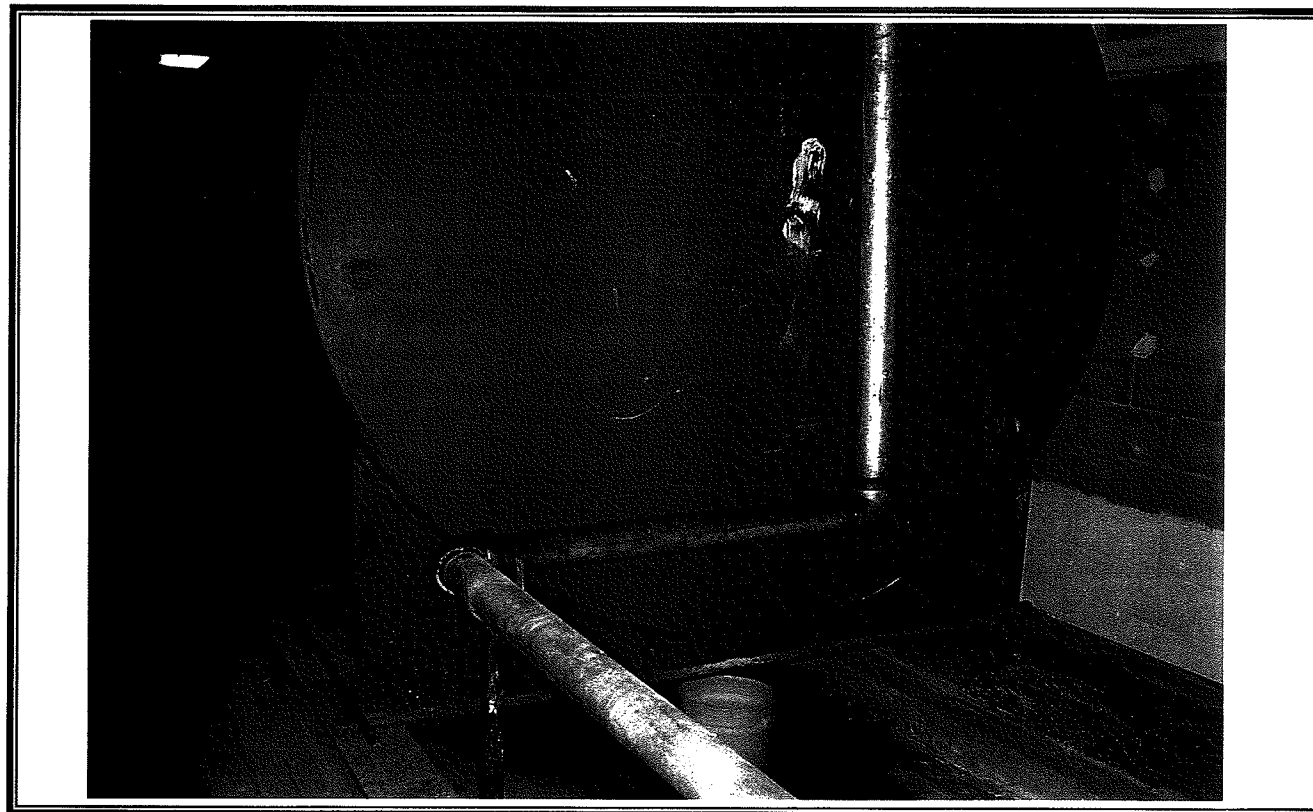
Photo 6  
Photo Date  
11/21/06

View of the steel 6,000 gallon fuel oil tank and supports at Midtown Tower Building.  
The product gauge indicated that the tank contained 1,300 gallons of fuel oil.  
The steel supports to the tank and the steel product lines from the tank are evident.

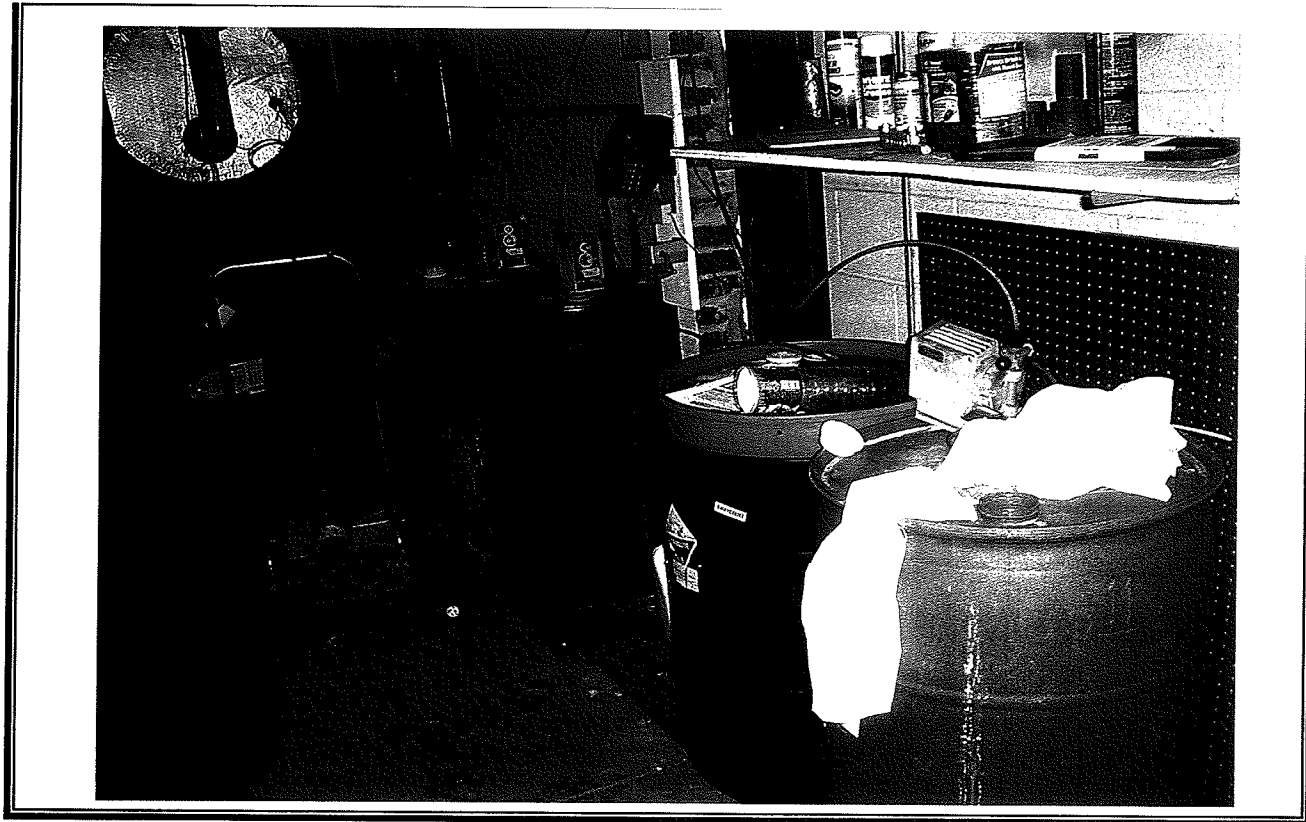
Photo 7  
Photo Date  
11/21/06

Several 55-gallon size drums of antifreeze, corrosive chemical treatment and scale inhibitor treatment were observed in the Midtown Tower 3<sup>rd</sup> floor HVAC room. Chemicals are used in active HVAC systems. Smaller containers of various oil and lubricants were also observed. No evidence of on-going leaks or spillage was observed during November 2006 site observations. Midtown Plaza is listed with the U.S. EPA as a possible past Hazardous Waste

View of drums of various chemical treatments for the Midtown Tower Central HVAC Plant. Drums contained corrosive chemical treatment, scale inhibitor and treatments. Several drums were labeled Corrosive.

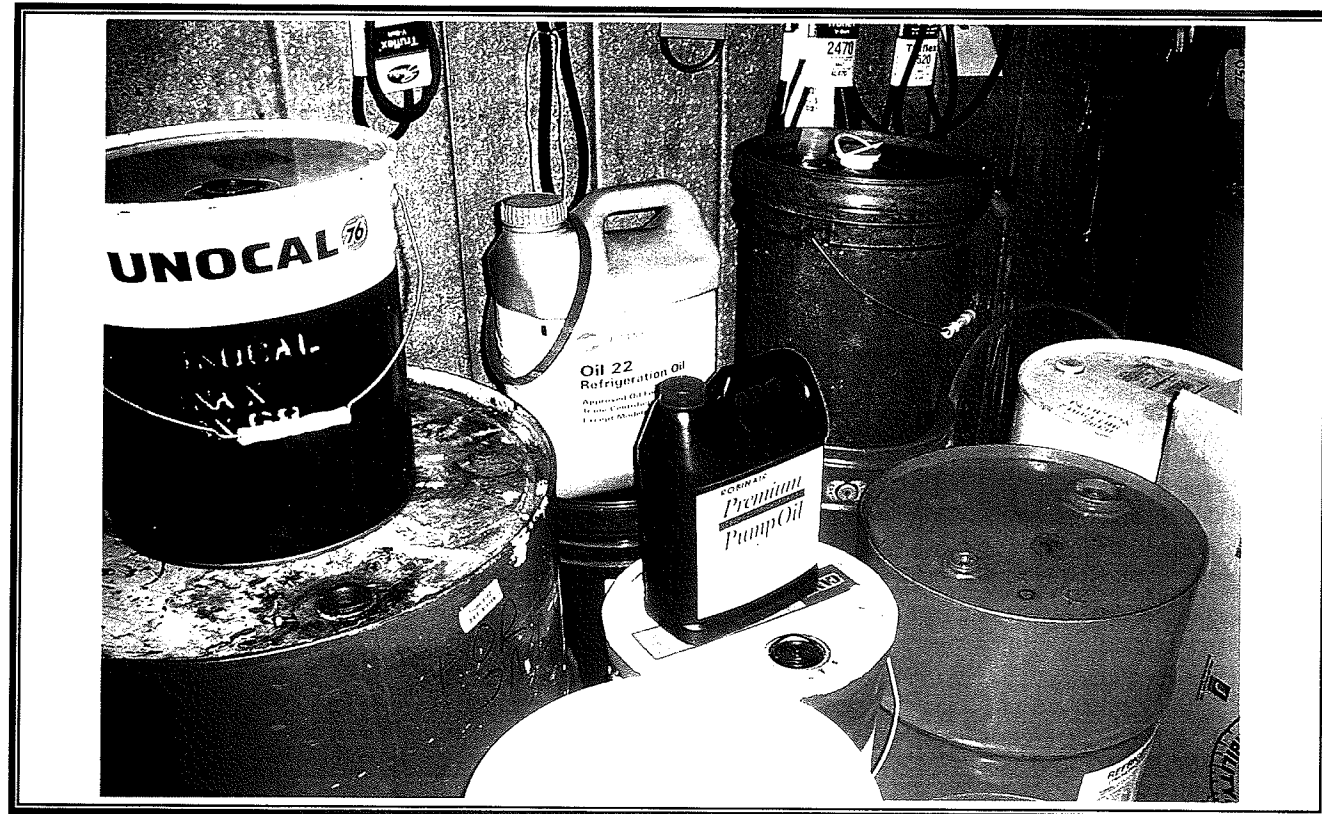
Photo 8  
Photo Date  
11/21/06

View of various containers of refrigerant oil, pump oil and other lubricants. Containers were observed in the Midtown Tower HVAC Central Plant.

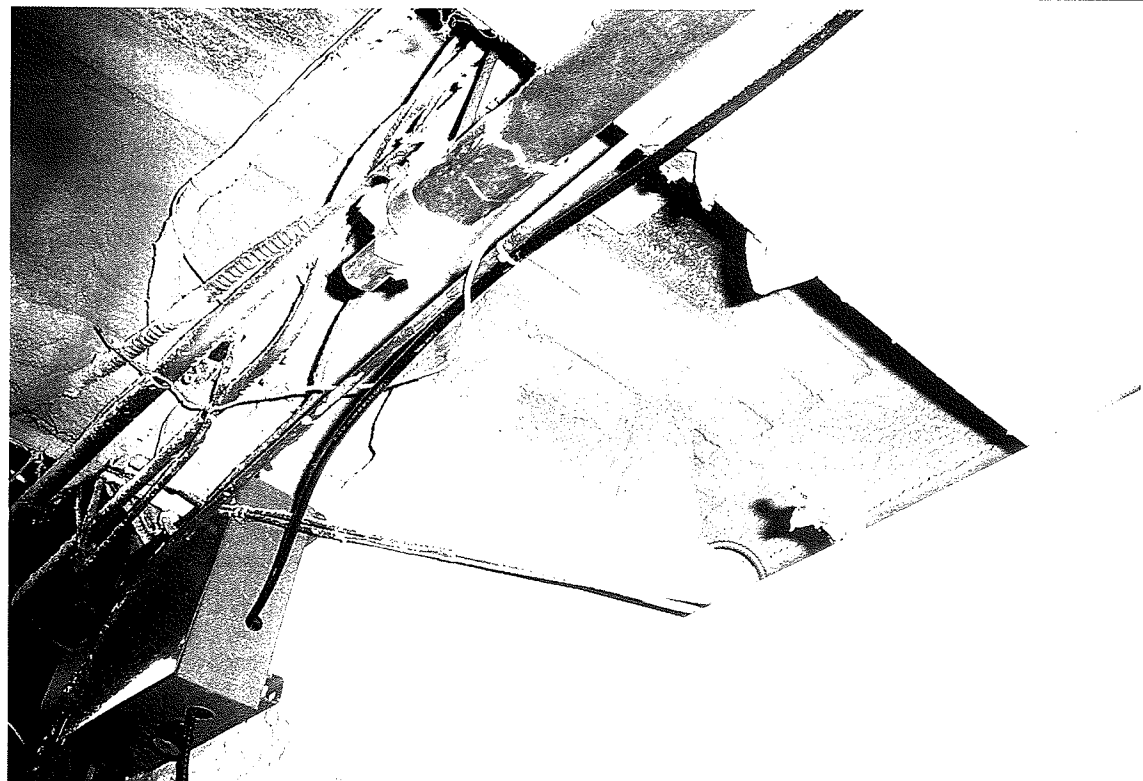
Photo 10  
Photo Date 11/21/06  
View of spray-on fireproofing on the ceiling deck surface and ceiling beams.  
View is of an exposed ceiling deck and beams in the Midtown Tower Central HVAC Plant.

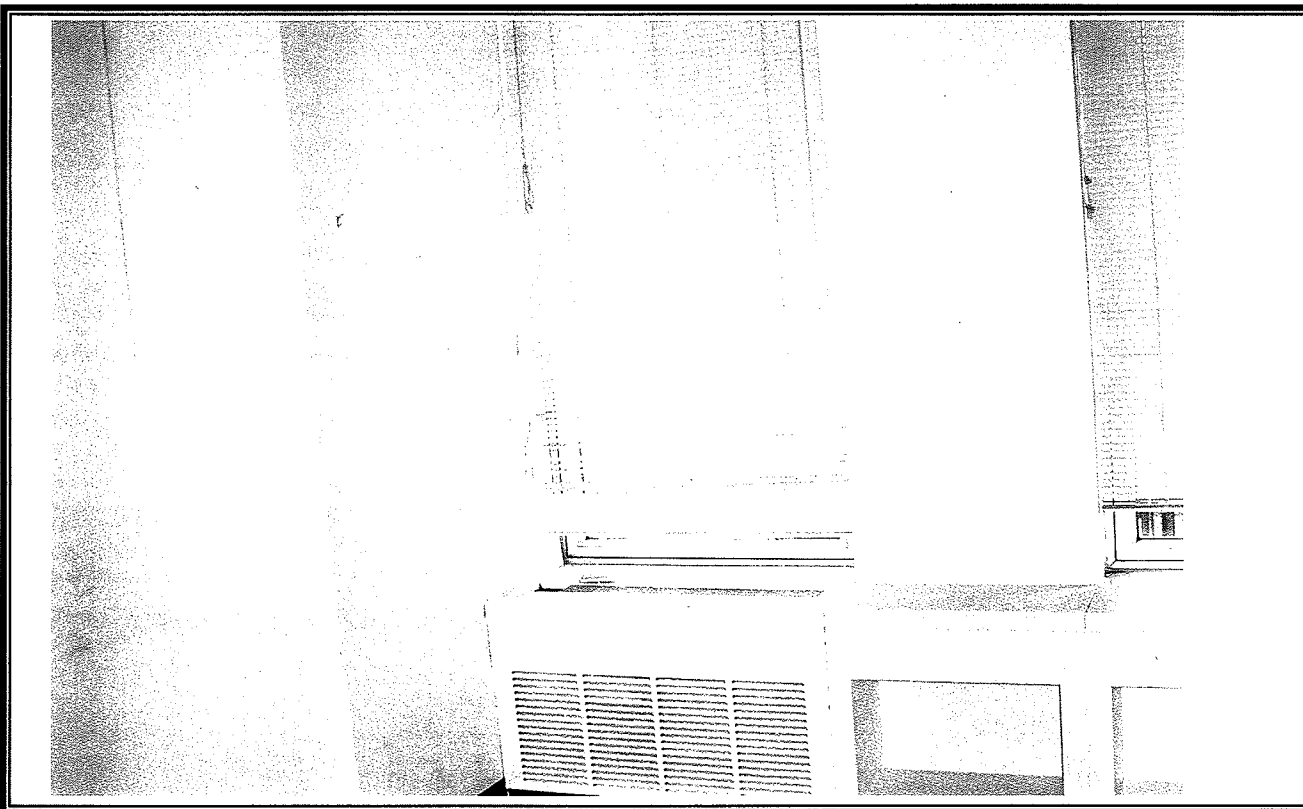
Photo 12  
Photo Date  
11/21/06

View of painted walls and window sills in a vacant office in the Midtown Tower Building.  
Limited peeling paint was observed by windows and on painted surfaces of heat radiators.

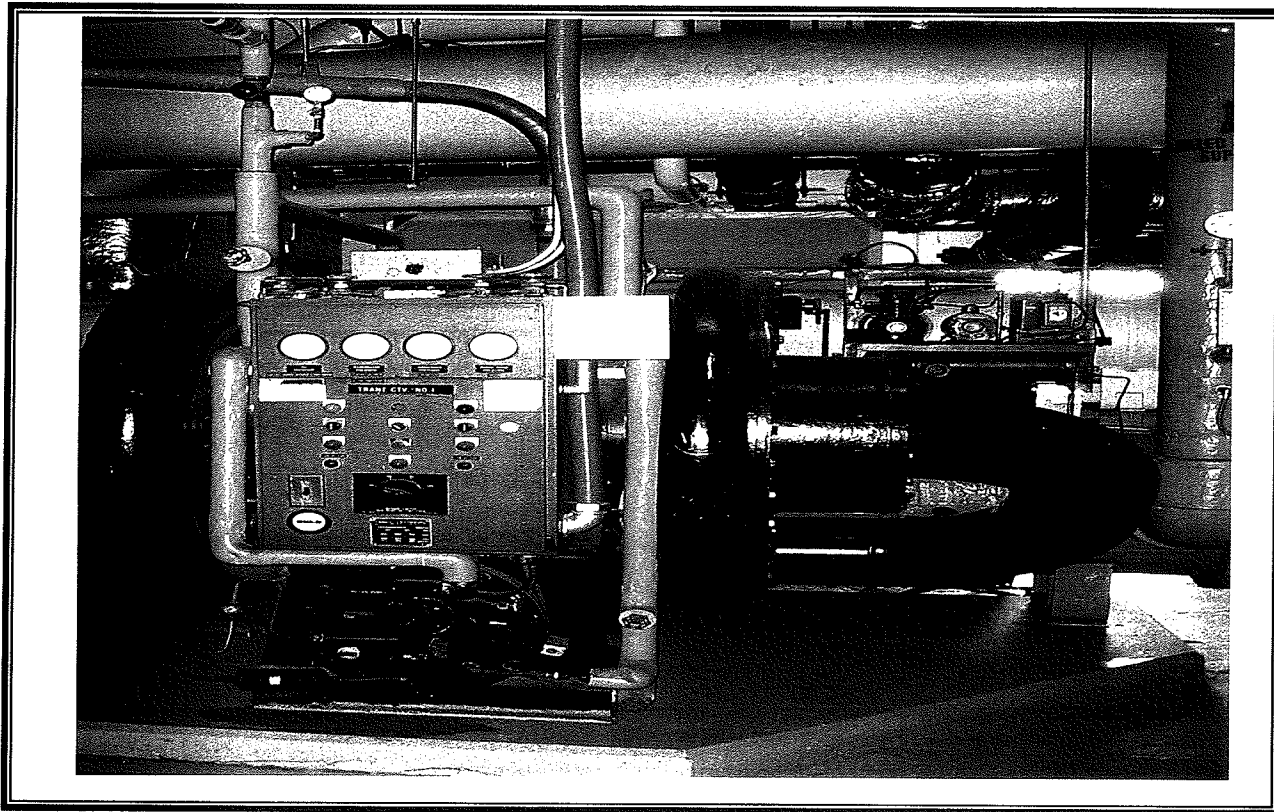
Photo 1  
Photo Date 12/05/06  
Midtown Tower - Main Chiller Plant  
Front view of 910 ton chiller installed in 1967. R-11 machine was re-tubed in 1988

Recommendations: Full cooling load requirements for the Tower, the Mall, and the Euclid Building are approximately 1400 to 1500 tons of refrigeration. All existing chillers have exceeded its useful life and have to be replaced with new and more efficient machines.

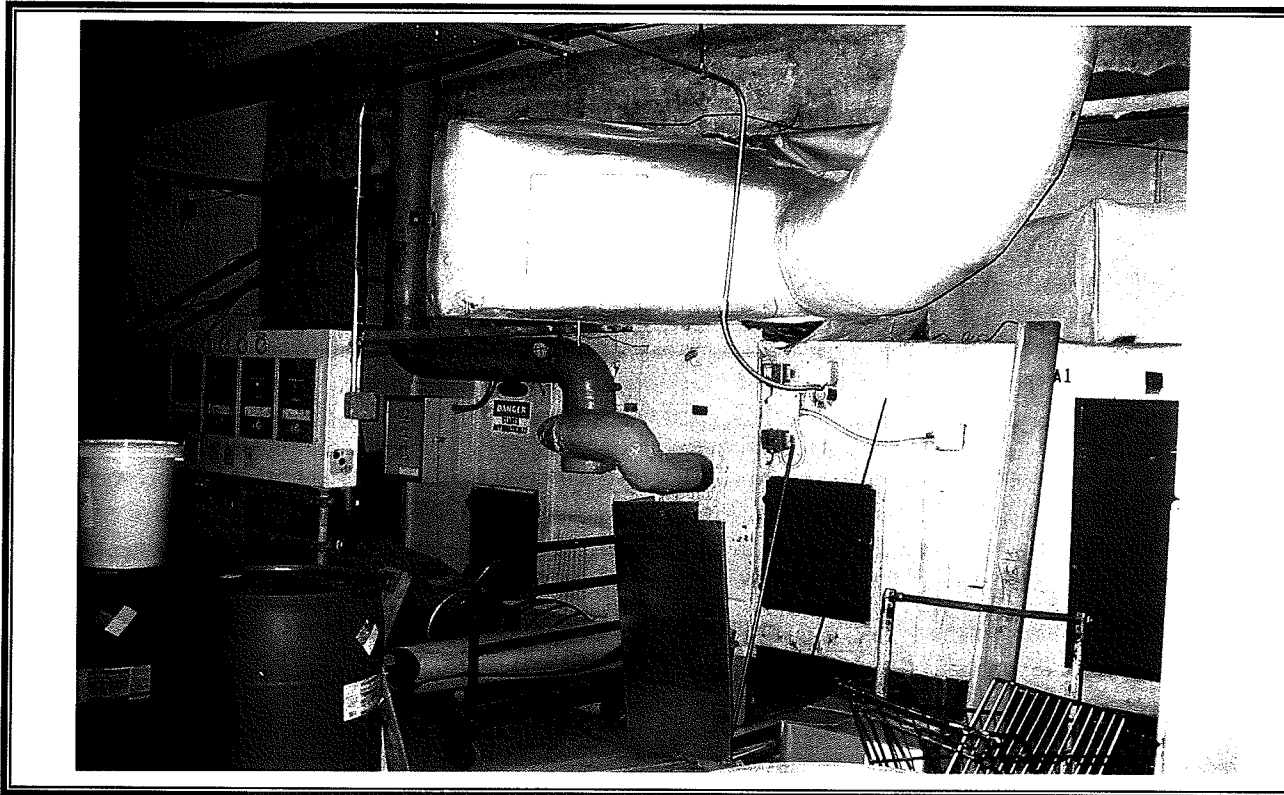
Air Handling Units located in the 3<sup>rd</sup> floor mechanical room and supplying air to the Tower and the Mall are as follows: AC-1, 80,000 CFM, 100 HP, fan was replaced in 1985; AC-2, 52,000 CFM, 50 HP, supplies Mall; AC-6, 26,000 CFM, 60 HP, VAV System supplies Mall Terrace; PA-1 & 2, 24,000 CFM, 40 HP each. All air handlers are 44 year old, are beyond its useful life, and should be replaced or refurbished.

Photo 3  
Photo Date 12/05/06  
Midtown Tower - 3-rd Floor Mechanical Room  
PA-1 Air Handling Unit, 44 years old.  
Steam heating coil is disconnected and abandoned in place.

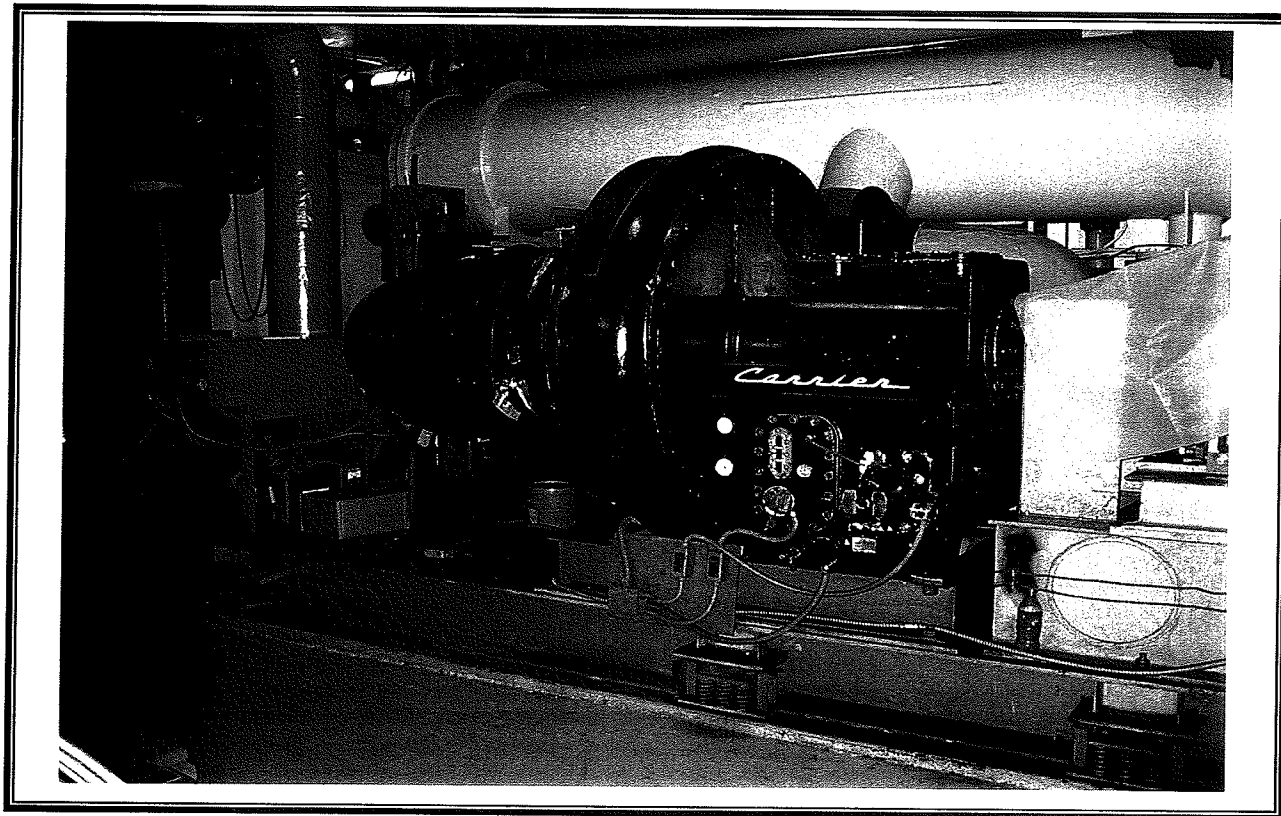
Photo 2  
Photo Date  
12/05/06

Midtown Tower - Main Chiller Plant  
Back view of 910 ton chiller installed in 1967. R-11 machine was re-tubed in 1988

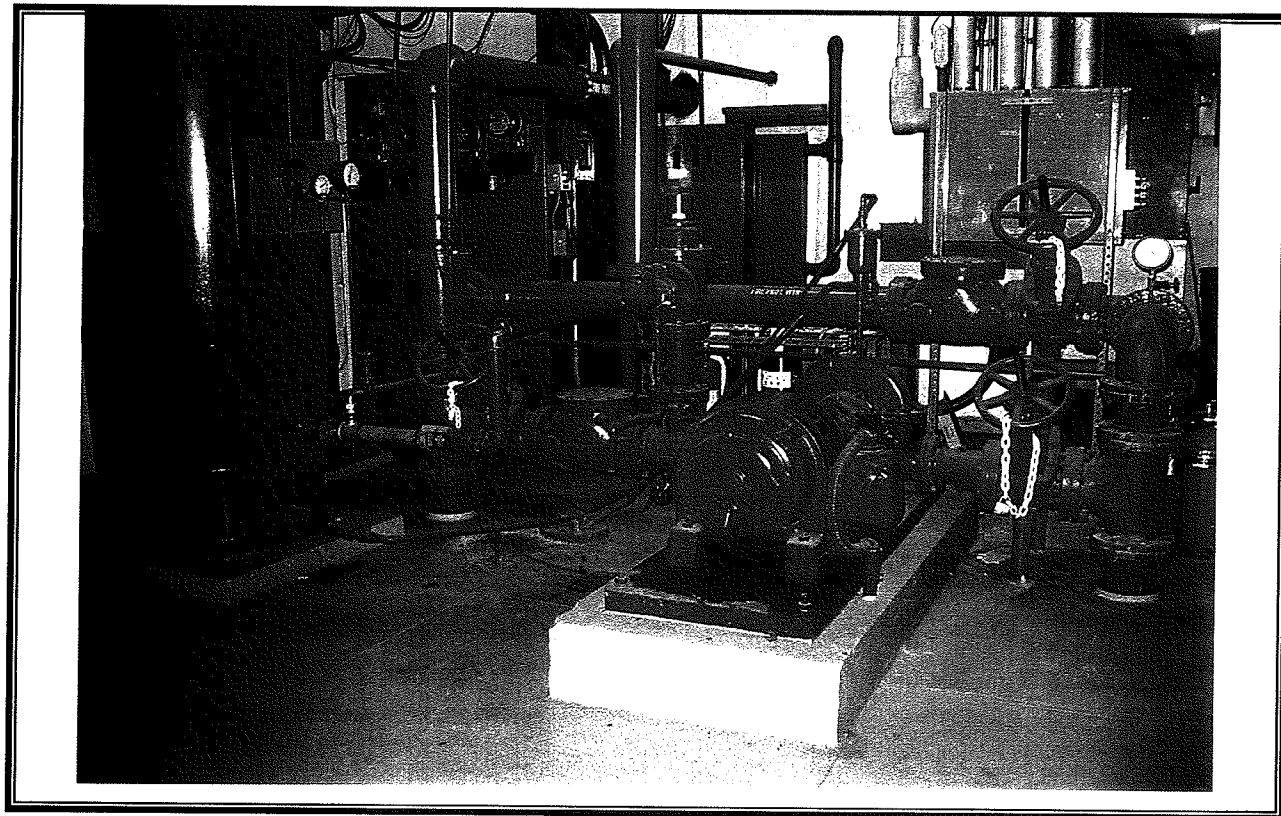
Photo 5  
Photo Date  
12/05/06

Midtown Tower - 3 rd Floor Mechanical Room  
Fire pump is 46 years old and inadequate

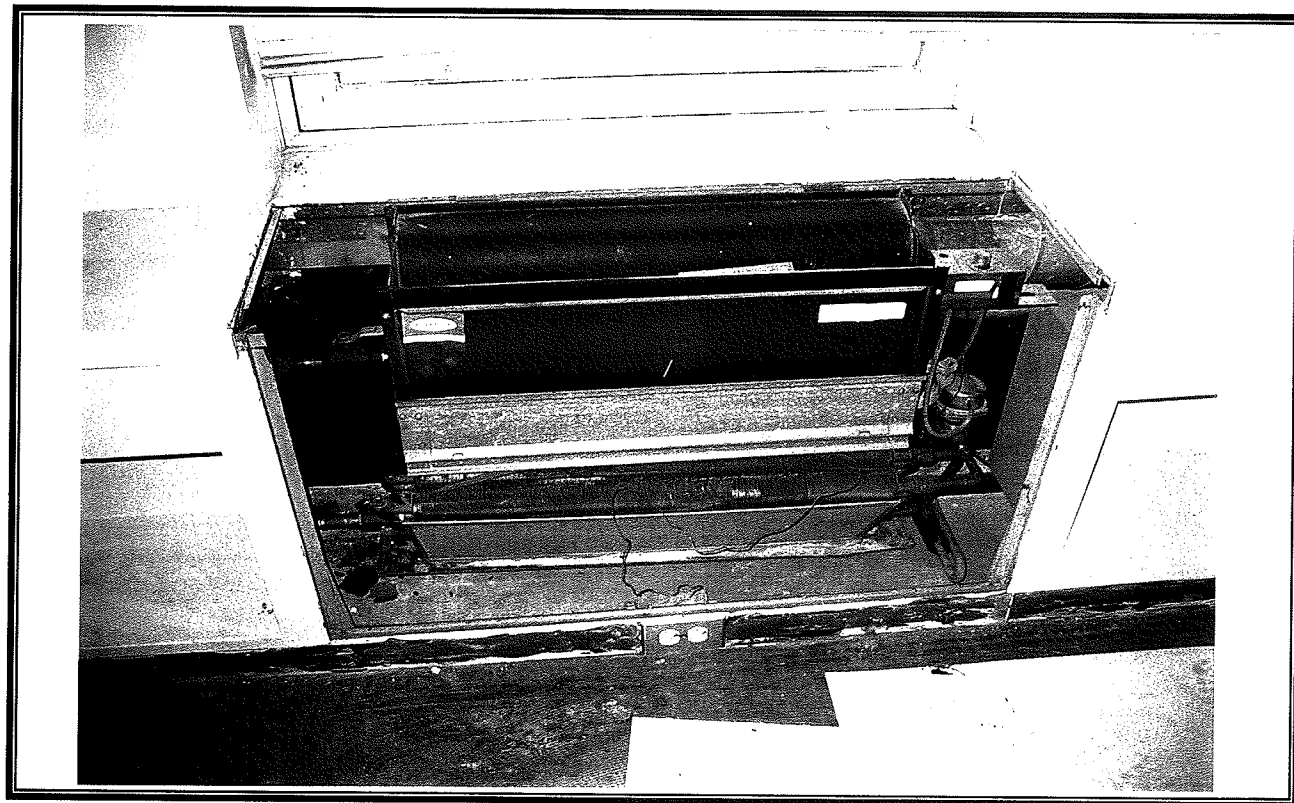
Photo 7  
Photo Date  
12/05/06

Heating and cooling are provided by 2-pipe induction units along the perimeter, which are fed from the main air handling units. All induction units are original to building and have to be replaced. New units should have DDC controls in lieu of pneumatics.

Midtown Tower - 6 th Floor.  
Typical perimeter induction unit

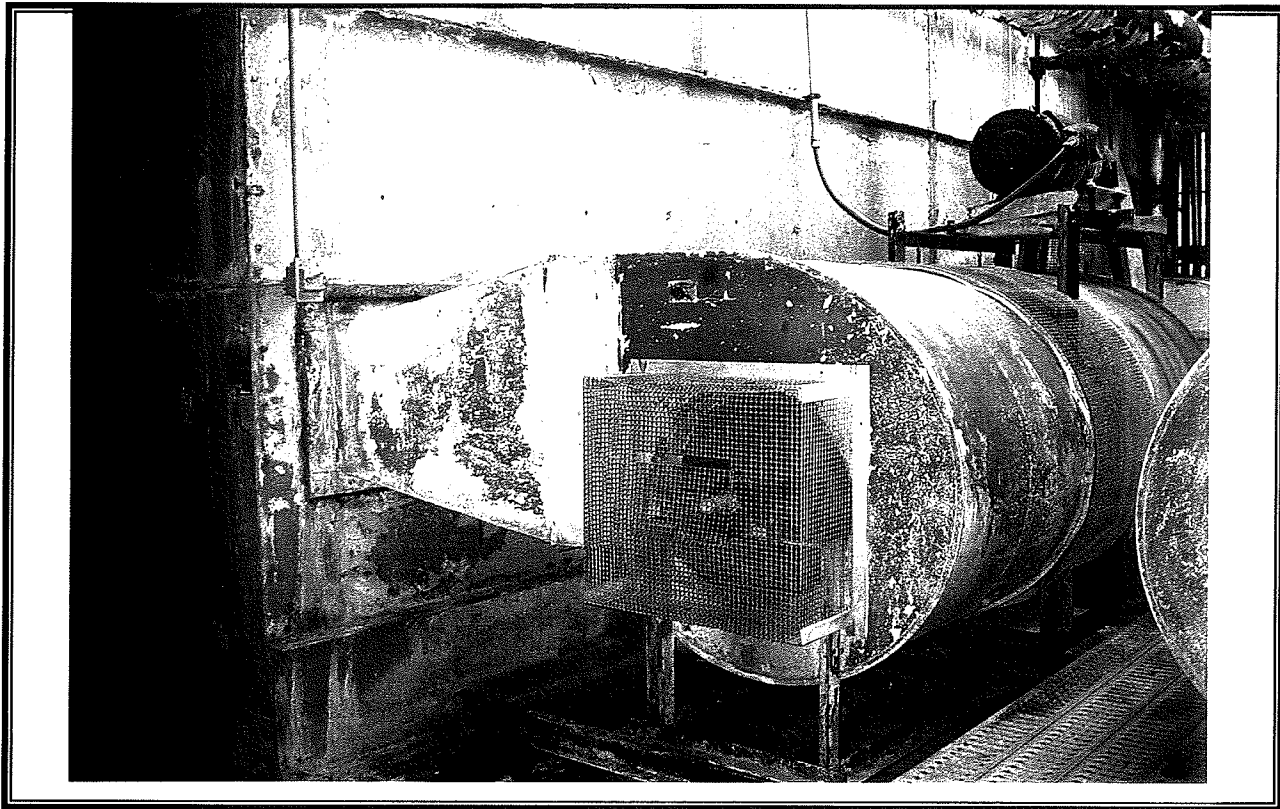
Photo 6  
Photo Date  
12/05/06

Midtown Tower - Main Chiller Plant  
One of 4 cooling Towers

Recommendations: Remove all 4 towers and replace with 2 towers for 1400 to 1500 ton capacity.

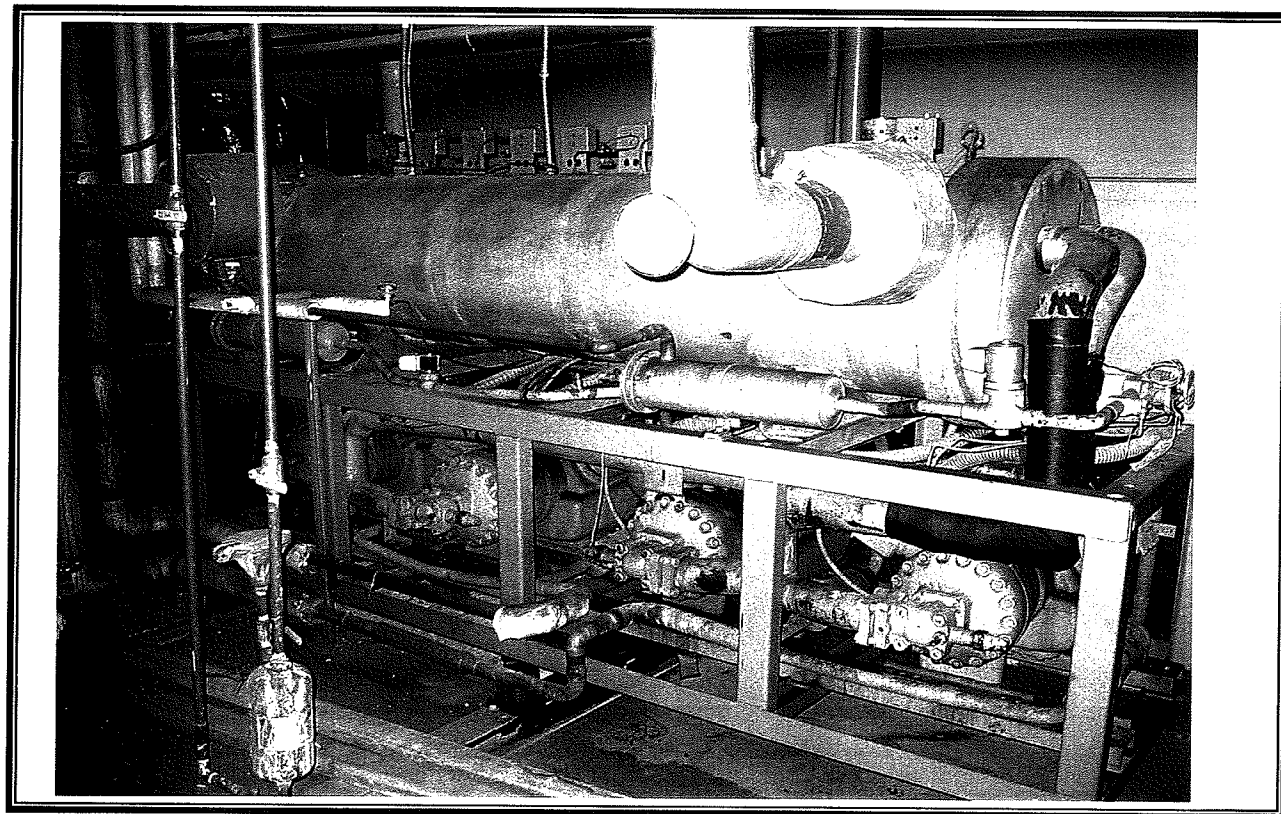
Photo 9  
Photo Date  
12/05/06

Midtown Tower - 18th Floor Mechanical Room  
100 ton air cooled reciprocating chiller.

18<sup>th</sup> floor chiller needs to be removed; replacement can be done at the later date, when restaurant is leased to the tenant.

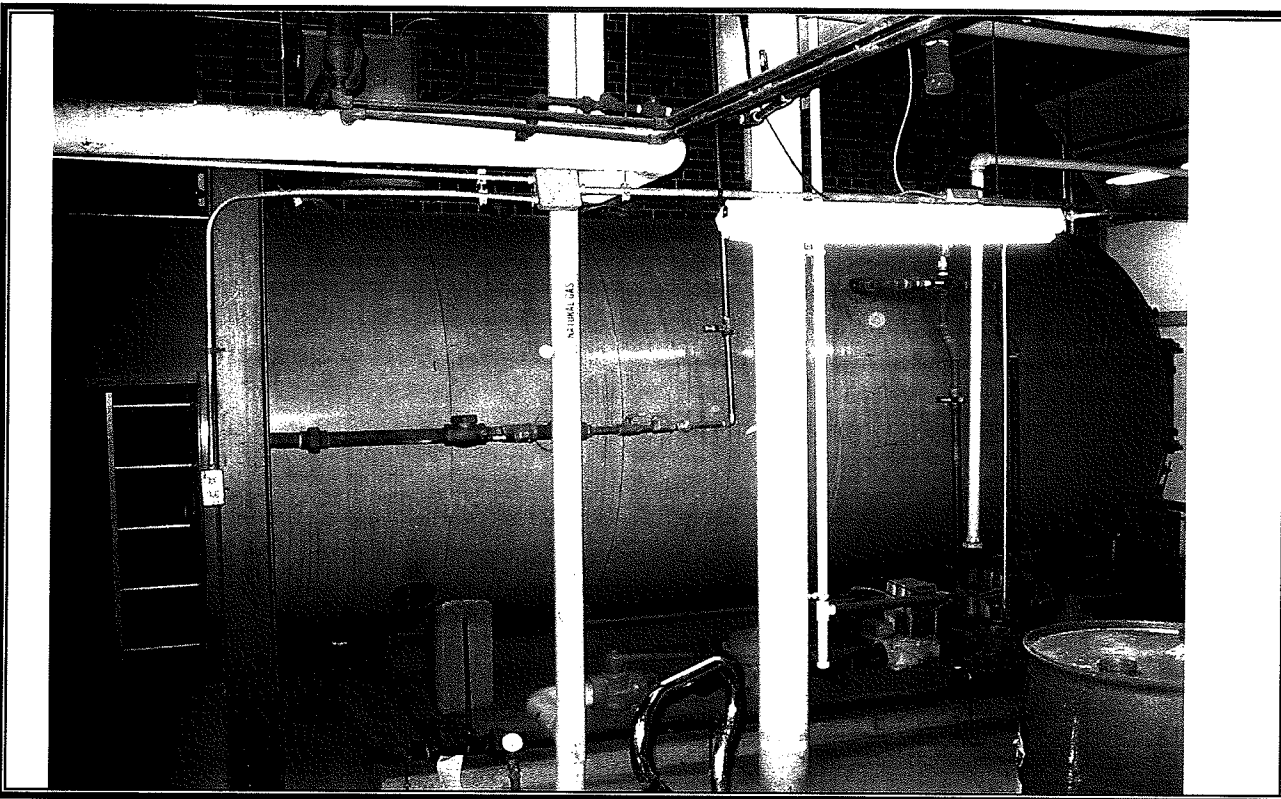
Photo 10  
Photo Date  
12/05/06

A 200-hp, dual fuel, Burnham high pressure steam boiler (1985), located at the ground level supplies steam to hot water converters for heating hot water for the Tower, the Mall, and the Euclid Building. Originally steam was also supplied to some Air Handling Units; presently many of steam coils are disconnected and abandoned in place.

Midtown Tower  
Main Boiler - 200 HP. High pressure steam

Recommendations: Boilers are in good to fair condition and can remain in service.

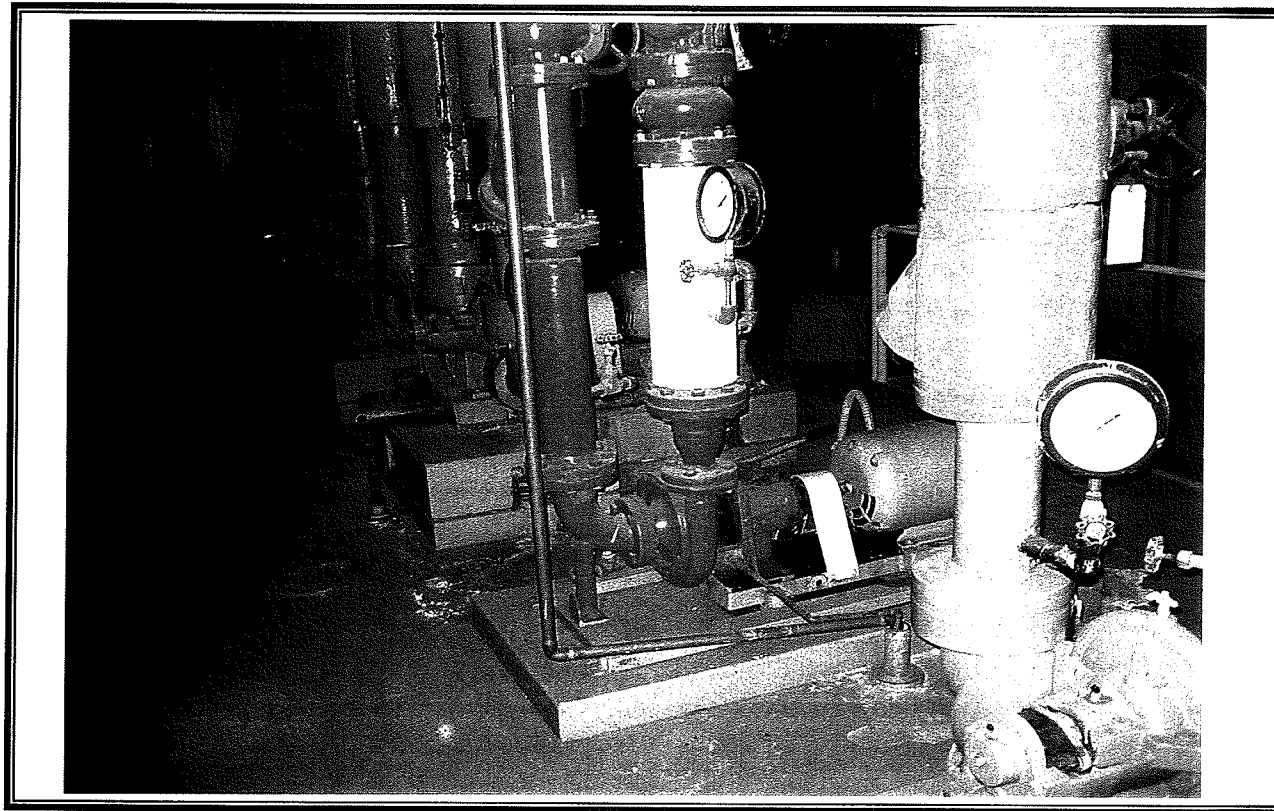
Photo 11  
Photo Date  
12/05/06

Euclid Building.  
Chilled water/hot water pumps. 44 years old; some of them are out of service.

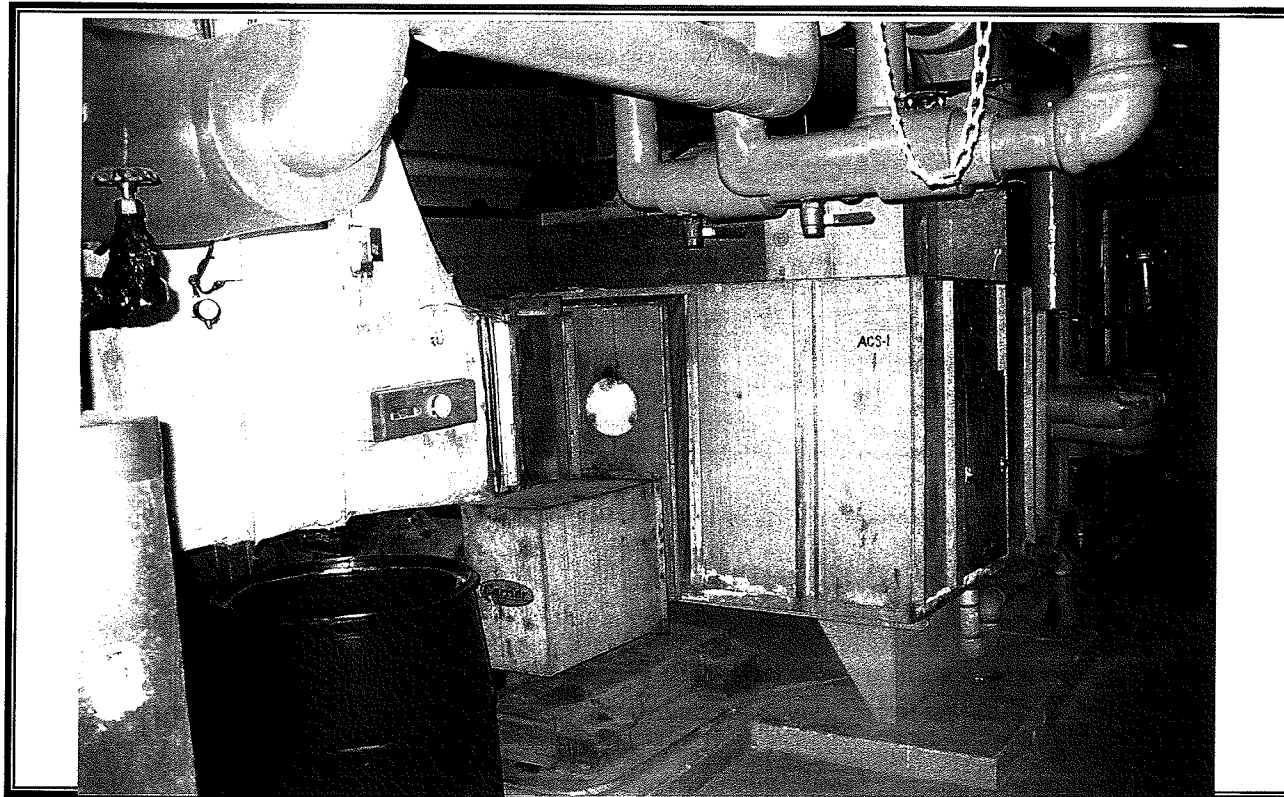
Photo 12  
Photo Date  
12/05/06

Euclid Building  
ASC-1 Air Handling Unit feeding the induction units. AHU is approximately 44 years old.

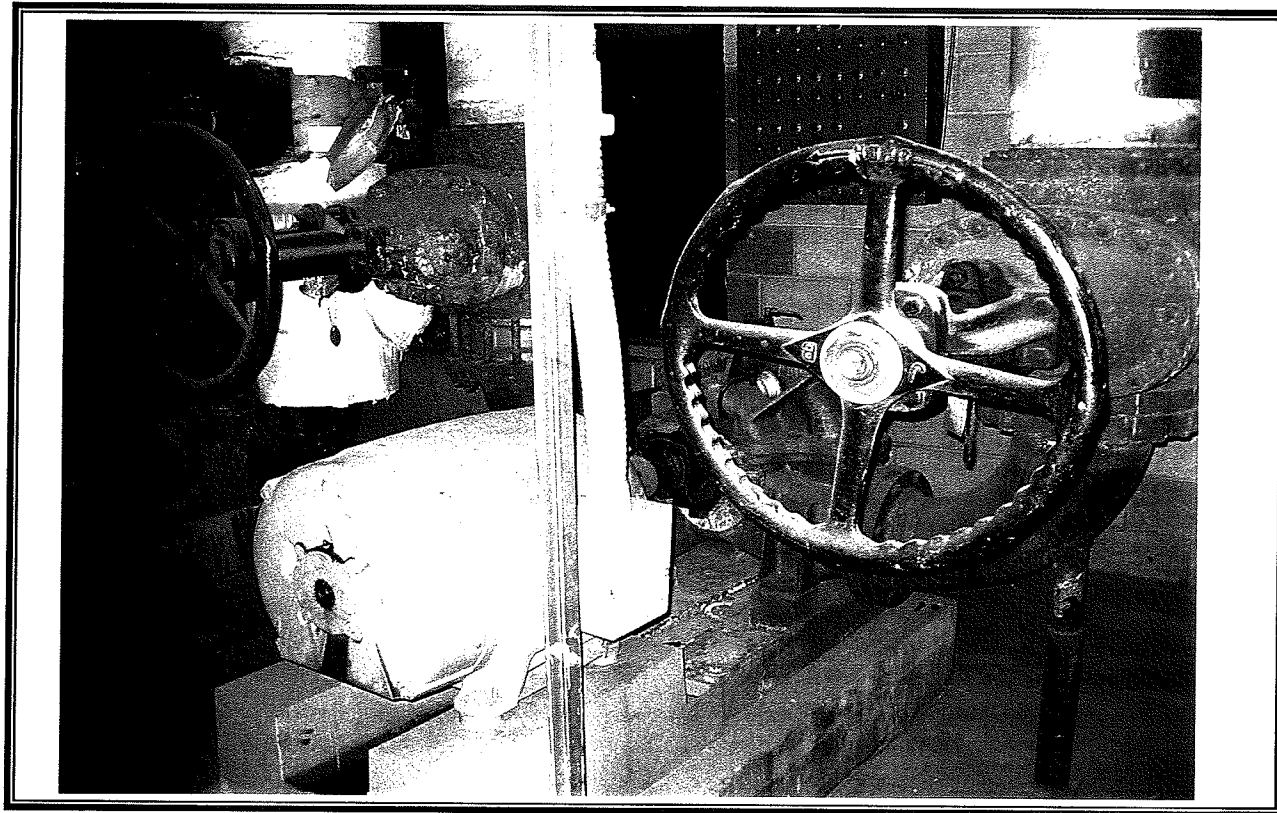
Photo 15  
Photo Date 12/05/06  
McCurdy Building  
Chilled water and condenser water pumps  
Out of 6 pumps, only one is operational

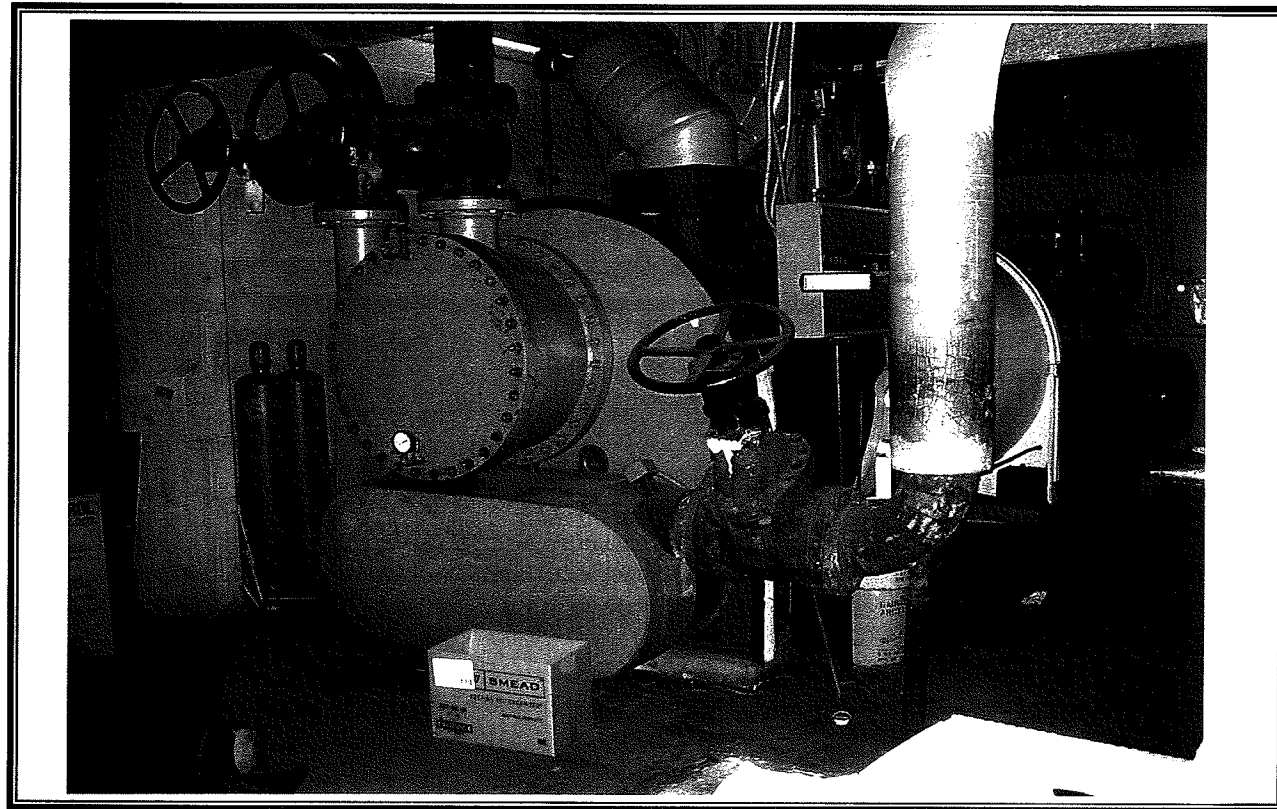
Photo 17  
Photo Date 12/05/06  
McCurdy Building  
600 ton York chiller is approximately 40 years old.  
It was taken out of service in 1985
