### **Midtown Building Assessment**

### Building Assessment

The City of Rochester

*December 8, 2006*

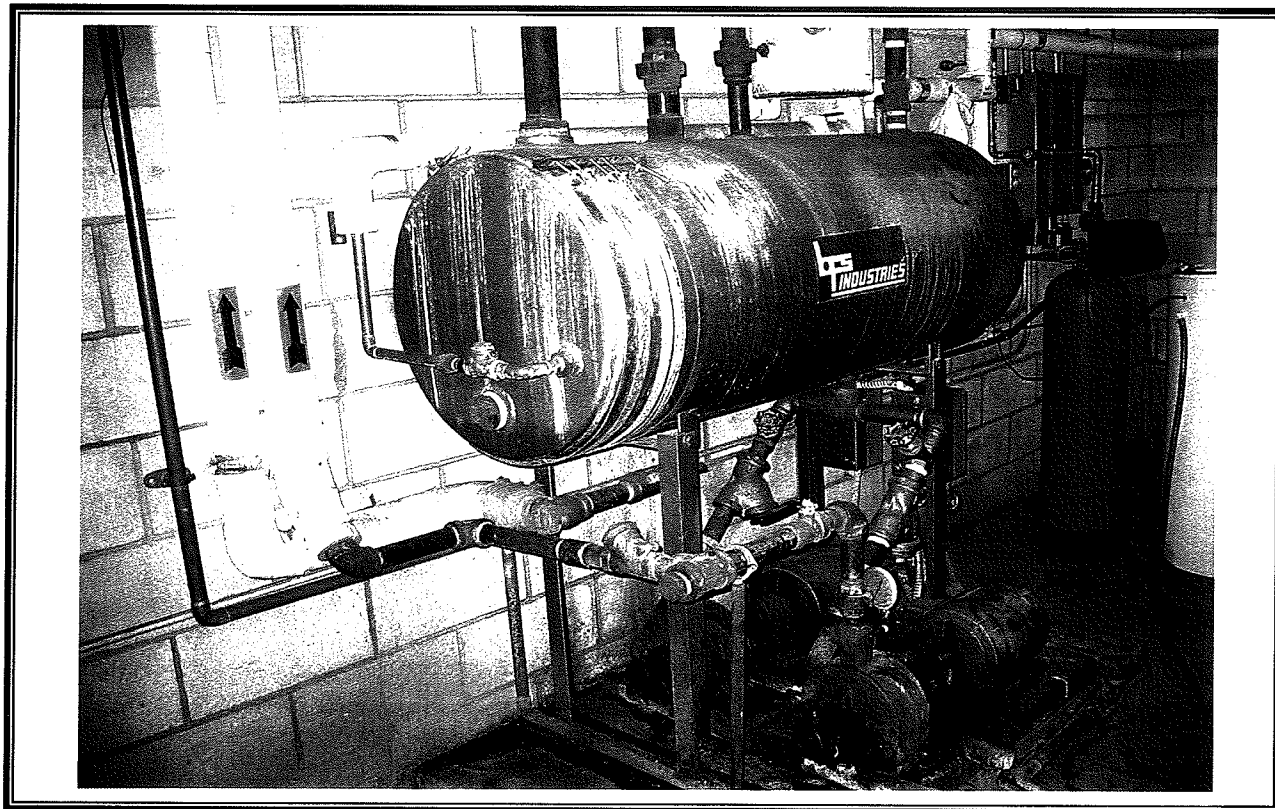
Photo 19  
Photo Date  
12/05/06

McCurdy Building  
Boiler feedwater tank was leaking and has patches on it.

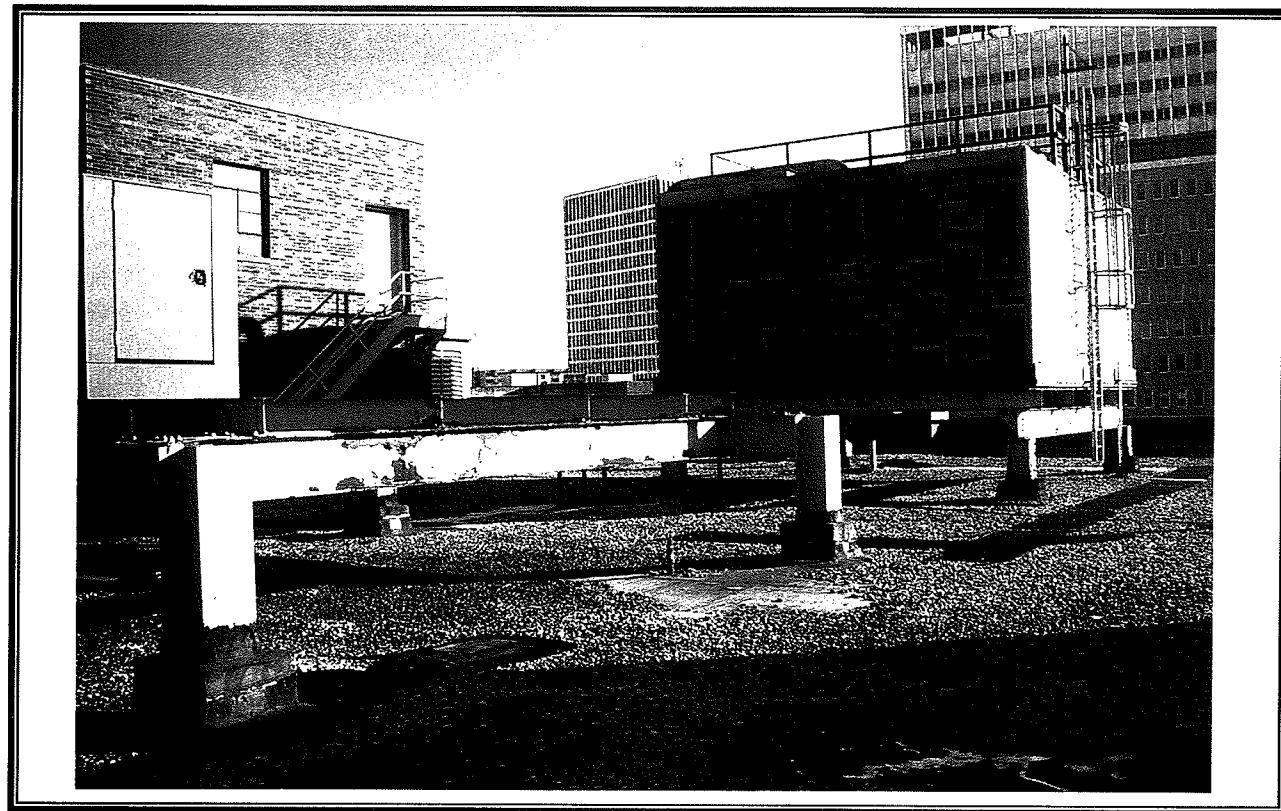
Photo 21  
Photo Date  
12/05/06

McCurdy Building  
One cooling tower has been removed and one abandoned in place.

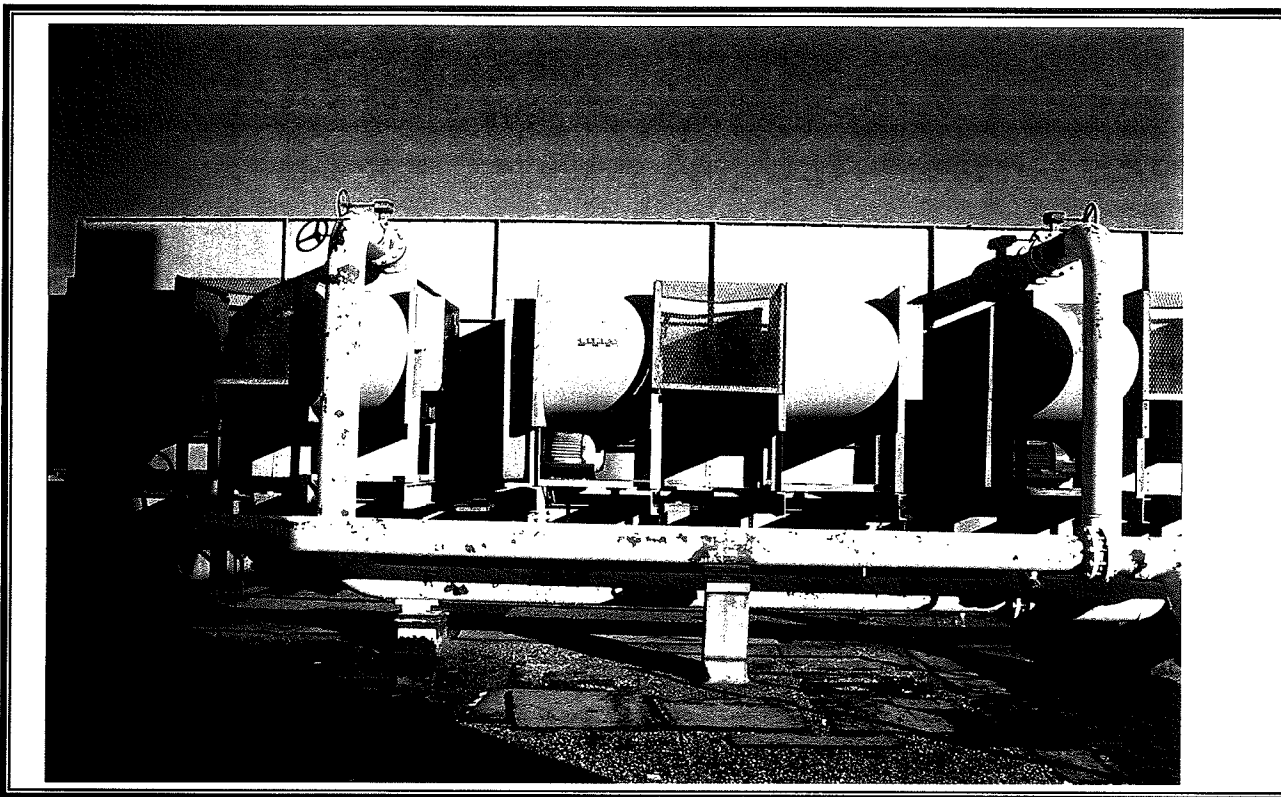
Photo 22  
Photo Date  
12/05/06

Seneca Building  
12 cells Binks cooling tower was rehabilitated in in late 80th.

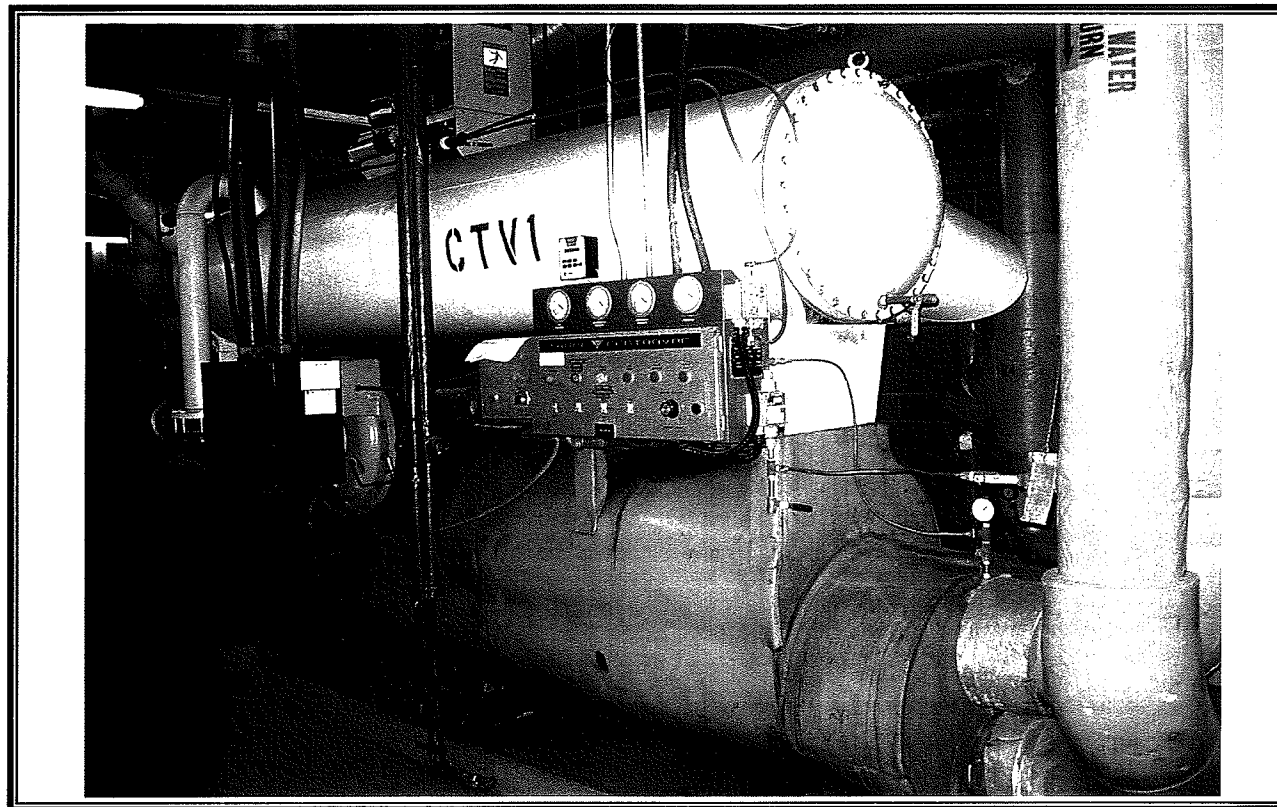
Photo 23  
Photo Date  
12/05/06

Seneca Building  
One of three 490 t Trane chillers. Two machines were refurbished in 1997 to run on R-123.  
Third machine should be refurbished or replaced

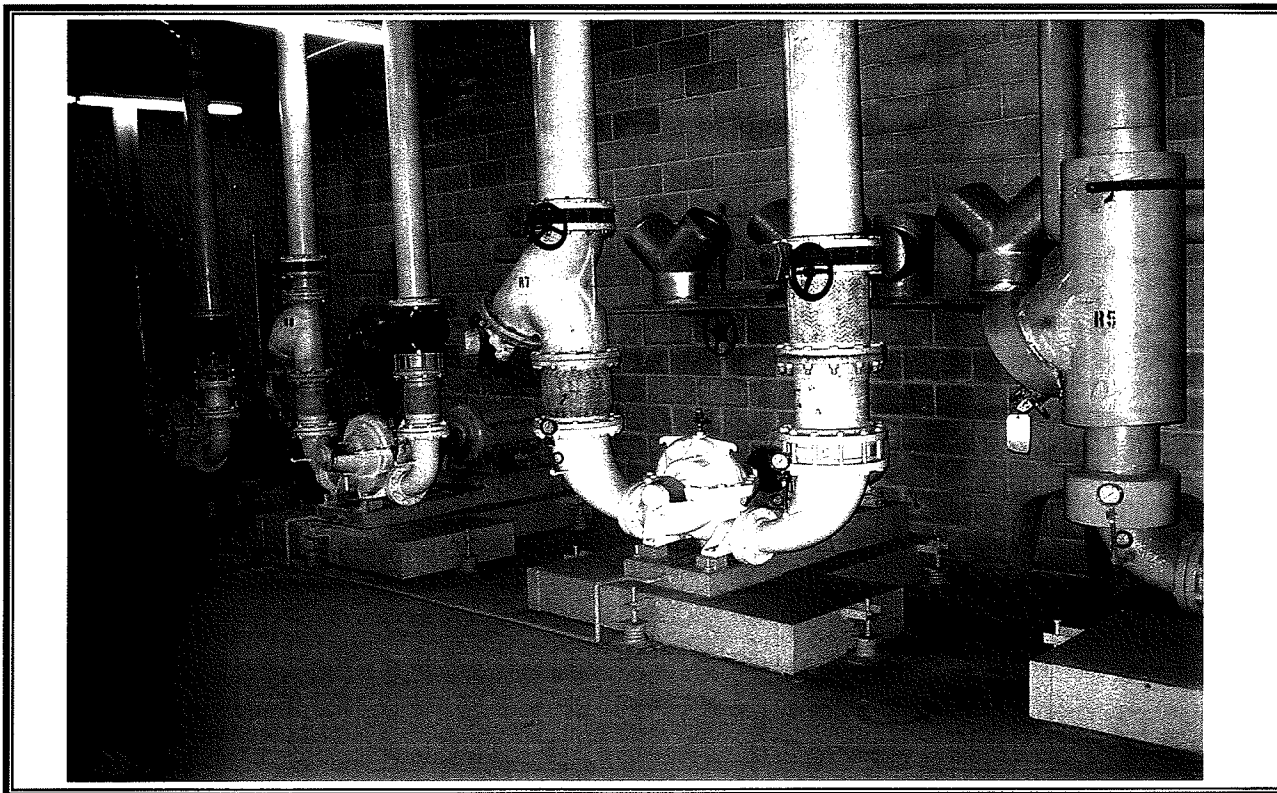
Photo 24  
Photo Date  
12/05/06

Seneca Building  
34 years old chilled water and condenser pumps. One pump out of 6 was replaced approximately 10  
years ago. Five other pumps need to be replaced.

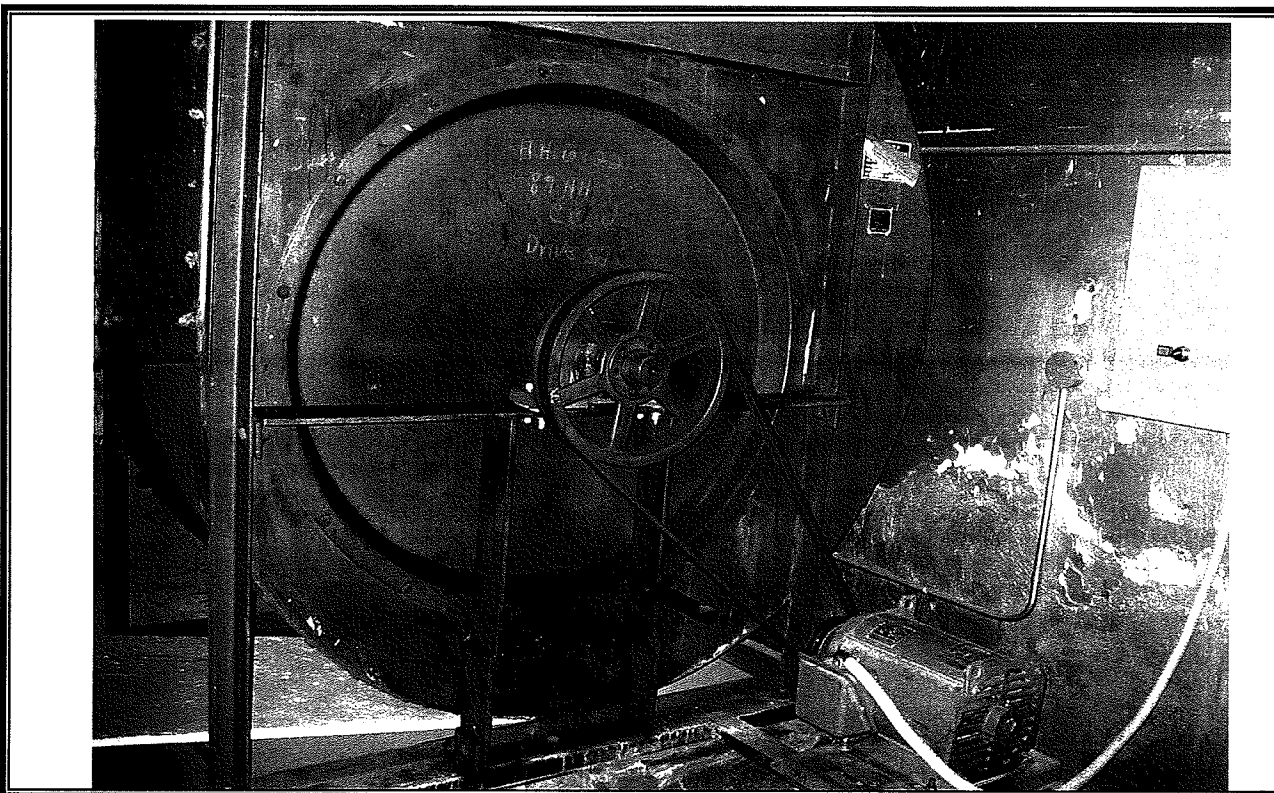
Photo 26  
Photo Date  
12/05/06

B. Forman Building  
40 + years old air handling unit AH1A located in the basement

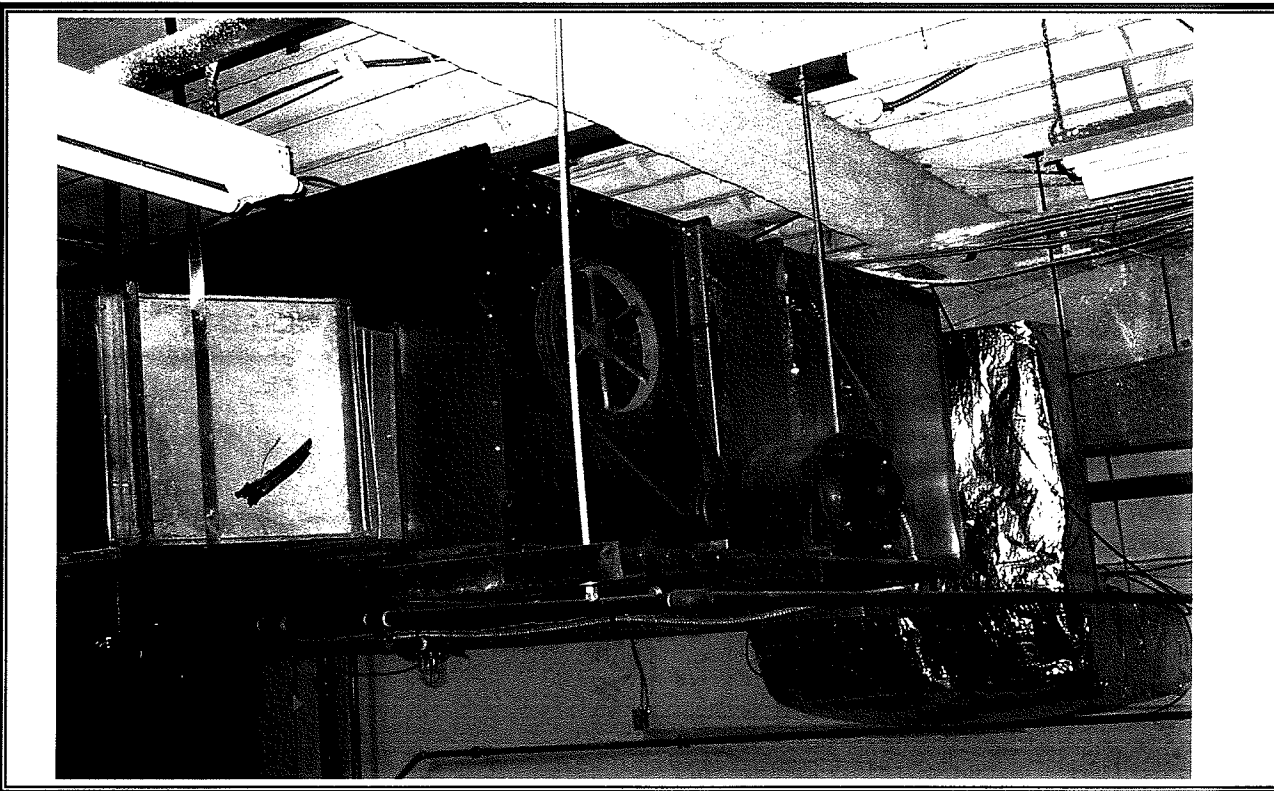
Photo 28  
Photo Date 12/05/06  
B. Forman Building  
40+ years old air handling unit suspended from the ceiling

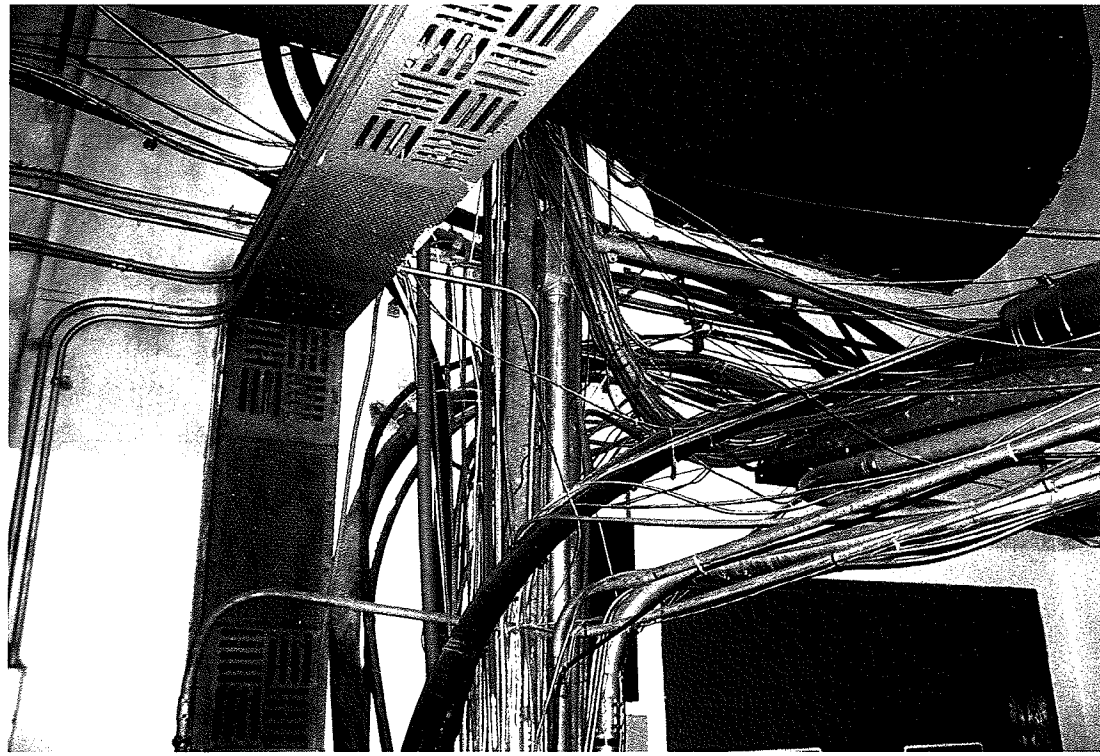
Photo 1  
Photo Date  
12/05/06

Bus duct used as conduit support Midtown Tower

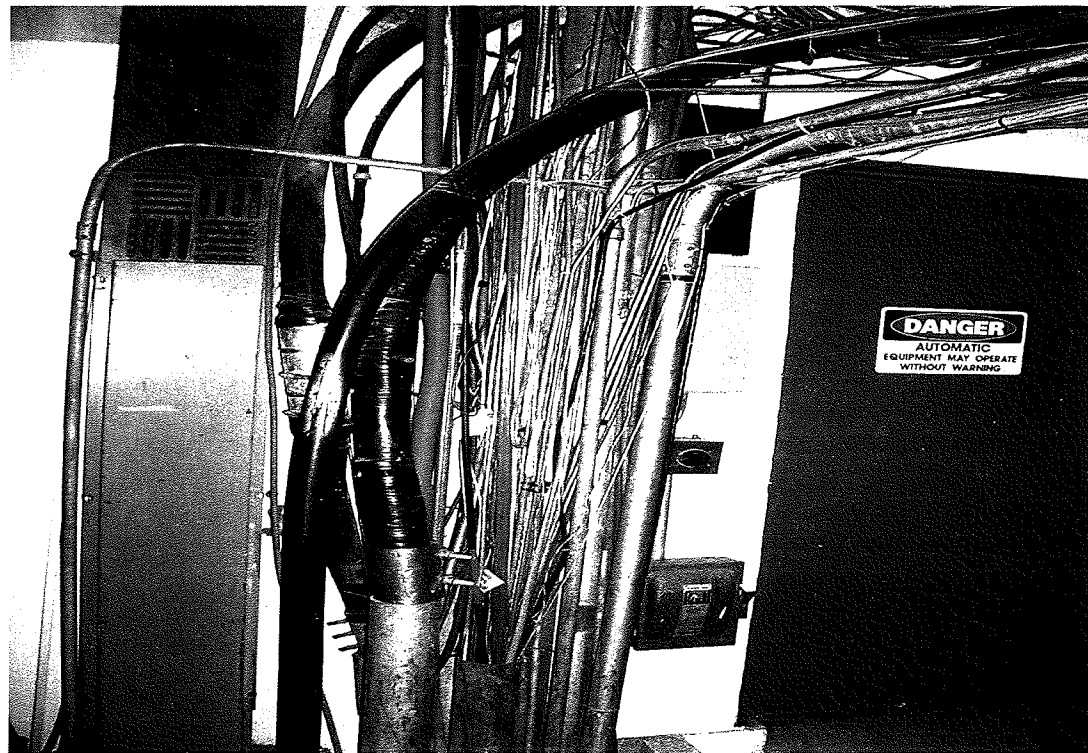
Photo 2  
Photo Date  
12/05/06

The existing communication system is past its usefull life and a modern system should be install

Typical communication within Midtown Tower

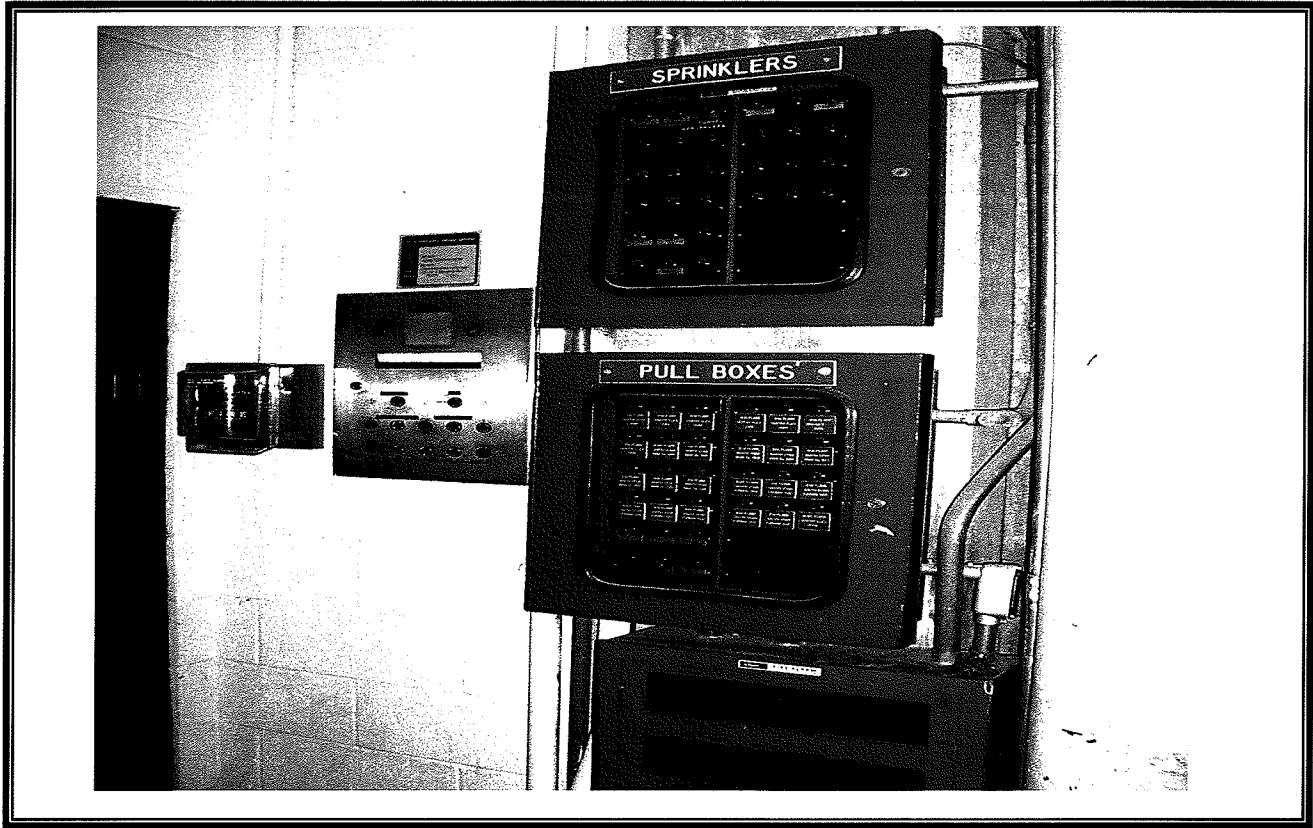
Photo 3  
Photo Date  
12/05/06  
Non-addressibel fire alarm system Midtown Tower
