Pre-Demolition Asbestos Survey Report
for
The McCurdy's Building
of
Midtown Plaza Complex
Rochester, New York

FINAL
December 17, 2008

Report of Asbestos Survey Services

1.0 EXECUTIVE SUMMARY

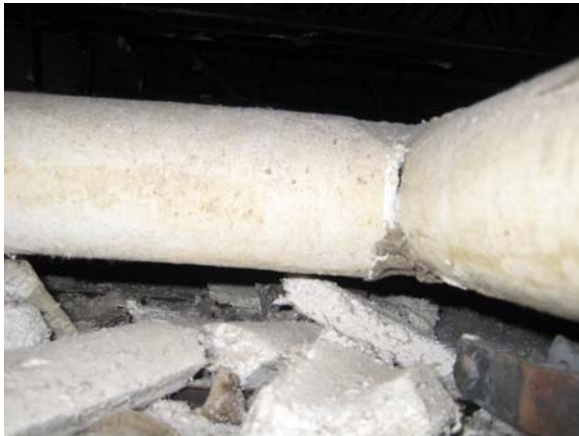
IMG 1618

2. Fixed plaster ceilings in Section 1 of this building have ACM pipe insulation above and debris is noted in all areas. This plaster ceiling system is to be considered contaminated. See IMG(s) 1618,1624,1581,1620. The plaster ceiling and all suspect ACM found above the ceiling (including pipe insulation) shall be abated as part of the ceiling system.

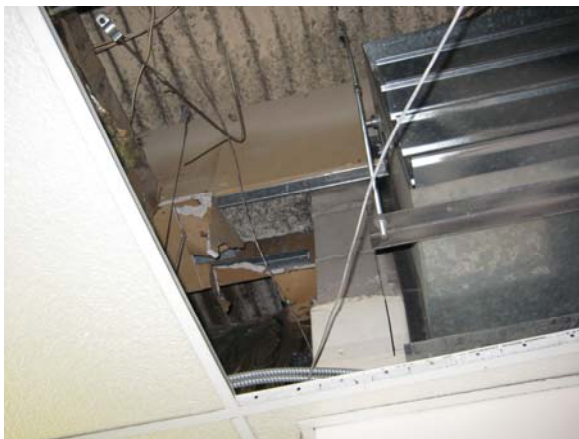
IMG 1611

3. "Encapsulated" fireproofing, primarily found in Section 2, still shows ACM through gaps and holes throughout. All ceiling systems installed below this material should be considered contaminated. See IMG(s) 1611, 1595.

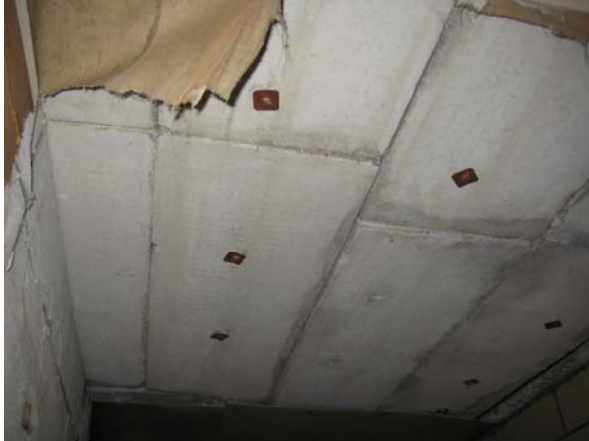
IMG 1655 – duct insulation blocks

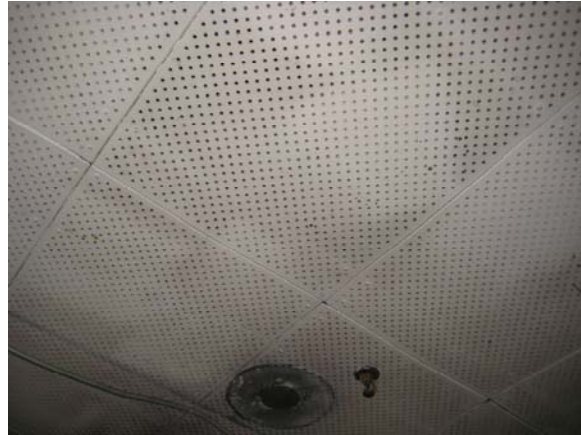
ACM Transite ceiling panels in basement

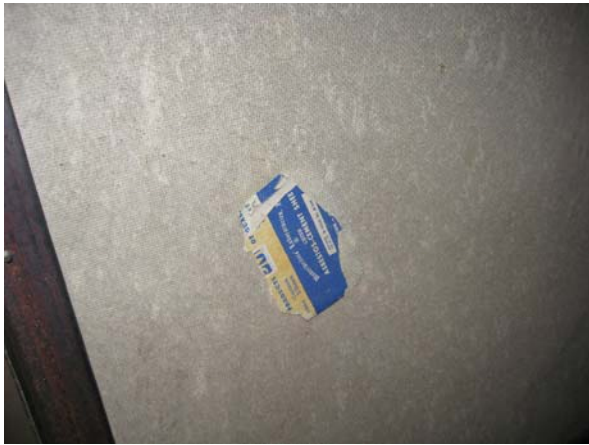
ACM Transite boards
