March 23, 2012

Re: Midtown Plaza – Seneca Building Asbestos and Lead-Based Paint Evaluation
Rochester, NY

CITY OF ROCHESTER
ASBESTOS SURVEY
FORMER MIDTOWN PLAZA
SENECA BUILDING

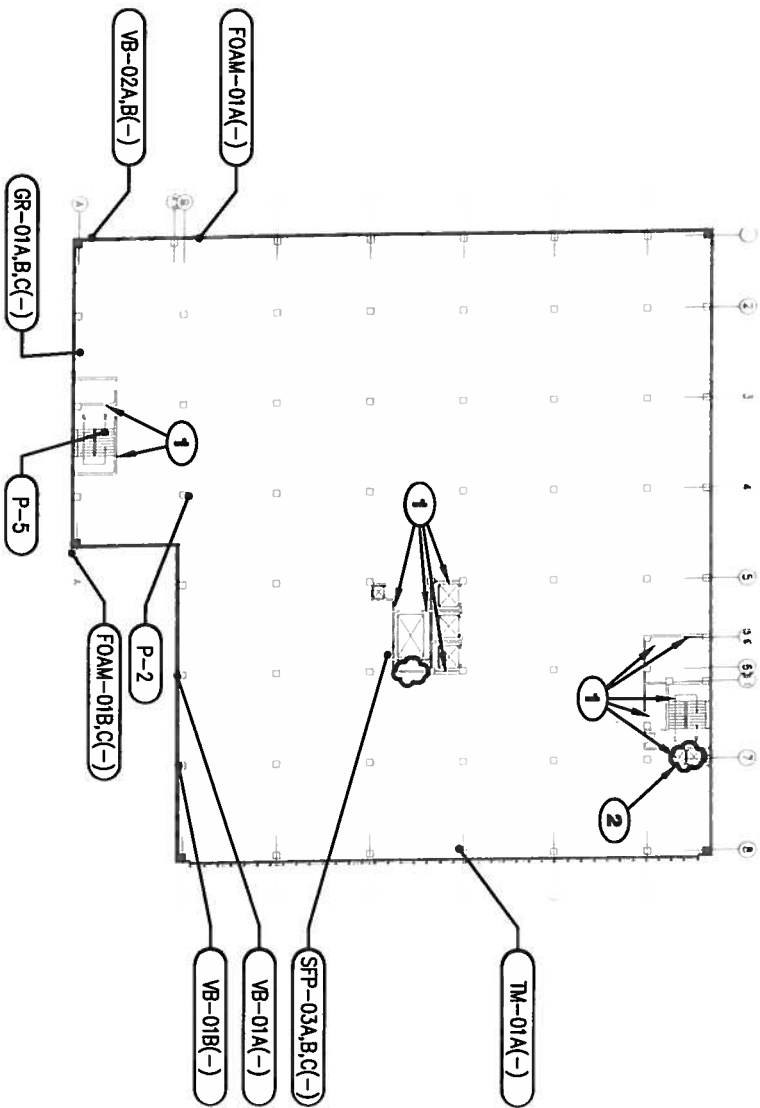
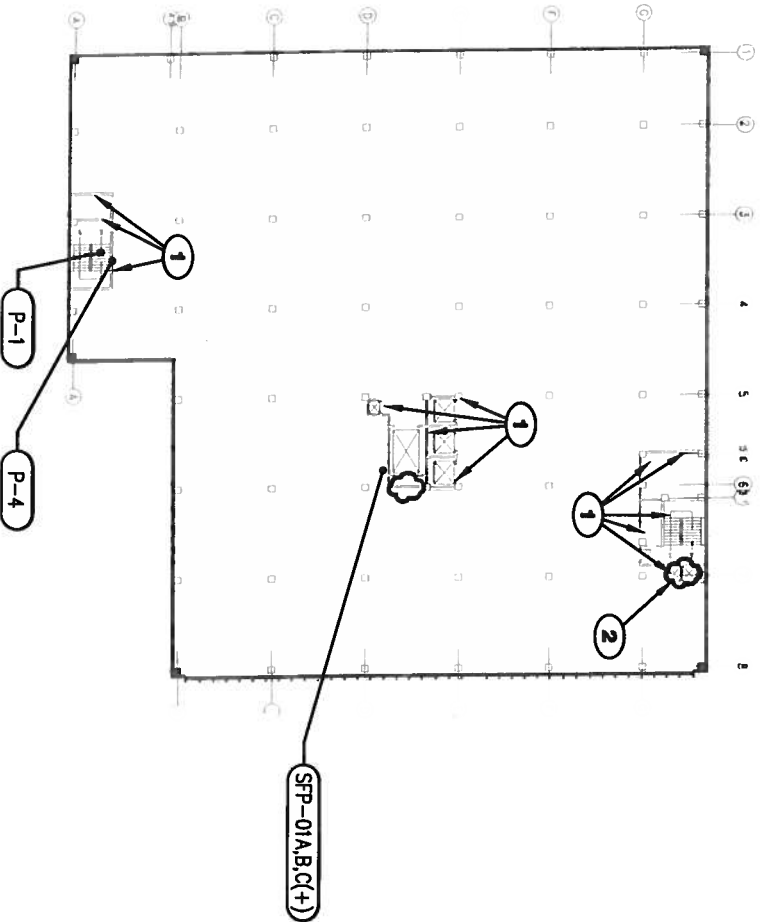
Figure Number
1

Sample locations and asbestos containing materials are illustrated on attached Figures 1-3. The asbestos containing structural steel fireproofing (SFP) is located inside the elevator pipe chase and also in the vicinity of the wall demolition on the first and second floor adjacent to the same chase. The material was apparently concealed inside the chase and the wall demolition exposed it. This same SFP is anticipated to be at the tops of the wall locations at the stair towers and other CMU walls that connect directly to the above corrugated steel floor deck. The chase system at the south stairwell is also anticipated to conceal SFP, this chase was not accessible during the survey. The anticipated ACM SFP locations are illustrated on the attached figures. Quantities listed in the report represent material observed during the inspection in the elevator pipe chase. If construction activities will not impact the other potential SFP sandwiched between the tops of the stair tower walls, stair chase and the steel floor deck this material could remain in place. However, if demolition of further interior CMU walls is to occur, asbestos containing SFP should be assumed present in those locations.

AREA OF ACM FIREPROOFING ON BEAMS, WALLS AND FLOORS INSIDE CHASE

- KEYED NOTE:**
- 1 ACM FIREPROOFING IS POTENTIALLY CONCEALED BETWEEN WALL TOPS AND UNDER SIDE OF DECK.
 - 2 ACCESS LIMITED, ACM FIREPROOFING ASSUMED IN THIS LOCATION.

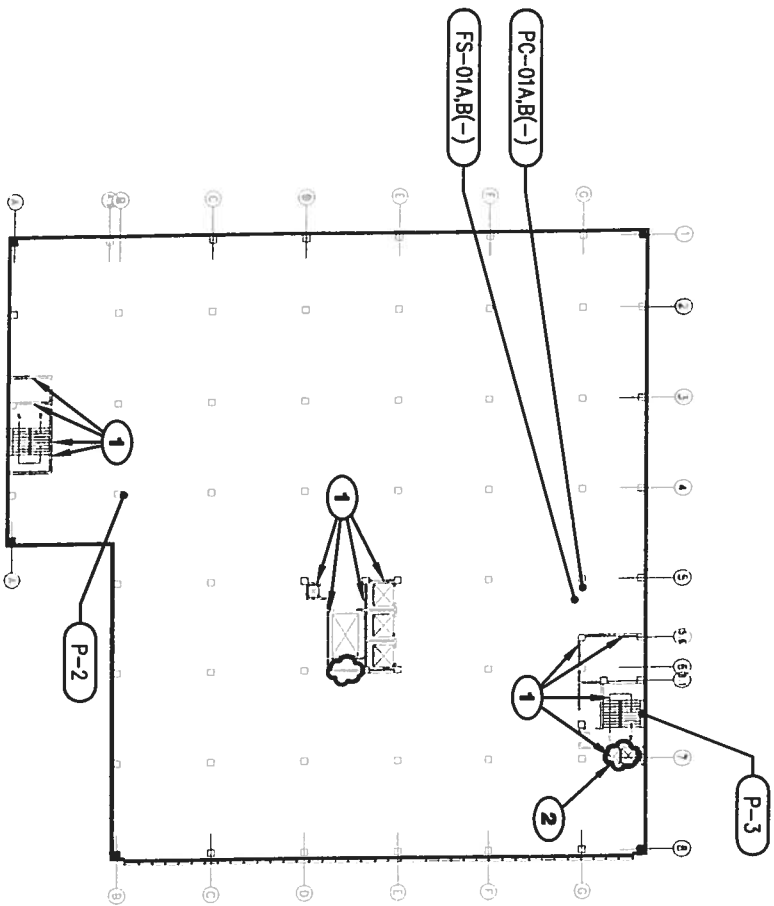
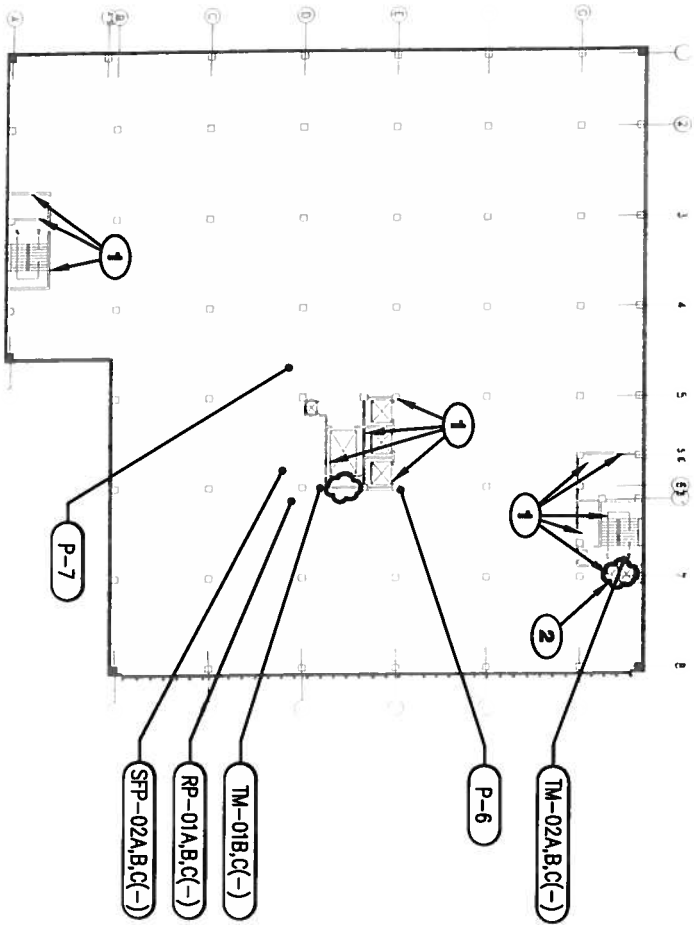
Figure Number
2

AREA OF ACM FIREPROOFING ON BEAMS, WALLS AND FLOORS INSIDE CHASE

- 1 ACM FIREPROOFING IS POTENTIALLY CONCEALED BETWEEN WALL TOPS AND UNDER SIDE OF DECK.
- 2 ACCESS LIMITED, ACM FIREPROOFING ASSUMED IN THIS LOCATION.

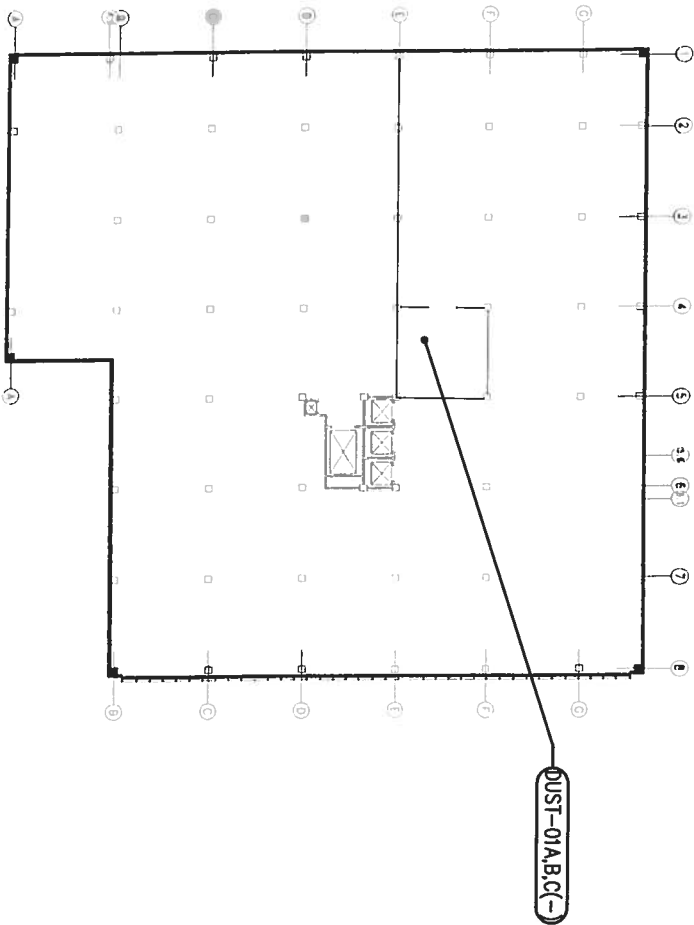
Figure Number
3

AREA OF ACM FIREPROOFING ON BEAMS, WALLS AND FLOORS INSIDE CHASE

- 1 ACM FIREPROOFING IS POTENTIALLY CONCEALED BETWEEN WALL TOPS AND UNDER SIDE OF DECK.
- 2 ACCESS LIMITED, ACM FIREPROOFING ASSUMED IN THIS LOCATION.

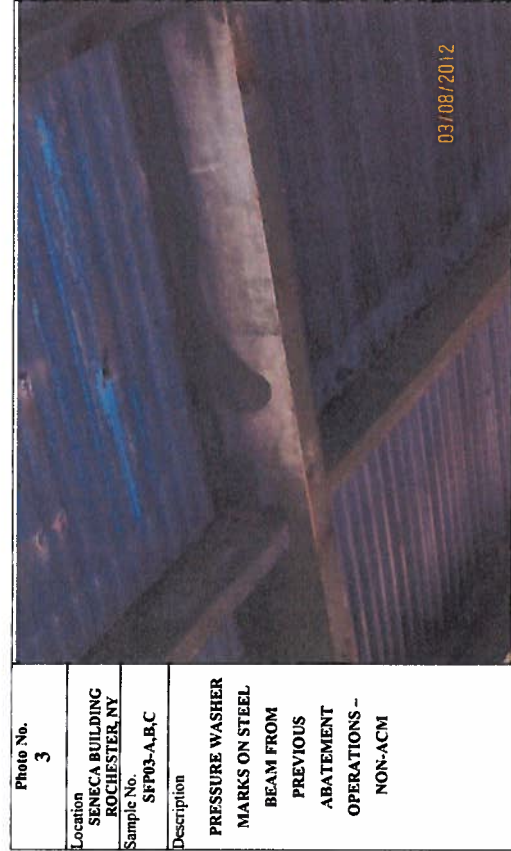
It was noted during the investigation that numerous beams and columns appeared to show signs of residual asbestos containing SFP (see attached picture 3). The beams seem to show the path of a pressure washer as it was sprayed on the beams and columns. Due to this concern, the white residue was sampled for asbestos content, however, no asbestos was found. Other locations showed concrete like material troweled on the beams and this too was sampled and found to be non-ACM.
