## West River Wall Reconstruction Planning and Preliminary Design

### Interim Report – Site Reconnaissance and Inventory of Current Conditions

July 3, 2014

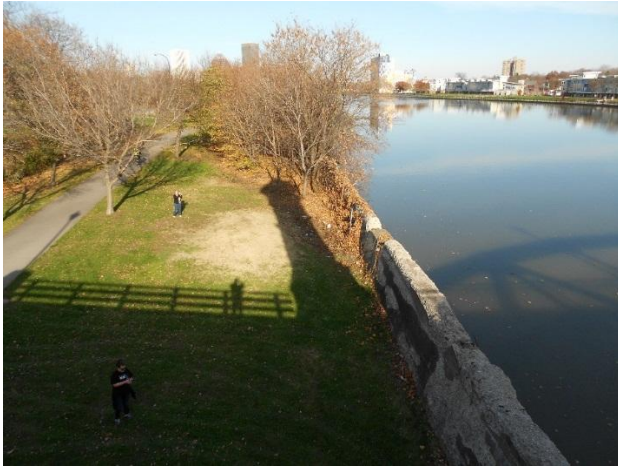
*The Riverway Trail and the west river wall, looking north from the Ford Street bridge.*

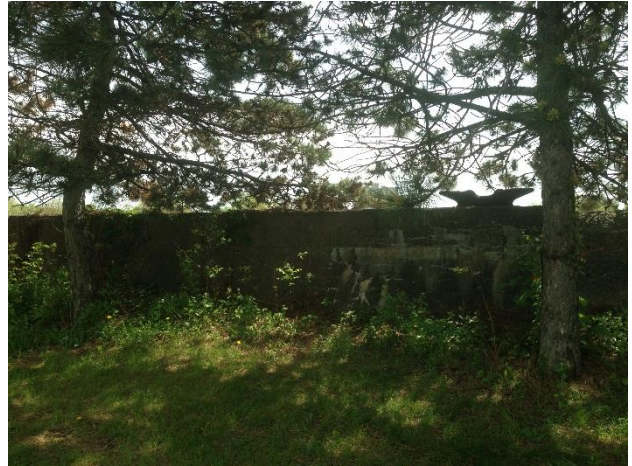
*An obstructed view of the River from the Riverway Trail*

In its current condition, the west river wall today exists as a physical and visual barrier between the Corn Hill community and the Genesee River. Exchange Boulevard further separates the neighborhood from the River and the existing Riverway Trail, as there are limited safe locations for pedestrians to cross the street. The Corn Hill community has expressed a desire to improve access to the River and enhance the public spaces between the River and Exchange Boulevard.

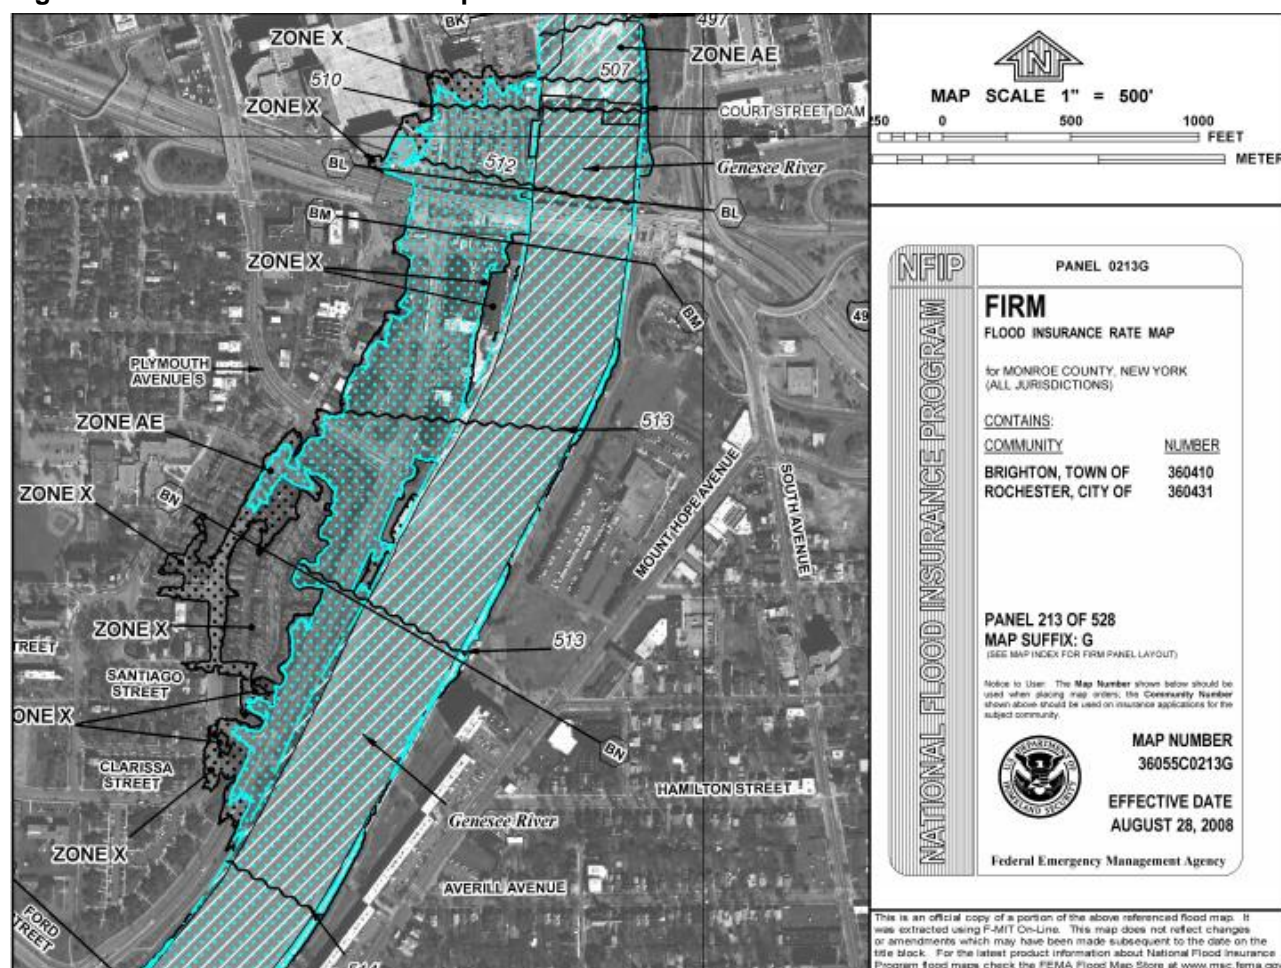
**Figure 2-2 Flood Insurance Rate Map**

As shown in Figure 2-2 there are areas in Corn Hill that are in the newly mapped floodplain.

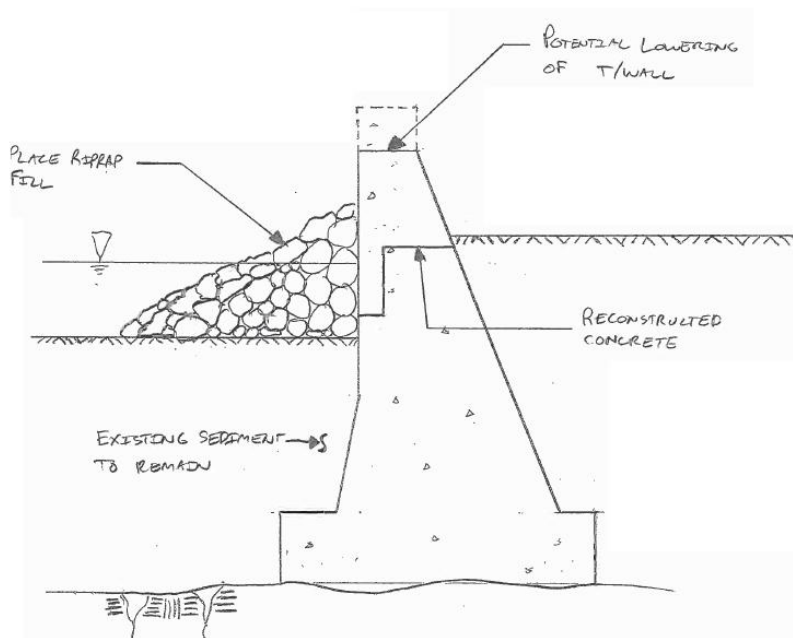
**Option 1 - Placement of stone fill riverside of the wall:**

- Provides increased resisting side pressured to stabilize the wall structure.
- Would likely restrict navigation in front of the wall.
- Improves wave attenuation (improves conditions in channel for recreational rowing).

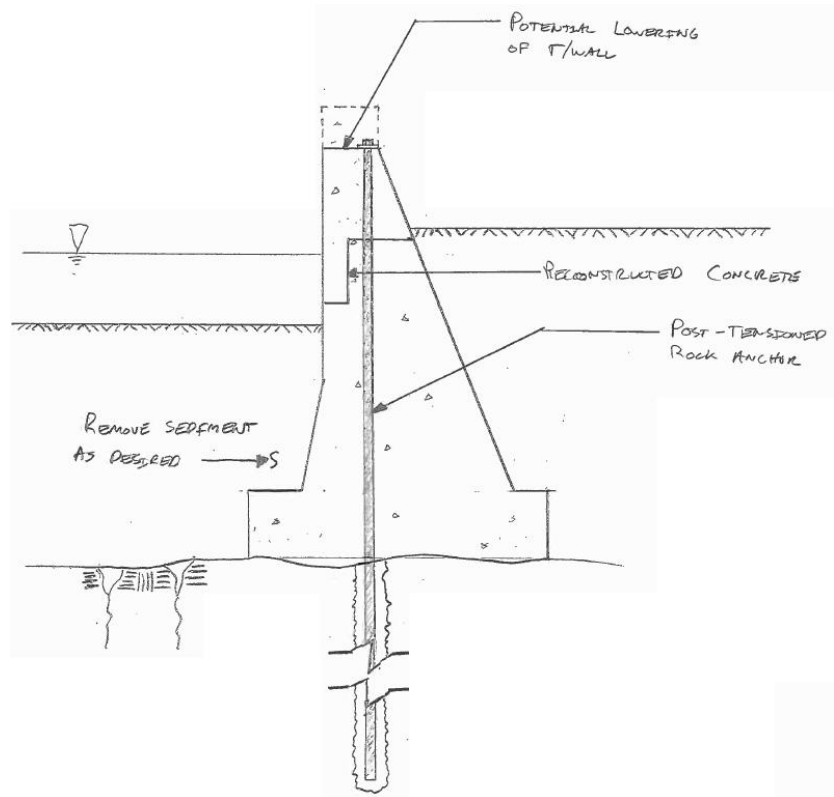
**Option 2** - Install vertical post-tensioned rock anchors through wall:

- Provides sliding and overturning resistance to stabilize the wall.
- Would allow for future dredging/erosion in front of the wall and permit navigation in front of the wall.

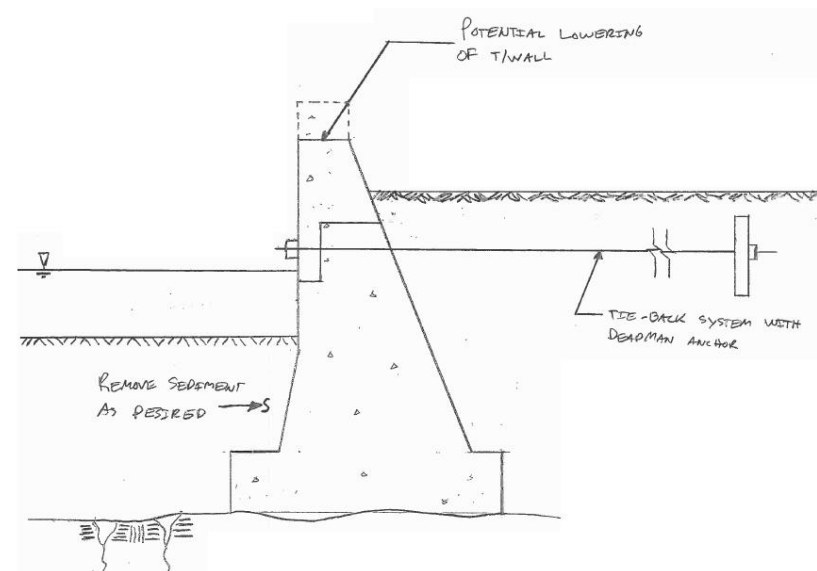
**Option 3** - Install tie-backs and deadman system:

- Provides sliding and overturning resistance to stabilize the wall.
- Tiebacks and deadman result in poor access to utilities and may hinder future use of land (interfere with tie-backs).
- Requires a high level of earthwork disturbance for tie-back installation.

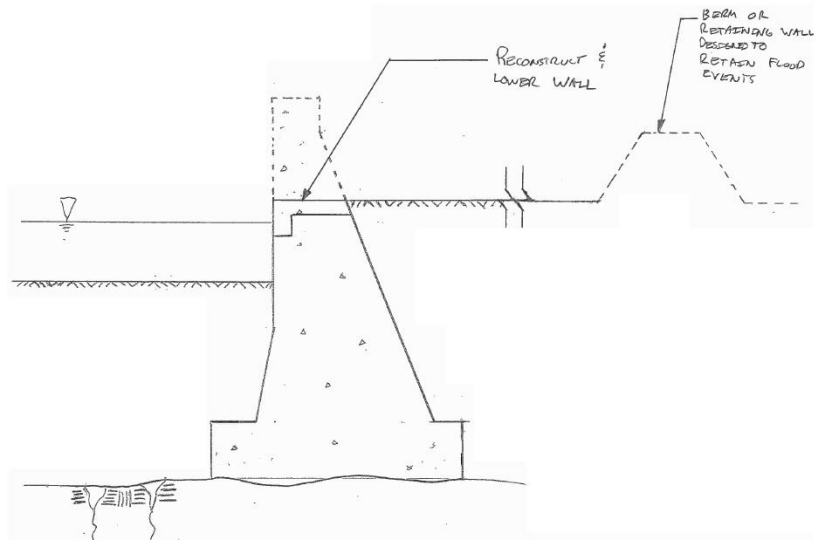
**Option 4 - Lowering of the wall and lowering of landside soils:**

- Lowering of the wall is limited by flood protection requirements. Hence, as secondary wall/berm or terrace may be needed to provide offset flood protection.
- Lowering of landside soils would improve stability results.

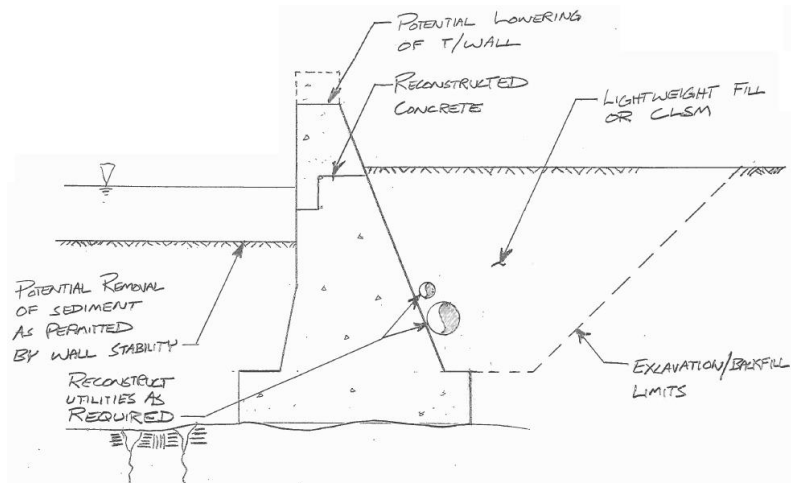
**Option 5 - Excavation behind a backfill with lightweight or self-supporting materials (CLSM):**

- Provides reduced driving side soil pressures in selected areas and may improve wall stability to satisfy criteria.

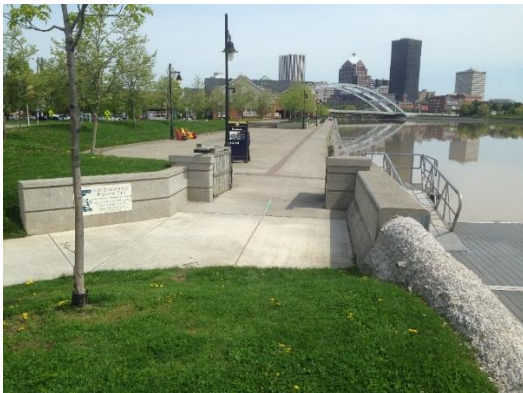
*The Riverway Trail looking north towards Corn Hill Landing, showing existing flood gates and the transition from old to the new sections of the river wall.*
