Garage Inspection & Rating Program

Mortimer Street Parking Garage

October 1st, 2019

EXECUTIVE SUMMARY

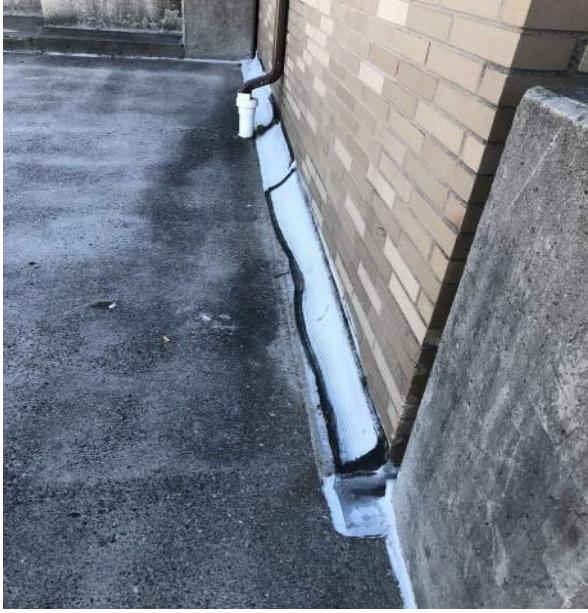
Photo #7

<u>Expansion Joint Case 1</u> Major repair need for roof expansion joint of Southeast stairs, multiple feet of failed material.

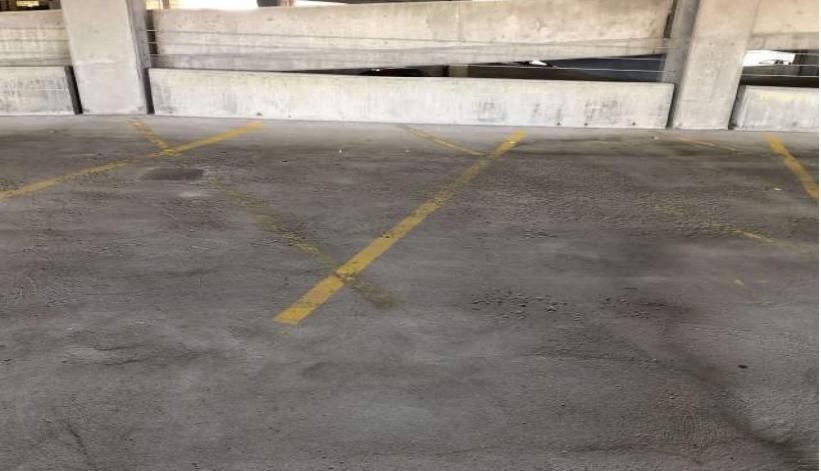
Photo #8

<u>Typical Deck Condition</u> Typical condition of the decks in the garage. All of the decks except for the 2nd floor deck are not coated with any visible membrane.

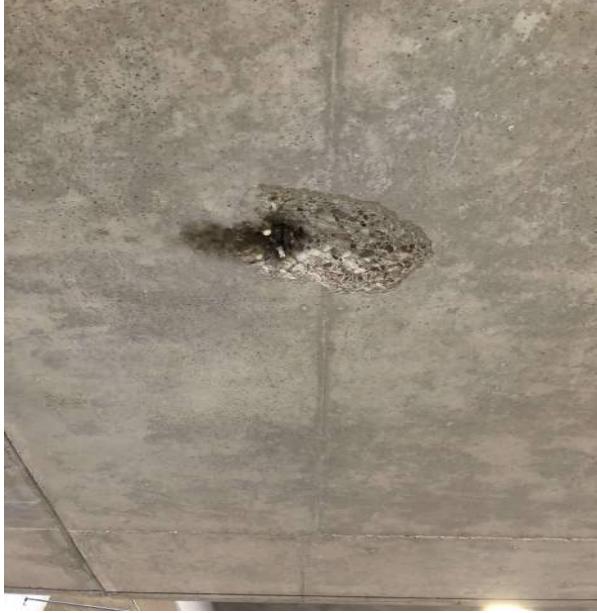
Photo #9

Deck Case 1 Spall under tendon with grease stain, showing chair. No know other occurrences but grease stains prevalent in on the decks of the top two levels.

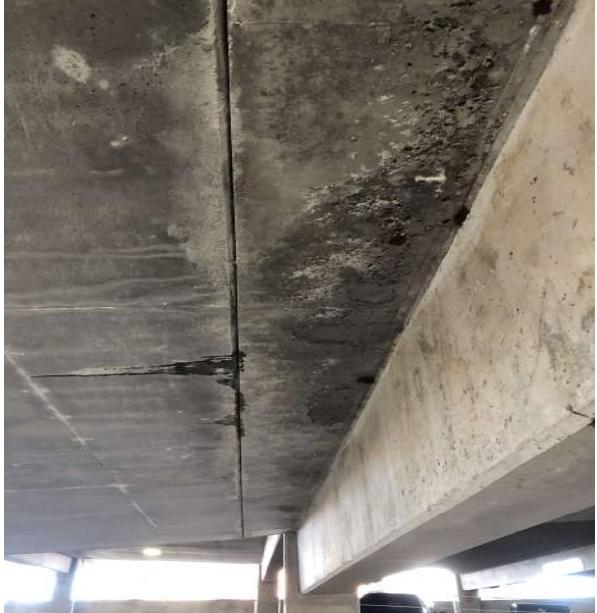
Photo #10

Deck Case 2 Heavy efflorescence at a construction joint. Location also has hairline cracks, rust stains, grease stains, and small delaminations.

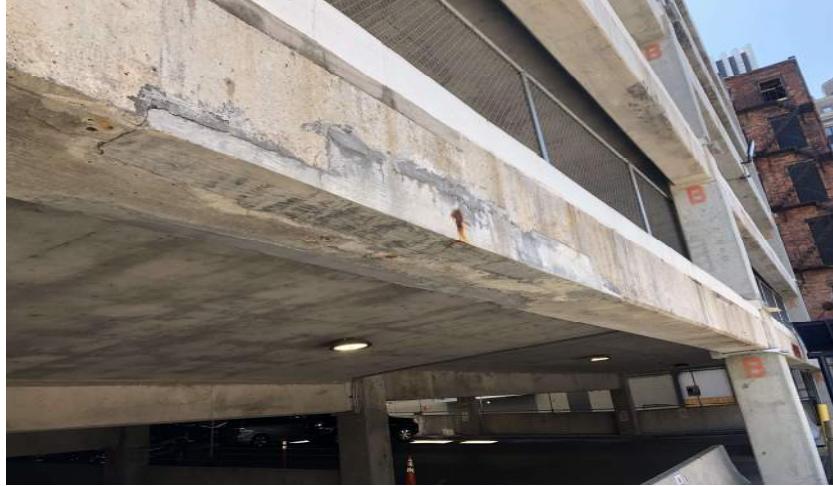
Photo #13

Beam Case 1 Wide/open cracks and heavy rust stains on a beam at about mid span. Monitoring would be recommended, very localized to very few beams.

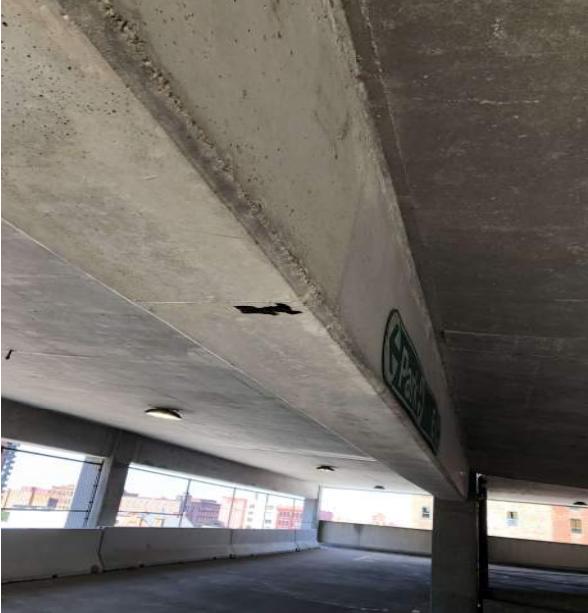
Photo #14

Beam Case 2 Grease stains from the post tensioning tendons are common among the beams in the garage. Locations of the grease stains vary as well as the size of the stains. Not all of the beams have them but a fair amount of the beams have them in various locations/floors of the garage.
