## Garage Inspection & Rating Program

### East End Parking Garage

475 East Main Street  
Rochester, New York 14604

**October 1<sup>st</sup>, 2019**

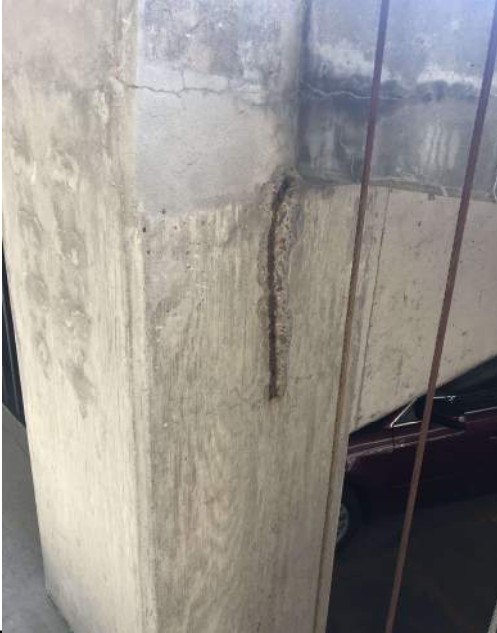
| <p><b><u>Column Case 1</u></b></p> <p>Columns are generally in good shape however some locations have concrete spalling or exposed rebar. Hairline cracking and staining is also common.</p> | <p>Photo #1</p> |

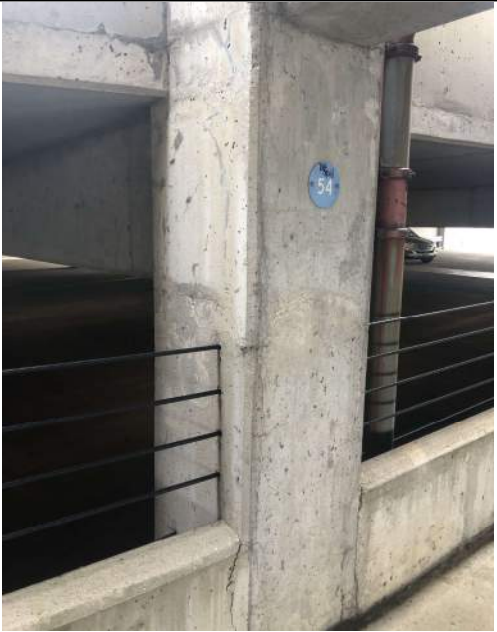
| <p><b><u>Typical Column Condition</u></b></p> <p>Typical column with hairline cracking.</p> | <p>Photo #2</p> |

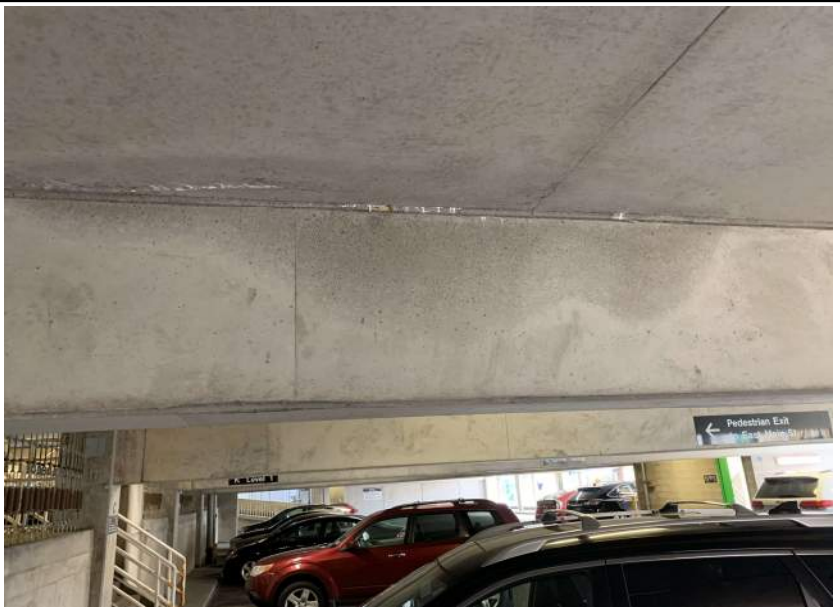
| | Photo #3 |

| <p><b><u>Typical Beam Condition</u></b><br/> Typical Beam. Light efflorescence beginning at the Deck/Beam intersection.</p> | |

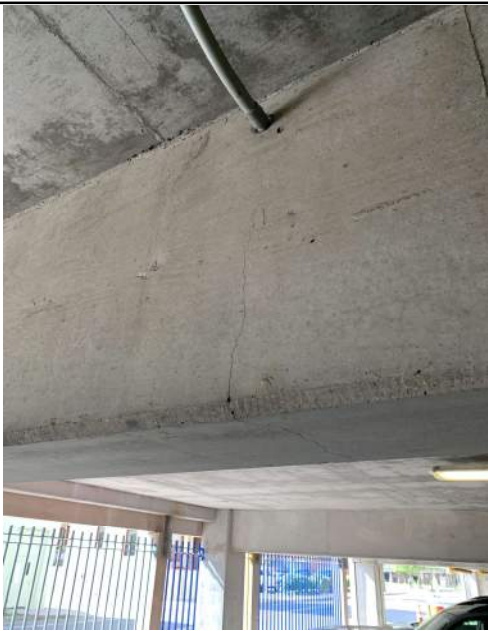
| | Photo #4 |

| <p><b><u>Typical Beam Condition</u></b><br/> Beam with typical hairline cracking.</p> | |

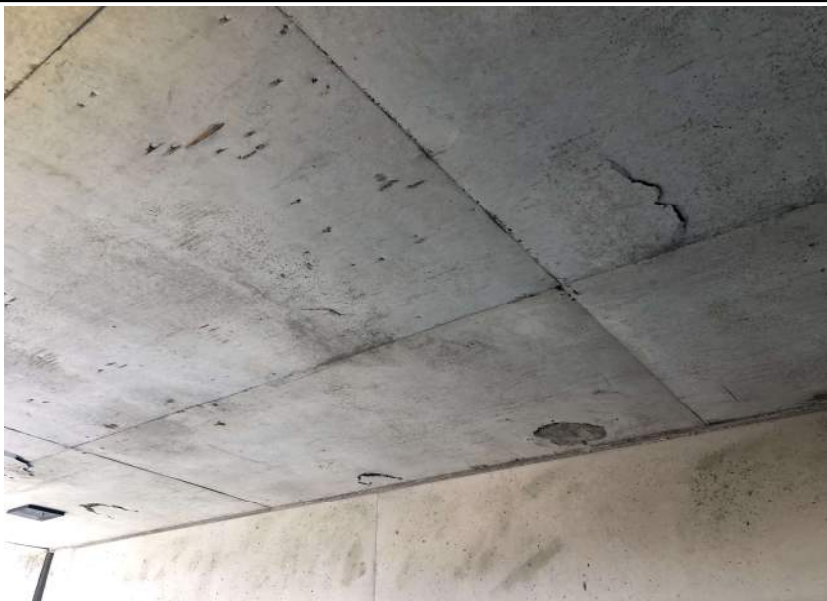
Photo #5

**Typical Deck Condition**

Typical deck with small delaminations.

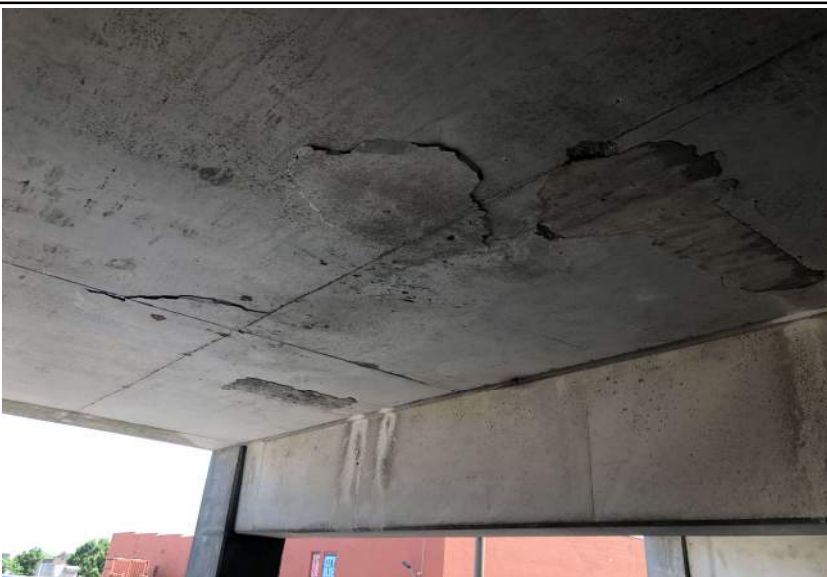
Photo #6

**Deck Case 1**

Large deck delaminations with efflorescence at the deck/beam intersection.

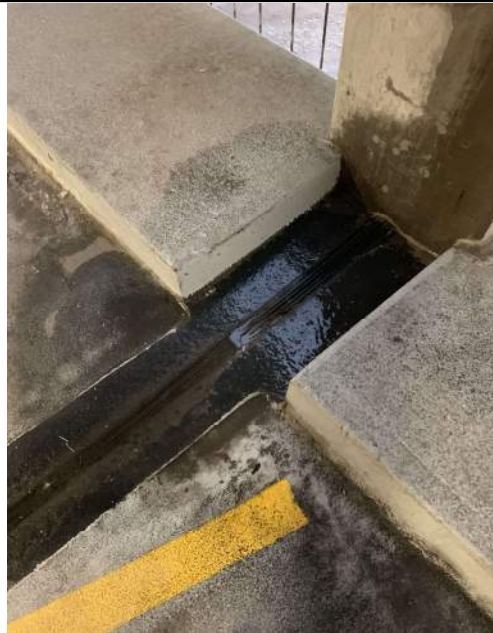
Photo #7

**Expansion Joint Case 1**

Dirt in gland, header is worn but in good shape. Water pooling on top of joint. Water runs off end of joint and drips to floor below.

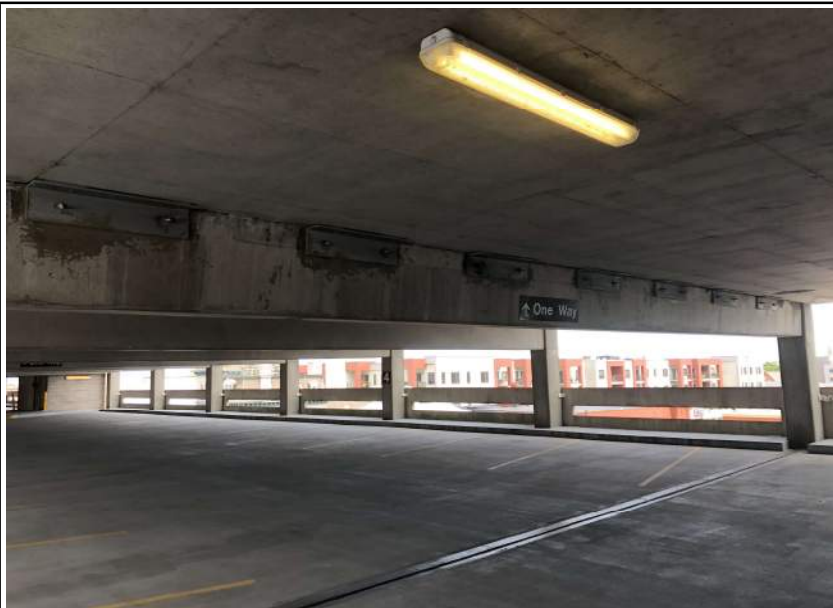
Photo #8

**Expansion Joint Case 2**

Expansion Joint in poor condition. Water is penetrating joint and heavy spalling/delamination has occurred on beam below.

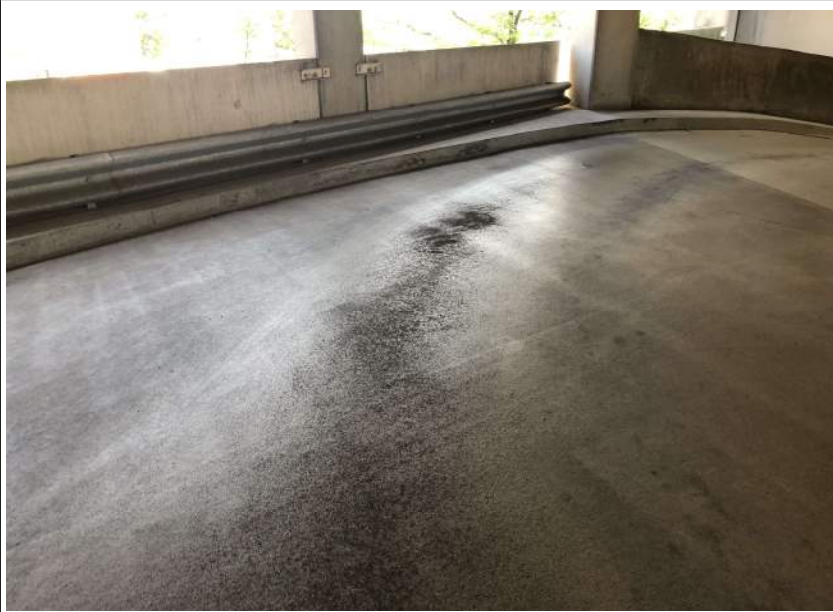
Photo #9

**WP & Sealant Case 1**

Wear showing on waterproofing membrane.

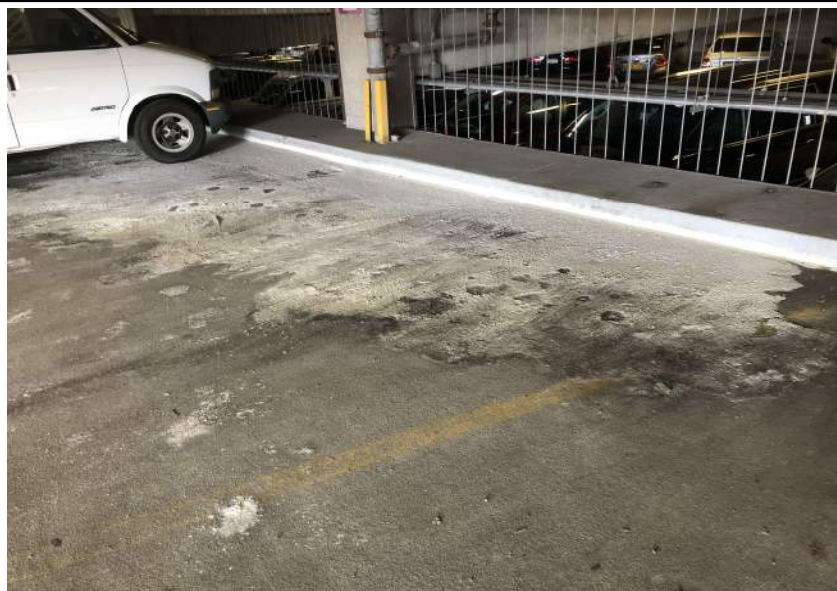
Photo #10

**WP & Sealant/Deck Case 1**

Heavy chloride deposits on deck/waterproofing. Should be cleaned to avoid future deterioration of waterproofing, deck and beam below.

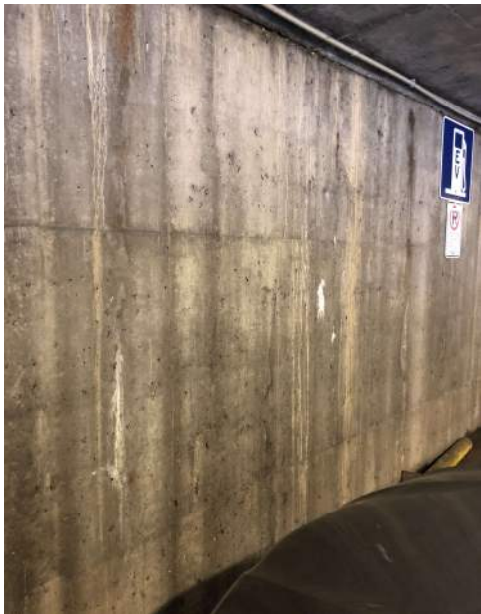
| <p><b><u>Typical Wall Condition</u></b><br/> Typical wall showing staining and spots of light efflorescence.</p> | <p>Photo #11</p> |

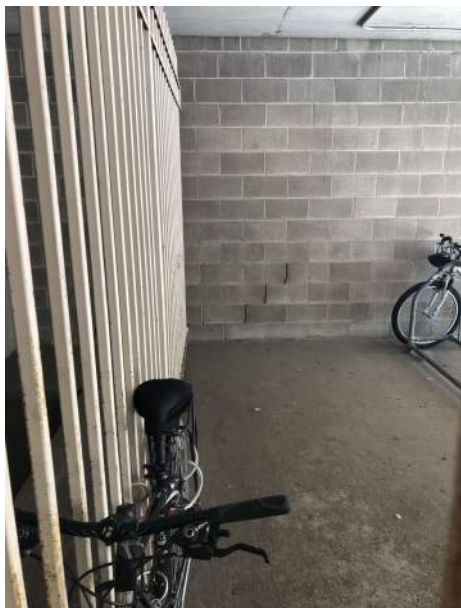
| <p><b><u>Wall Case 1</u></b><br/> Typical masonry wall with step cracking.</p> | <p>Photo #12</p> |

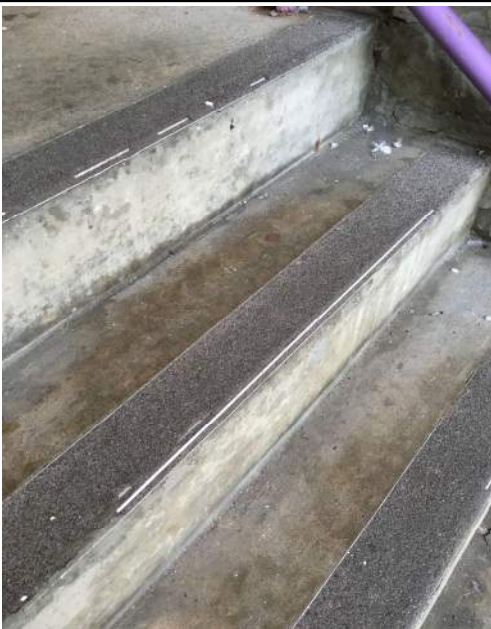
| <p><b><u>Typical Stairs Condition</u></b><br/> Typical example of stair nosings.<br/> Starting to show wear but<br/> functioning as intended.</p> | <p>Photo #13</p> |

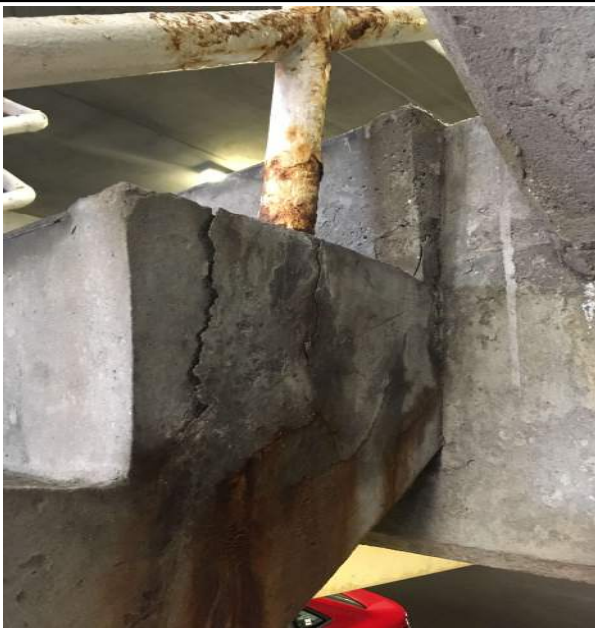
| <p><b><u>Stairs Case 1</u></b><br/> Heavy rust/rust staining,<br/> efflorescence and delamination is<br/> common at interior stairs.</p> | <p>Photo #14</p> |

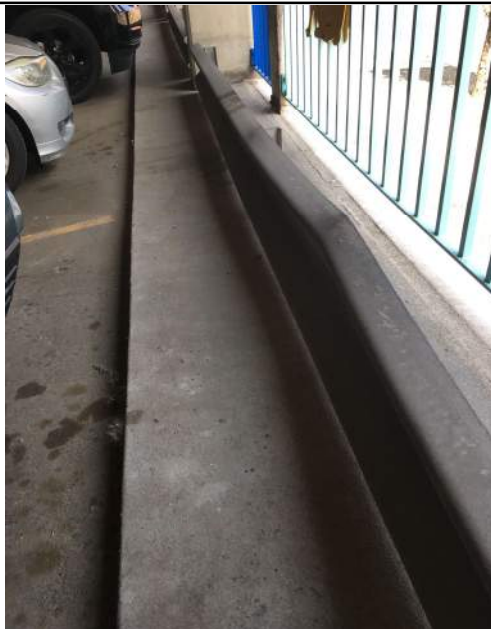
Photo #15

**Vehicle Barrier Case 1**

Bent vehicle barrier.

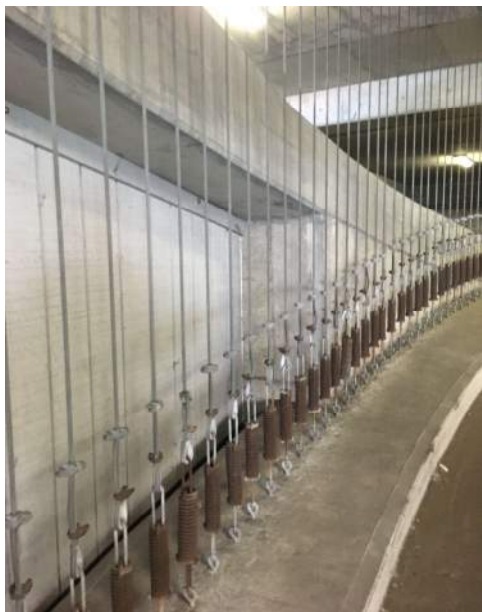
Photo #16

**Vehicle Barrier Case 2**

Typical cables. Surface rust/light corrosion is common throughout.

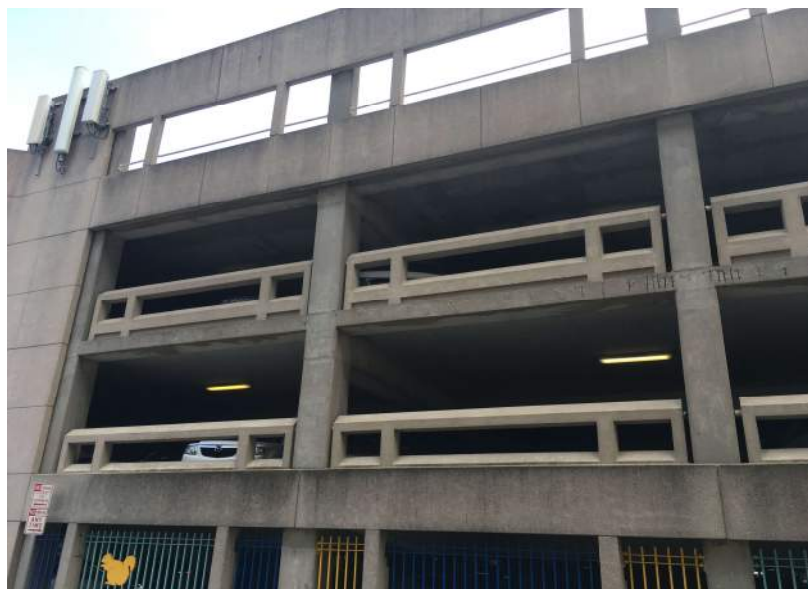
Photo #17

**Typical Façade Condition**

Typical façade image. Spots with spalled concrete. Staining throughout.

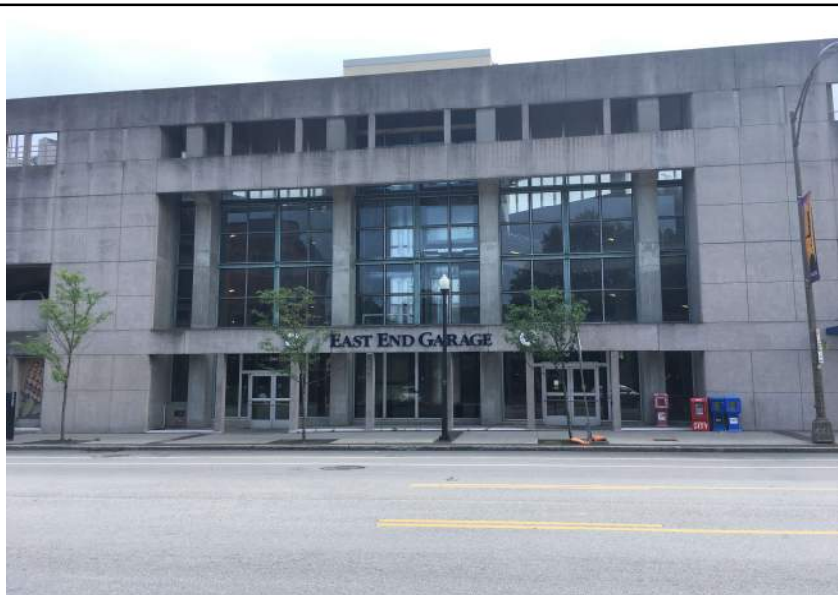
Photo #18

**Façade Case 1**

Elevation view of façade. Staining throughout with some spots needing concrete repair.

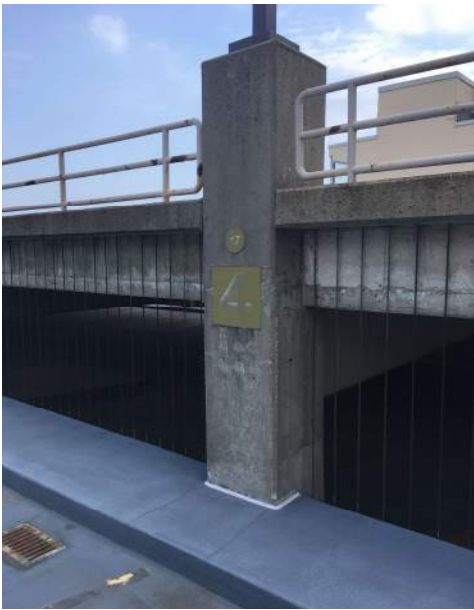
| <p><b><u>Signage Case 1</u></b><br/>Upper level signs are worn and difficult to read.</p> | <p>Photo #19</p> |
