## Garage Inspection & Rating Program

### **Genesee Crossroads Parking Garage**

69 Andrews Street  
Rochester, New York 14614

**October 1st, 2022**

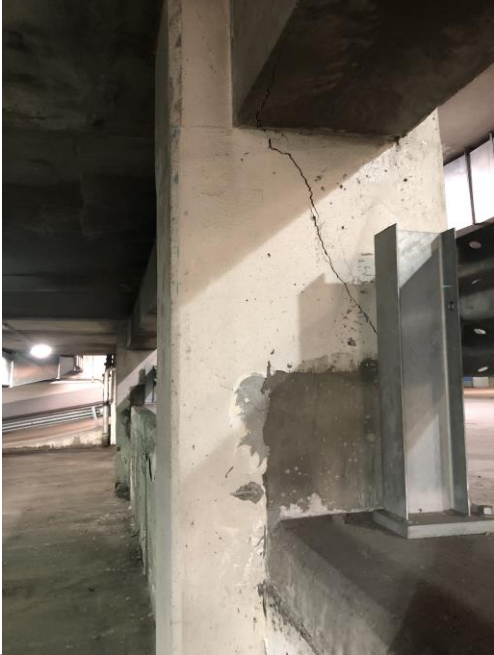
Photo #1

LEVEL RATINGS	OVERALL RATING	SUMMARY NOTES
<b>COLUMNS</b>	A Level	5.96	<b>5.77</b>	Columns on lower levels have signs of deterioration with scaling, peeling paint, and rusted angles at corners. Multiple locations of delaminations throughout garage. See Photos 1 & 3
	B Level	5.91		
	C Level	5.93		
	D Level	5.10

<p><b><u>Column Case 1</u></b> Diagonal crack in column near beam interface.</p>

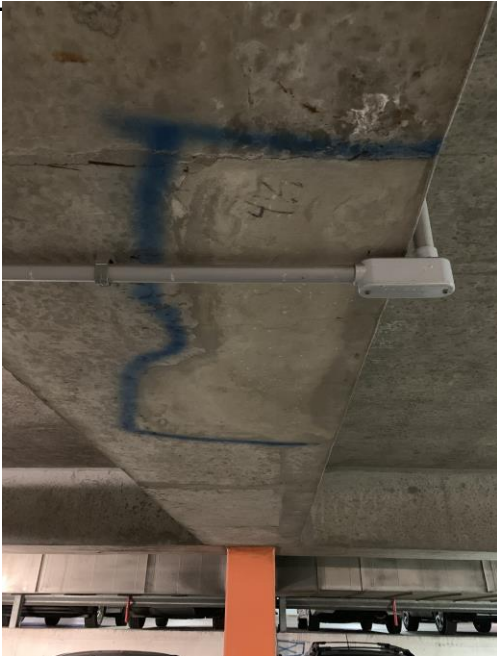
Photo #2

LEVEL RATINGS	OVERALL RATING	SUMMARY NOTES
<b>BEAMS</b>	PLAZA A	5.50	<b>5.38</b>	Typical hairline cracks throughout. Beams on Plaza A & B have cracking with efflorescence & corrosion stains, most scheduled for repair under the Plaza Waterproofing Project. See Photos 2, 4, 5 & 6.
	PLAZA B	4.61		
	A Level	5.60		
	B Level	5.61

<p><b><u>Beam Case 1</u></b> Typical Previously Marked Delamination On Beams</p>

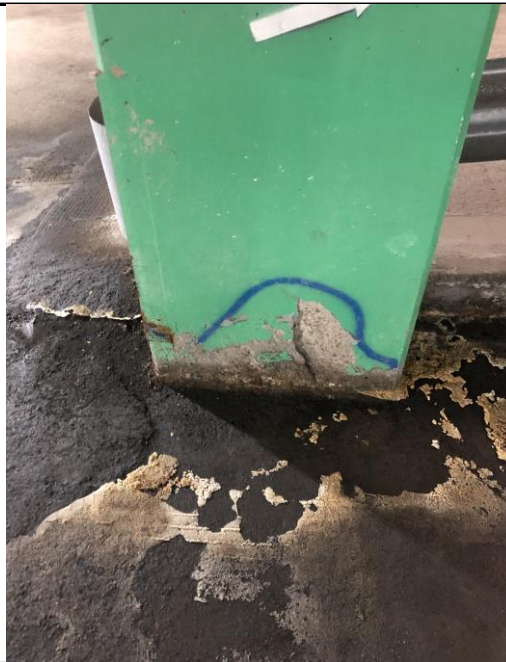
Photo #3

**Column Case2**  
Typical spalled column with exposed reinforcement at base.

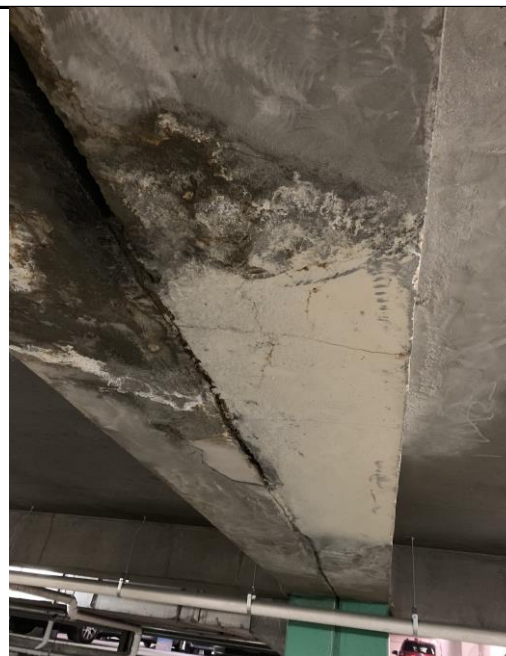
Photo #4

**Beam Case 2**  
Typical deterioration and water infiltration at beam near expansion joint.

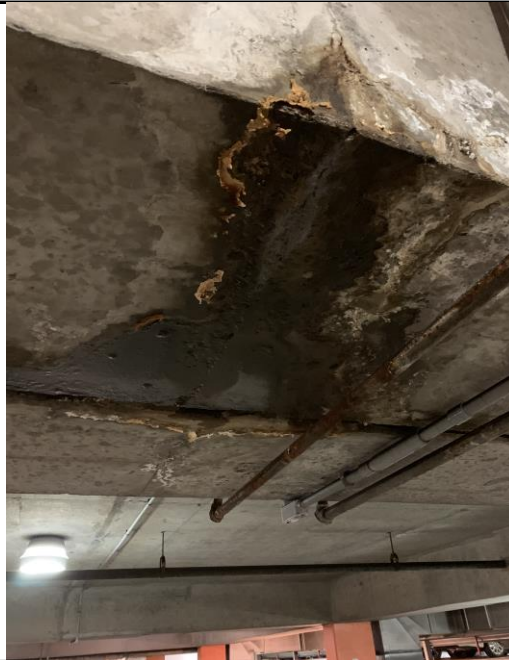
Photo #5

LEVEL RATINGS	OVERALL RATING	SUMMARY NOTES
<b><u>EXPANSION JOINTS</u></b>	PLAZA A	3.00	<b>3.60</b>	Heavy water infiltration and efflorescence Stains on Plaza Level A & B beams at joint locations. Active water leaking during rain event. The plaza joint is being replaced during the Plaza Waerproofing Project. See Photos 5 & 13.
	PLAZA B	3.00		
	A Level	4.00		
	B Level	3.00		
	C Level	5.00

**Expansion Joint Case 1**

Typical active leaking and beam deterioration at plaza level expansion joint.

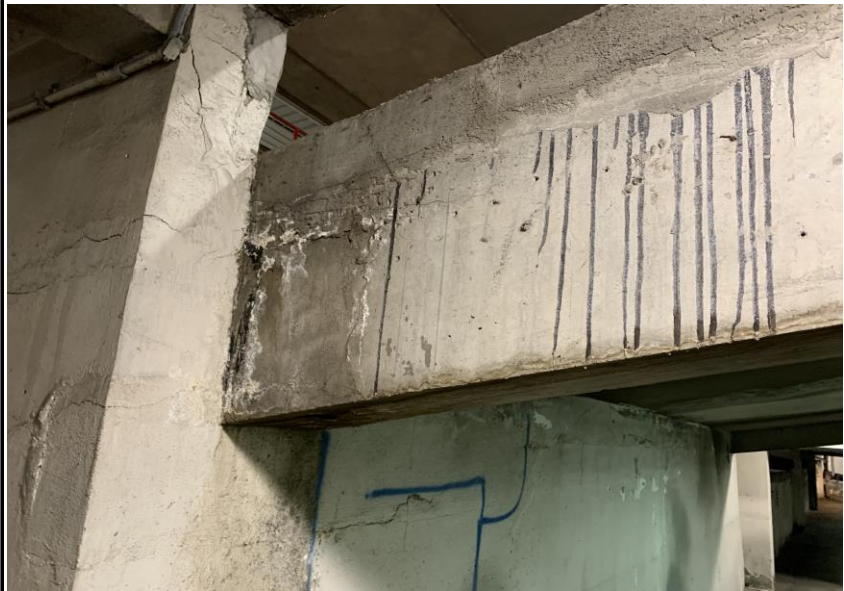
Photo #6

**Beam Case 3**

Deterioration at end of beam, with signs of active water penetration.

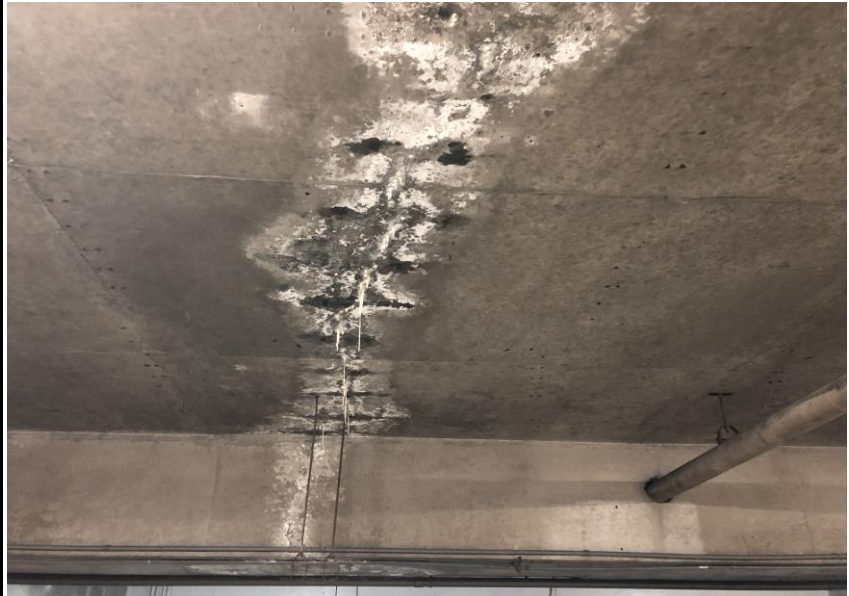
Photo #7

LEVEL RATINGS	OVERALL RATING	SUMMARY NOTES
<u>DECK</u>	PLAZA A	4.45	VISUAL ONLY	Areas of previously marked Delaminations & spalls. Plaza levels A & B have areas of cracking with water penetration, effloresence and staining. Many of these received epoxy injection in 2022. Some previously repaired areas have failed. See Photos 7 & 8.
	PLAZA B	3.99		
	A Level	5.43	4.85	
	B Level	5.46		
			CHLORIDE ADJUSTED	
			4.62

**Typical Deck Condition**

Typical cracks on underside of decks with water stains and efflorescence.

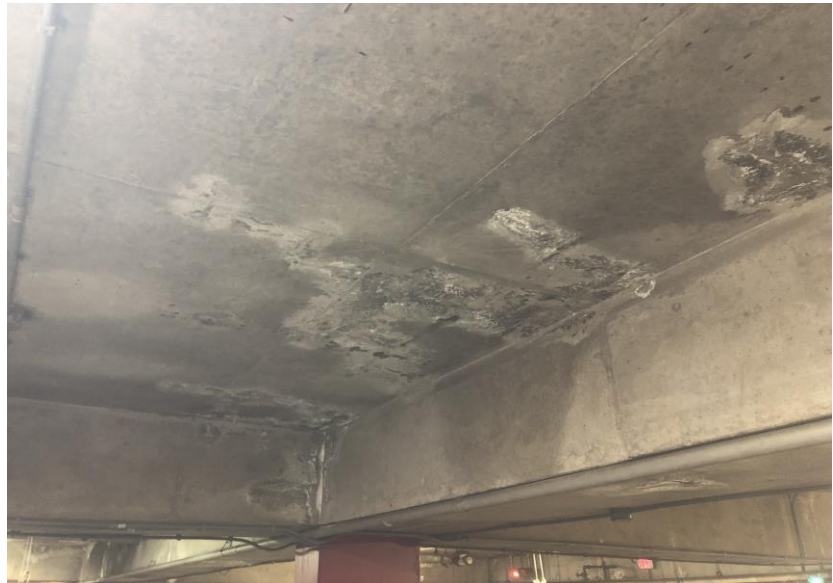
Photo #8

**Typical Deck Condition**

Typical delamination and efflorescence on underside of deck.

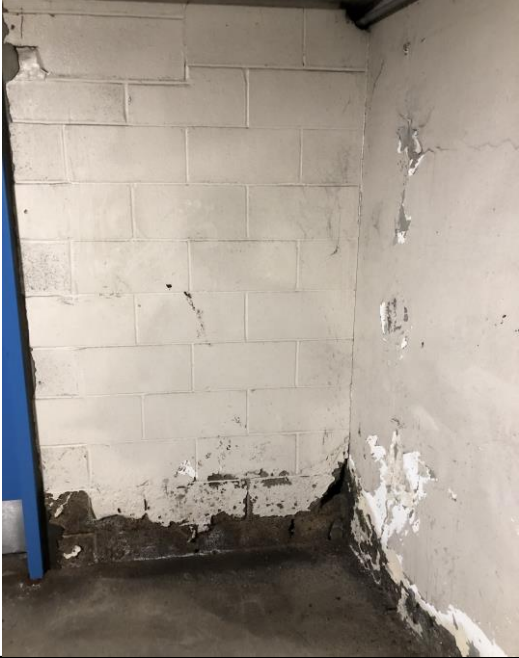
<p>Photo #9</p>

LEVEL RATINGS	OVERALL RATING	SUMMARY NOTES
<b><u>WALLS</u></b>	A Level	5.12	<b>4.80</b>	Some areas of deteriorated cmu walls throughout the garage and areas of cracking in concrete walls. Sealing of cracks and painting of some walls at worst areas on Level A (west and south), Level C (south) and Level D (north) completed under 2012 contract. Worst remaining conditions are generally at short walls separating Levels C and D. See Photos 9, 10 and 11.
	B Level	5.07		
	C Level	4.66		
	D Level	4.50

<p><b><u>Wall Case 1</u></b> Typical scaling and spalling of CMU walls on lower levels.</p>

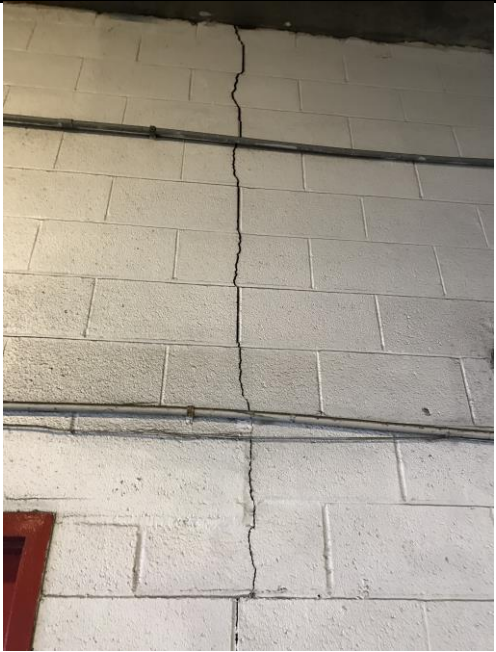
<p>Photo #10</p>

<p><b><u>Wall Case 2</u></b> Large crack through CMU wall.</p>

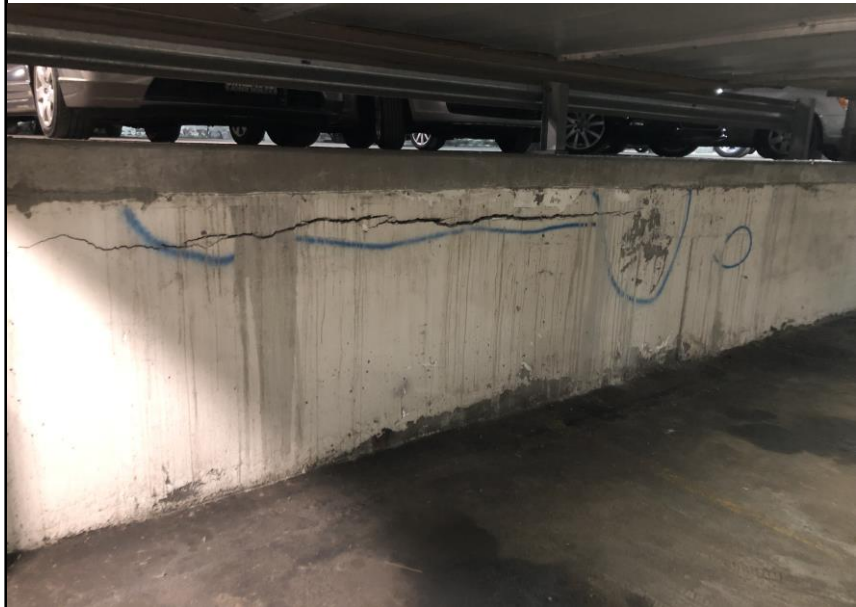
Photo #11

**Wall Case 3**

Heavy deterioration of concrete retaining wall between levels C and D.

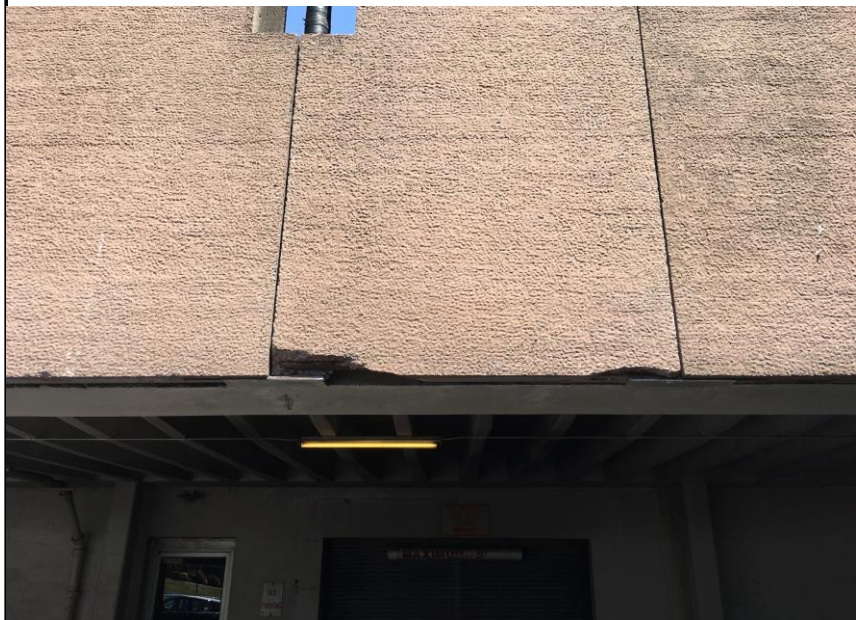
Photo #12

LEVEL RATINGS	OVERALL RATING	SUMMARY NOTES
<b><u>FAÇADE</u></b>	North	4.0	<b>4.00</b>	The façade is presently being replaced under the Plaza Waterproofing Project. See Photo 12 for conditions prior to the Plaza Waterproofing Contract.
	East	9.0		
	South	8.0		
	West	4.0

**Façade Case 1**

Broken precast panels on façade.

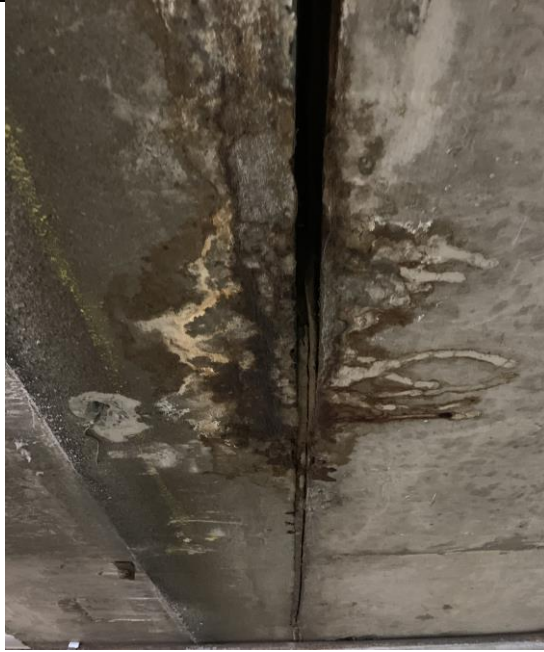
Photo #13

**Typical Expansion Joint Condition**

Typical water and efflorescence staining from failed expansion joint on levels Plaza A, Plaza B and A.

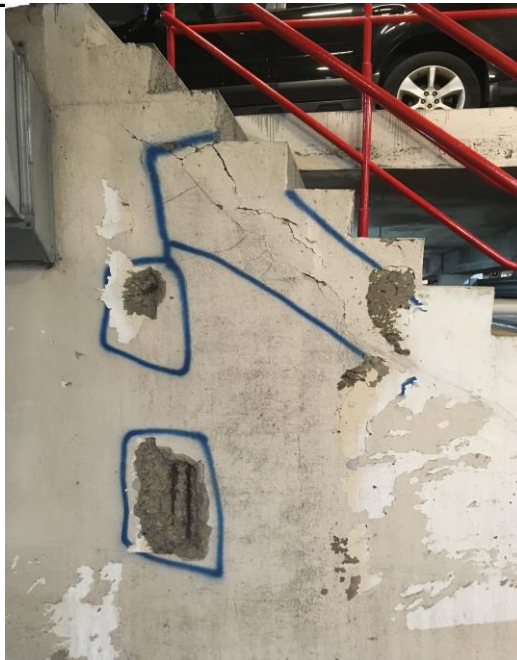
Photo #14

**Stairs Case 1**

Delamination on side of cast-in-place stairs.

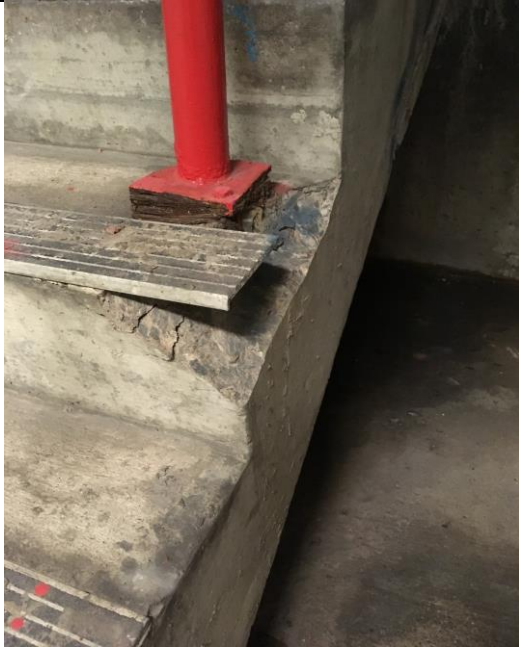
Photo #15

<p><b><u>Stairs Case 2</u></b> Failed nosing and spall near post base on stair.</p>

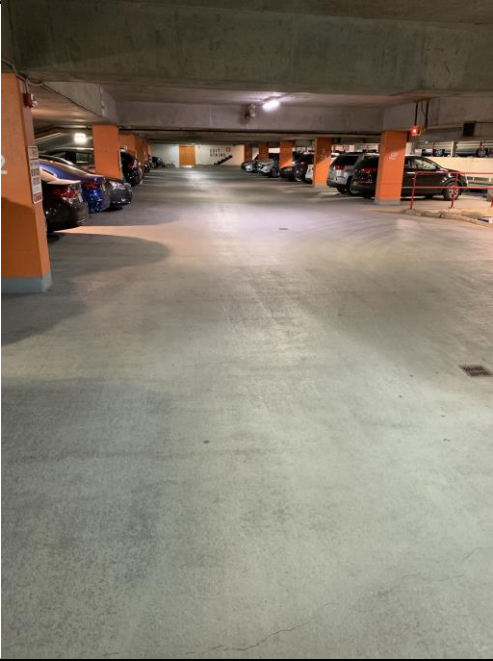
Photo #16

LEVEL RATINGS	OVERALL RATING	SUMMARY NOTES
<b><u>WATER-PROOFING &amp; SEALANTS</u></b>	PLAZA A	N/A	<b>5.00</b>	Waterproofing Membrane is in good shape throughout the garage. There is no waterproofing membrane on ramps. Levels C and D do not have waterproofing. Ramps have cracking with efflorescence and water penetration on underside. Plaza level membrane is currently being replaced. See Photo 16
	PLAZA B	N/A		
	A Level	5.00		
	B Level	5.00		
	C Level	8.00		
	D Level	8.00

<p><b><u>WP &amp; Sealant Case 1</u></b> Typical membrane image on Plaza A, Plaza B, A and B. Small bubbling and failed locations throughout.</p>

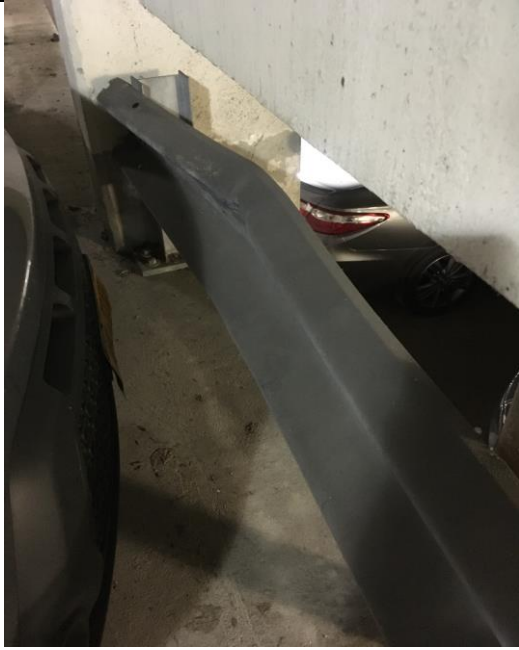
<p>Photo #17</p>

LEVEL RATINGS	OVERALL RATING	SUMMARY NOTES
<b><u>VEHICLE BARRIERS</u></b>	A Level	5.60	<b>5.66</b>	Vehicle barriers are generally in good condition. Some areas with impact damage and loose bolts throughout. See Photo 17.
	B Level	NA		
	C Level	5.89		
	D Level	NA

<p><b><u>Vehicle Barrier Case 1</u></b> Impact damage on vehicle barrier. Loose bolts and bent condition Typical throughout.</p>
