High Falls Overlook

Feasibility Report

City Project No. 19324

City Project No. 19324
December 2021

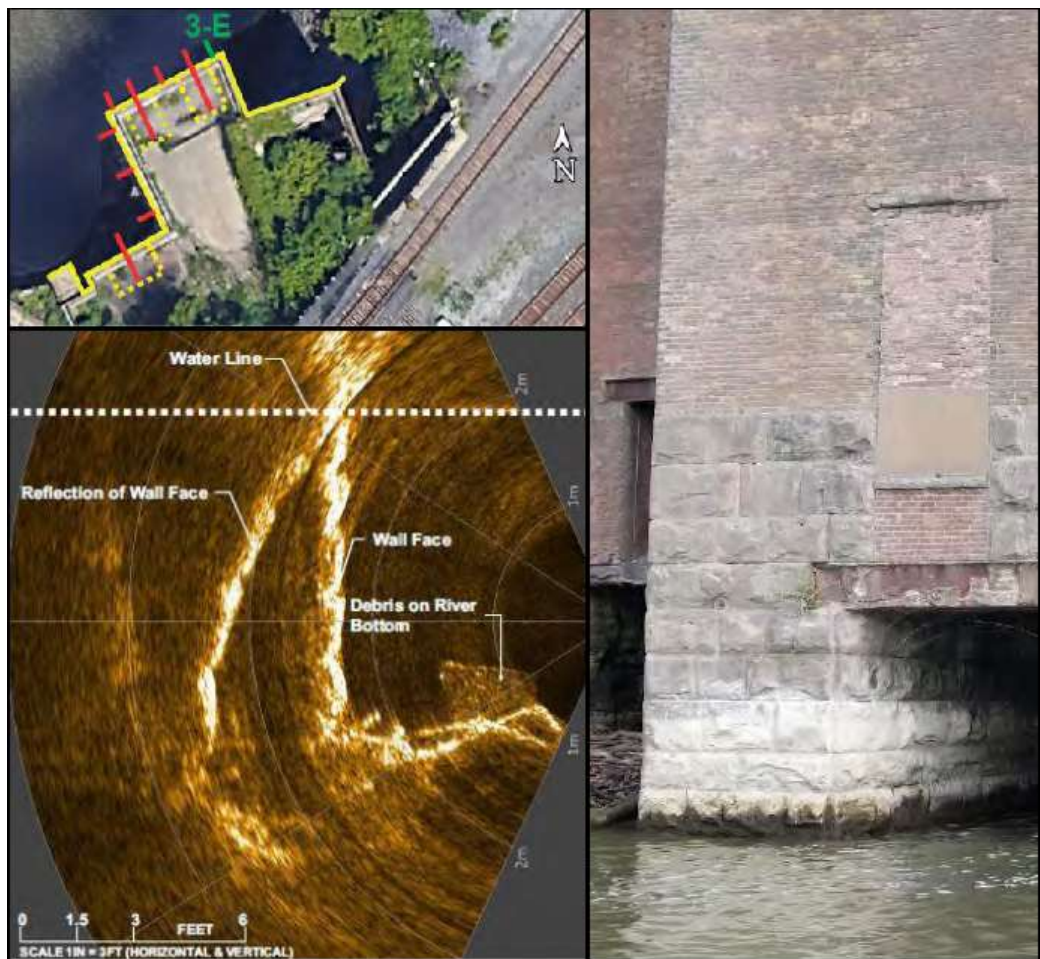
Figure 5 - Sonar Profile of Foundation

To assess the condition of the subwater surface building foundations, ASI Marine gathered data utilizing both Multi-beam Echo Sounder System and Two-Dimensional Imaging Sonar. The Multi-Beam System yielded basic bathymetric data of the plunge pool and adjacent areas while the Imaging Sonar provided profile-like images of the foundations and adjacent floor of the river. In general, the foundations were found to be intact, and no scouring was evident. The foundation area closest to the falls may have been constructed on a debris pile, but this was not able to be confirmed; the remainder of the foundation appeared to be bearing on bedrock.

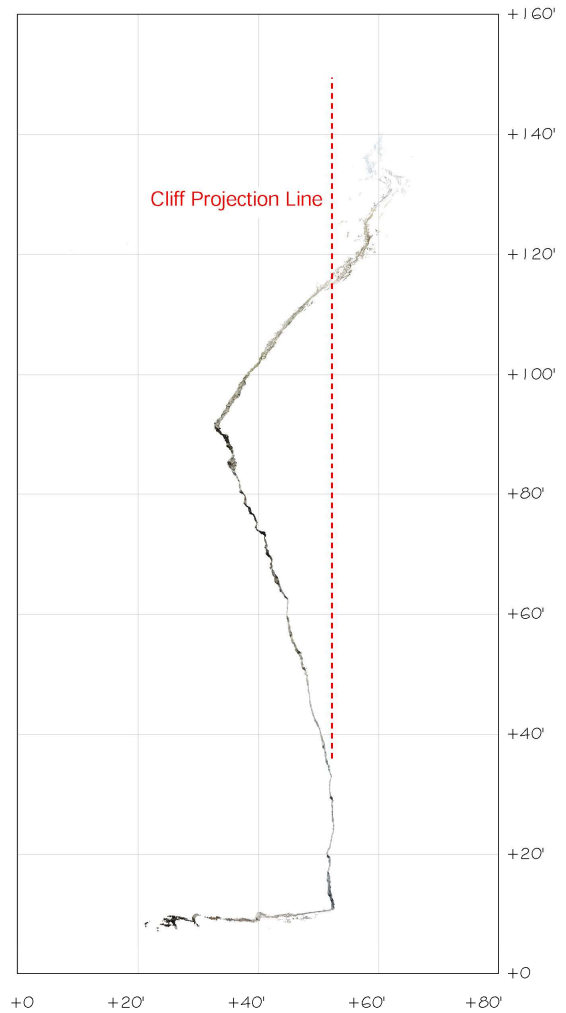
6 Section 6
1" = 20'-0"

Transposing this data onto the topographical survey established a cliff-projection line, which demonstrates the point at which the maximum erosion of the cliff has occurred. Based upon previous experience with the bedrock strata in this area and its angle of fracture, it was

determined that 1. ground level improvements are to be more

than 40 feet back from the cliff projection line, 2. improvements at a distance between 20 and 40 feet from the cliff projection line are required to extend to bedrock, and 3. no improvements are permitted within 20 feet of the cliff projection line. This information was critical to assessing the potential access schemes to Station No. 4 and to delineating the scope of proposed improvements in High Falls Terrace Park.

Figure 7 - Cliff Profile Developed from Scan

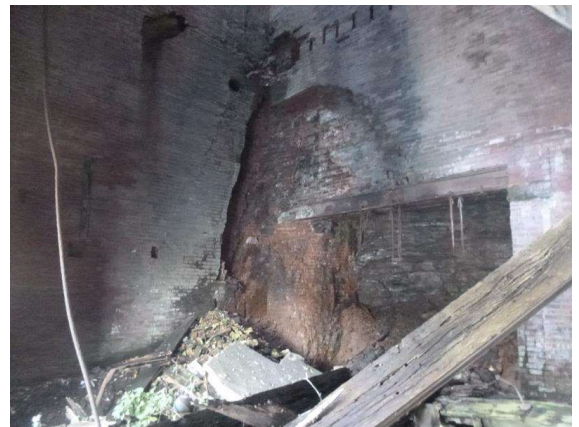
Figure 12 – Significant Cracking and Unsecured Brick

The multi-wythe brick and stone walls that remain, forming the exterior envelope of Station No. 4, are in poor condition. Hands-on inspections revealed that there is major vertical cracking at multiple locations. Displacement of the brick is evident in the vicinity of these cracks, along with several other areas of displacement due to bulging of the outer courses of brick. Substantial areas of loose mortar and brick are present including sections of brick that have broken free from the building and collapsed. This deterioration is likely the result of several different issues: the proximity to the falls leads to constant exposure to moisture, freeze thaw cycles, the age of the structure, lack of maintenance, rust jacking, and no adequate roof.

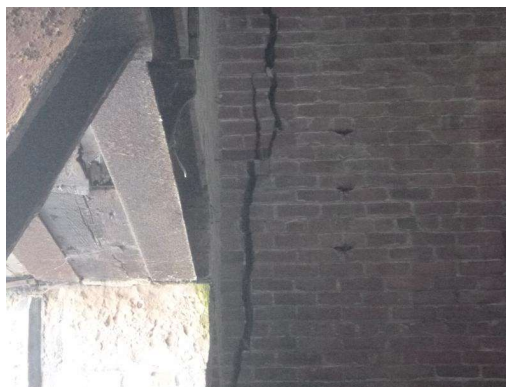
Figure 13 - Cracking of Masonry

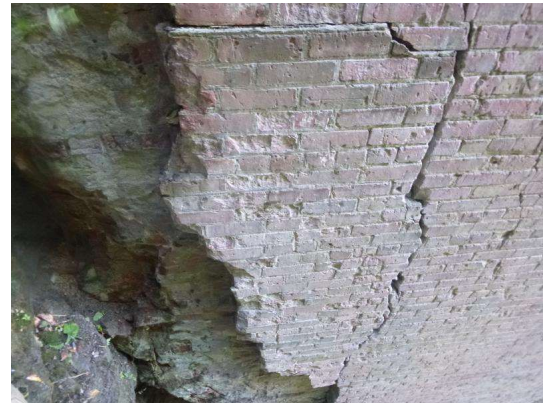
Figure 15 - Unsecured Brick

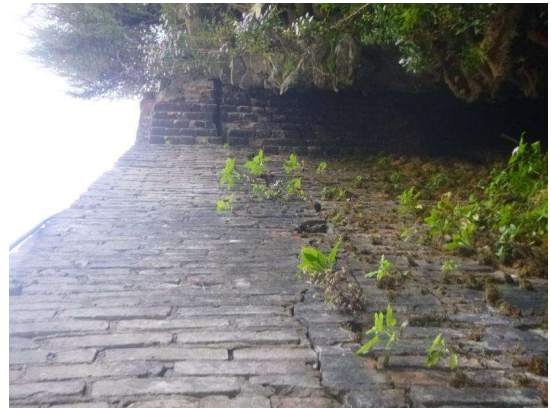
Figure 14 - Horizontal Displacement of Brick

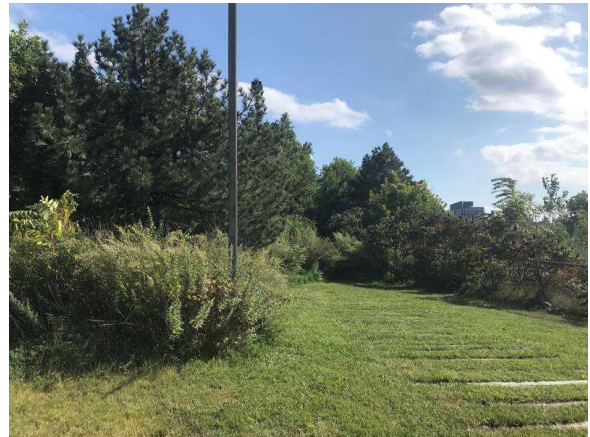
Figure 21 - Overgrowth at south end of park
