High Falls Overlook

Feasibility Report

City Project No. 19324

City Project No. 19324
December 2021

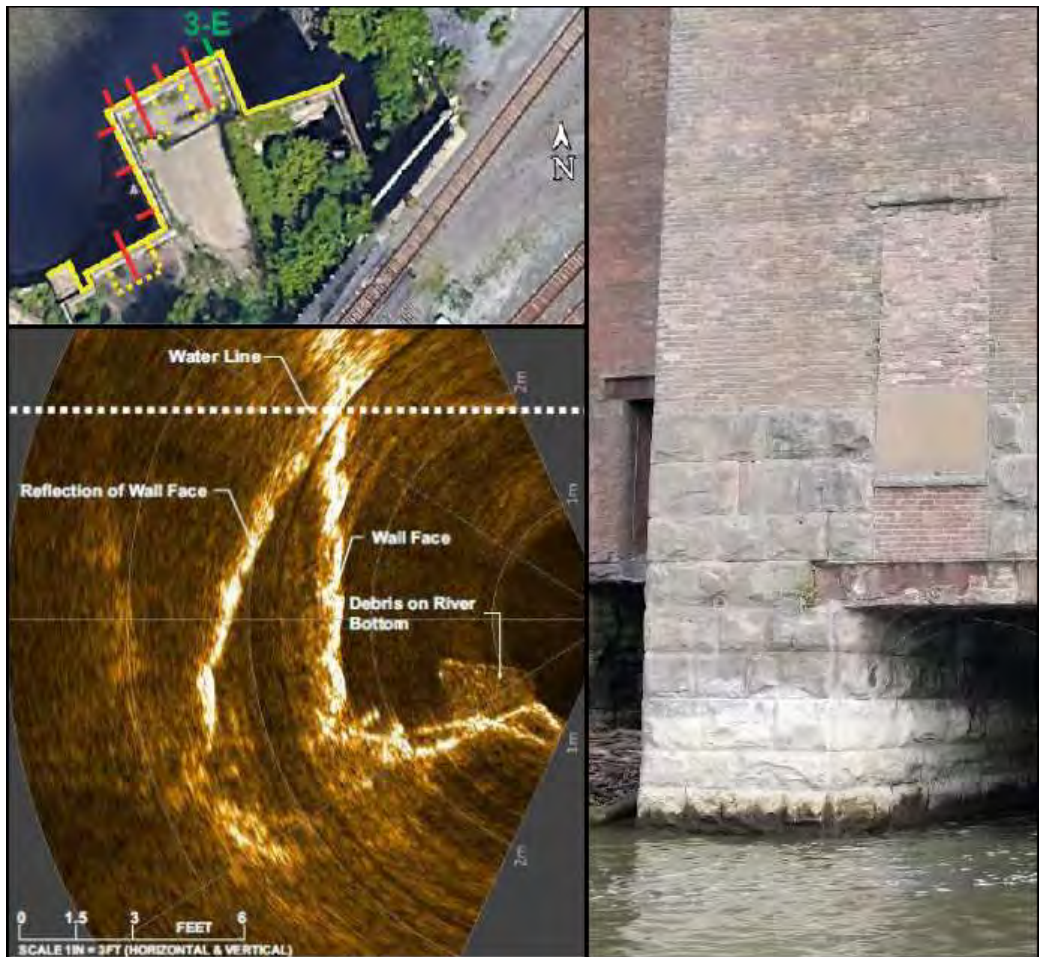
Figure 5 - Sonar Profile of Foundation

To assess the condition of the subwater surface building foundations, ASI Marine gathered data utilizing both Multi-beam Echo Sounder System and Two-Dimensional Imaging Sonar. The Multi-Beam System yielded basic bathymetric data of the plunge pool and adjacent areas while the Imaging Sonar provided profile-like images of the foundations and adjacent floor of the river. In general, the foundations were found to be intact, and no scouring was evident. The foundation area closest to the falls may have been constructed on a debris pile, but this was not able to be confirmed; the remainder of the foundation appeared to be bearing on bedrock.

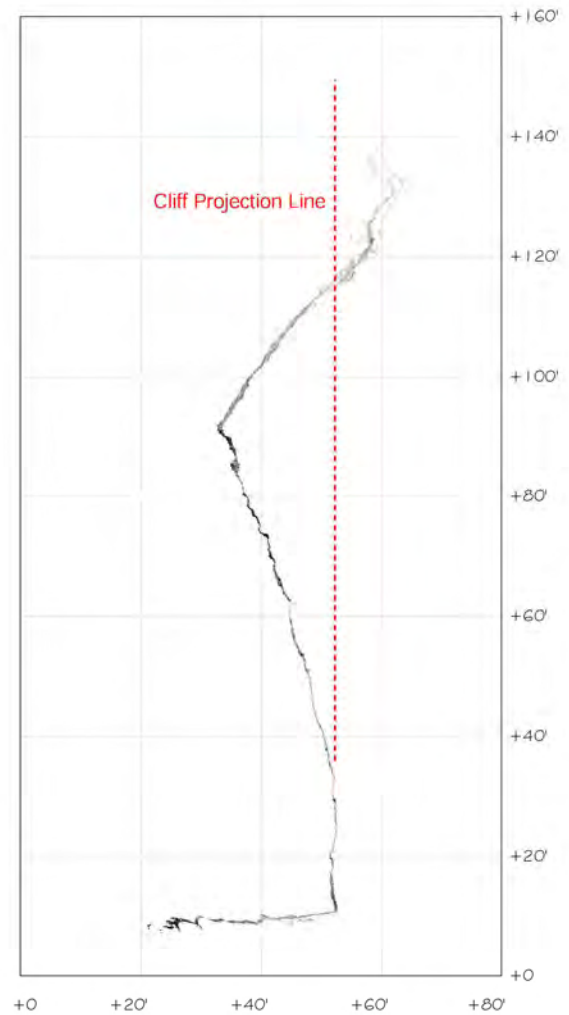
Figure 7 - Cliff Profile Developed from Scan

Using a drone with side view LiDAR capabilities, MG3D performed a 3D point-cloud scan of over 500 feet of the rock face from Station No. 4 and proceeding northerly. HUNT-EAS processed the data cloud into complete model of the cliff and created cross-sections at regular intervals for assessment by geotechnical engineers. These cross-sections show that the basal erosion of the cliff has created overhangs along most of the area analyzed, with average overhangs of 20 feet and a maximum overhang of over 40 feet at the location most proximate to Station No. 4.

Transposing this data onto the topographical survey established a cliff-projection line, which demonstrates the point at which the maximum erosion of the cliff has occurred. Based upon previous experience with the bedrock strata in this area and its angle of fracture, it was

determined that 1. ground level improvements are to be more

than 40 feet back from the cliff projection line, 2. improvements at a distance between 20 and 40 feet from the cliff projection line are required to extend to bedrock, and 3. no improvements are permitted within 20 feet of the cliff projection line. This information was critical to assessing the potential access schemes to Station No. 4 and to delineating the scope of proposed improvements in High Falls Terrace Park.

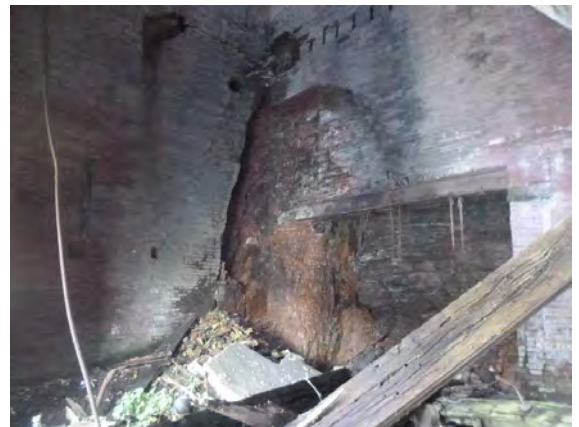
Figure 12 – Significant Cracking and Unsecured Brick

Based on observations, investigations, and reports provided by multiple consultants, previous reports provided by the City of Rochester, and historical data, the reuse of the former RG+E Power Station No. 4 is not feasible or recommended. The condition of several important elements to the structural integrity of the building are very poor, including the upper floor and framing level, intermediate floor levels, and exterior brick and stone building envelope.

The multi-wythe brick and stone walls that remain, forming the exterior envelope of Station No. 4, are in poor condition. Hands-on inspections revealed that there is major vertical cracking at multiple locations. Displacement of the brick is evident in the vicinity of these cracks, along with several other areas of displacement due to bulging of the outer courses of brick. Substantial areas of loose mortar and brick are present including sections of brick that have broken free from the building and collapsed. This deterioration is likely the result of several different issues: the proximity to the falls leads to constant exposure to moisture, freeze thaw cycles, the age of the structure, lack of maintenance, rust jacking, and no adequate roof.

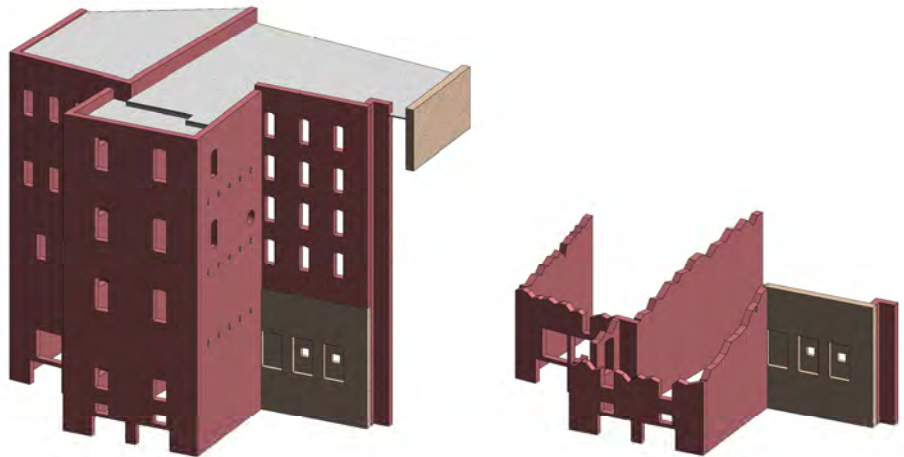
Figure 16 – Model of Existing Station No. 4 (left) and Potential Remnant (right)

Demolition would eliminate the uncertainty of when and how portions of the building may collapse over time. The foundation and remnant to be left in place would continue to deteriorate but sudden and significant collapse of the remaining structure would be unlikely.

Demolition would entail removal of the upper, brick portion of the structure, potentially down to the existing stone foundation. The brick, concrete, steel, and wood materials demolished would be removed from the site. With the existing foundations left in place, consideration should be given to leaving the bottom 20 feet of the building in place as a representative historical remnant of the existing structure.

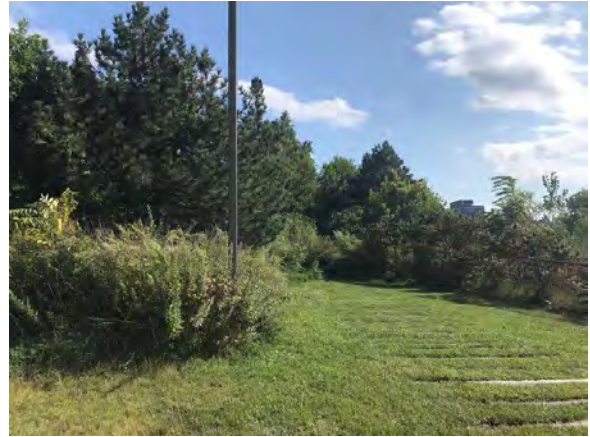
Figure 21 - Overgrowth at south end of park

overlook structure that runs parallel with the cliff edge. The site slopes gently away from the bottom of the pedestrian ramp to the north, following the cliff edge. The existing retaining wall, pedestrian ramp, and overlook structure block the expansive scenic views of the falls and the city to the south from within the park. Additionally, the cliffside vegetation grows above the existing asphalt trail in many locations, limiting views into the gorge.
