# Preliminary Structural Condition Report

For  
Iola Campus  
Buildings 1, 2, 4, 5, 7, 8, 9 and 10

Date of Inspections: November 20, 2007 & November 27, 2007  
Date of Report: December 19, 2007

Re: Iola Campus  
Buildings 1, 2, 4, 5, 7, 8, 9 and 10

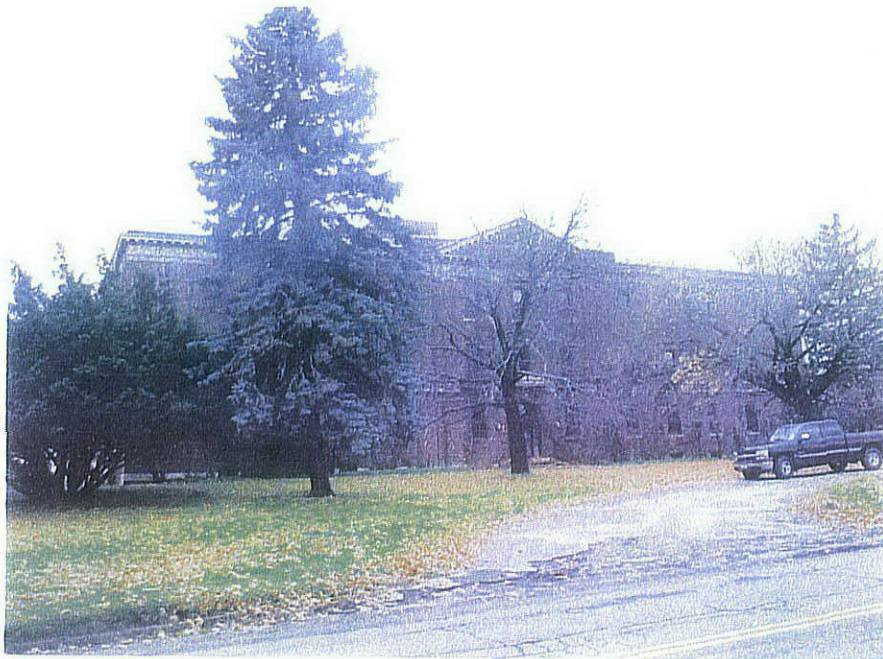
The exterior of this building was the best compared to all the other buildings from a structural point of view, (see photo 1). The exterior structural components were found in good condition, there did not appear to be any signs of settlement or major cracks, the walls all appeared to be straight and plumb. Some minor repointing will be required in the future.

**Photo 1**  
Looking at Building – 1.

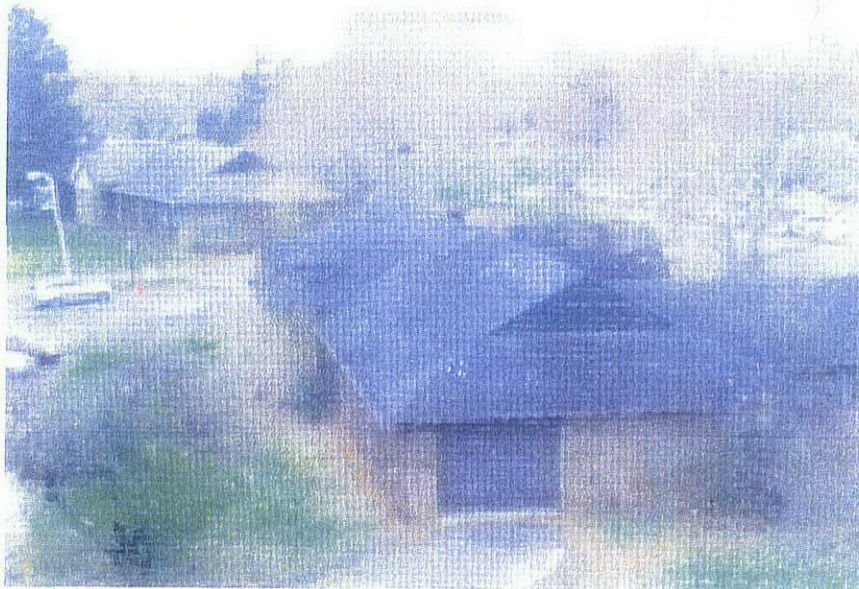
Years of neglect have affected the exterior structural components of this building. The roof structure (which we inspected from the ground) was found in poor condition. At some areas there are holes through the roof. The roof could potentially collapse at any time, (see photos 2 & 3).

**Photo 2**  
Looking at Building –2.

1. Building 2 – Repair roof.
2. Building 4 – Repair roof.
3. Building 5 – Repair parapets, repair terrace slabs, investigate steel structural elements.
4. Building 7 – Further investigate steel structural elements.
5. Building 8 – Further investigate if any dryrot/wetrot or termite damage exists.
6. Building 9 – Further investigate if any dryrot/wetrot or termite damage exists.
7. Building 10 – Repair parapets, repair stair towers.

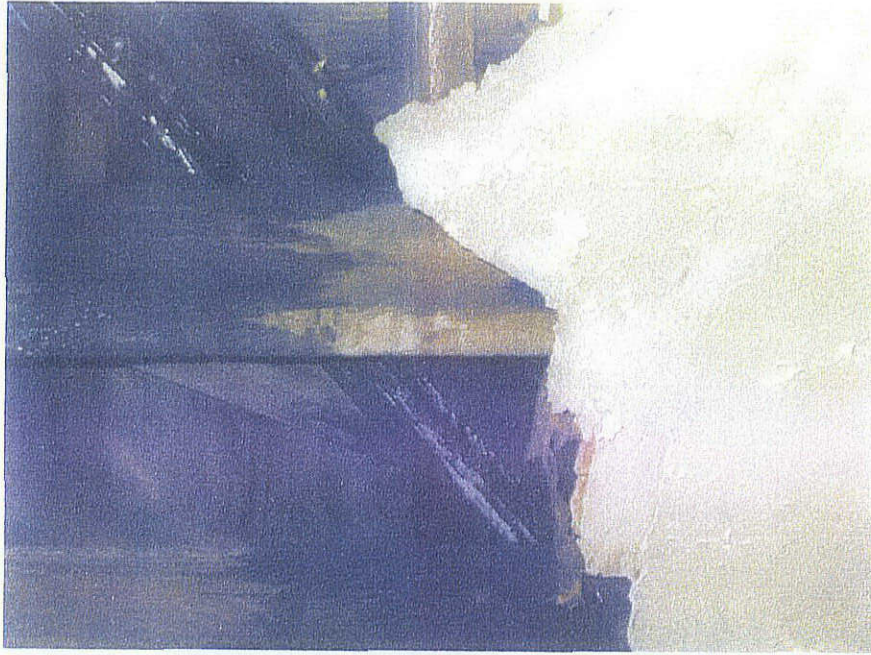
**Photo 3**

Based on visual evidence the columns were found in fair condition, the wood floor structure (over the partial basement) felt spongy at a couple of locations, the slab on grade has heaved in several locations. As previously stated the roof structure is in poor condition specifically on the East side of the building where it has already failed. Shoring has been installed to temporarily support the roof in this area. It may be that dryrot exists throughout the roof structural members, (see photos 3 to 5).

Looking at the roof structure of Building - 2. Notice the roof members at this area are full of moisture.

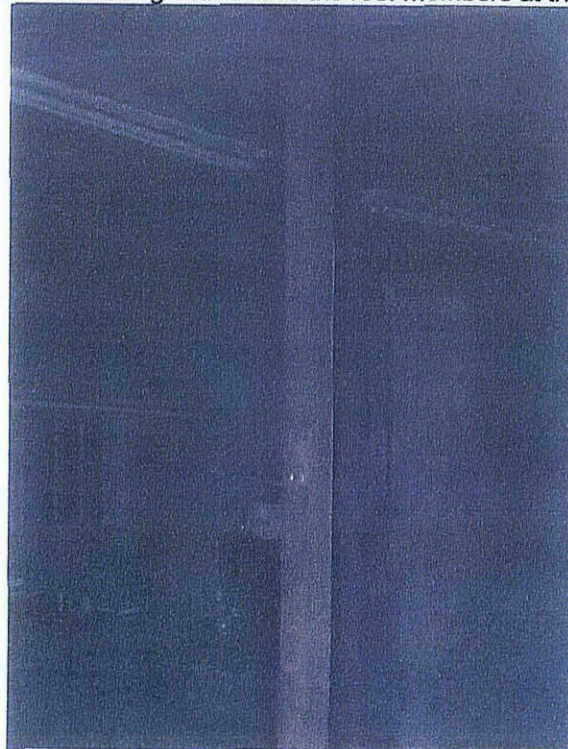
**Photo 4**

Wood columns

Looking at the interior of Building - 2.

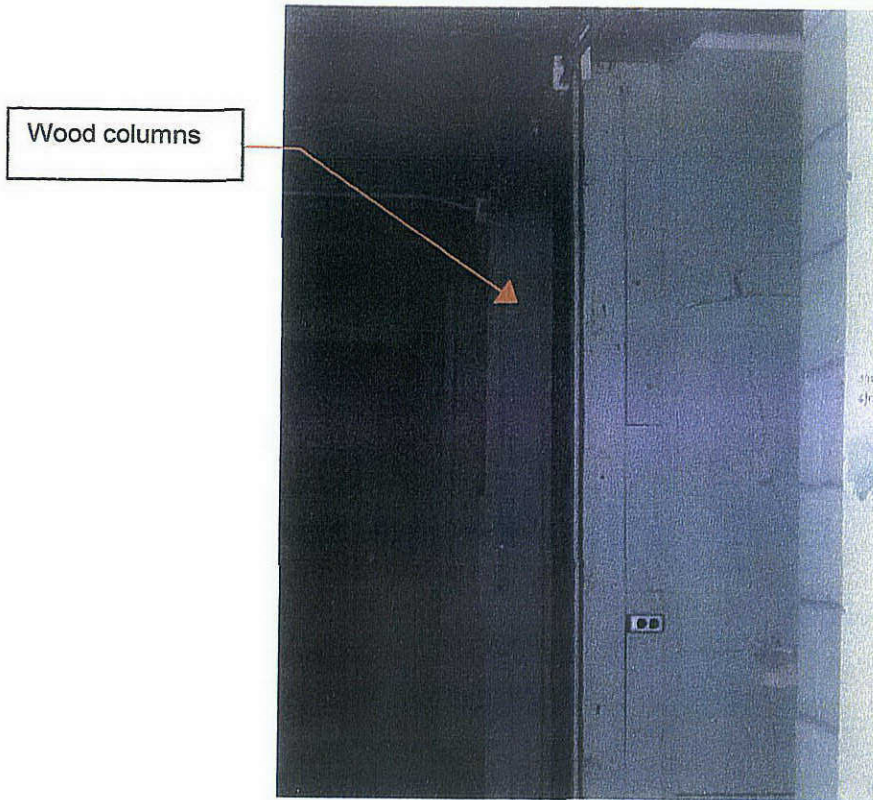
**Photo 5**  
Looking at another interior photo of Building - 2.

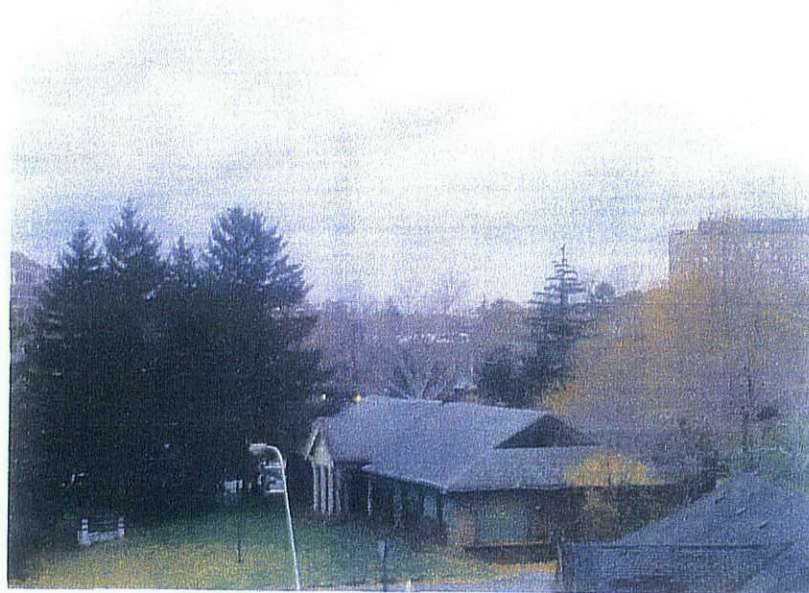
This building is in similar structural condition as Building 2, (see photo 6).

**Photo 6**  
Looking at Building - 4.

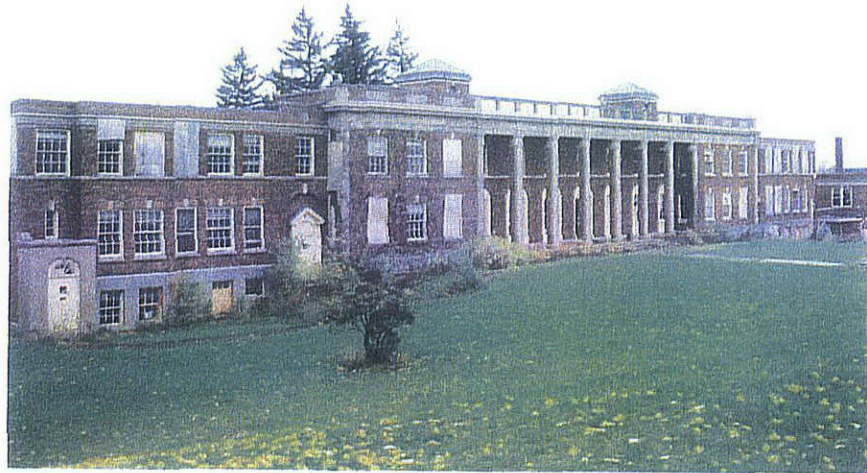
**Photo 7**  
Looking at the West elevation of Building – 5.

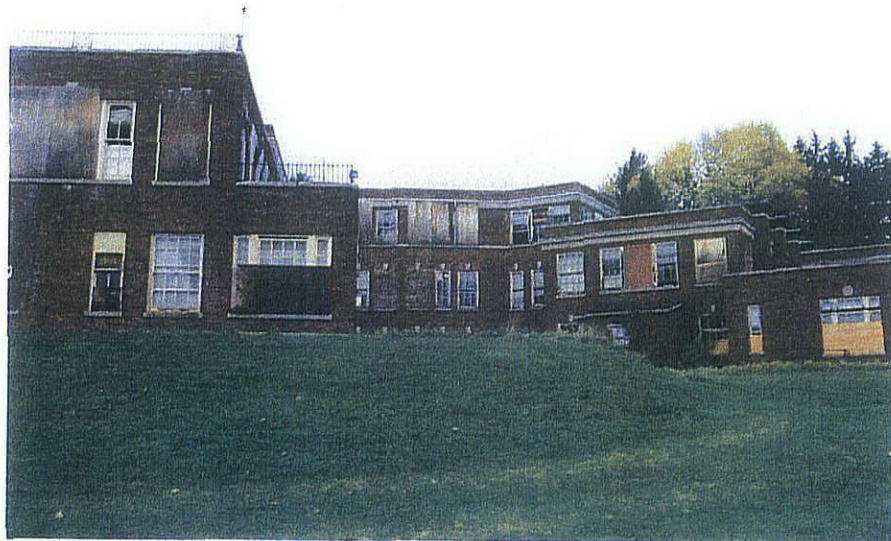
The exterior masonry walls with the exception of some of the parapets were found in fair condition. There was no evidence of major cracks or settlement, (see photos 2 & 8). Some of the parapets have pushed outwards and will need to be repaired as soon as possible, (see photo 9), if left as is they could partially collapse during a heavy wind storm. While walking around the building we noted that the terrace slab has caved in (probably over the tunnel). This is currently dangerous and should be repaired as quickly as possible. The roof structure at a few locations while walking on the roof did not feel stable. This could be due to deterioration of the structural member(s). The roof is in poor condition and allowing water to enter the building and probably causing the deck to rust, (see photo 11).

**Photo 8**  
Looking at the south-west corner of Building – 5.

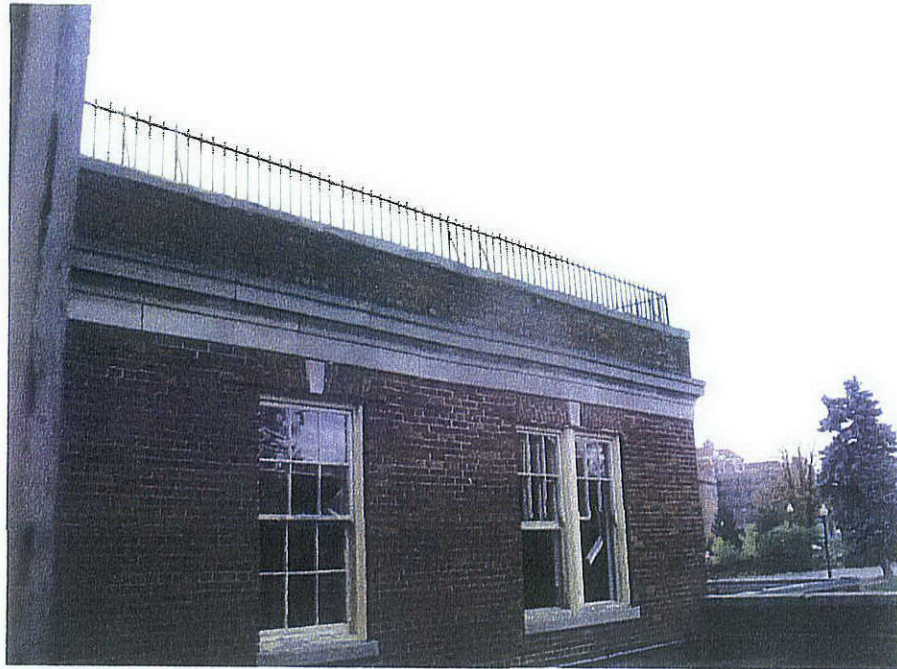
**Photo 9**

Looking at a section of the parapet of Building – 5 that is in poor condition.

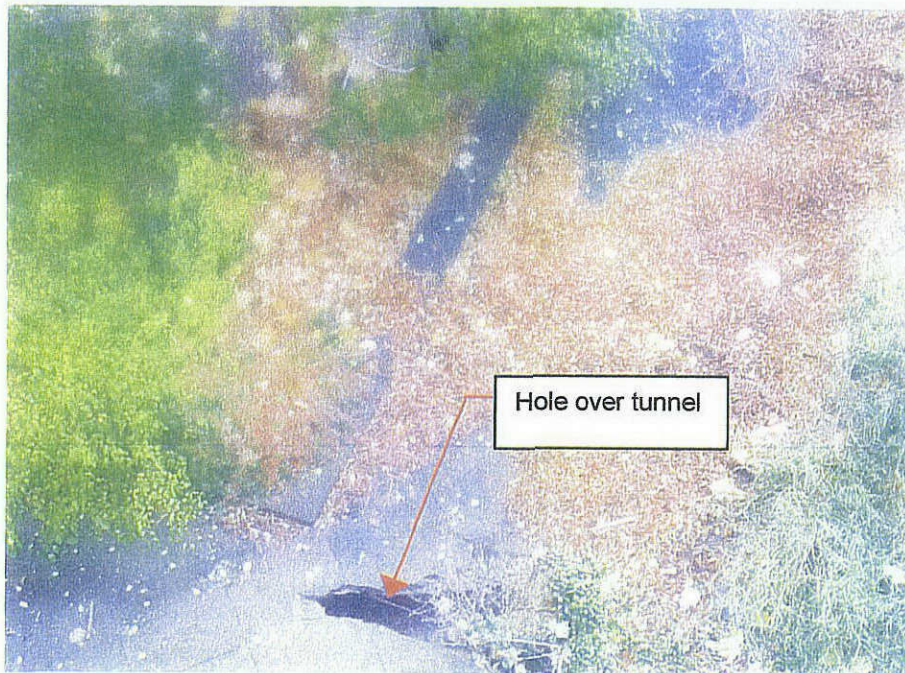
**Photo 10**

Looking at the Building – 5 Terrace slab that has caved in.

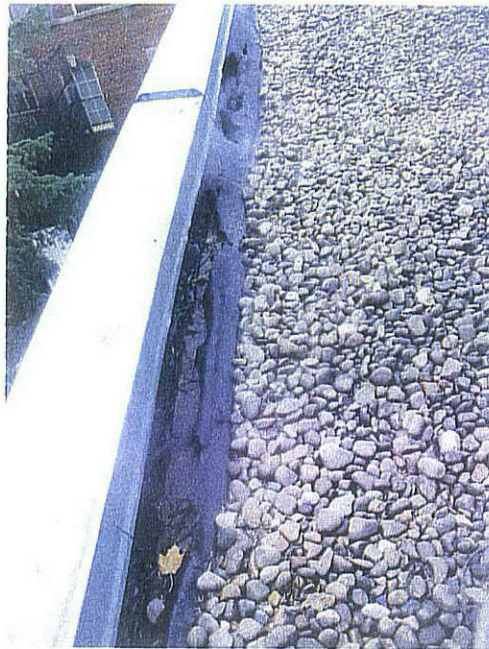
**Photo 11**

Looking at the ballasted membrane roof of Building – 5.

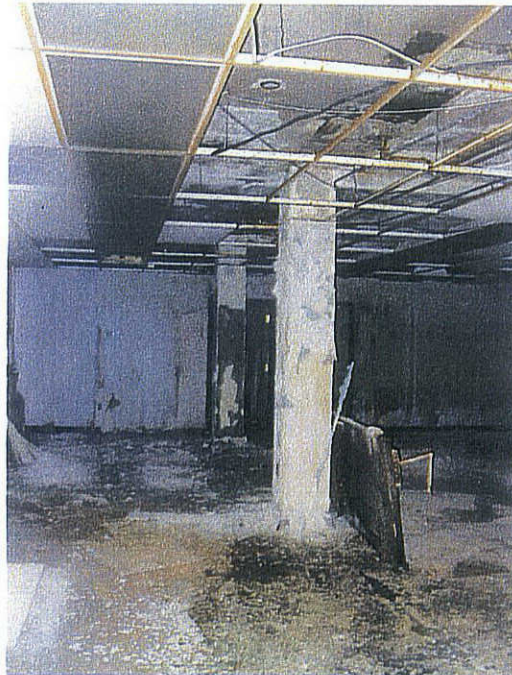
**Photo 12**

The floor structural members (columns, beams, connections) were not visible since they were covered with plaster; however, we did not notice any major issues such as excessive deflection, lateral support problems or any other stability concerns, (see photo 12).

Looking at an interior photo of Building – 5. Notice that water is entering the building and could be causing excessive rust damage.

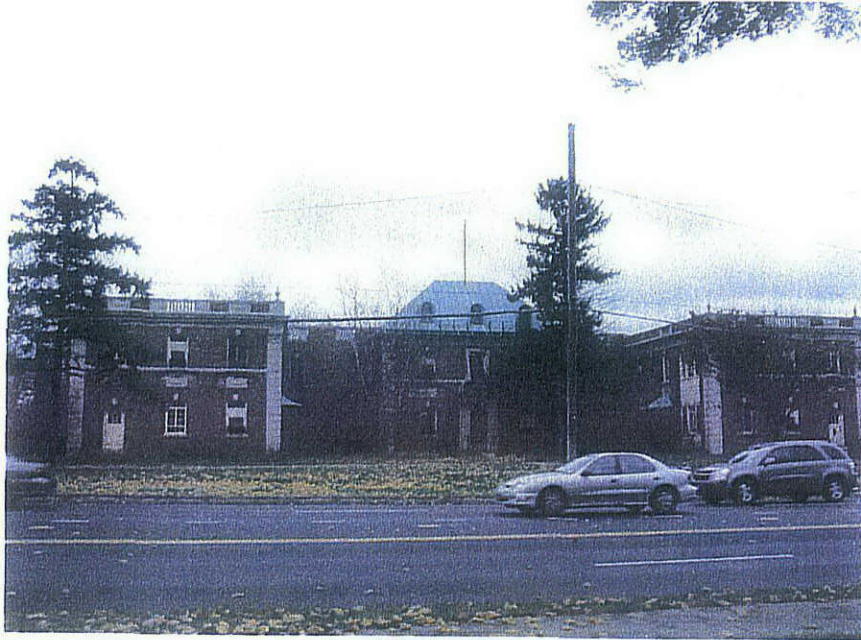
The exterior of this building was found in good/fair condition. The walls were found straight and plumb, (see photo 13). At some locations the decorative stones were removed and as a result we were able to see that the exterior wall construction consists of structural clay tile and brick, (see photo 14).

**Photo 13**  
Looking at Building - 7.

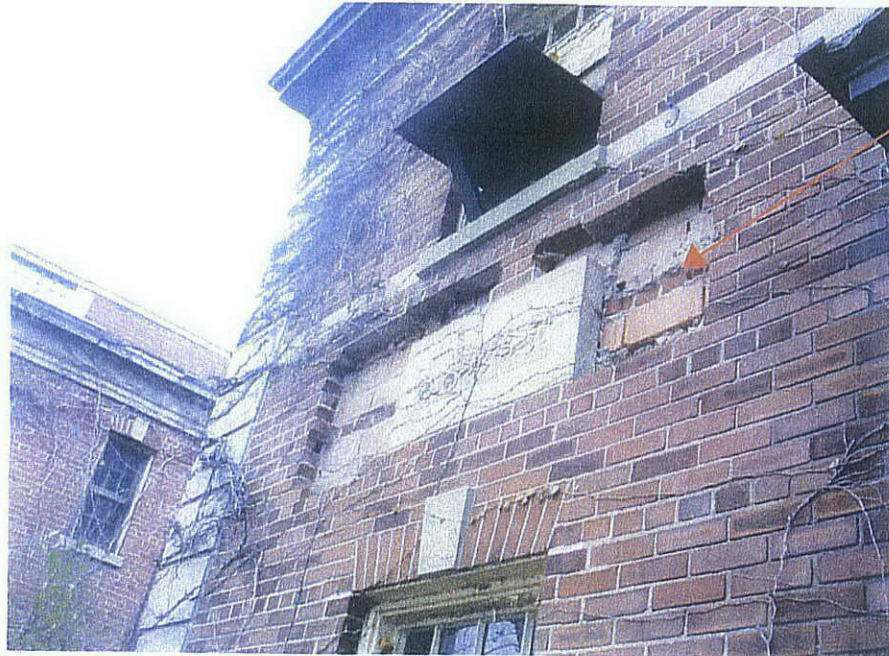
Structural clay tile

**Photo 14**  
Looking at Building - 7. Just North of the front entrance. This is where the decorative stone was removed.

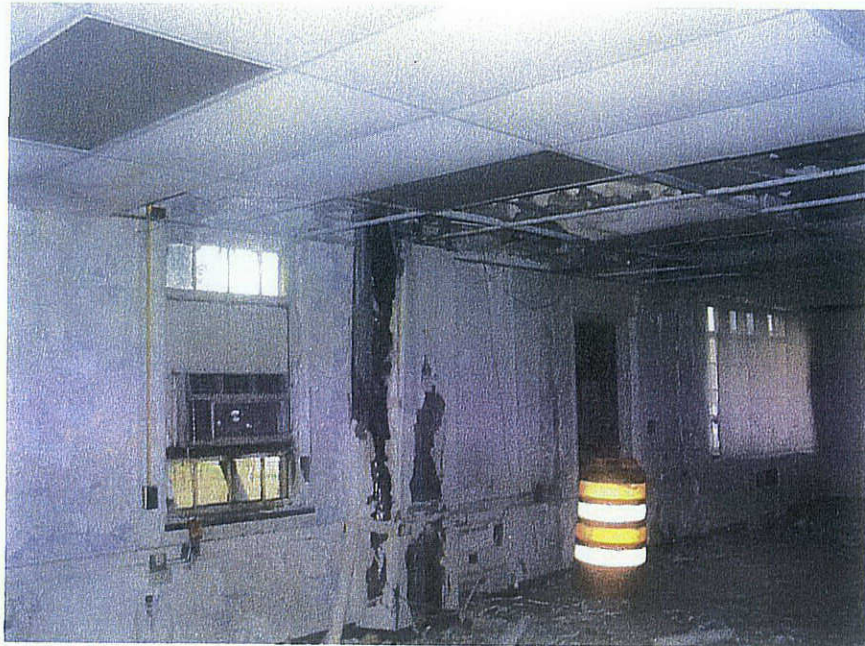
**Photo 15**

The building has been neglected for some time as evidenced by the peeling paint and cracked plaster throughout. Where visible the concrete slab, steel columns and beams were found in good/fair condition, (see photos 15 to 18); however, we would like to point out that there is a good possibility that some damage could exist since the building has been exposed to weather for some time. Excessive rust damage to the connections (beam to beam, beam to column) is a strong possibility, there also may be major rust damage to the columns and beams.

An interior shot of Building - 7, notice the poor condition of the interior.

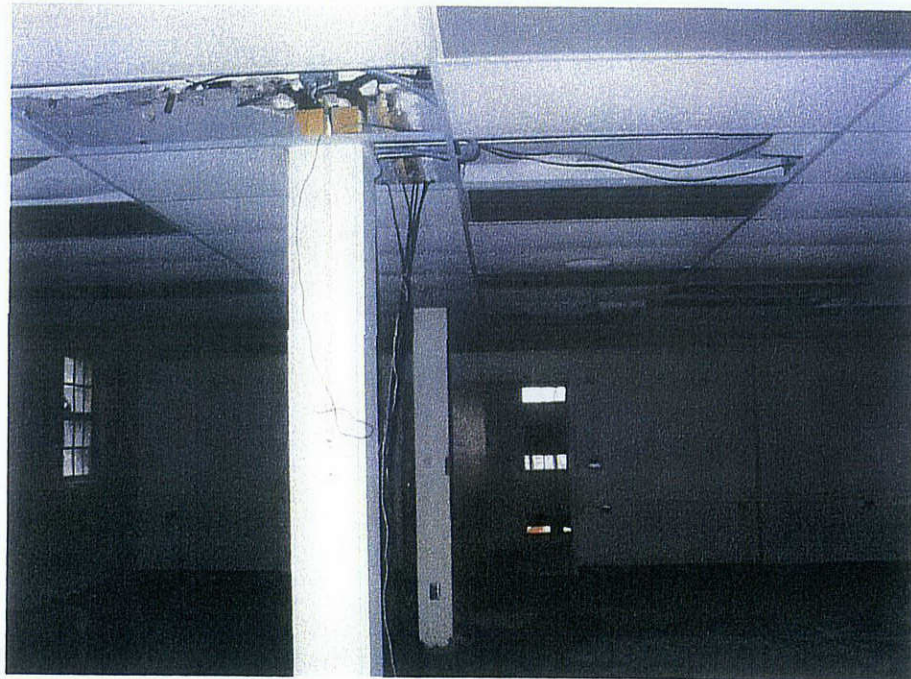
**Photo 16**

Looking at some of the columns of Building - 7.

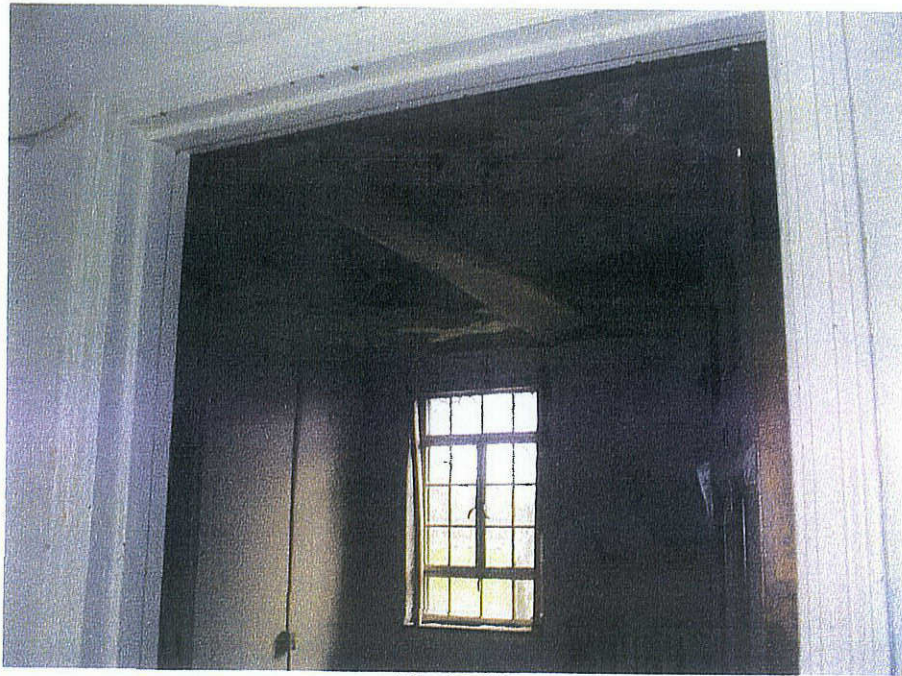
**Photo 17**  
Another photo of the interior of Building - 7.

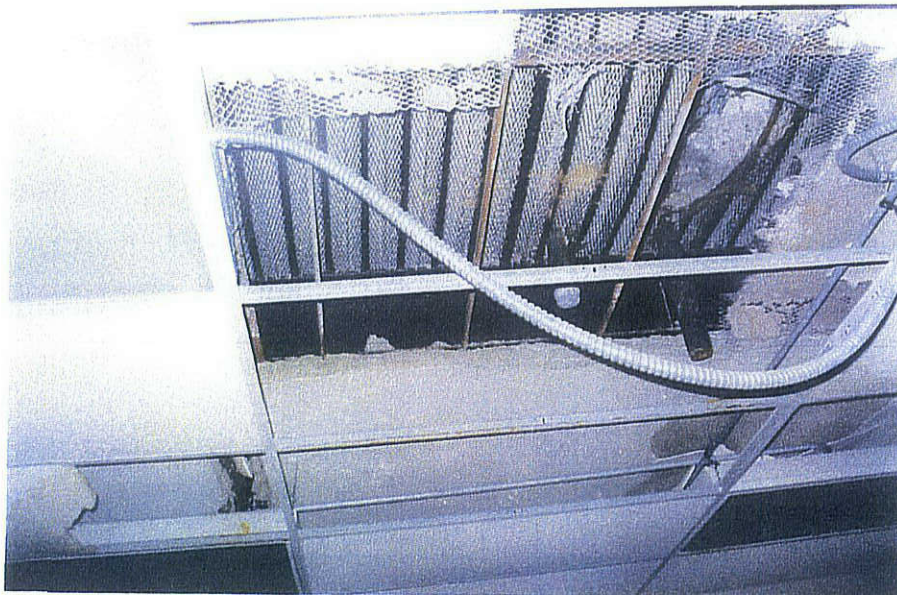
**Photo 18**  
Looking at a section of the floor of Building - 7. The concrete slabs were supported on metal lath.

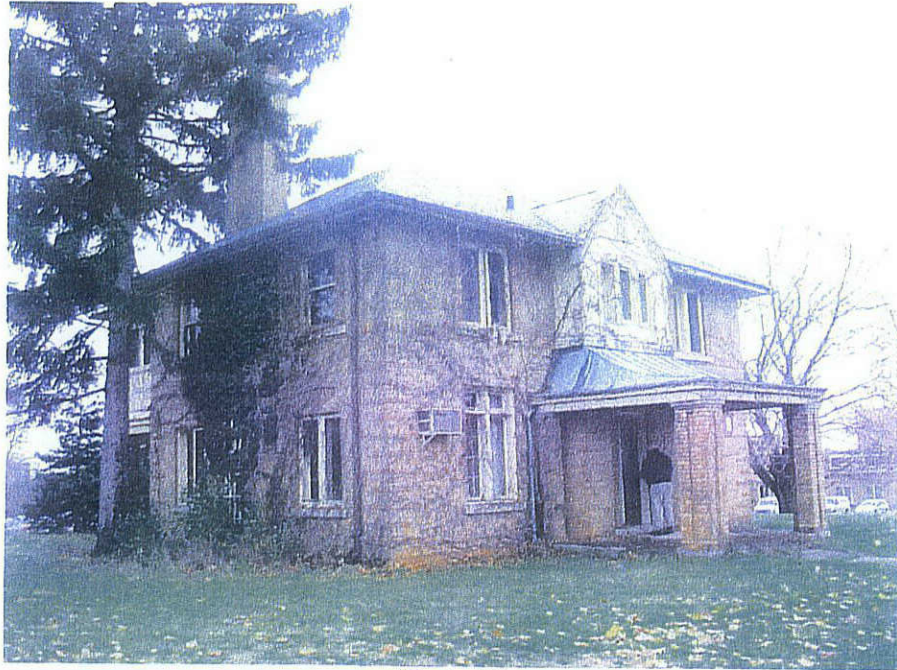
The exterior construction of this building is wood frame with brick veneer, essentially it is typical residential construction. The brick veneer was found in good condition, the walls appeared to be plumb, the roof structure was inspected from the ground and looked to be in fair condition, (see photo 19). However, like the other buildings in this campus this building has been neglected for some time, as a result there may be internal damage to the main structural elements, (see photo 20) such as wetrot, dryrot or termite damage.

**Photo 19**  
Looking at Building - 8.

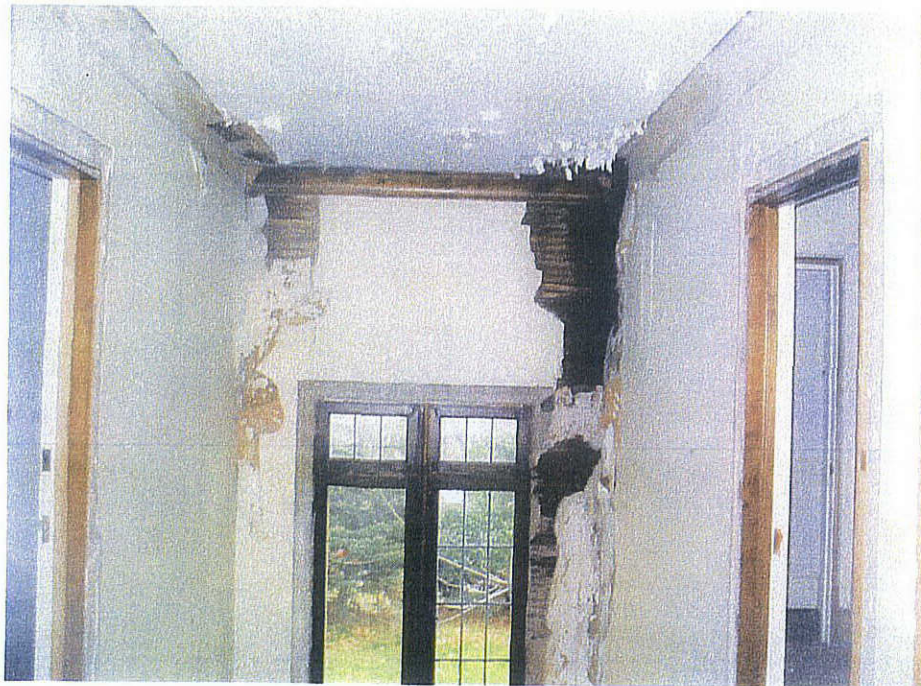
**Photo 20**  
Looking at one of the areas (east stair wall of Building - 8) where dryrot/wetrot issues could exist.

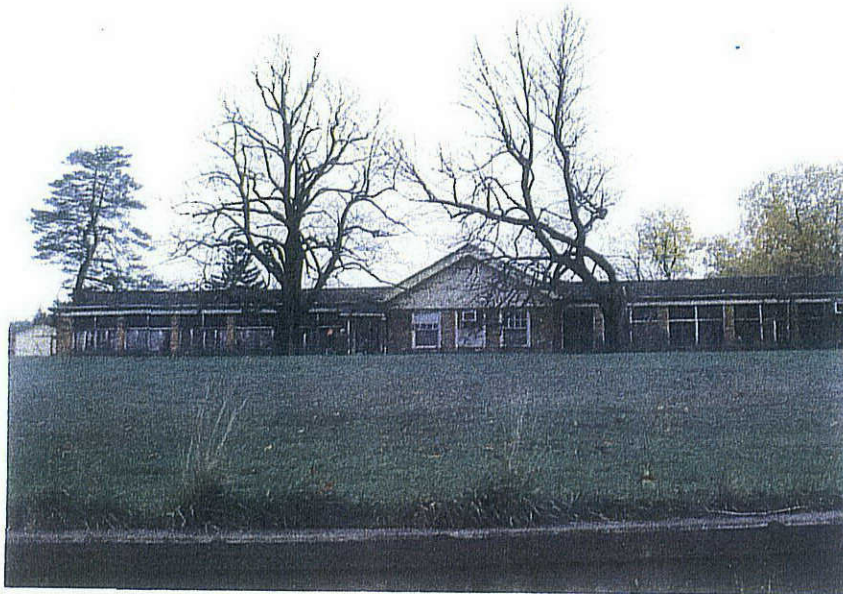
No major issues were found with the exterior walls. The roof structure on the surface visually appeared in fair condition, (see photo 21); however, since the roof structural members have been exposed to the weather (due to damaged/deteriorated shingles) there may be damage to the structural members such as dryrot or wetrot, (see photo 22).

**Photo 21**  
Looking at Building - 9.

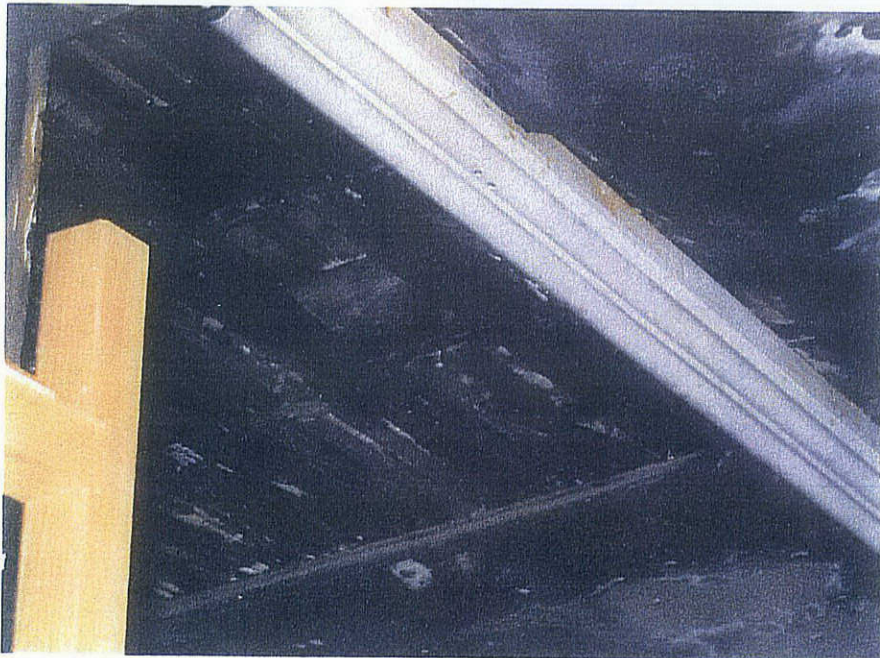
**Photo 22**  
Looking at the ceiling/roof structure of Building - 9. Notice the structure is full of moisture.

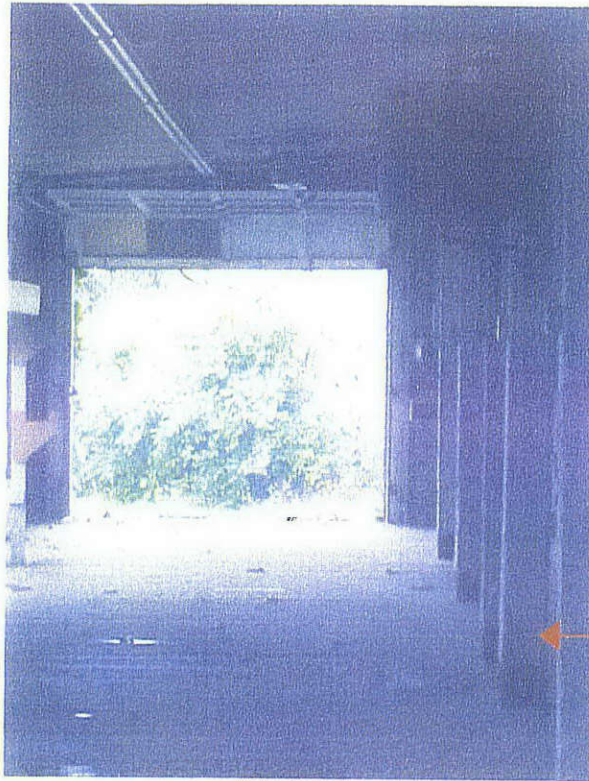
**Photo 23**

The wood columns have vertical cracks, (see photo 23). This is typical for heavy timber and usually it is not a concern; however, in this case since the building is exposed to the elements, water that enters the cracks creates constant moisture and could be causing the columns to deteriorate from inside out.

Vertical crack in column

Looking at the interior of Building - 9. The vertical cracks in the columns can be seen in the photo.

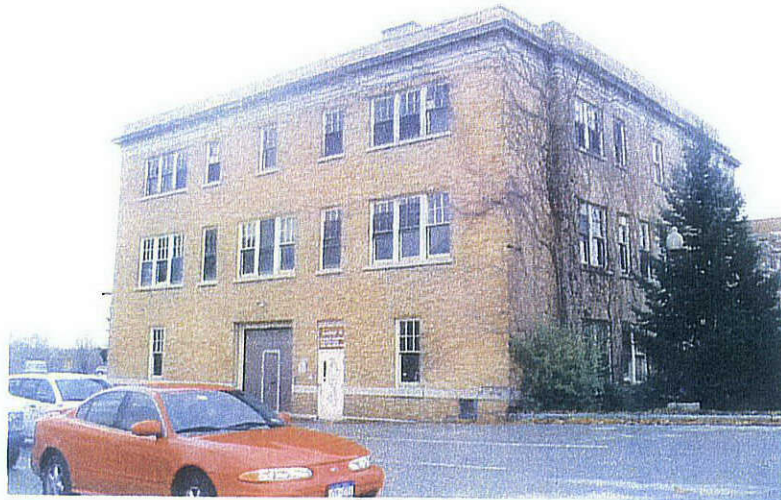
**Photo 24**

The brick exterior walls have vertical/diagonal cracks at several locations caused by differential settlement. We believe the building is still moving as evidenced by the fact that the cracks were previously repaired and have opened again, (see photos 24 & 25). The parapet walls have tipped inwards, (see photo 26) and currently are in danger of partially collapsing during a heavy wind storm.

Looking at Building - 10.

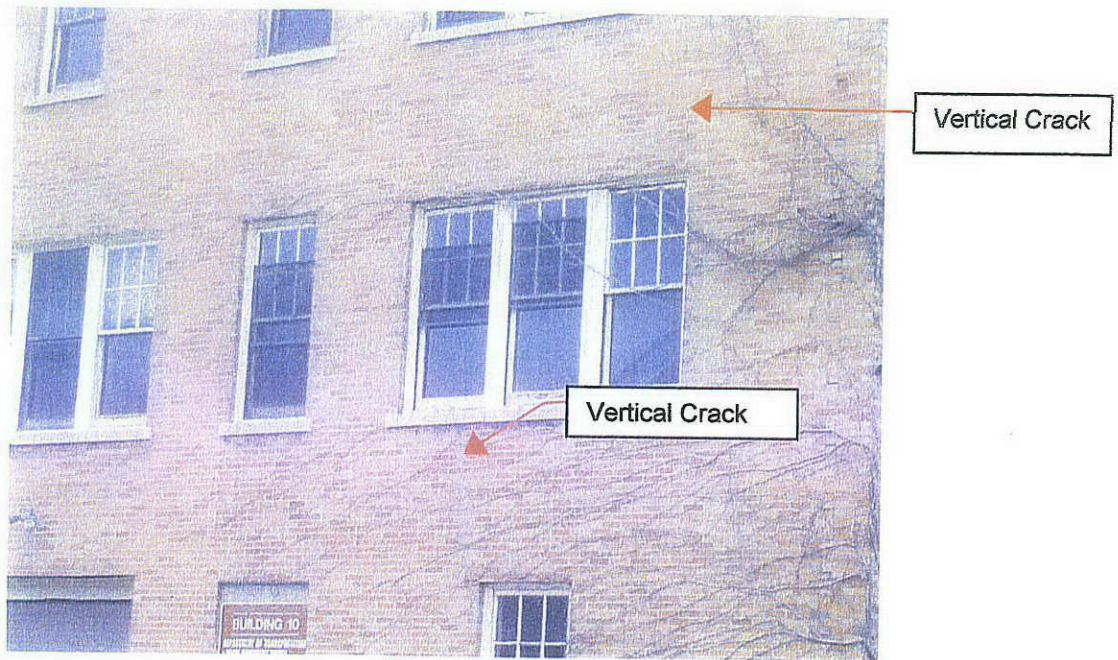
**Photo 25**  
Looking at a couple of the vertical cracks in the East wall of Building – 10.

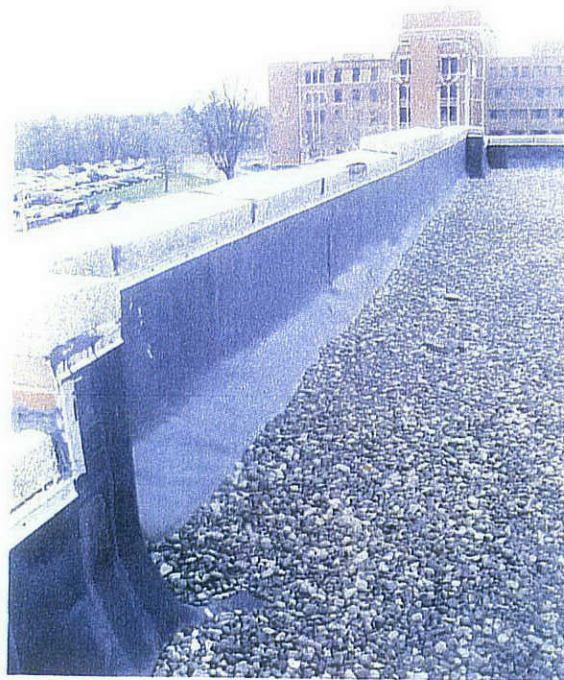
**Photo 26**  
Looking at one of the parapets of Building – 10 this is tipped inwards.

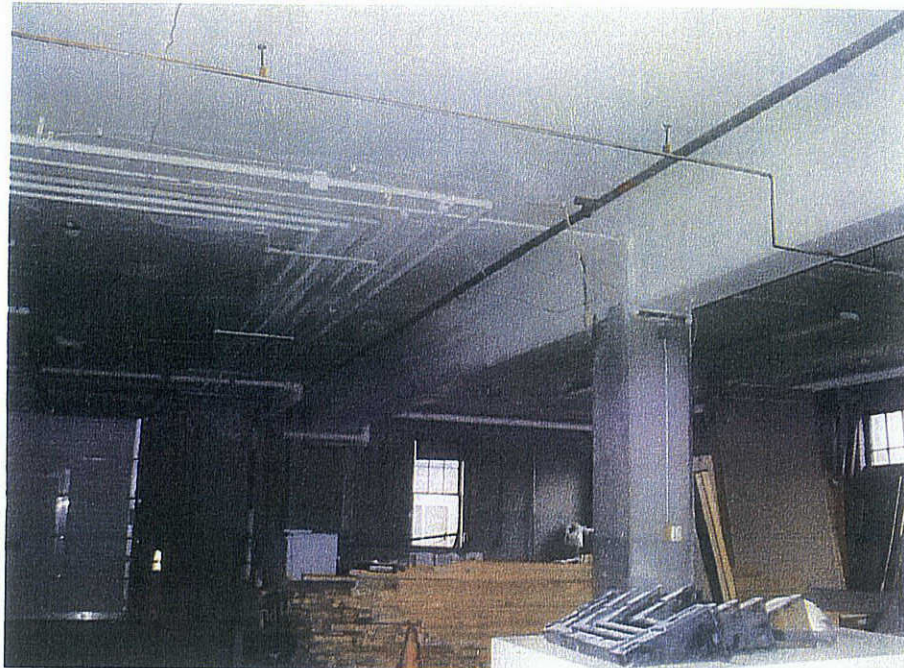
**Photo 27**

The concrete slabs, beams and columns have been exposed to moisture for some time. As a result there may be some internal damage that is not evident at this time, (see photo 27). As previously stated the issue with this building is differential settlement, specifically the stair towers, (see photo 28). The floor construction consists of solid one way slabs or 'T' beams formed with metal 'T' pans, (see photo 29).

Looking at the concrete columns and beams, the floor at this area is a one way solid slab.

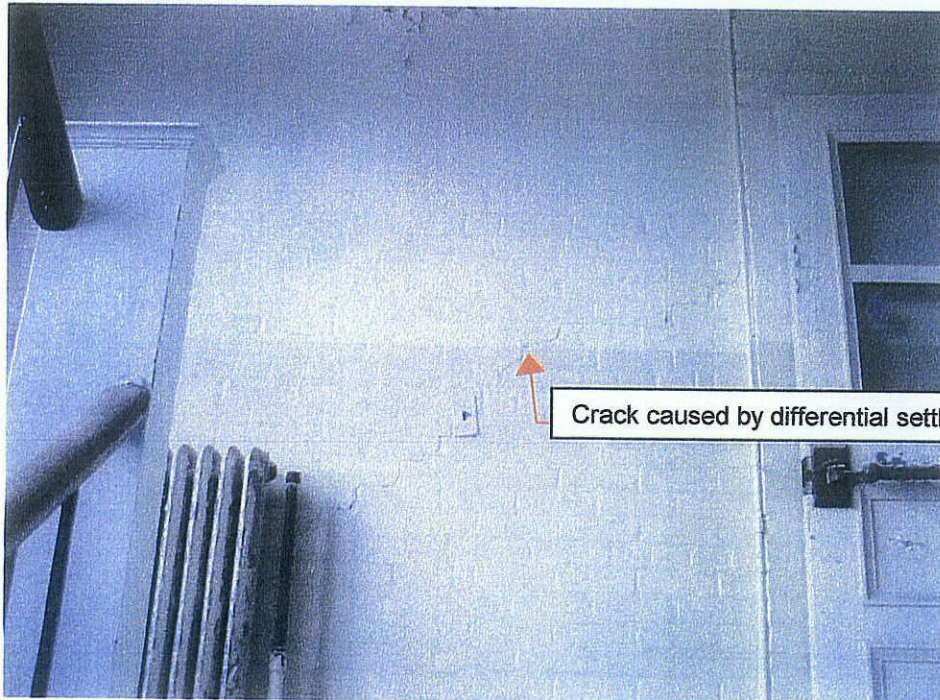
**Photo 28**

Crack caused by differential settlement

Looking at one of the settlement cracks in the South wall of the East stair tower. The West tower has similar cracks that were previously repaired and have opened again.

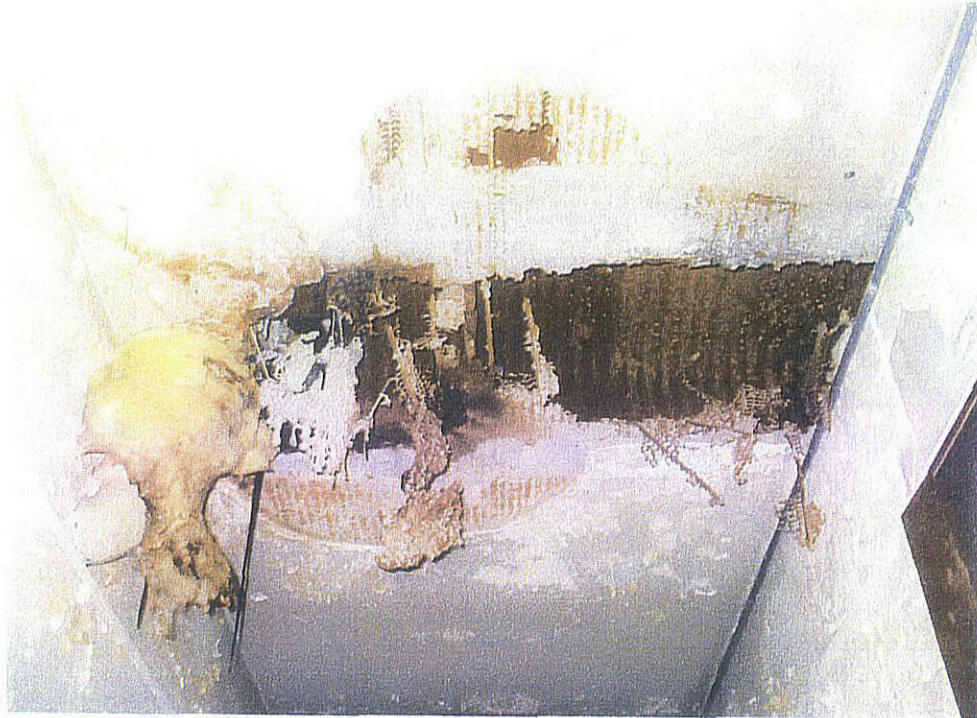
**Photo 29**  
Looking at a typical metal 'T' beam form pan.
