GENESEE VALLEY PARK WEST

MASTER PLAN

EXISTING PARK CONDITIONS

City of Rochester

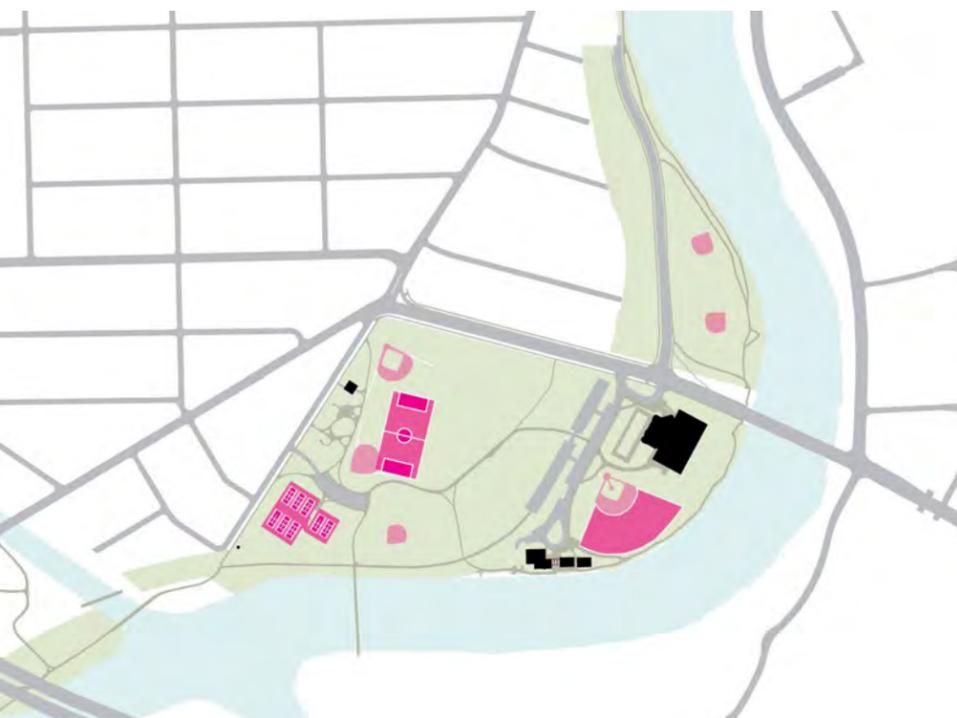
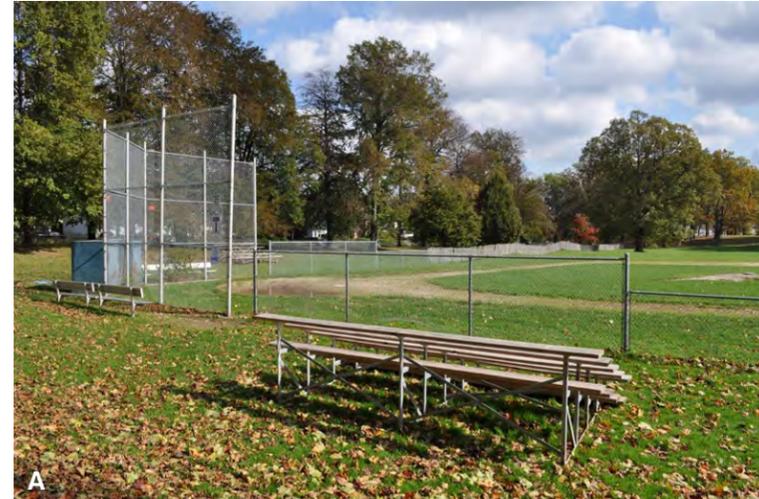
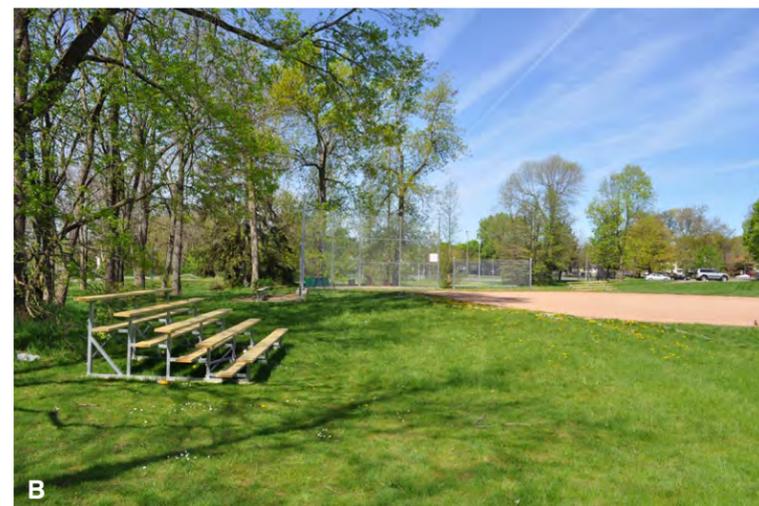
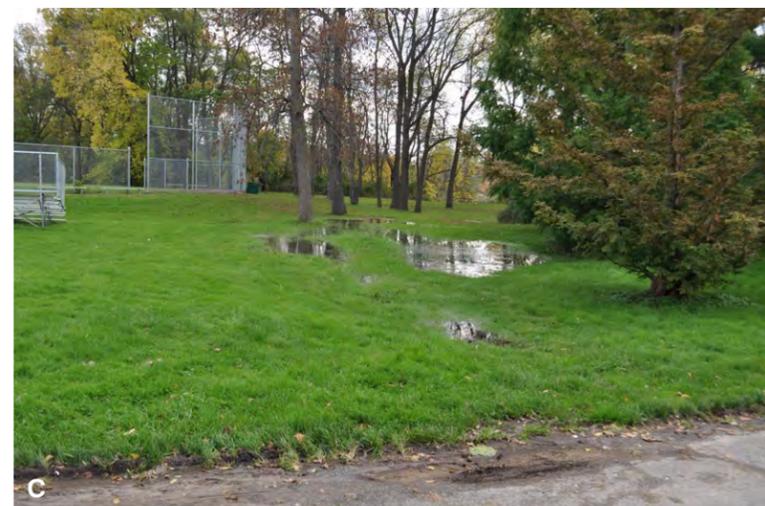
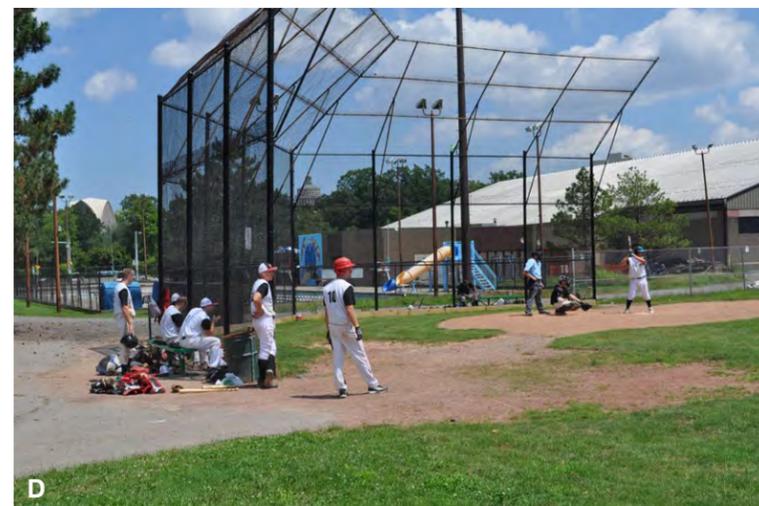
Ball field #1 is heavily used for high school baseball due to its size and condition. There are a lack of player or spectator amenities such as dug-outs or nearby rest rooms.

Ball field #4 is the park's only full sized baseball field and is lighted. It receives extensive league play but lacks necessary amenities such as dugouts, shade structures for players and spectators or pitching cages. The field also suffers damage and requires frequent repair due to over-use and unintended use due to group rentals and event parking. As the only lighted turf area it is in high demand on summer evenings.

inaccessible due to wet swales and standing water / poorly drained areas cause stagnant smell in the spectator and infield area – limiting enjoyment and use.

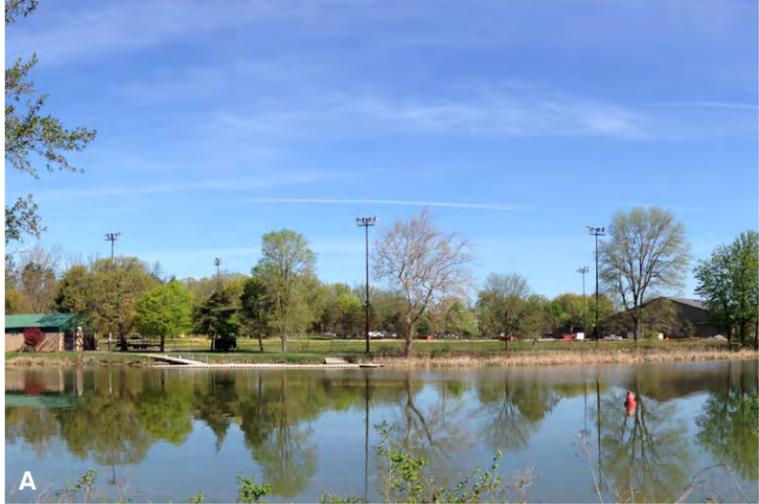
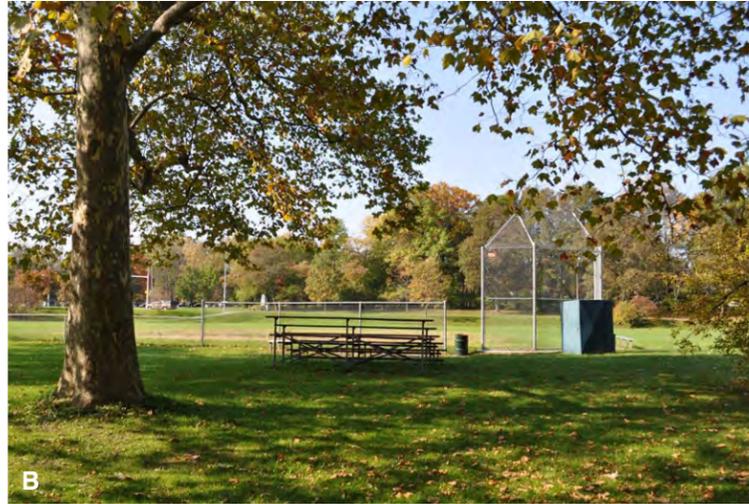
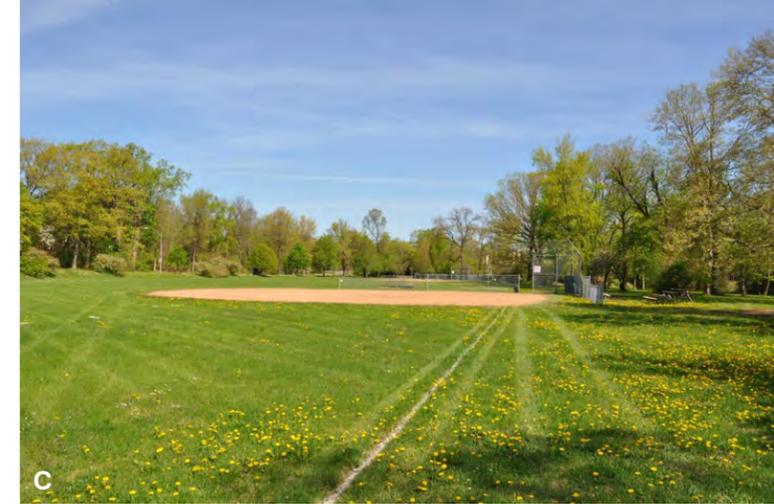
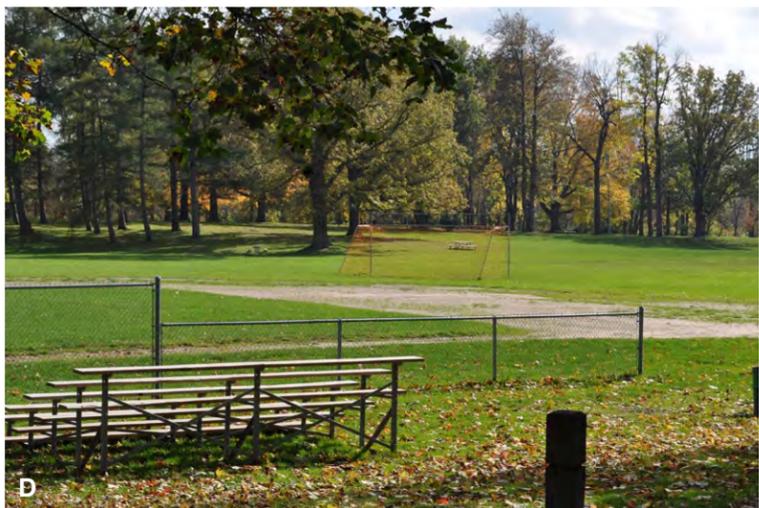
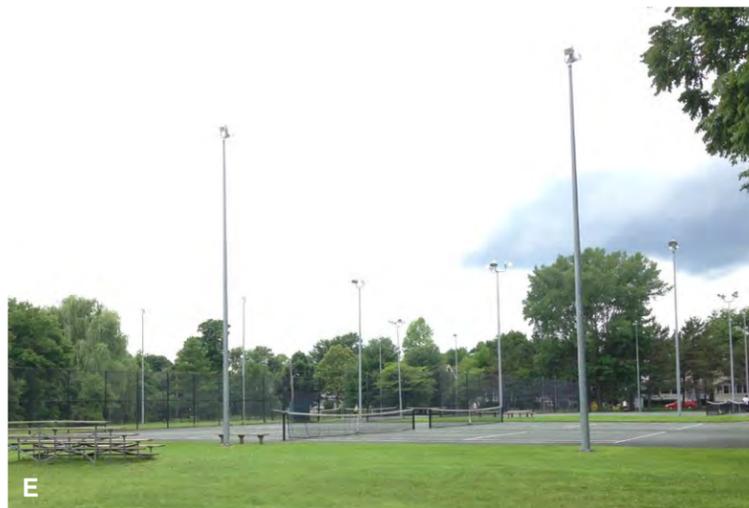
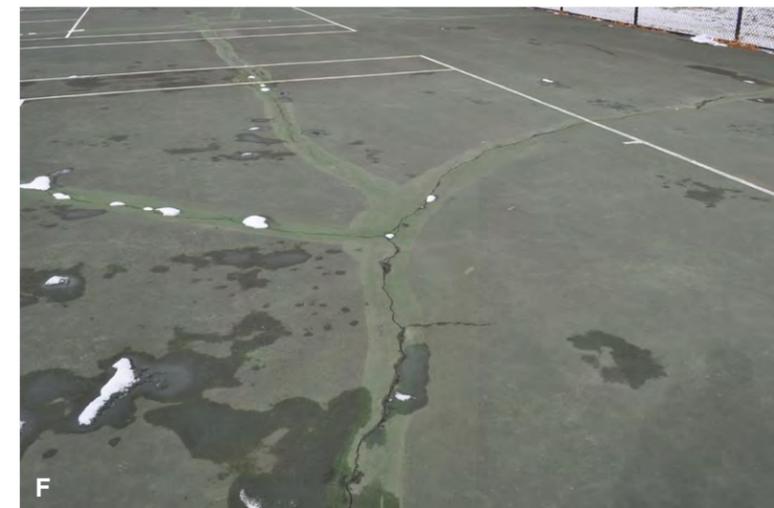
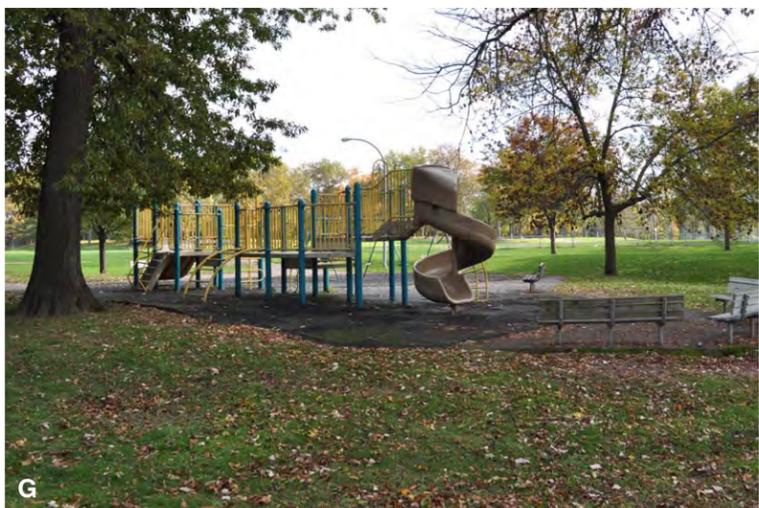
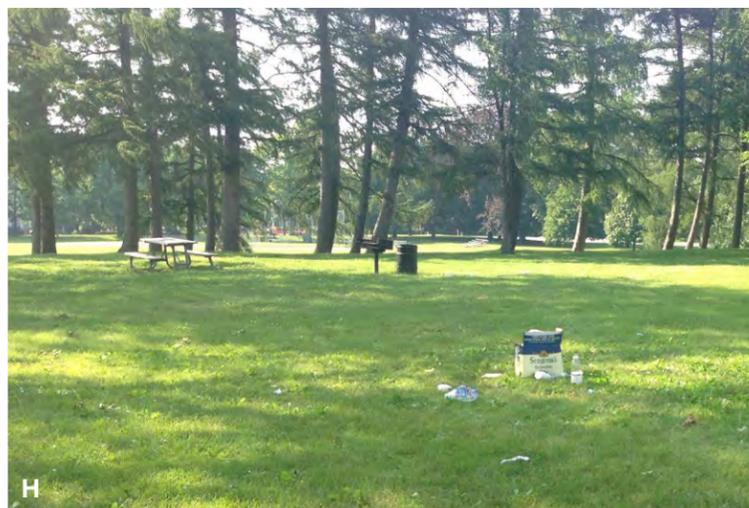
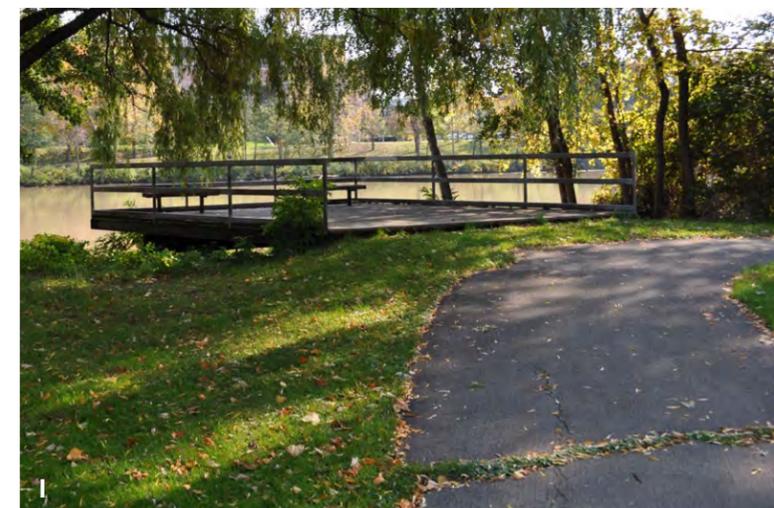
Ball Field #4's extensive lighting system is visible from the east side of GVP.

Fields #5 and #6 are located north of Elmwood Avenue. They have been used for Little League play intermittently over the past years. The Rochester little league and neighborhood groups have requested that these fields be repaired.

The fields (#5 and #6) are in need of repair and exhibit poor drainage. The Brooks Landing Phase 2 project is currently reviewing possible repair options.

The tennis courts are accessible from nearby Genesee Street, near an independent parking area. The courts are well used throughout the season despite damage to the court surfacing.

The tennis court area has extensive surfacing failure throughout nearly all courts and increasingly limits or discourages play. The exact cause of the failures are unknown but appear to be due to high ground water, inadequate base preparation and poor drainage.

The playground has good access to the neighborhood and is well shaded, however, equipment is worn and the safety surfacing is warping and does not meet current guidelines. The equipment does not attract children older than five and limits the play experience.

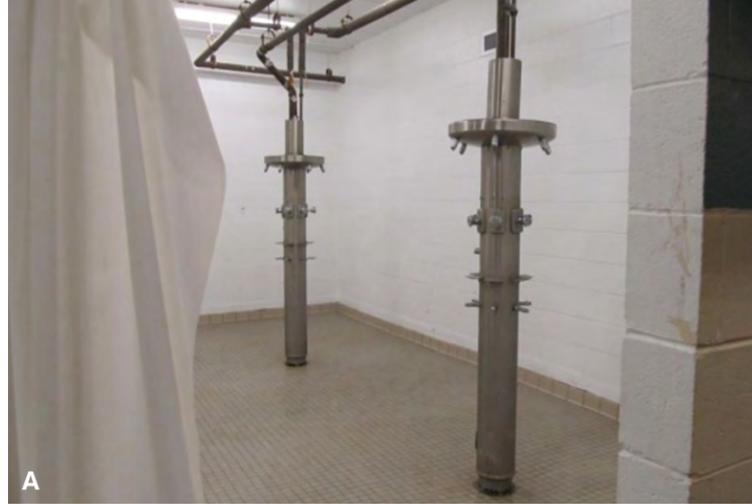
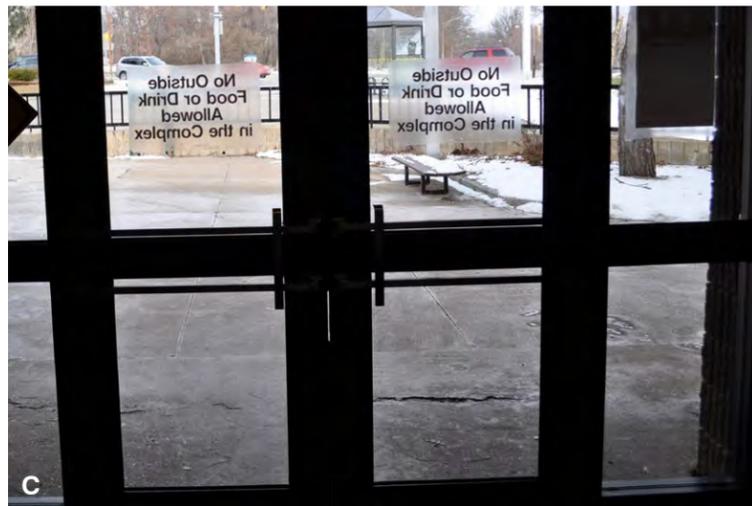
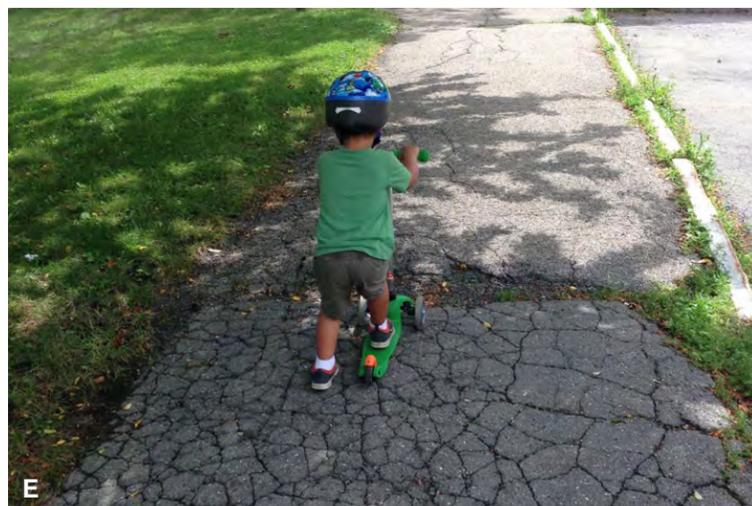
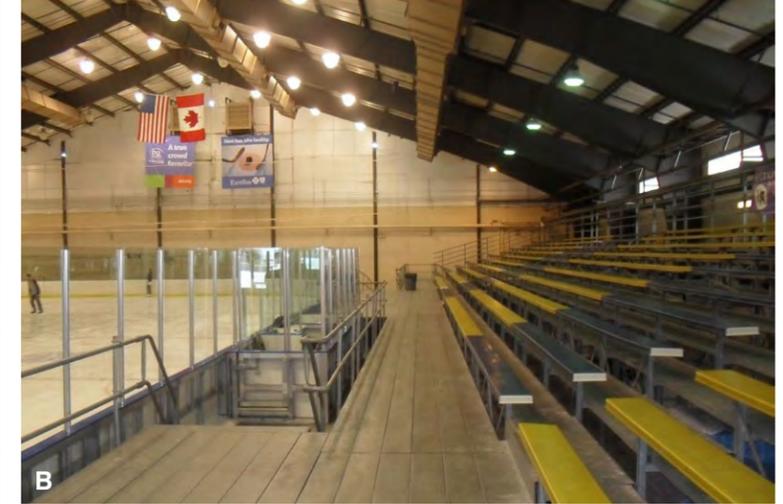
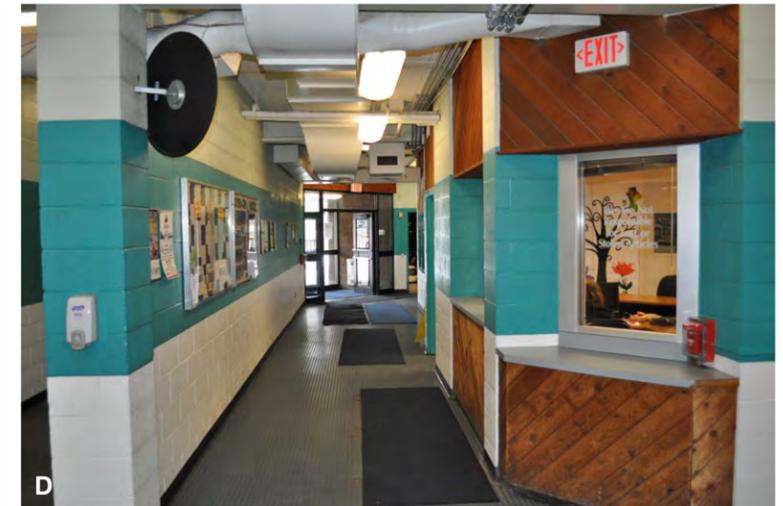
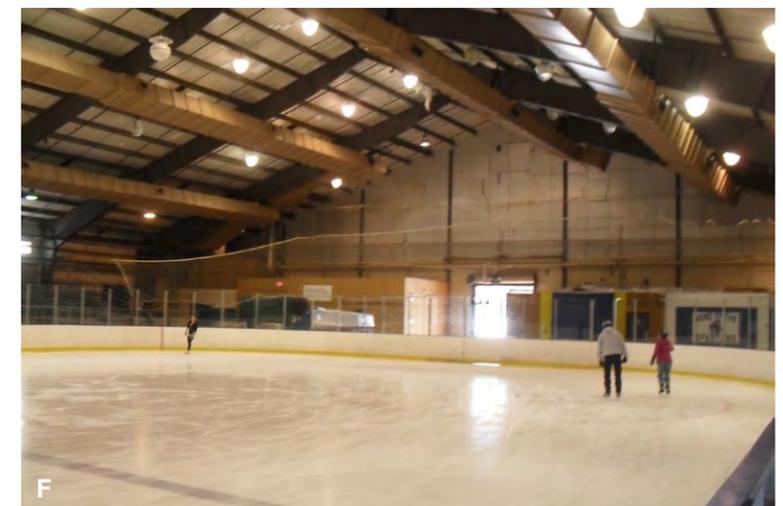
A. Interior locker rooms include undesirable "gang" style shower facilities.
 B. Interior of ice rink functions well but exhibits general worn and outdated appearance.
 C. Paving at exterior exit shows severe concrete spalling and wear, likely from salt use.
 D. Interior main corridor from building entry to locker rooms and ice rink access. Space is narrow and finishes are unattractive.
 E. Exterior sidewalks along main parking lot show severe wear, cracking and are in need of repair.
 F. Interior ice rink area functions well though lacks natural light and finishes are worn. Significant mechanical upgrades to rink slab are currently underway.

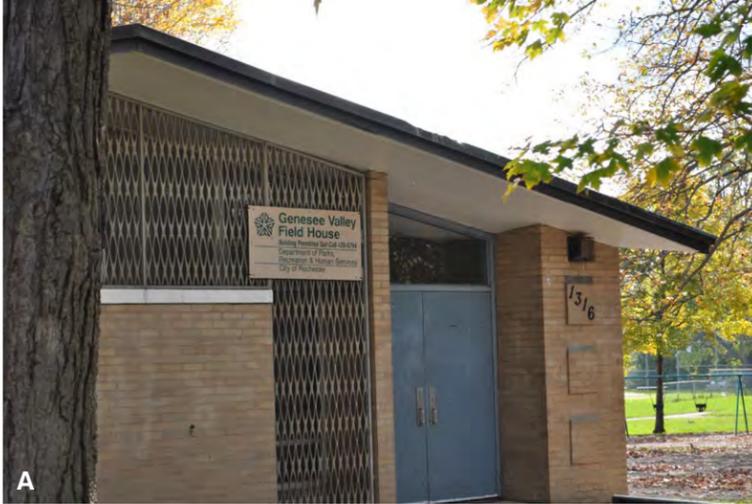
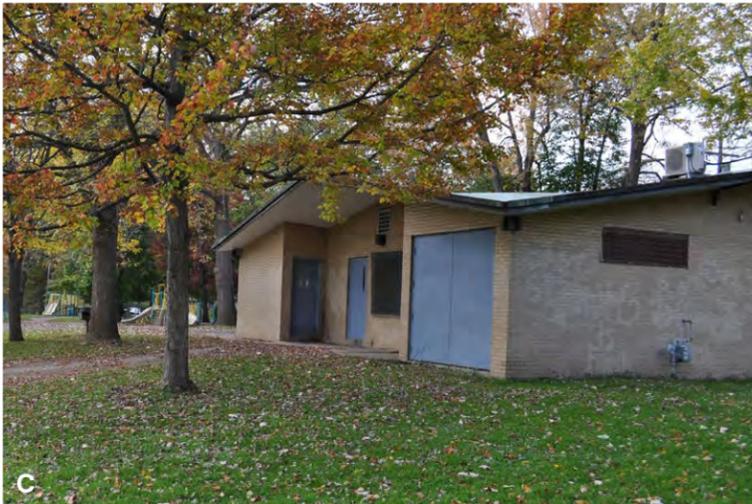
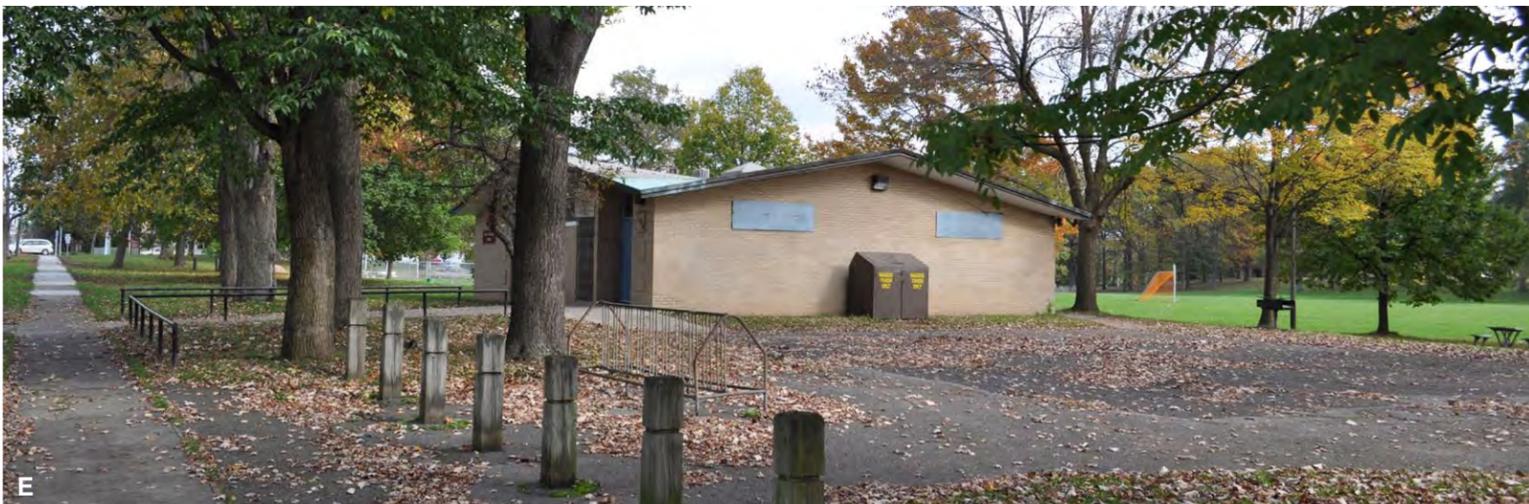
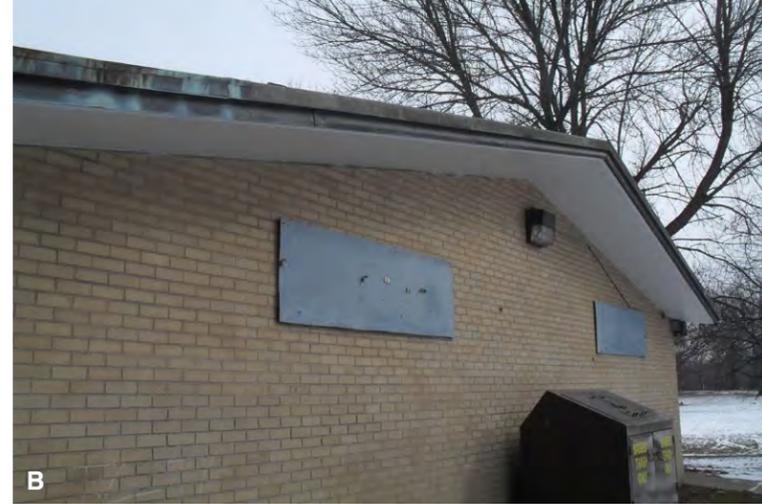
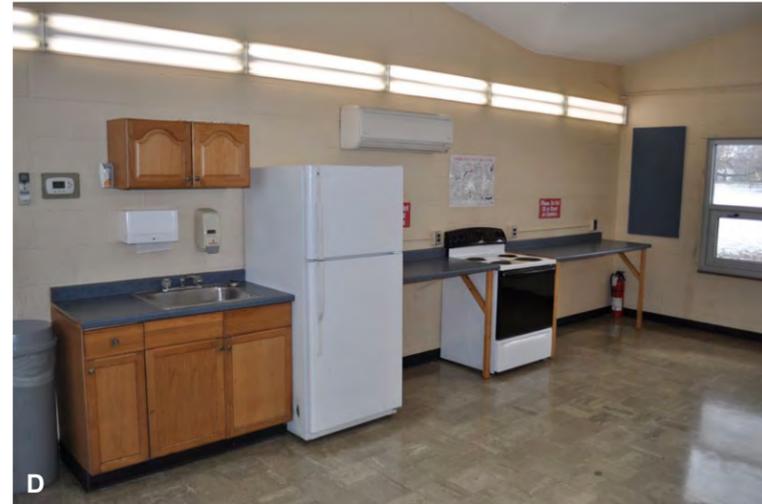
A. Main entry to the Genesee Valley Field House. The entry fronts Genesee Street and includes a sidewalk from the public right-of-way to the door.

B. The south side of the Field House exterior included plywood over former windows.

D. The kitchen within the field house is simple and in fair condition, however the finishes, structure and appliances appear structurally weak and may not withstand prolonged public use.

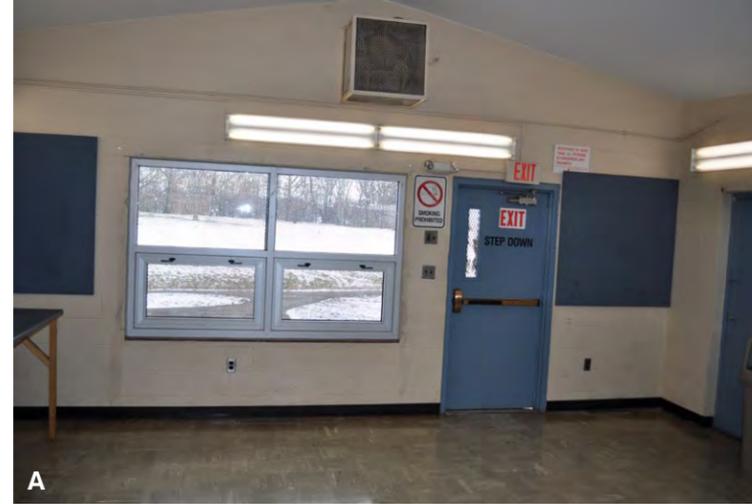
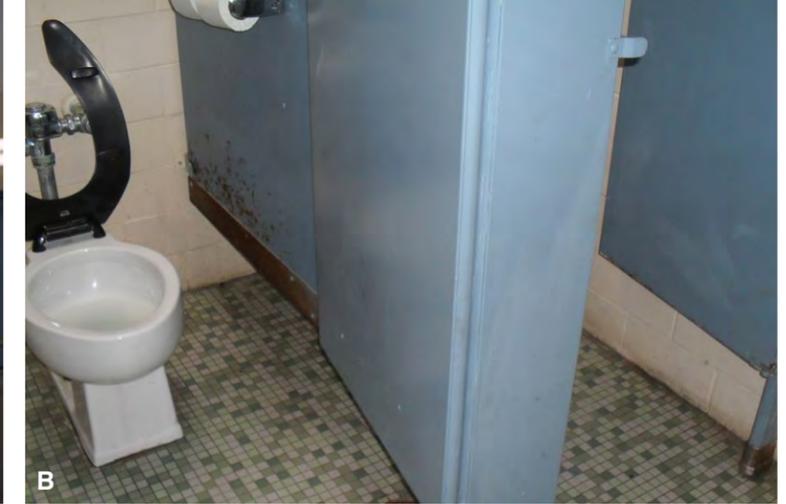
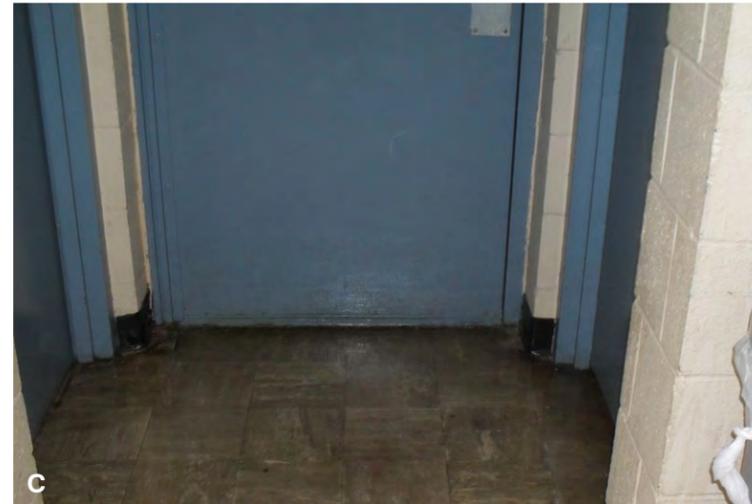
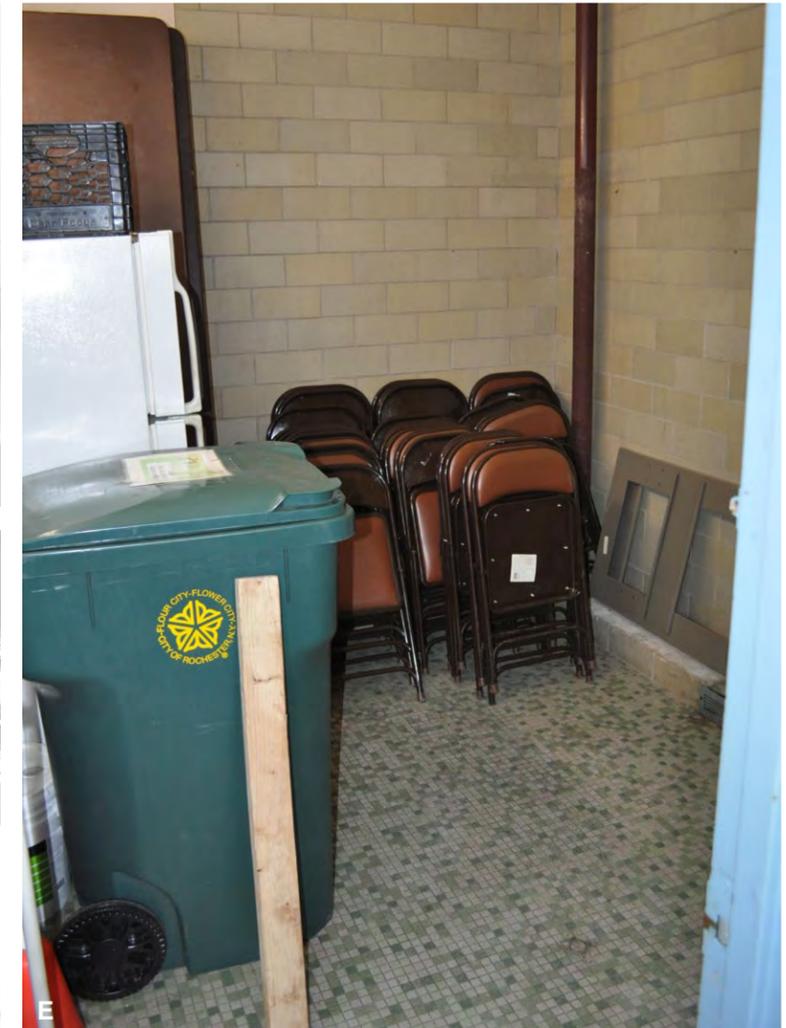
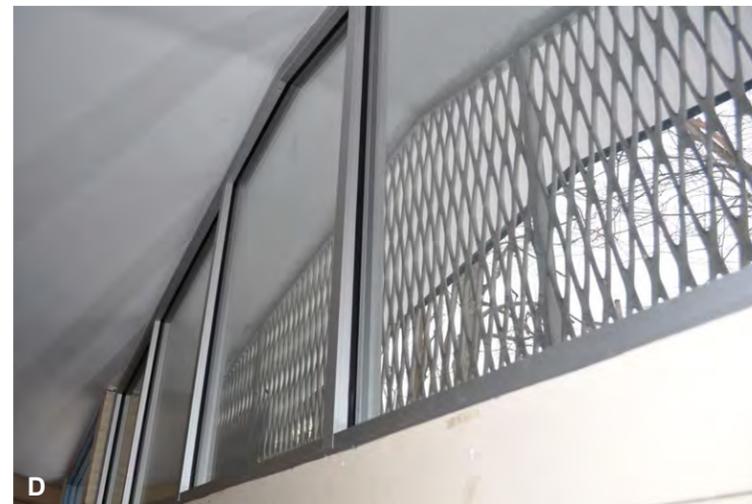
B. Restroom finishes are worn in appearance and appear visually unpleasant.

C. Some interior door frames exhibit rust deterioration.

D. Windows within the Field House were recently replaced with aluminum frames and are in good condition.

E. Interior storage area includes storage, fridge and municipal garbage can in the same space.

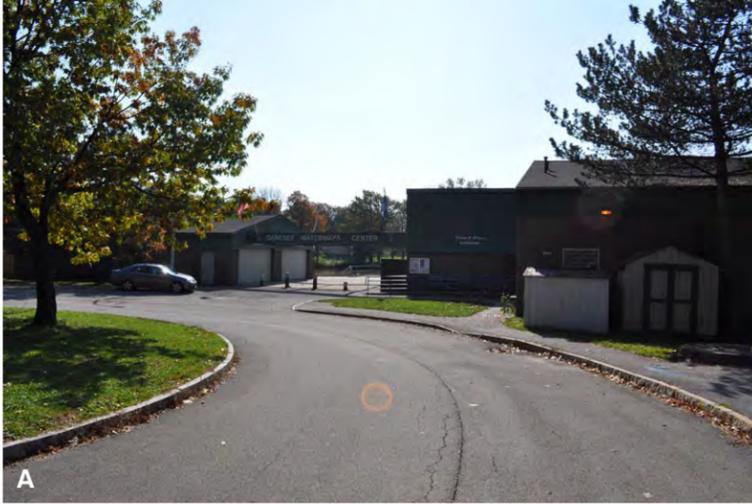
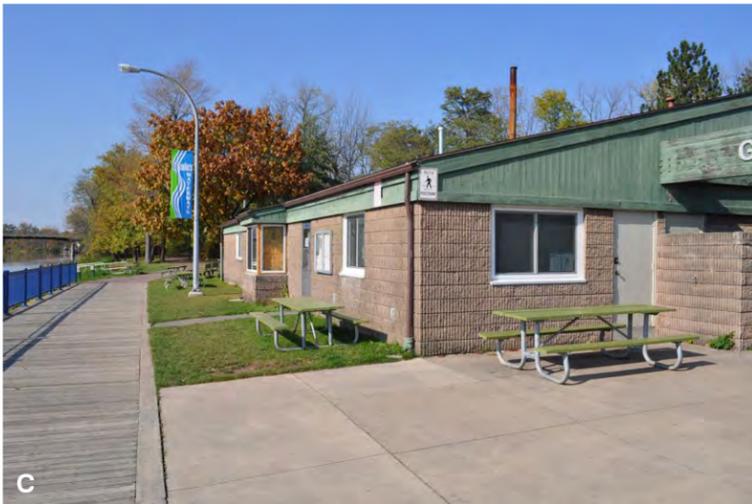
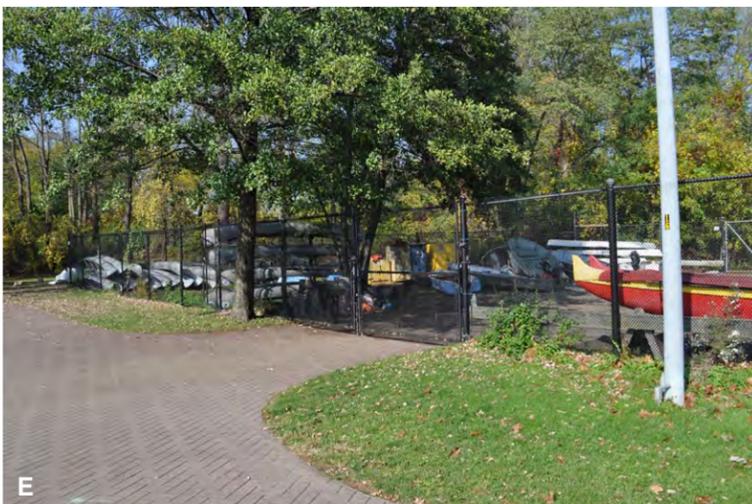
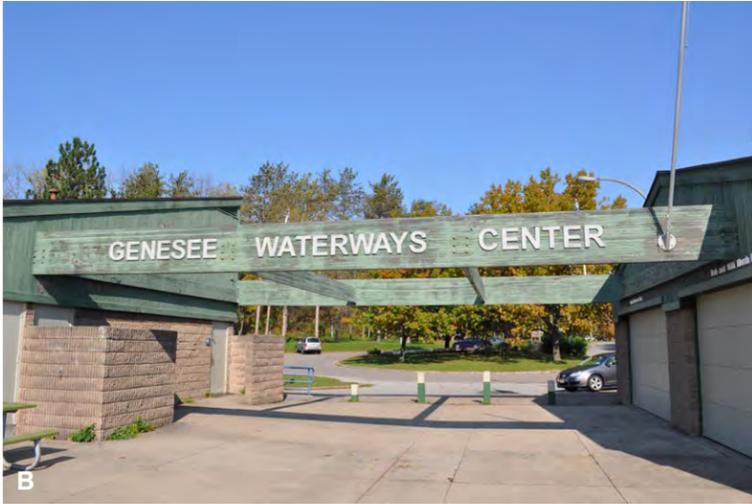
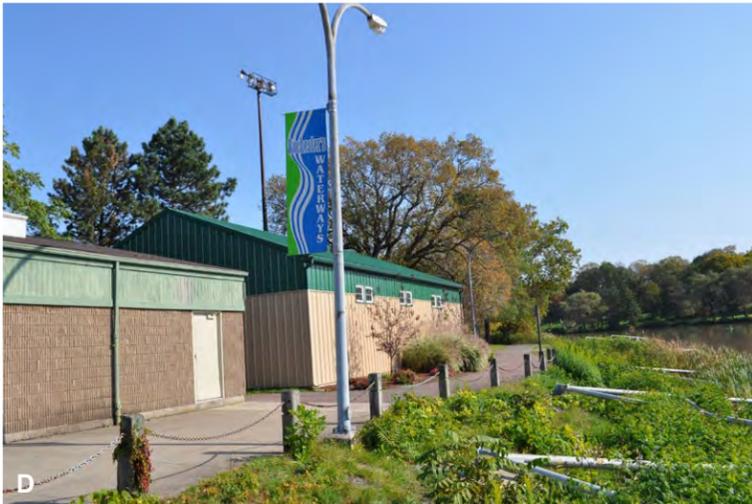
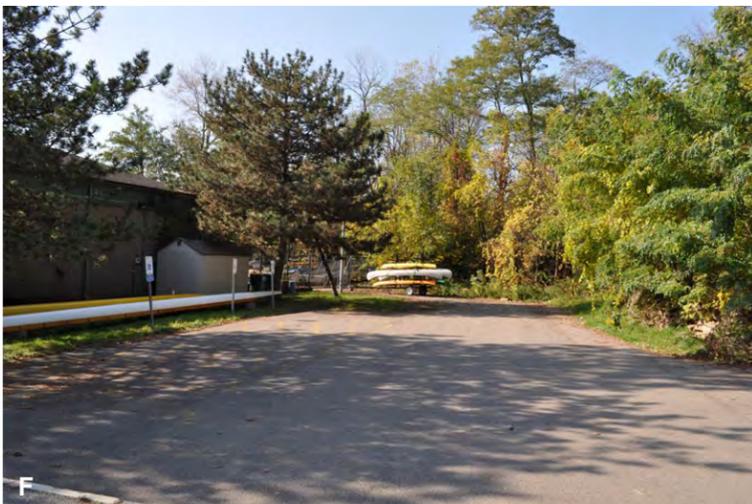
A. Entry / drop-off vehicular loop at the Genesee Waterways Center. The main boat house and administrative offices have no clear entry from the parking lot. Exterior storage units placed at entry for use by various user groups.

B. Pedestrian / hand-carry boat access between main boat house (left) and "little" boat house (right). The drop off loop can be seen in the background.

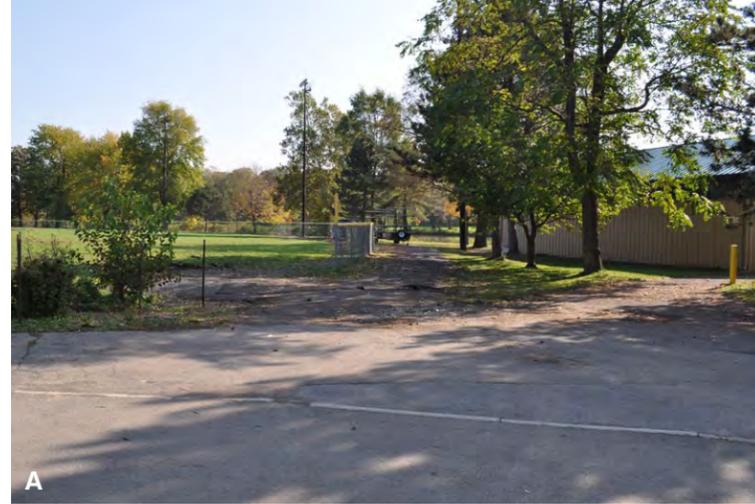
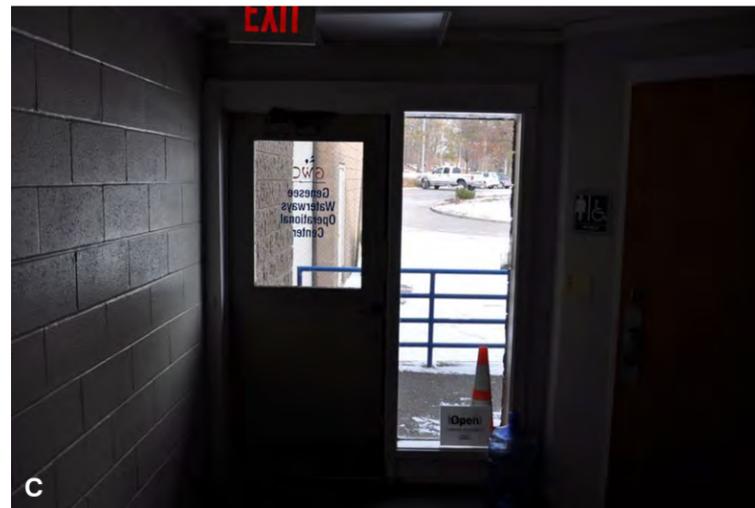
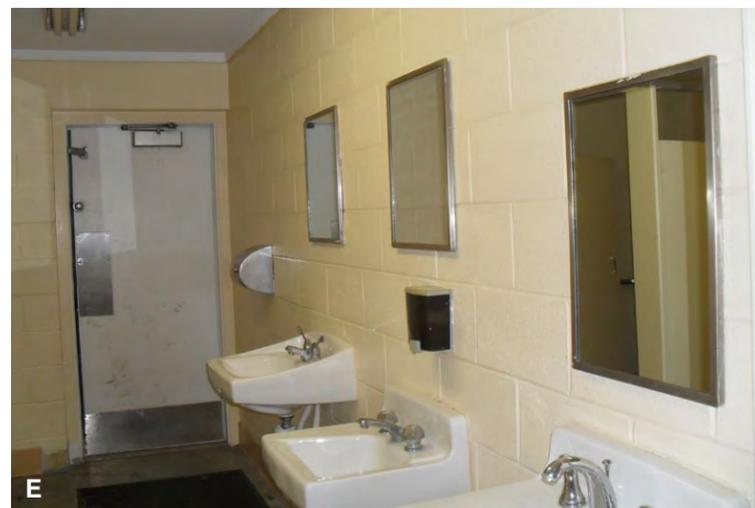
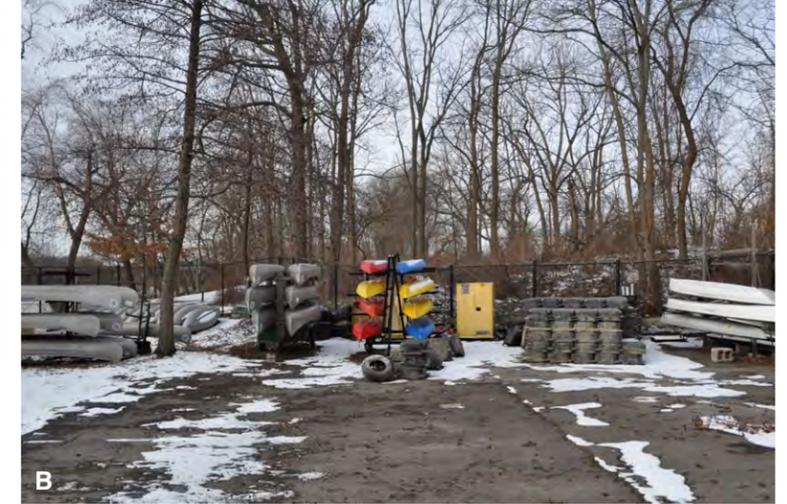
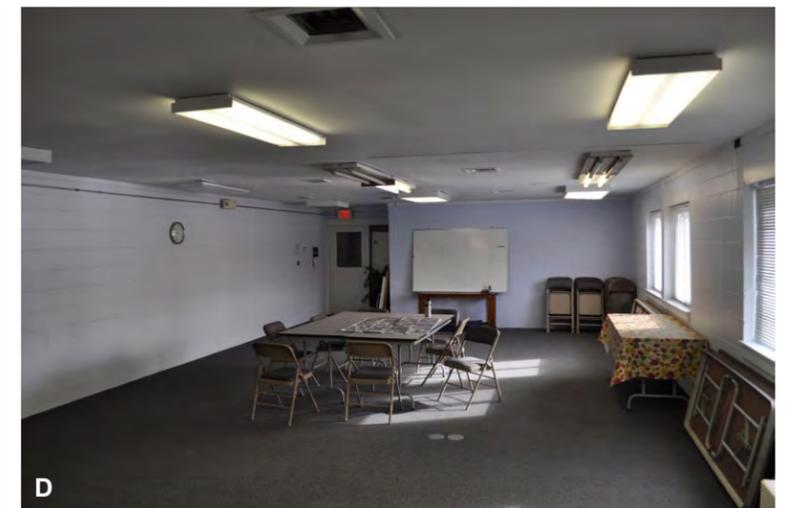
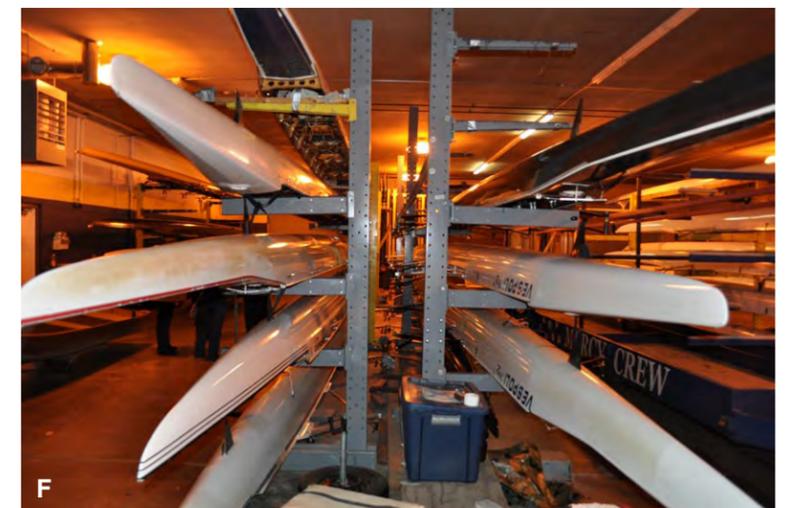
Ad-hoc vehicular access way from parking lot / drop-off loop to bay doors of McQuaid boat house (far side of building). Access way skirts outfield fence of Ball Field #4. Trailer parking is often accommodated along this access drive in the lawn as no formal trailer parking exists in the park.

Main storage bay in the main ("big") boat house. The GWC fills every available storage space. Additional boat bays are needed, including a heated bay for repairs.

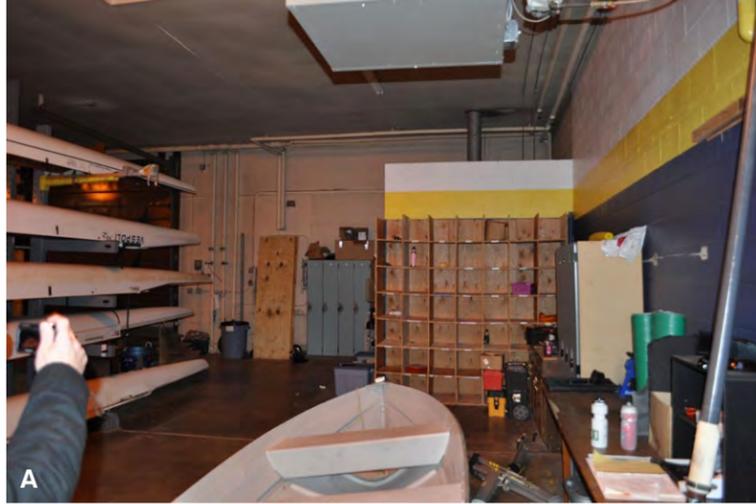
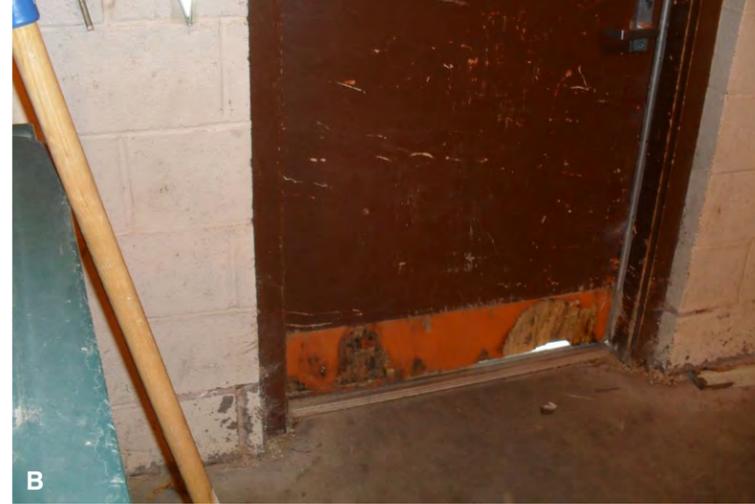
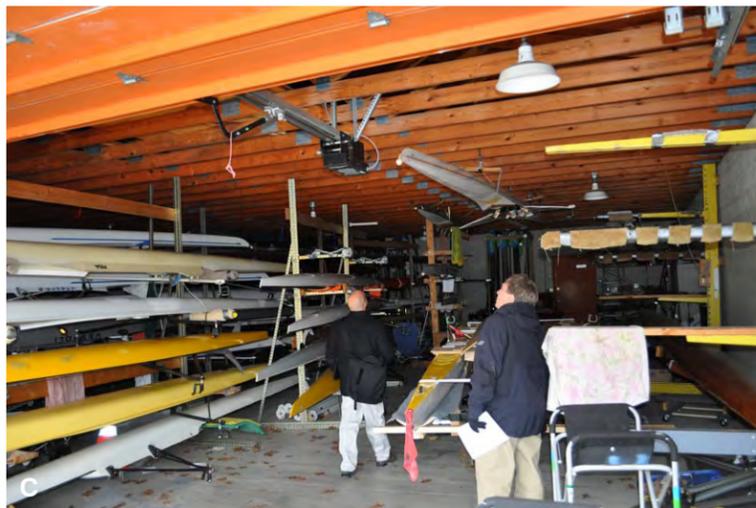
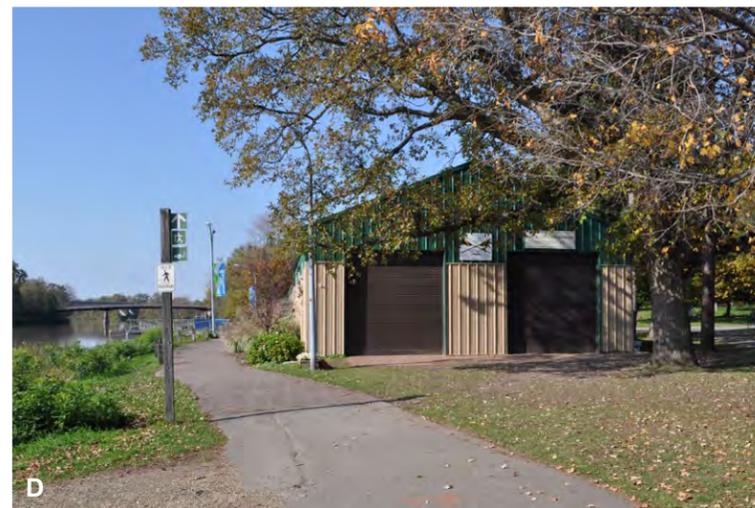
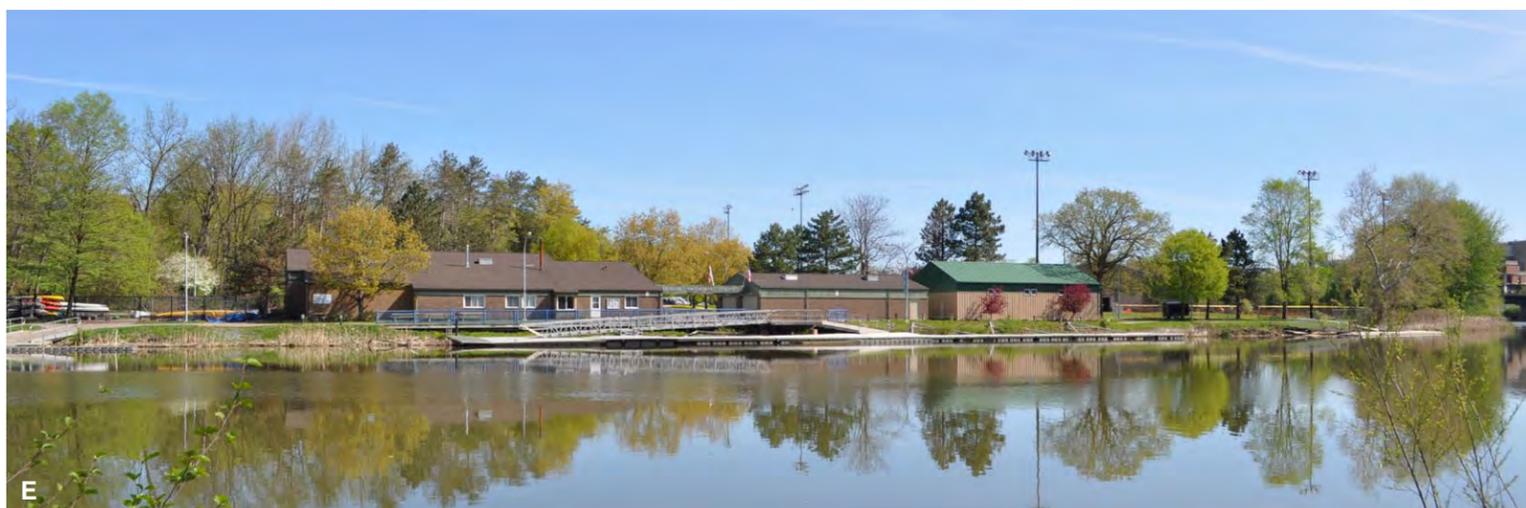
- A. Rower "locker" spaces within the main storage bay of the big boat house. No other traditional locker facilities exist on site for rowers.
- B. Many of the finishes within the facility are worn, in need of repair or otherwise can be categorized as being in poor conditions.

- C. River-side view of the main boat house and GWC administrative offices. The park's most recent improvements include trail upgrades along the GWC waterfront.
