GENESEE VALLEY PARK WEST

MASTER PLAN

EXISTING PARK CONDITIONS

City of Rochester

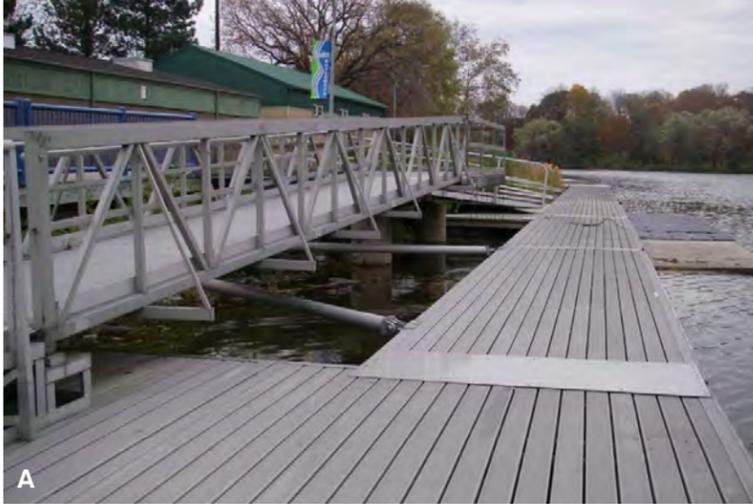
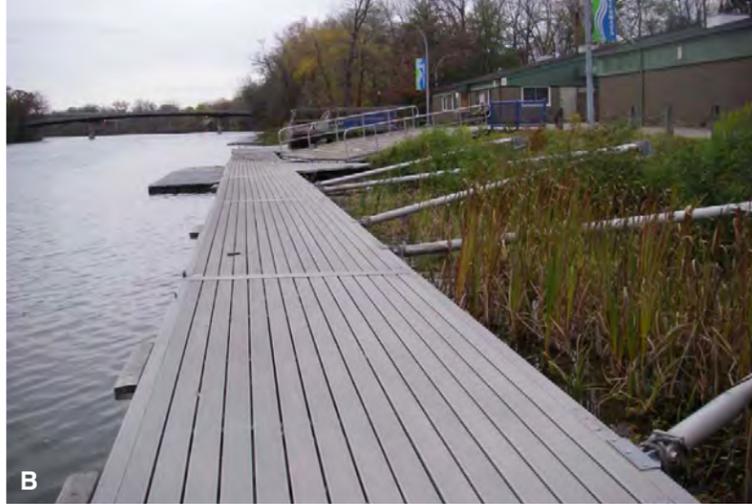
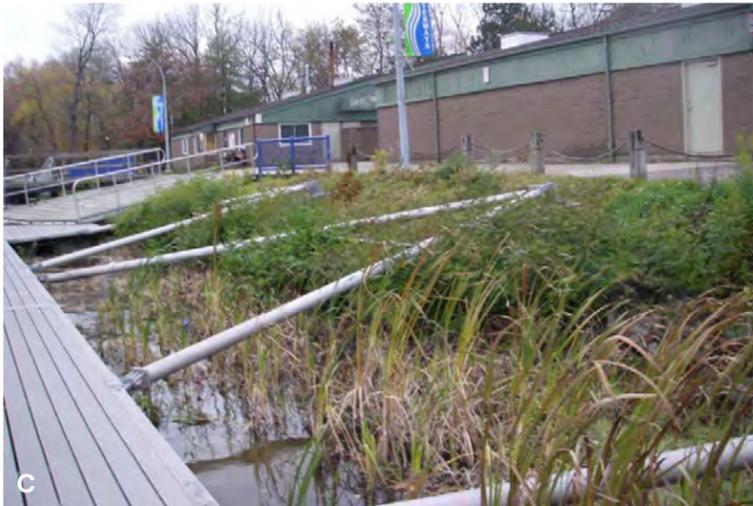
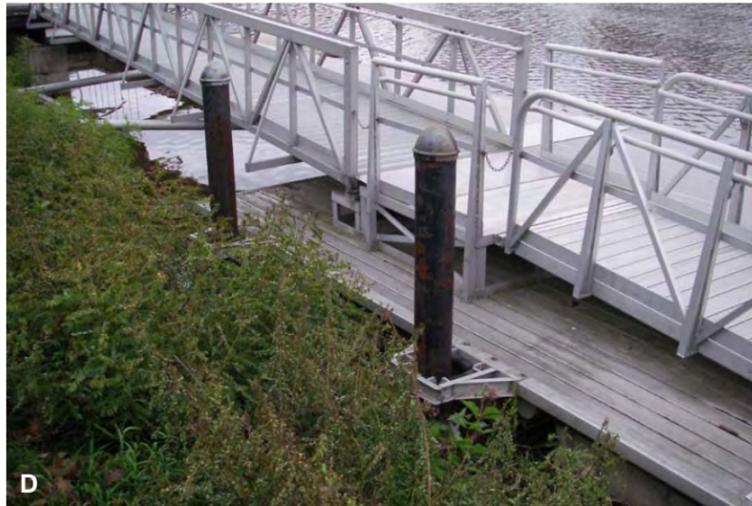
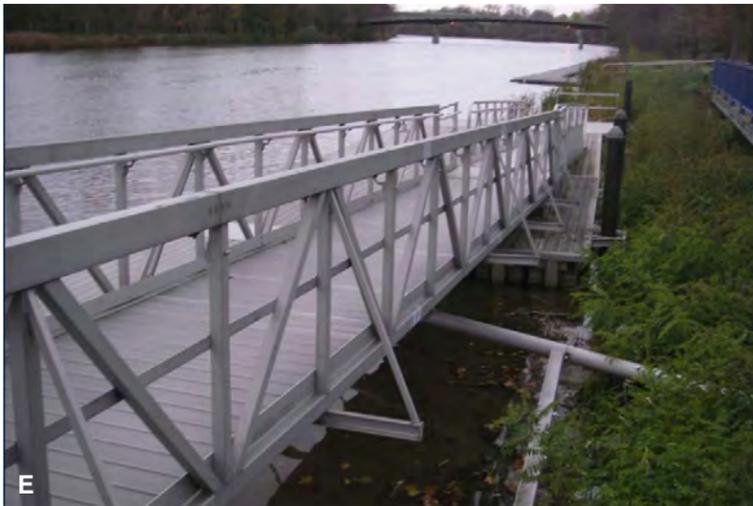
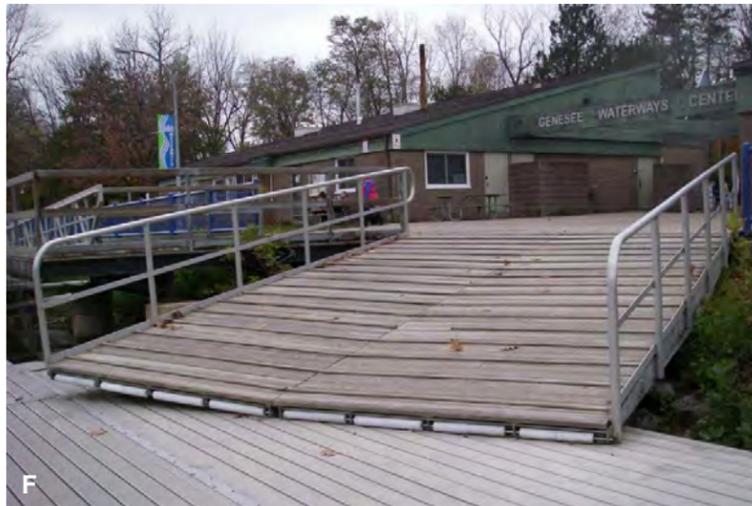
A. Rower Docks, looking North B. Rower Docks, looking South C. "Strong-Arm" Dock Mooring System D. Steel Pipe Piles with Roller Guides E. Accessible Gangway to rower docks F. Rower Access Gangway; note uneven toe, and lack of hinge plate (tripping hazards)

Interlocking HDPE flotation units are frequently used for paddler and rowing facilities, since they provide the low freeboard desired, are relatively inexpensive, and can be easily disassembled and reassembled for removal and reinstallation. Their modular nature also allows for the replacement of individual elements, should damage occur. However, HDPE flotation units and dock systems have several disadvantages. Due to their flexible, interlocking connections and light weight they tend to move underfoot more than other types of dock systems. This movement can give the perception of instability, and cause unease on the part of the user. HDPE is also subject to impact damage, and is less durable than other types of docks. HDPE requires UV stabilizers, and can break down in sunlight over a long period of time. Finally, since the units are modular, there can be slight variations in the walking surface, and there is some risk of tripping hazard.
