PHASE I ENVIRONMENTAL SITE ASSESSMENT

**COMMERCIAL BUILDING
32 YORK STREET
ROCHESTER, NEW YORK**

CITY OF ROCHESTER DEQ PROJECT #BOASAP-16

Date: December 20, 2017
(Revised January 3, 2018)

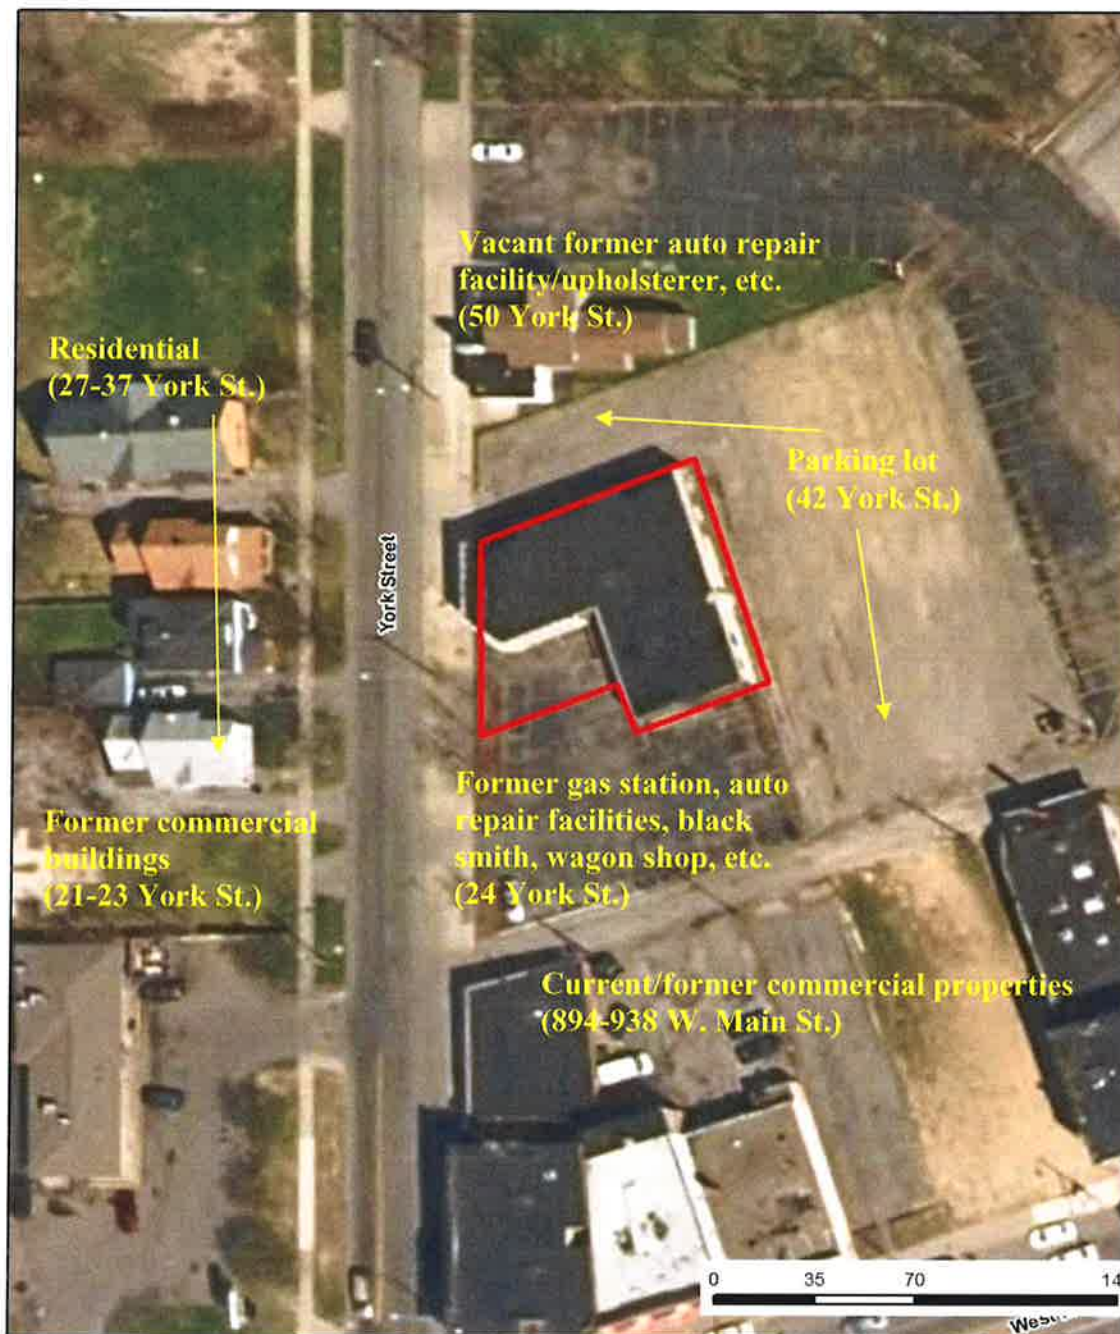
- 1) Base photograph provided above was obtained from the NYSGIS Clearinghouse, dated 2015.
- 2) Site sketch based on observations made at the time of the site visit performed by a Day Environmental, Inc. representative on November 27, 2017.
- 3) The highlighted area is only a representation of the assessed property, and does not depict the actual property boundaries of the assessed property.

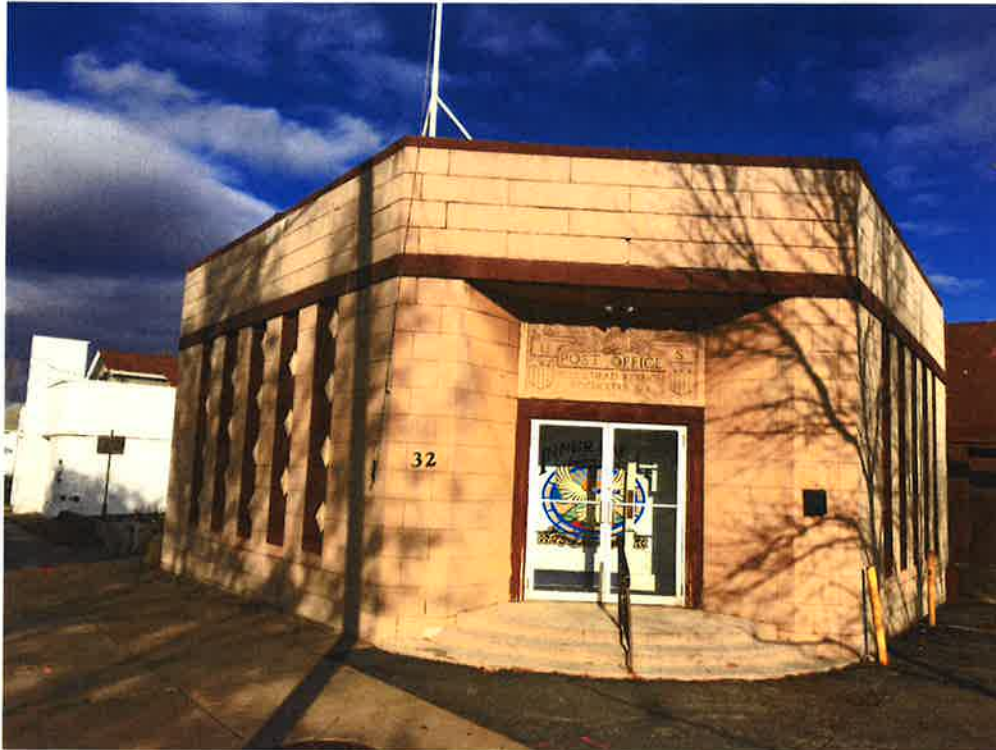
View of the front entrance (i.e., the southwestern portion) of the assessed building looking northeast from York Street.

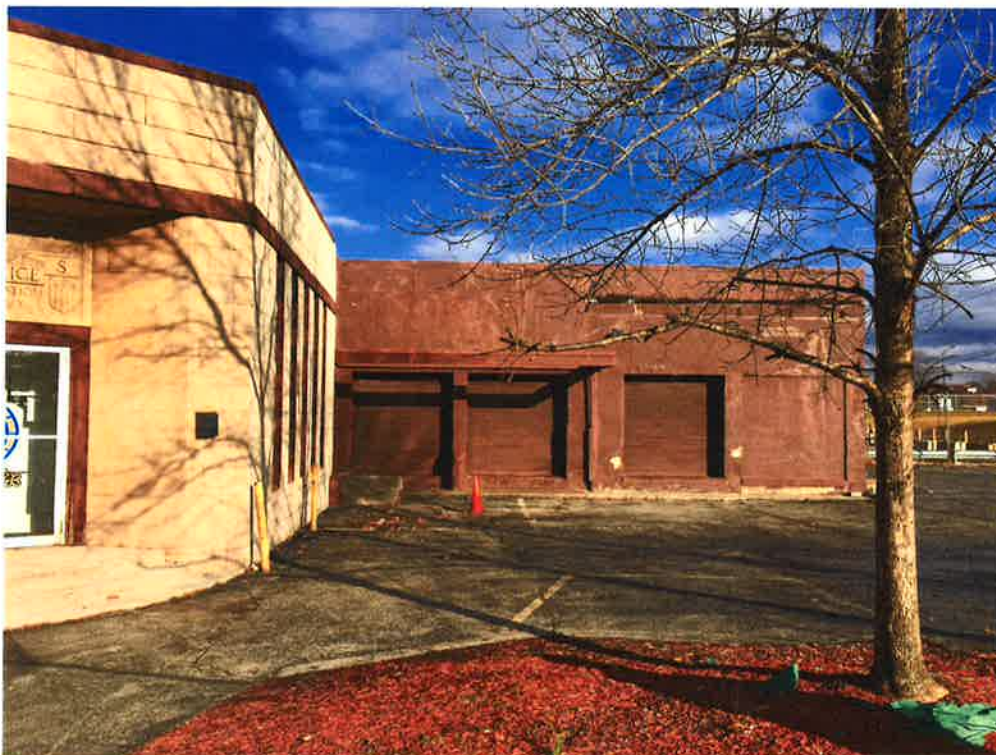
View of a portion of the entrance of the assessed building (the left side of the picture), and the southeastern portion of the building (with loading docks visible) looking easterly from York Street.

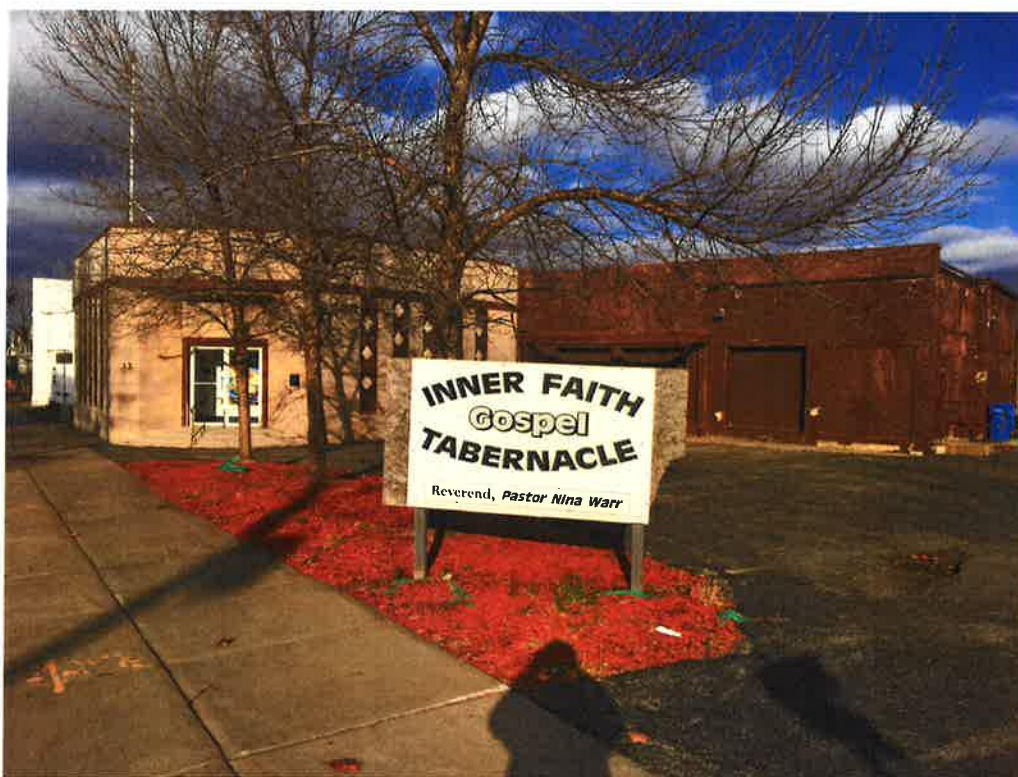
View of the assessed building looking northeast from York Street.

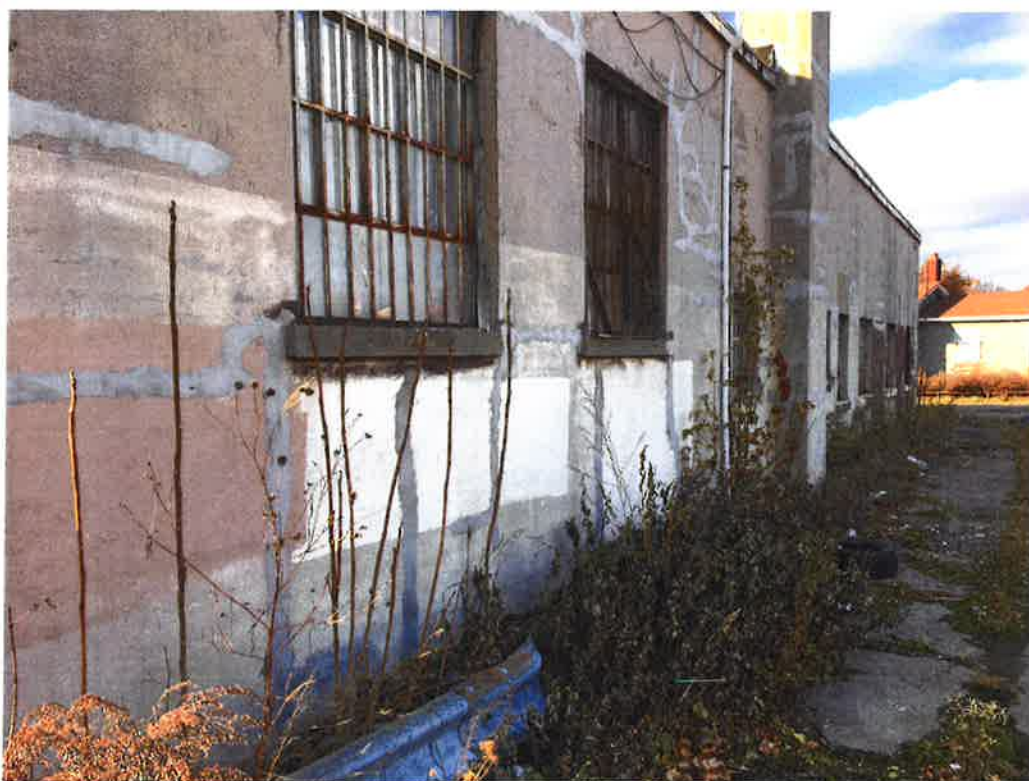
View of the eastern wall of the assessed building looking north from the parking lot at 42 York Street.
