Building Conditions and Land Use Survey Results Beechwood Focused Investment Area

Prepared by Enterprise Community Partners
for
The City of Rochester
Department of Community Development

November 7, 2008

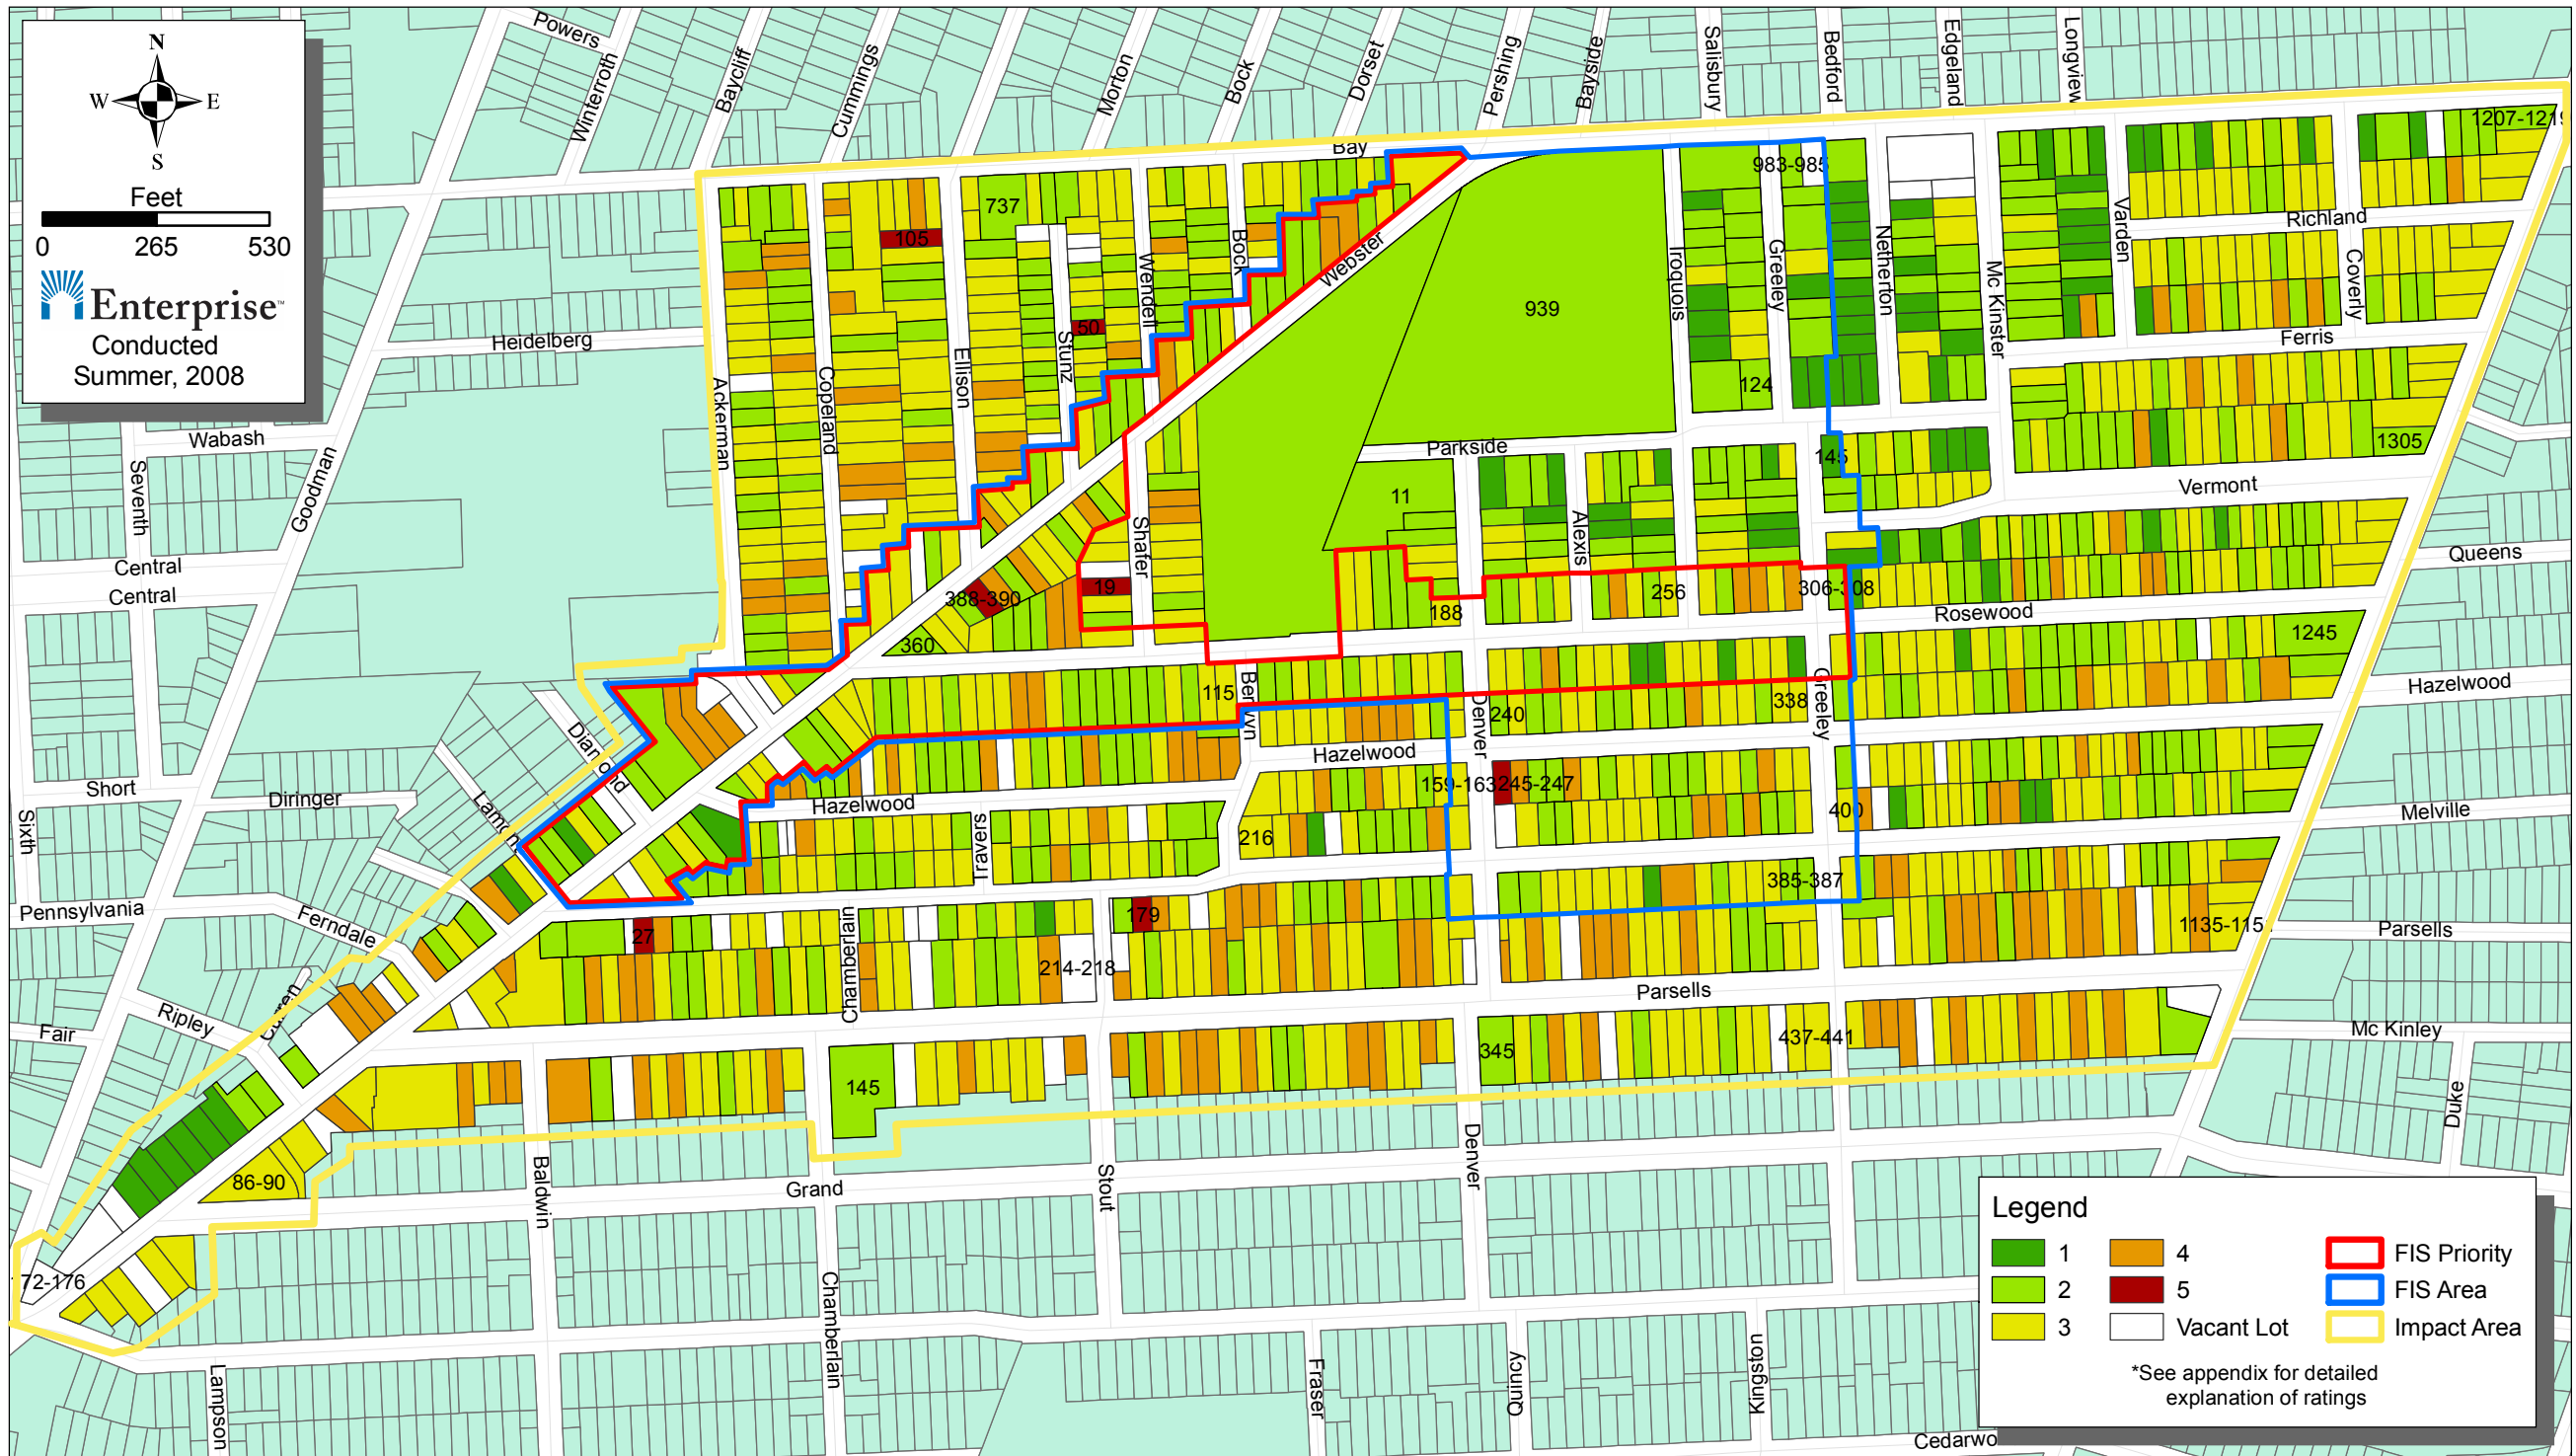
Beechwood FLS - Building Conditions

Building Conditions

Excellent – characteristics include recently rehabilitated or remodeled, new paint, roof in very good condition.

Sound – characteristics include sound condition, good maintenance, no immediate need for repairs.

Substandard Minor – characteristics include need for basic cosmetic repairs such as painting, trim, porch and fence repair.

Substandard Major – characteristics include bulging walls, sagging foundations, broken windows and need for substantial improvements.

Dilapidated – characteristics include abandoned, fire damaged, boarded up, vacant and possibly unsuitable for rehabilitation.

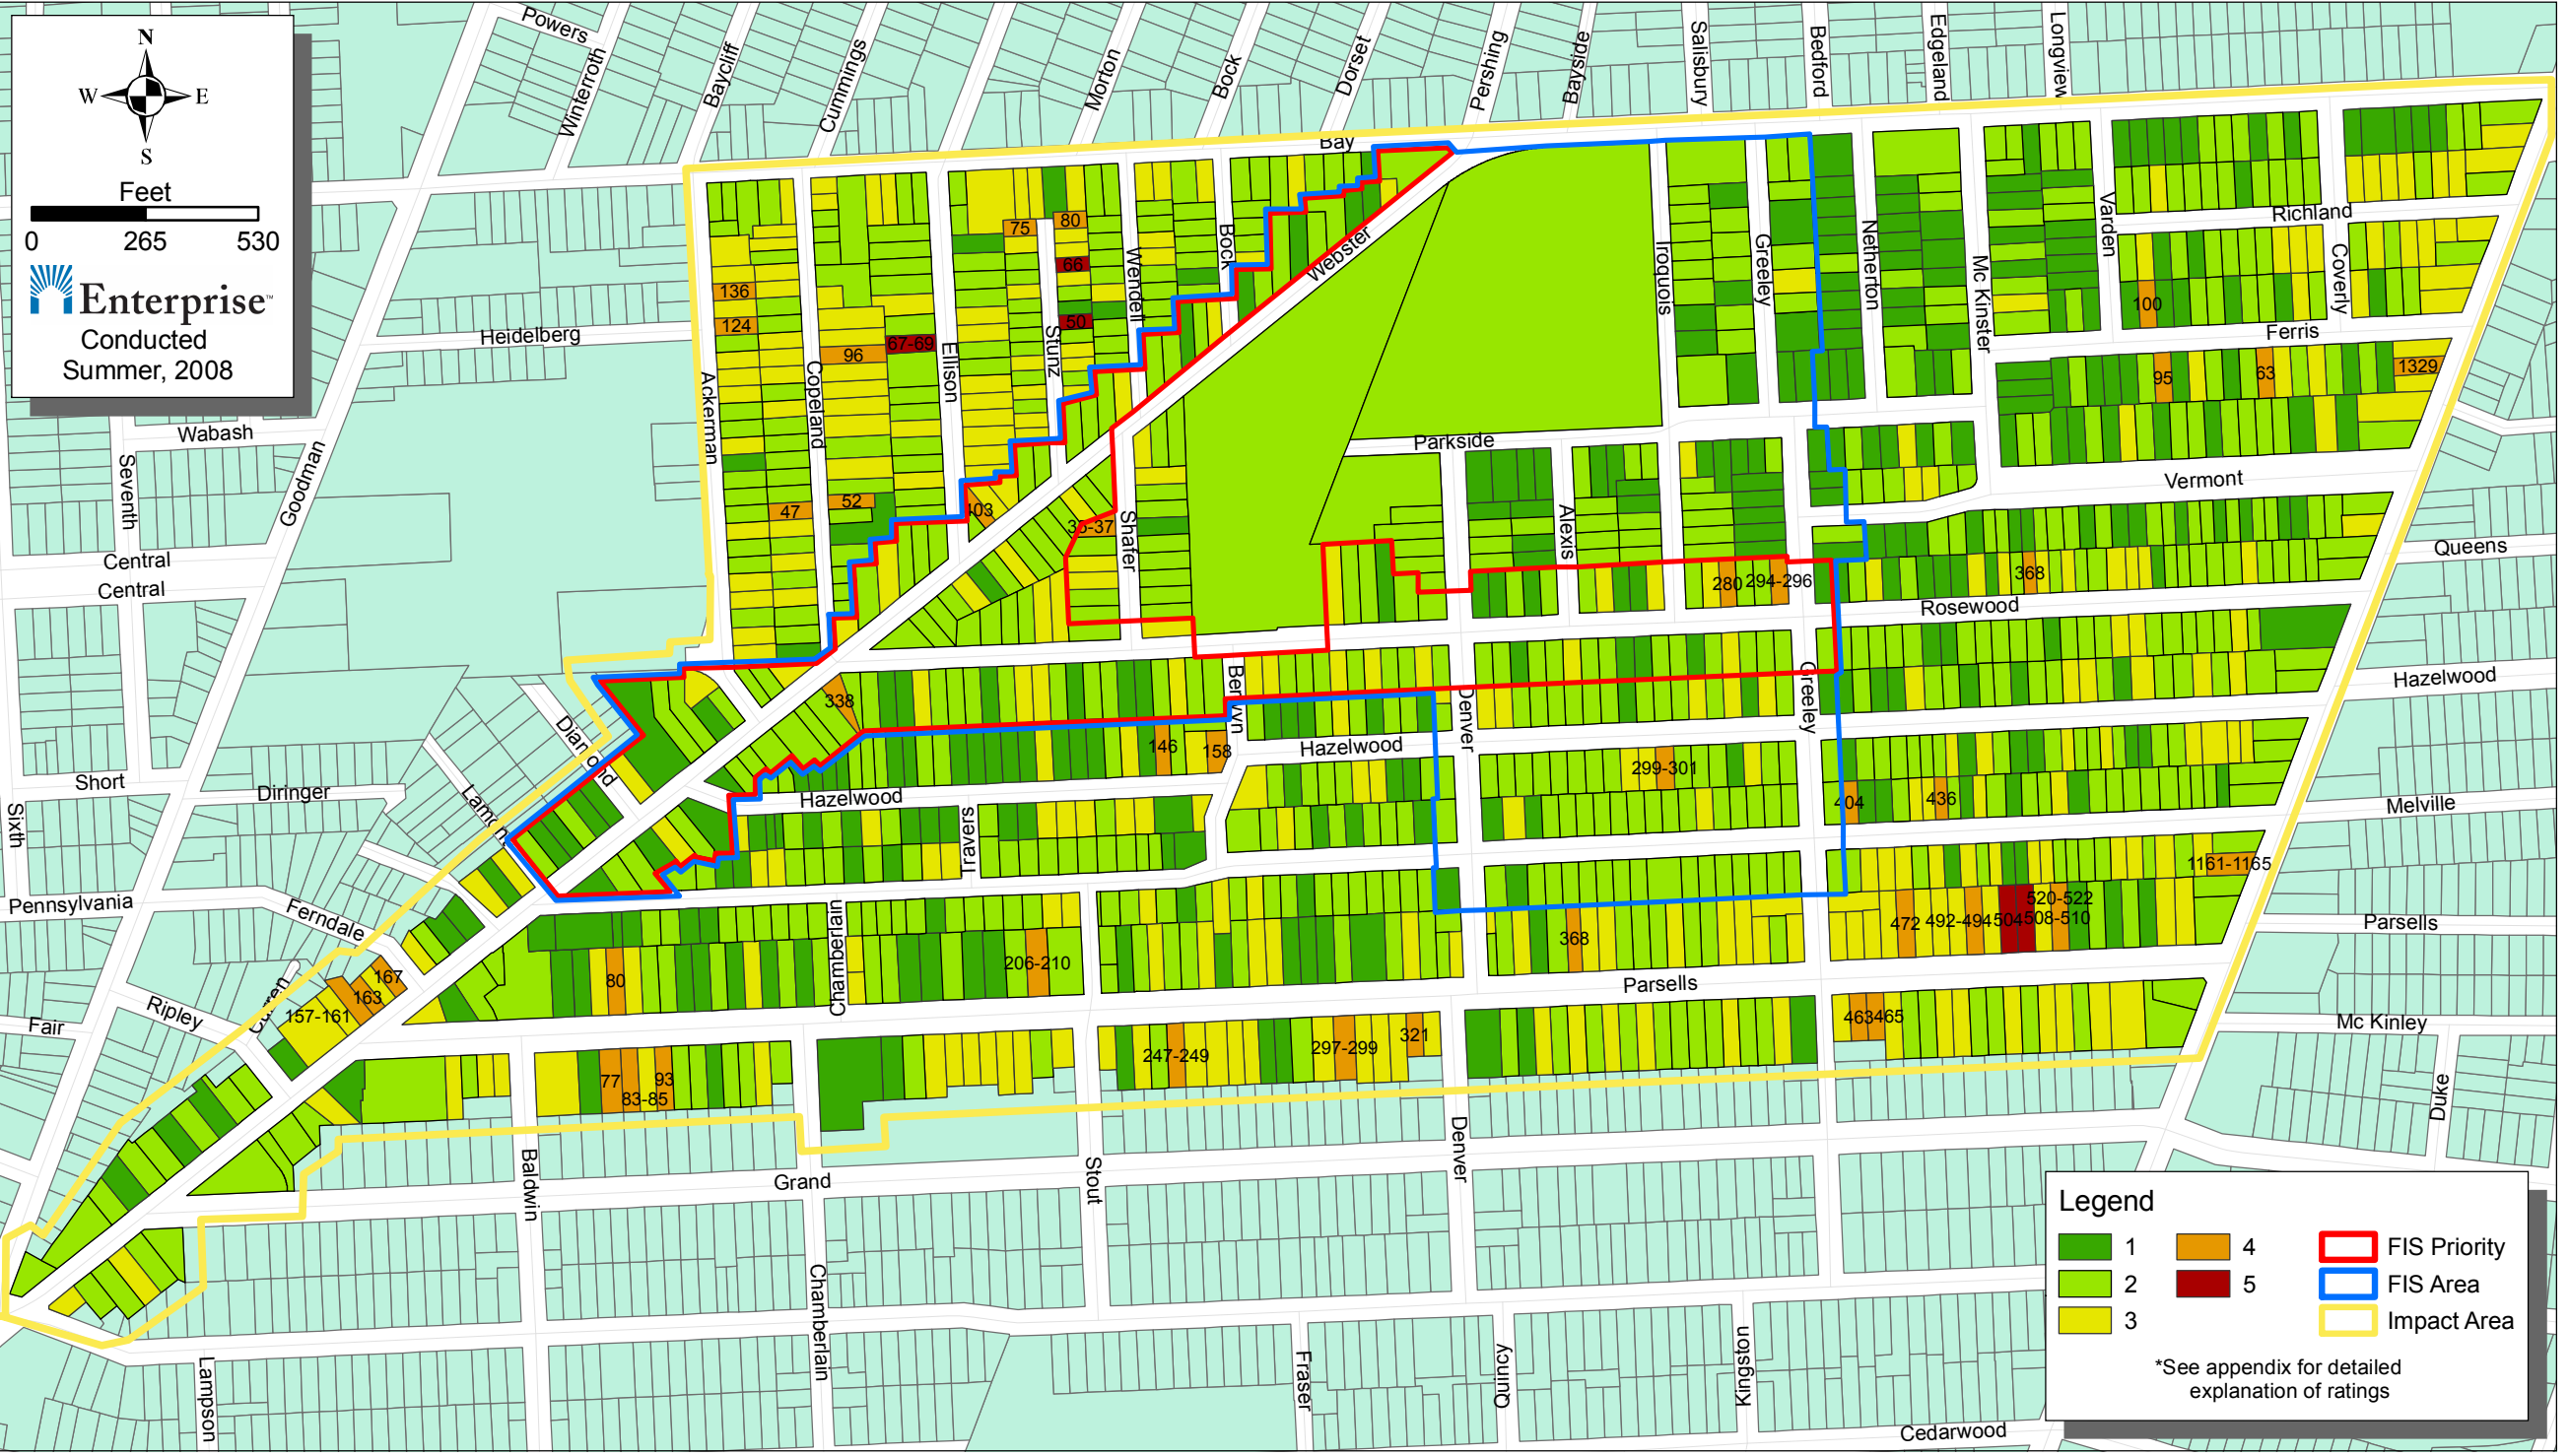
Beechwood FIS - Site Conditions

Site Conditions

- 1) Characteristics include neatly trimmed and healthy vegetation, no trash, well-maintained walkways, no vehicles on blocks, well-maintained fencing.
- 2) Characteristics include neatly trimmed and healthy vegetation, no trash, no more than one of the following: deteriorated walkways, vehicles on blocks, deteriorated fencing.
- 3) Characteristics include some untrimmed vegetation, some trash, no more than one of the following: deteriorated walkways, vehicles on blocks, deteriorated fencing.
- 4) Characteristics include significant untrimmed vegetation, and / or trash, no more than two of the following: deteriorated walkways, vehicles on blocks, deteriorated fencing.
- 5) Characteristics include all vegetation untrimmed, significant trash, two or more of the following: deteriorated walkways, vehicles on blocks, deteriorated fencing.
