# Building Conditions and Land Use Survey Results Jefferson Focused Investment Area

Prepared by Enterprise Community Partners  
for  
The City of Rochester  
Department of Community Development

October 31, 2008

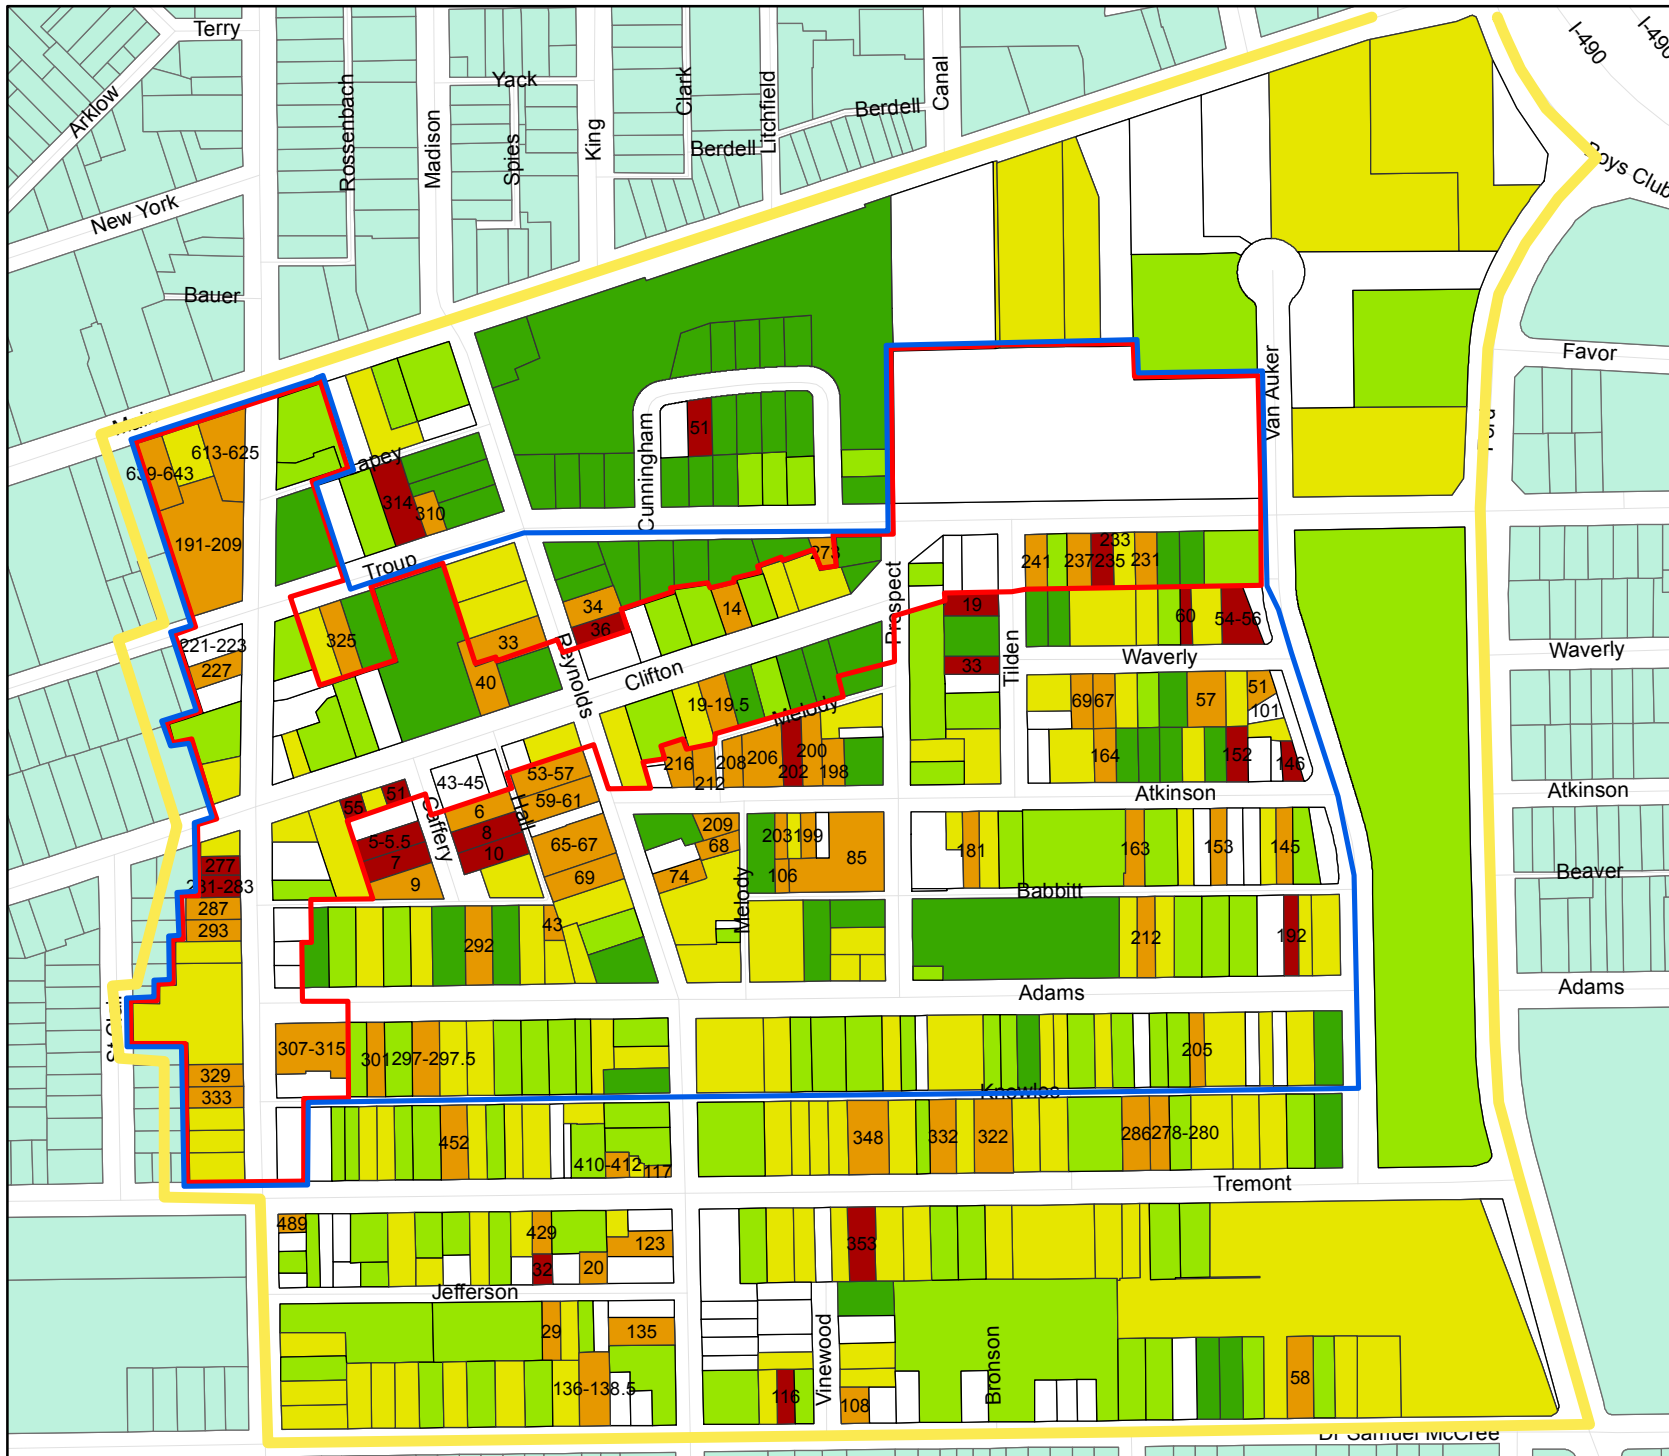
# Jefferson FIS Area - Building Conditions

## Building Condition
