MOUNT HOPE CEMETERY

CULTURAL LANDSCAPE REPORT

TREE INVENTORY & MANAGEMENT PLAN

LANDSCAPE EXISTING CHARACTER

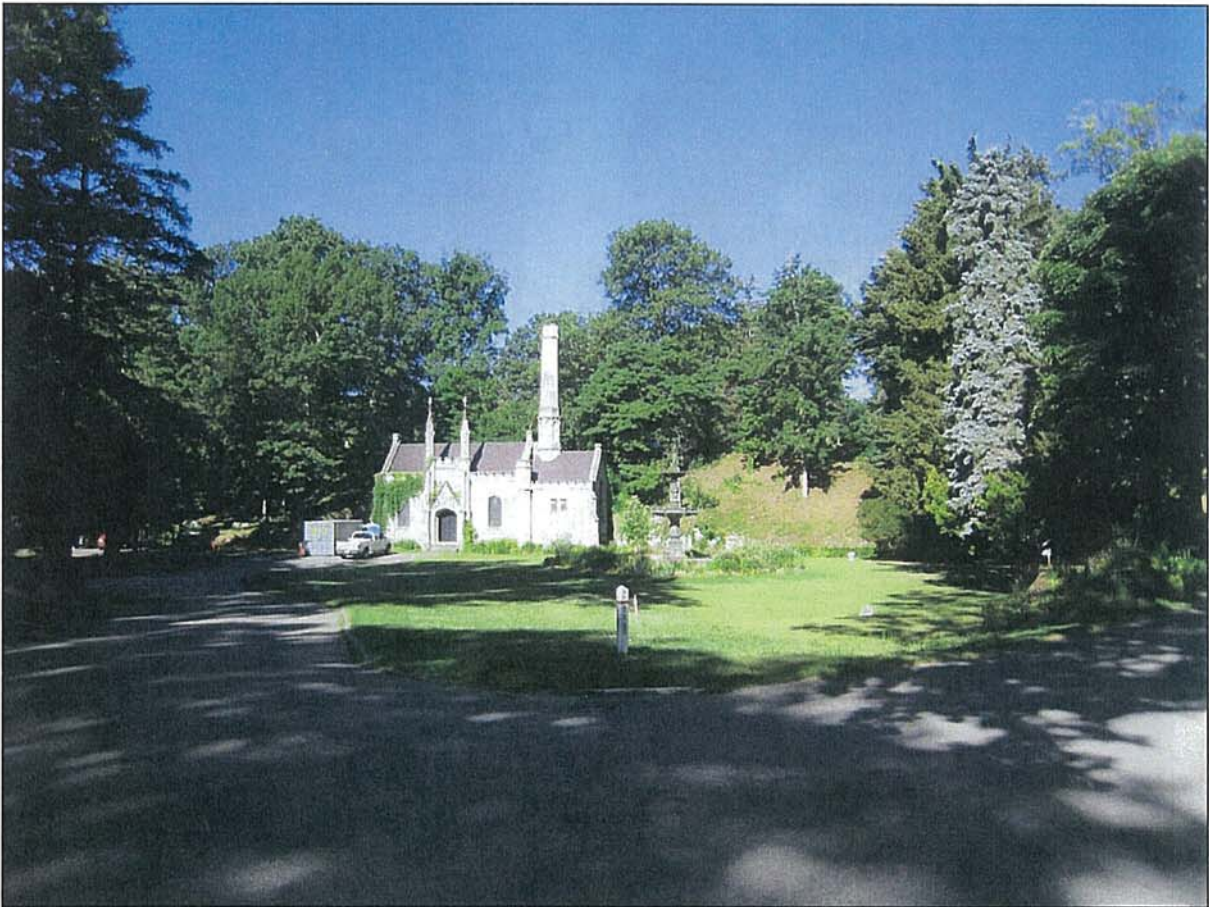
Figure III.1. Upon entering the cemetery from Mount Hope Avenue, the entrance drive leads through the iron gates and stone piers to a visually contained area defined by topography, open lawn, and additional cemetery drives. Courtesy Heritage Landscapes. (R-MTH-15Jul08-0006-Unit1.jpg)

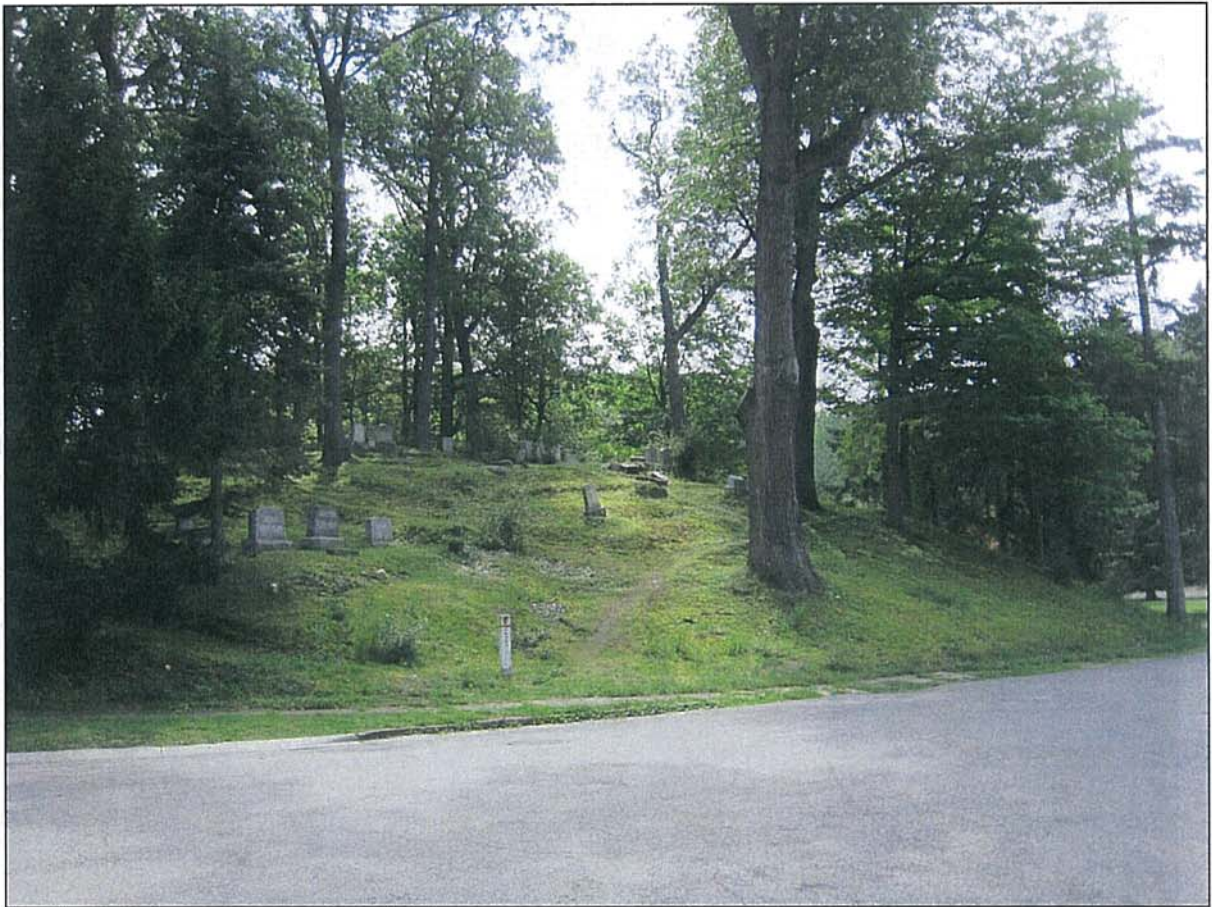
Figure III.2. Visual relationships include a series of inferior and superior views from within the central lawn area up to the steep edge slopes and from the edges of the area down to the central lawn space. Courtesy Heritage Landscapes. (R-MTH_20080813_4720-Unit1.jpg)

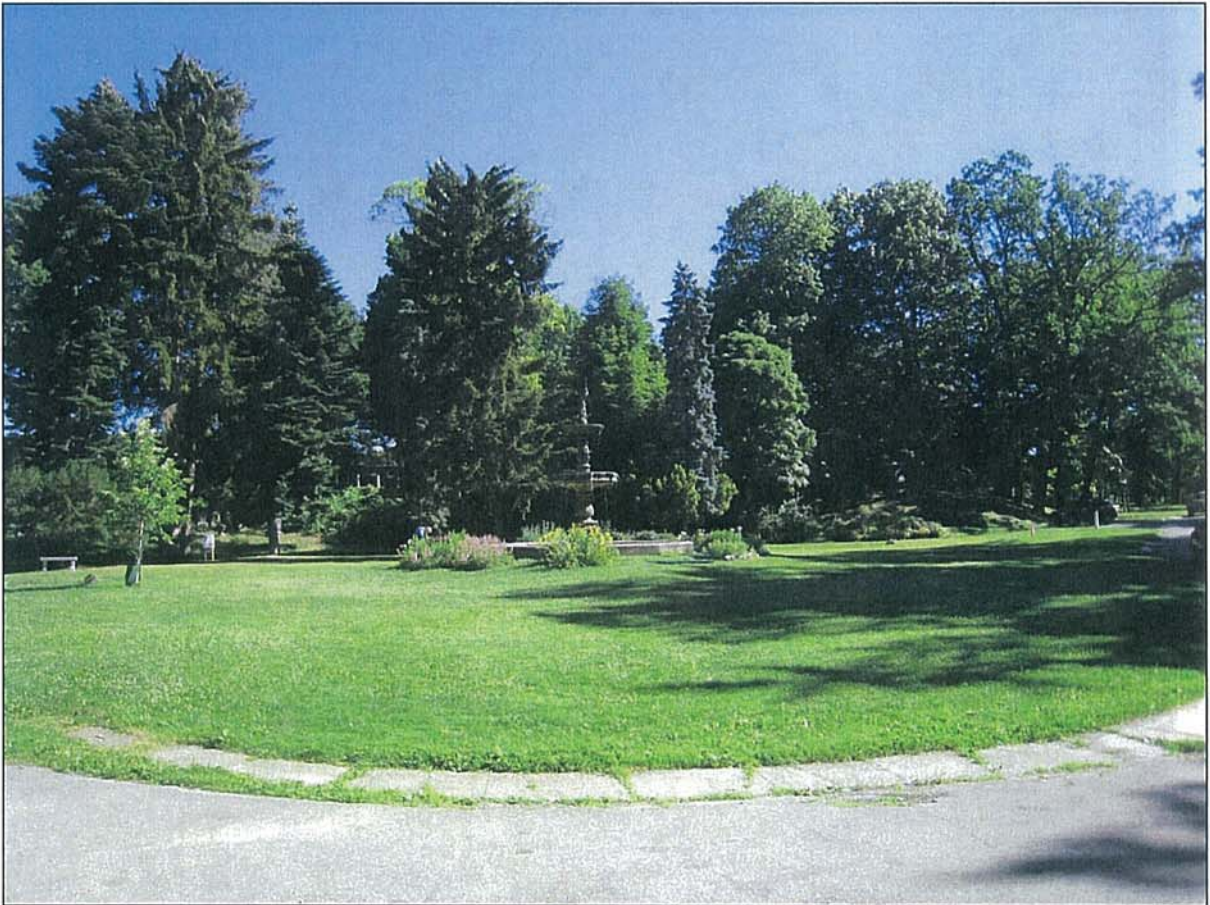
Water Features in Area 1 include the Florentine Fountain, dating to 1875. The fountain was repaired in recent decades, though one of the base panels is missing. The fountain is currently operational during summer months. Centrally located, the ornamental fountain is a prominent feature in the Cemetery Entrance landscape.

Figure III.4. Around the fountain at the cemetery entrance are planting beds containing flowering perennials, which are tended by the Friends of Mount Hope Cemetery. Courtesy Heritage Landscapes. (R-MTH-15Jul08-0109-Unit1.jpg)

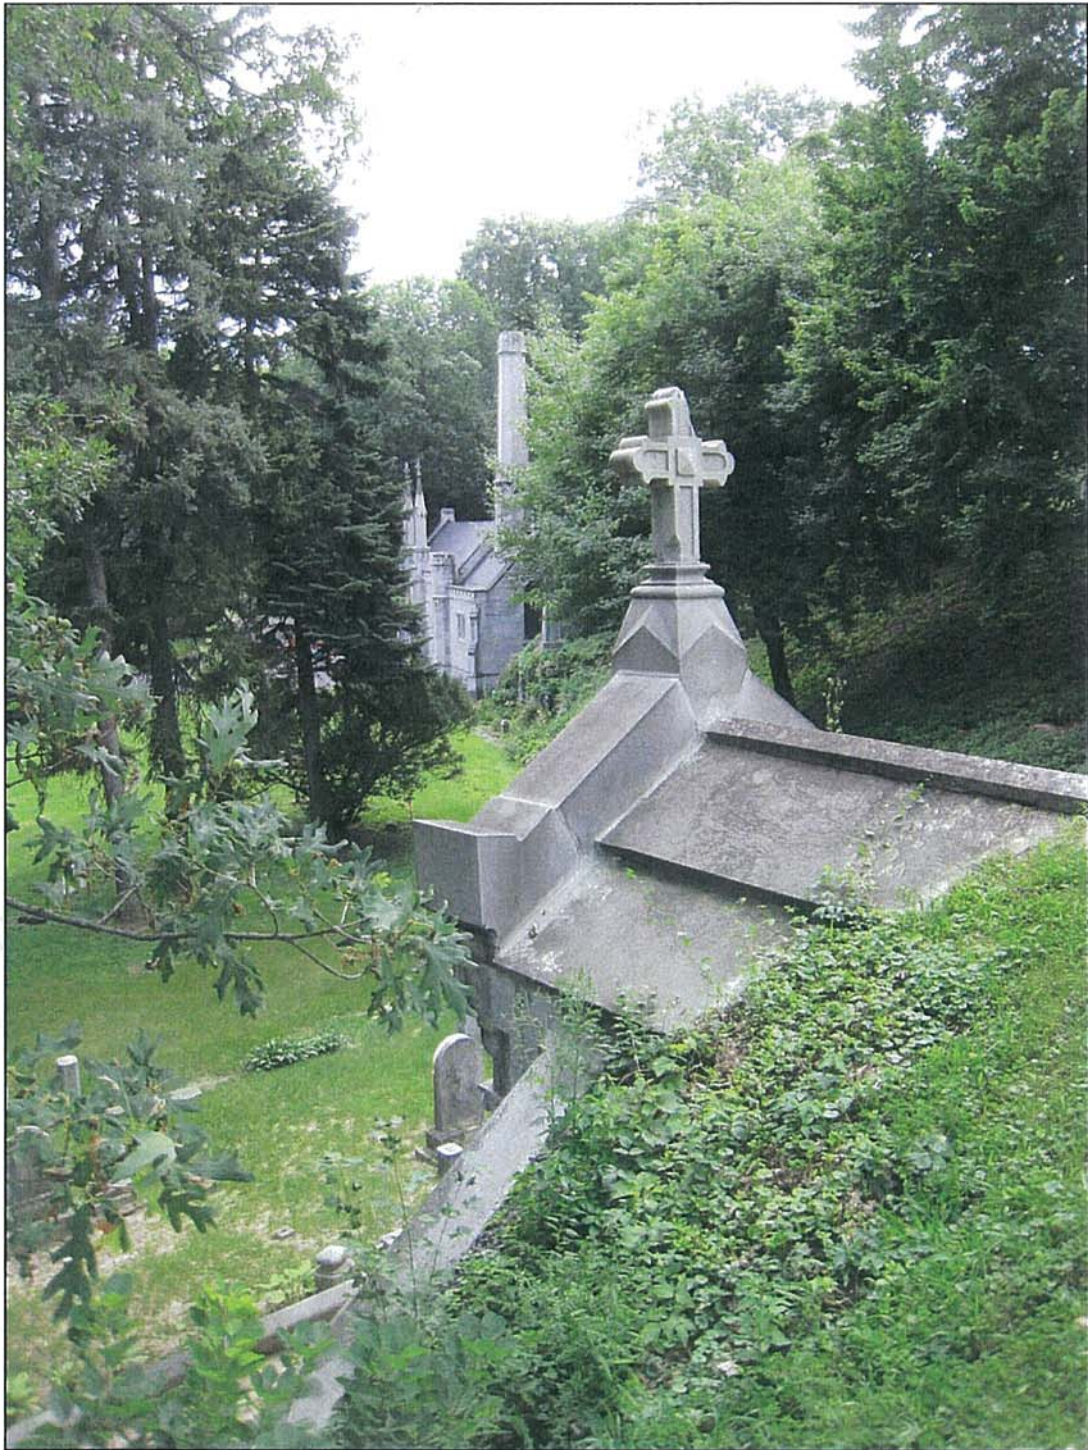
Figure III.6. The Cemetery Entrance area includes multiple structures, site furnishings, and objects. Structures include the gatehouse, chapel and crematory, gazebo, mausoleums, and stone retaining walls. Courtesy Heritage Landscapes. (R-MTH_20080813_4905-Unit1.jpg)

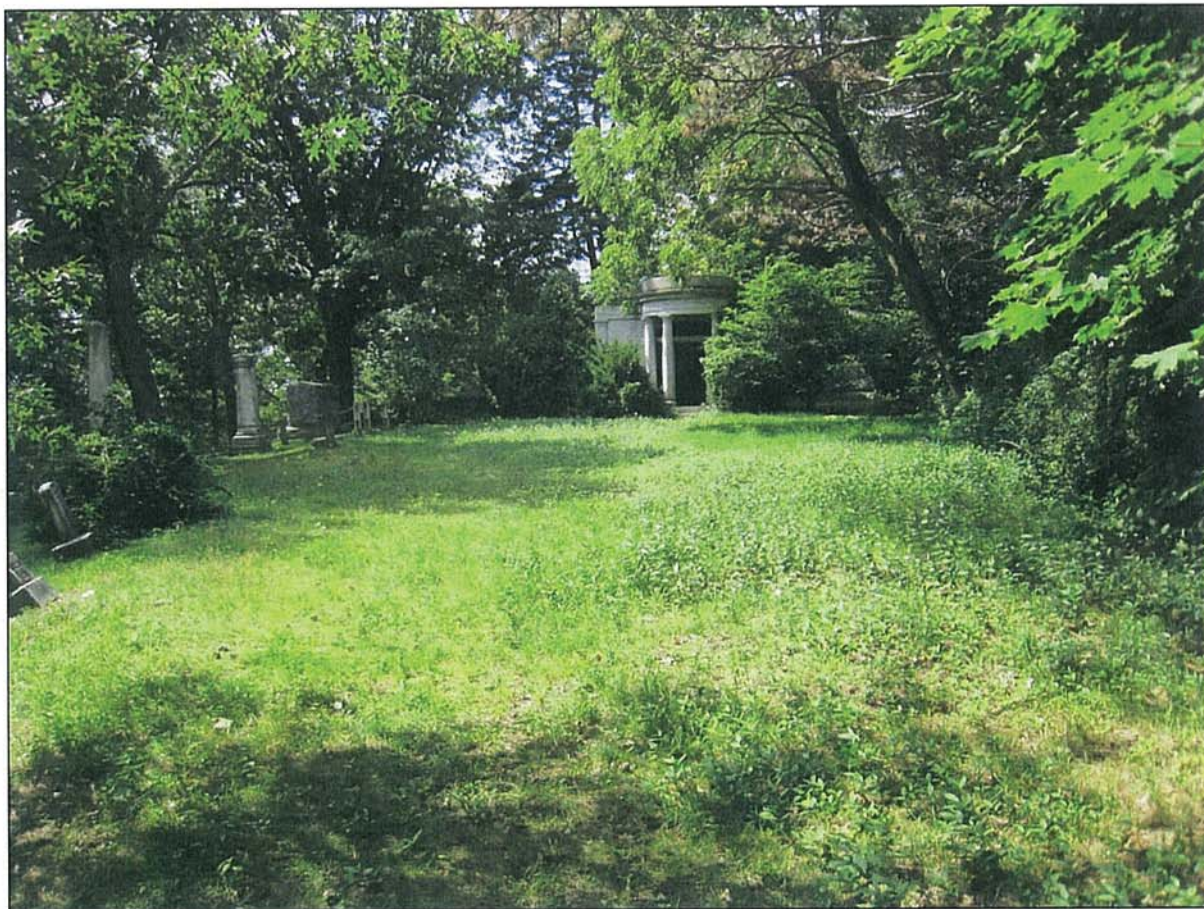
Figure III.14. The maturing tree canopy and presence of additional invasive species have partially obstructed many historic views. The historic view from the Fandango is no longer evident, primarily a result of vegetative growth. Courtesy Heritage Landscapes. (R-MTH_20080813_4711-Unit2 fandango.jpg)

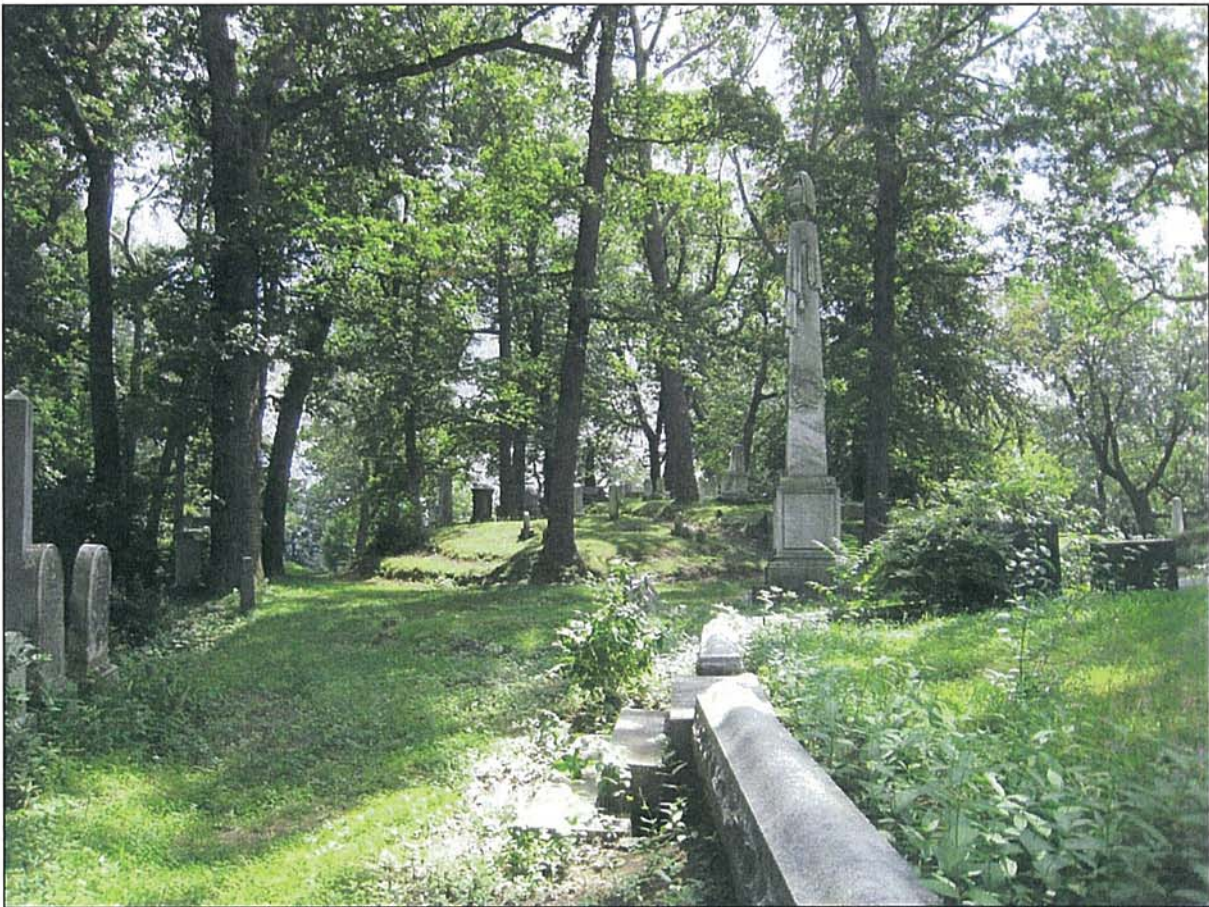
Figure III.19. Glacial activity formed the topography of Area 2 into valleys, rolling hills, steep slopes, ridges, and bowl-like depressions known as kettles. Courtesy Heritage Landscapes. (R-MTH_20080813_4791-Unit2 Hilltop.jpg)

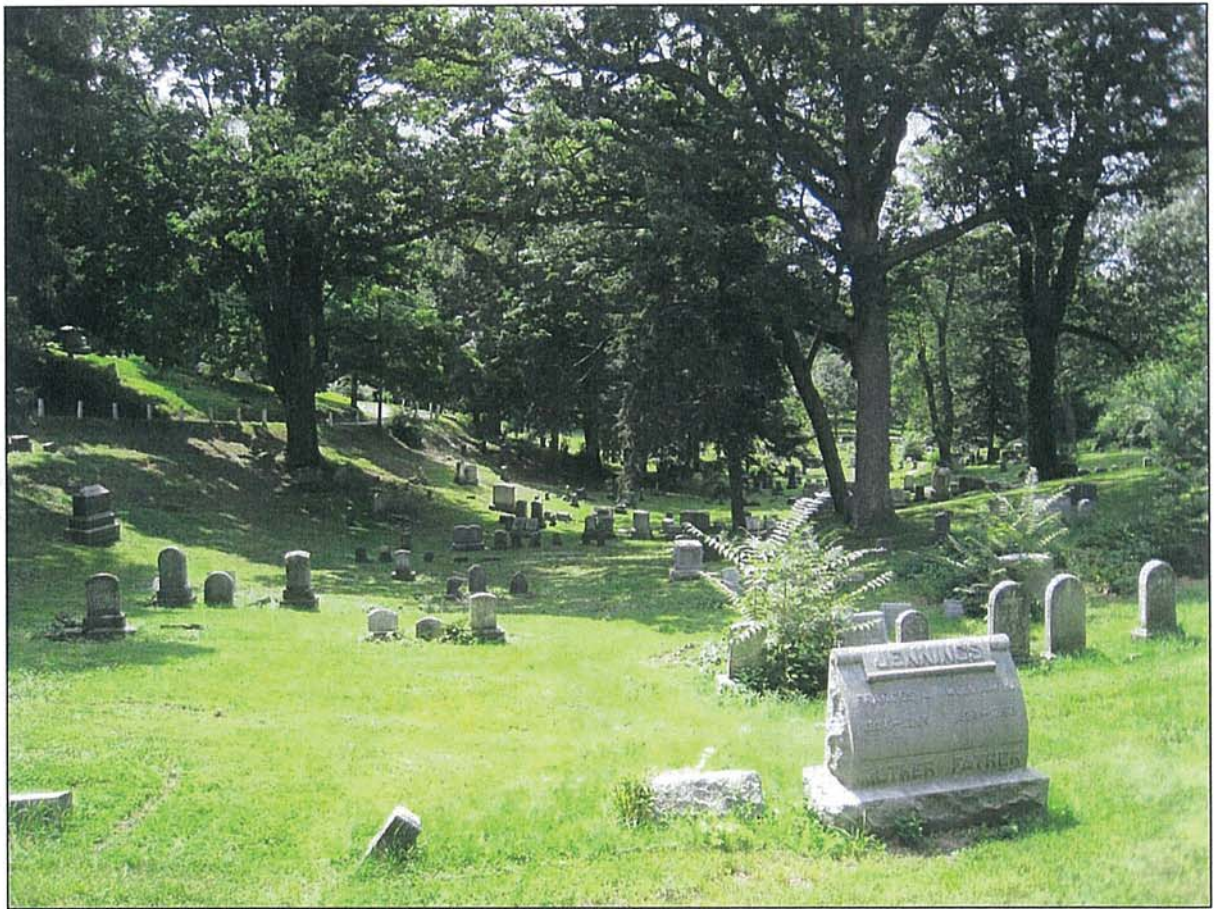
Figure III.20. Glacial activity, which formed the topography of Area 2, continues to characterize the topography and natural systems in Area 2. Courtesy Heritage Landscapes. (R-MTH_20080813_4858-Unit2.jpg)

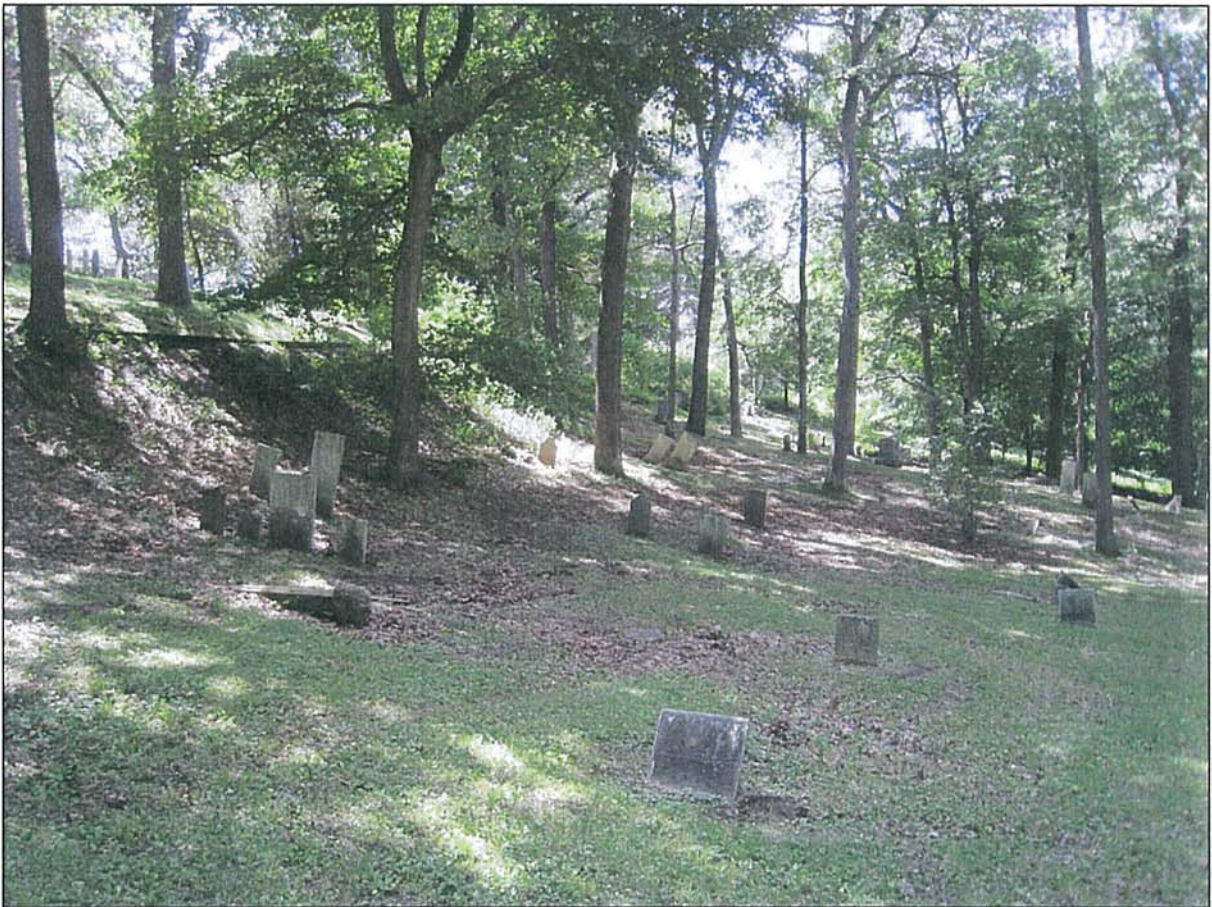
Figure III.21. Much of the vegetation in Landscape Area 2 is woodland species found growing on the steep hillsides with hundreds of individual trees over open mixed species lawn. Courtesy Heritage Landscapes. (R-MTH_20080812_4564-Unit 2 lower.jpg)

oak, American elm (*Ulmus americana*), white oak (*Quercus alba*), honeysuckle (*Lonicera* species), sassafras, buckthorn (*Rhamnus cathartica*), euonymus (*Euonymus* species), weeping forsythia (*Forsythia suspensa*), grape, Virginia creeper (*Parthenocissus quinquefolia*), and poison ivy. Other prominent plant species found throughout the slopes of Area 2 include ash (*Fraxinus* species), hickory (*Carya* species), sugar maple (*Acer saccharum*), American linden (*Tilia americana*), Norway spruce (*Picea abies*), tree-of-heaven (*Ailanthus altissima*), bramble (*Rubus* species), box elder (*Acer negundo*), dogwood (*Cornus* species), scarlet oak (*Quercus coccinea*), witchhazel (*Hamamelis virginiana*), Colorado spruce (*Picea pungens*), black walnut (*Juglans nigra*), yew (*Taxus* species), red maple (*Acer rubrum*), Austrian pine (*Pinus nigra*), eastern redbud (*Cercis canadensis*), Japanese maple (*Acer palmatum*), and barberry (*Berberis vulgaris*). Overall, the vegetation in the area is a combination of natural, planted, and volunteer growth found on the steep slopes with areas of open lawn. (See Figures III.21 and III.22.)

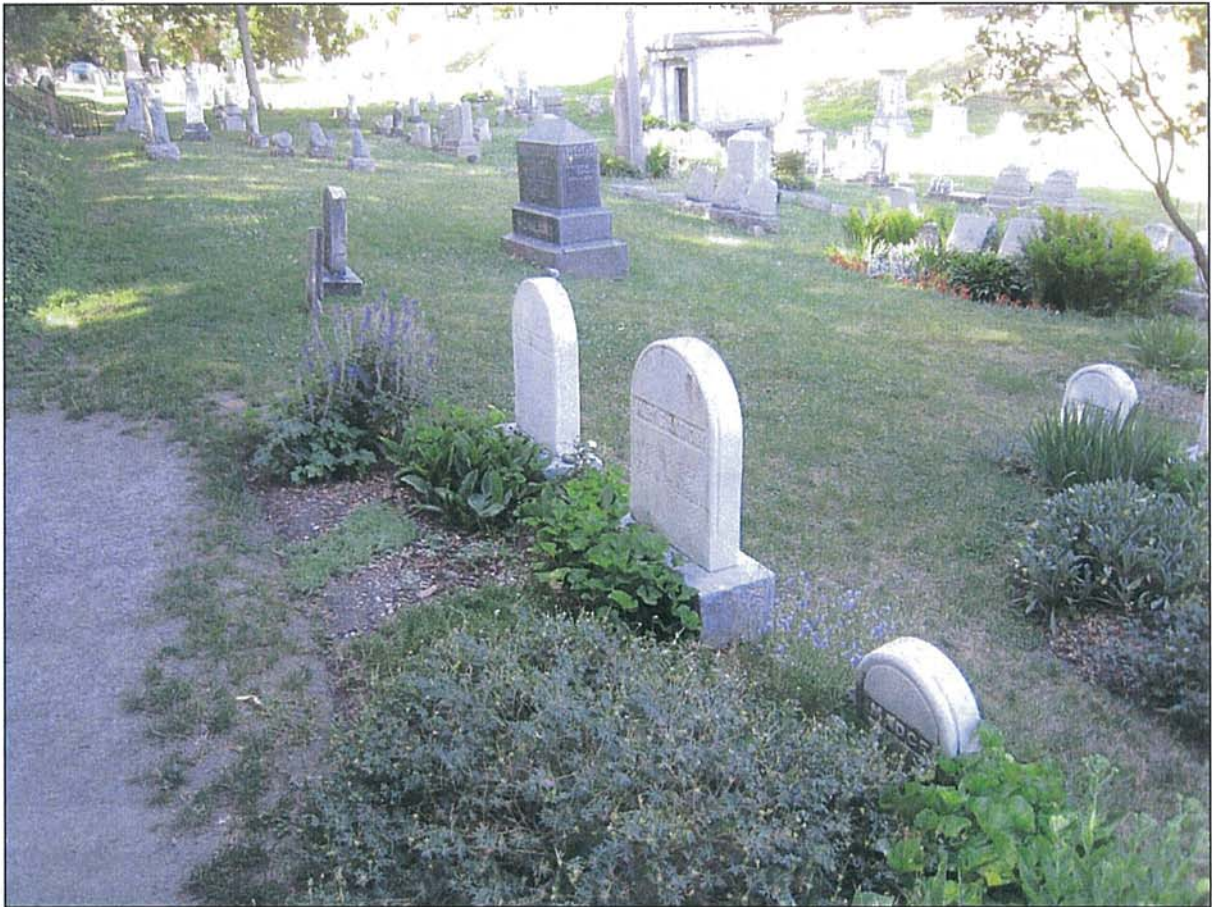
Figure III.24. Perennial plantings found at a number of gravesites in Landscape Area 2 have been included in the FOMH Adopt-a-Plot program. Courtesy Heritage Landscapes. (R-MTH-15Jul08-0040.jpg)

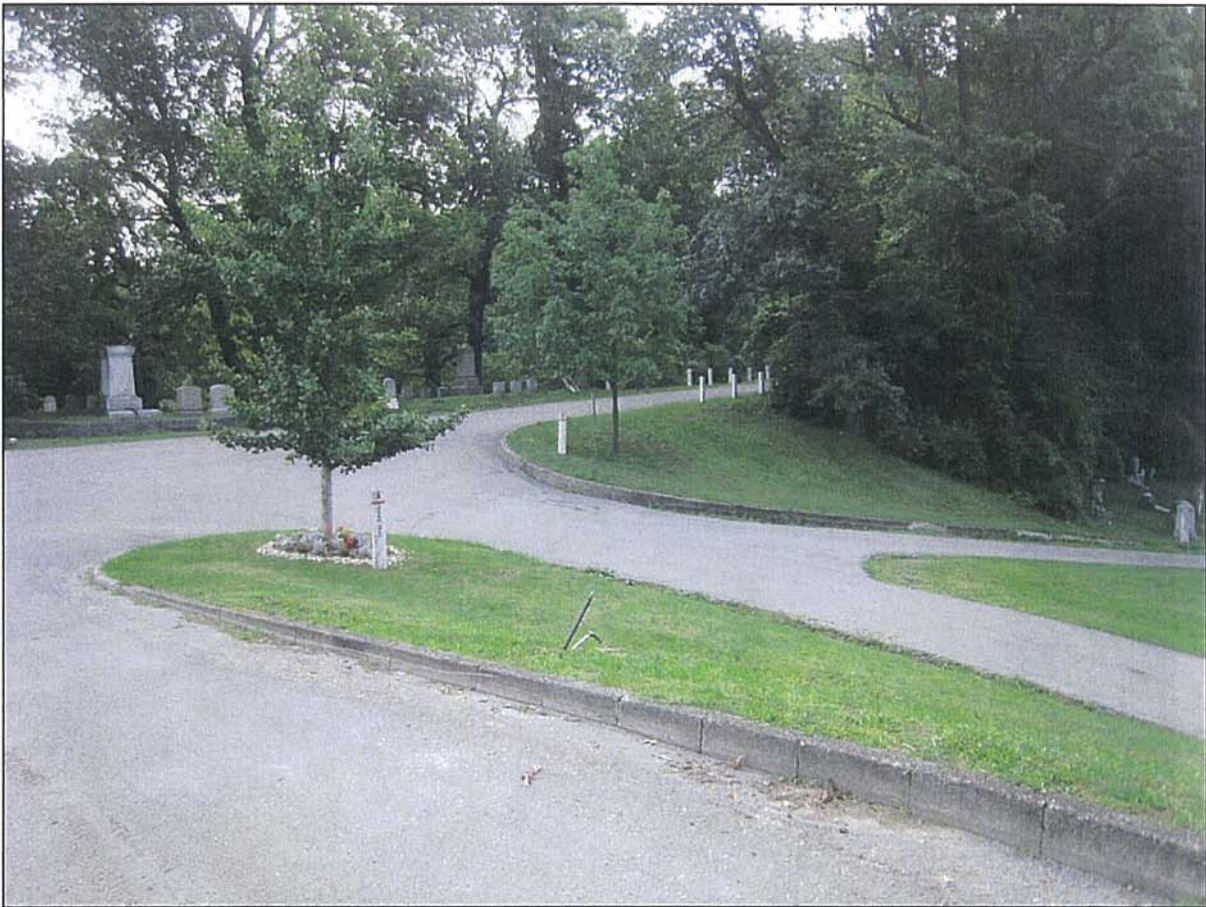
Figure III.25. Near the intersection with Linden Avenue, West and Glen Avenues branch to the west and form two additional elongated loops. Courtesy Heritage Landscapes. (R-MTH_20080813_4672-Unit2.jpg)

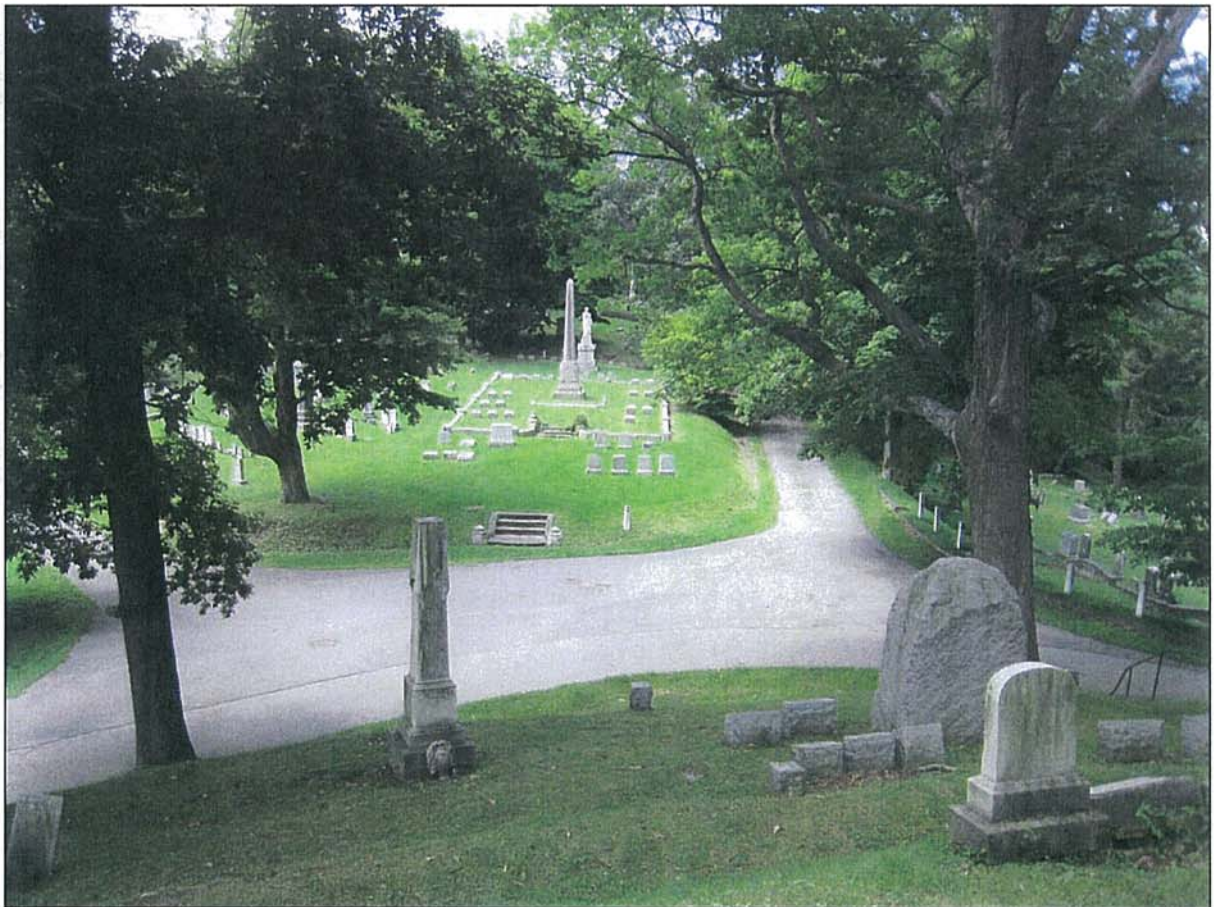
Figure III.26. Loop drives encircle high points in the landscape, including the knoll known as Patriot Hill, or alternatively, Revolutionary Hill or Rochester Hill. Courtesy Heritage Landscapes. (R-MTH_20080812_4530-view from patriot hill.jpg)

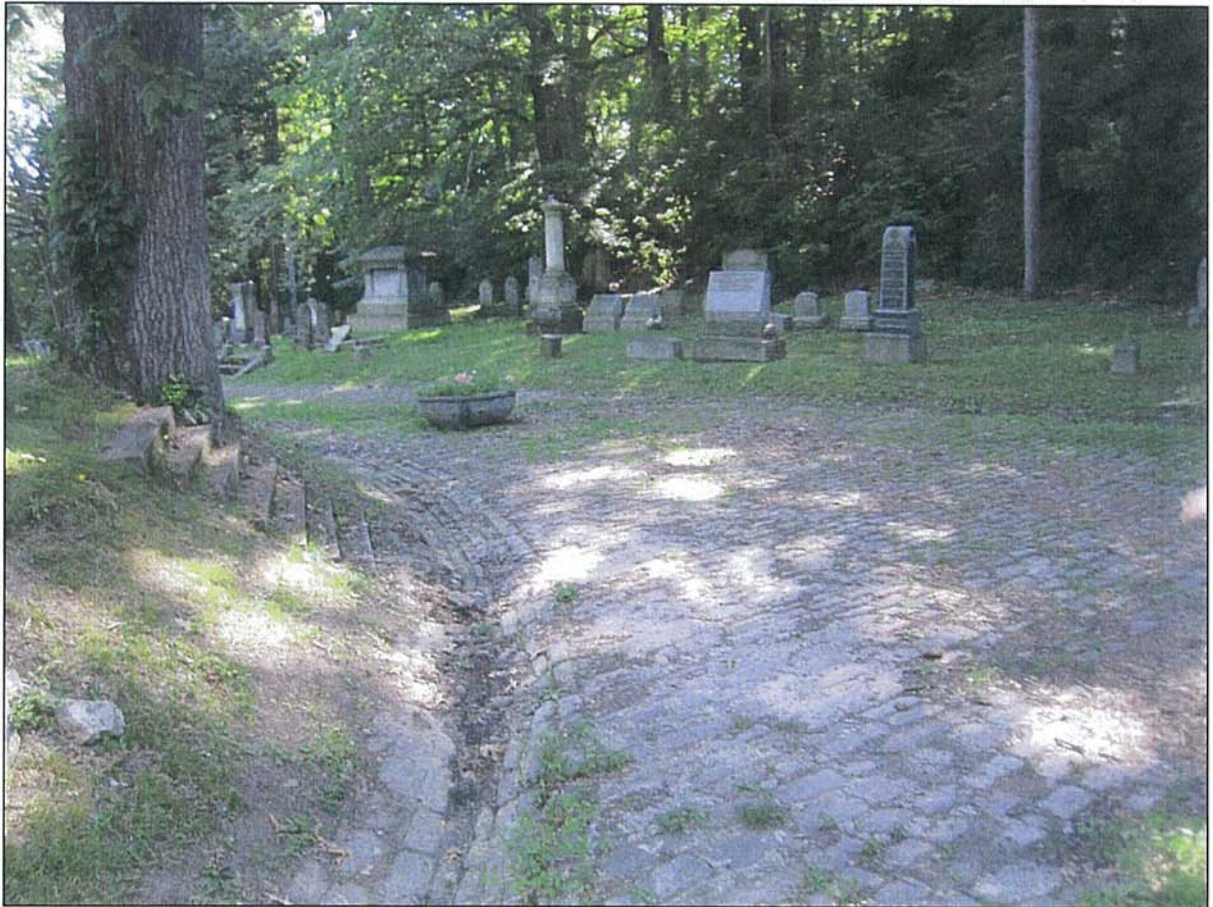
Figure III.27. At the northern end, a portion of Ravine Avenue is composed of historic cobblestones re-laid by FOMH. Large, concrete planters prohibit vehicular access to this drive section north of Hope Avenue. Courtesy Heritage Landscapes. (R-MTH-15Jul08-0077-Unit2ravine.jpg)

by FOMH. While the efforts to repair the historic stone drive were well-intentioned, they were not carried out with historic accuracy, notably, the mortar utilized for the repair. Large, concrete planters that do not date to the historic period prohibit vehicular access to this cobblestone drive section north of Hope Avenue. (See Figure III.27.) The southern portion of Ravine Avenue is surfaced with asphalt. Dell Avenue also branches to the east from Indian Trail Avenue, connecting at the south with Grove Avenue. Together, the southern portion of Indian Trail Avenue and Dell Avenue enclose a roughly diamond-shaped high point to the west of Sylvan Waters. Other drives in Area 2 include Highland and Hillside Avenues, which are no longer accessible by vehicle. These drives are degraded and covered in mixed species turf grass, leaf litter, duff, and herbaceous plant materials. (See Figures III.28 and III.29.) It is unclear whether the drives have been removed or remain under the organic material; however, substantial lengths of cobblestone gutters are noted in situ. Because of their condition, Highland and Hillside Avenues are accessible only to pedestrians, and appear to be less frequently used than other paths. In total, the curvilinear drive network is not only a functional feature, providing access through the landscape and negotiating the steep terrain; it also contributes to the overall landscape character, providing a strong sense of historic design, workmanship, use, sensory experience, and spatial and visual relationships..

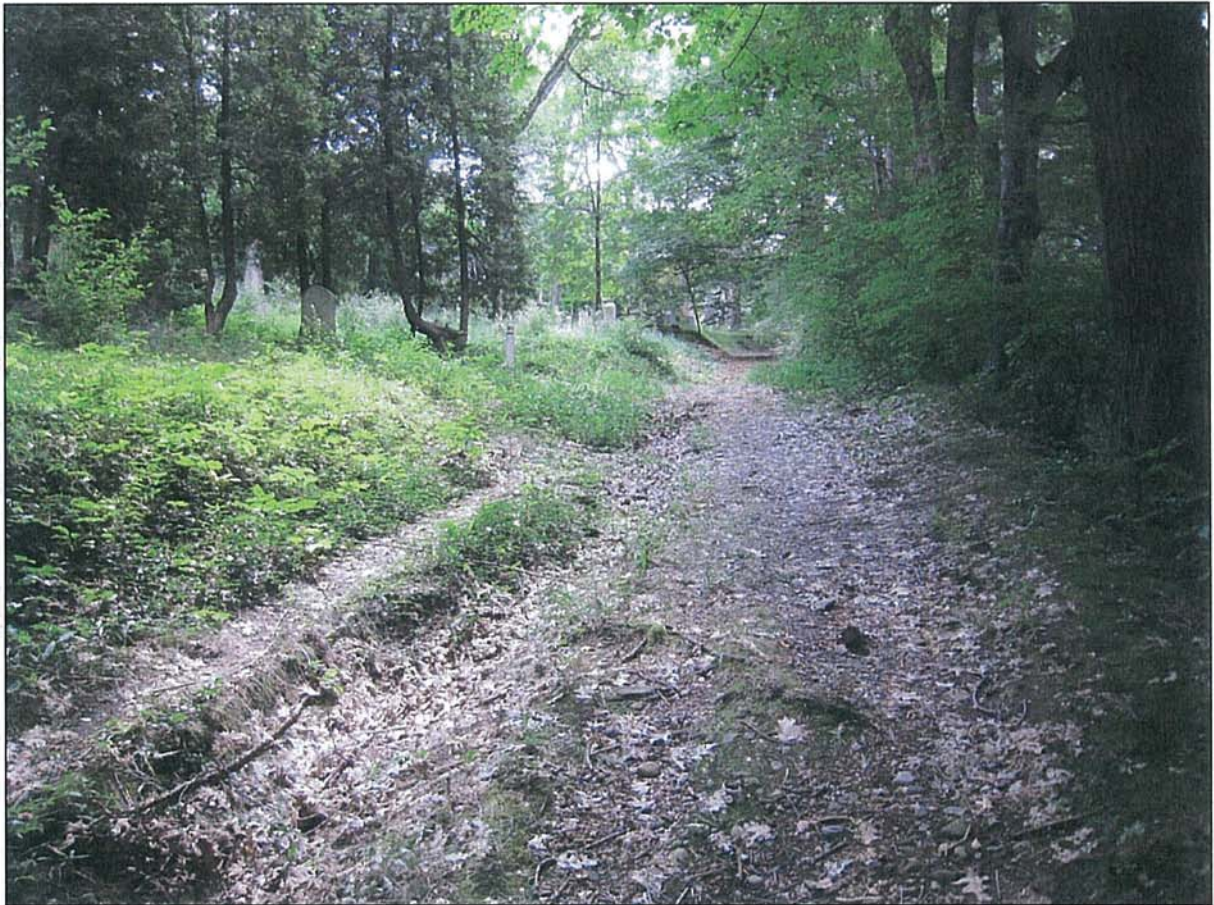
Figure III.28. Drives in Area 2 include Highland and Hillside Avenues, which are no longer accessible by vehicle. These drives are degraded and covered in mixed species turf grass, leaf litter, duff, and herbaceous plant materials. Courtesy Heritage Landscapes. (R-MTH_20080813_4743-Unit2-HillsideAve.jpg)

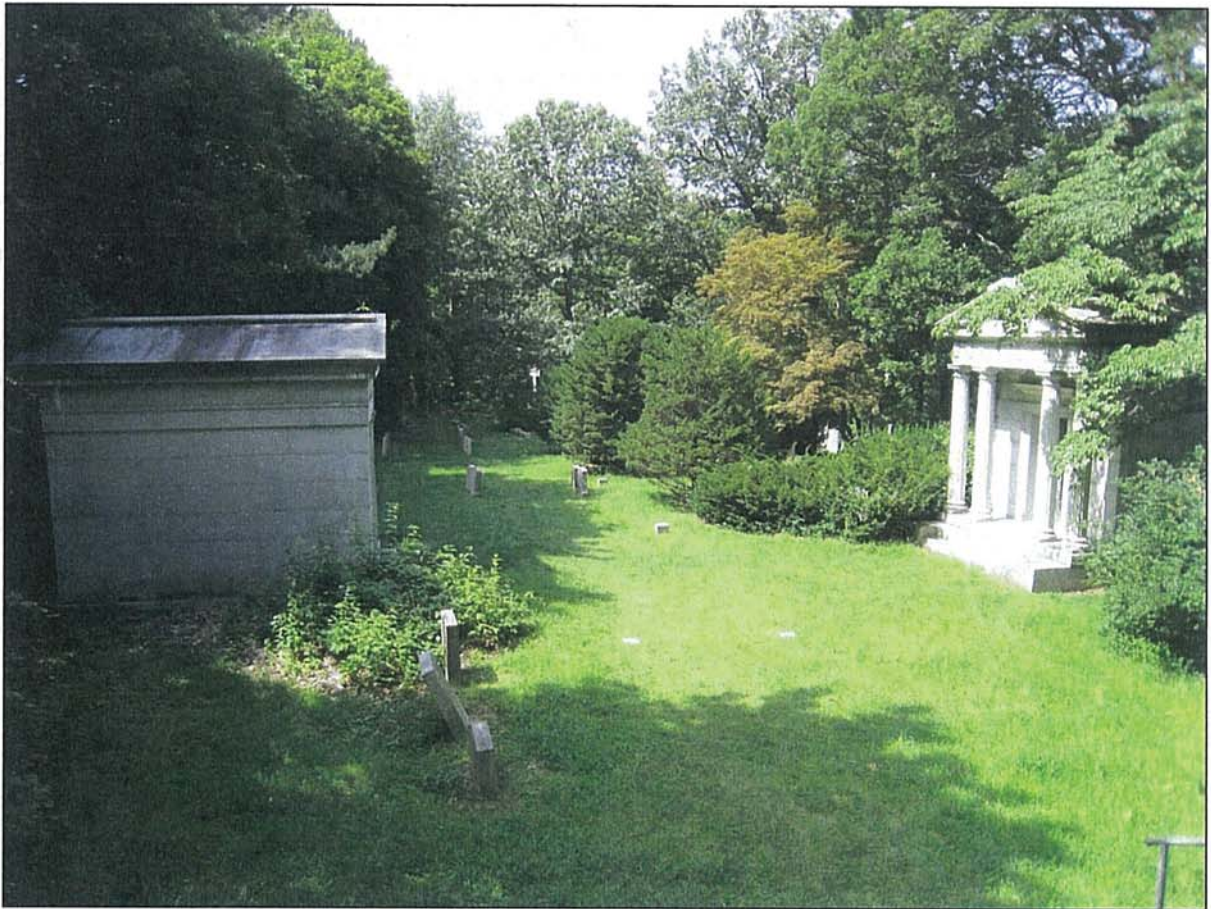
Figure III.29. Historic drives in Area 2 are degraded and covered in mixed species turf grass, leaf litter, duff, and herbaceous plant materials. Courtesy Heritage Landscapes. (R-MTH_20080813_4714-Unit2, highlandAve.jpg)

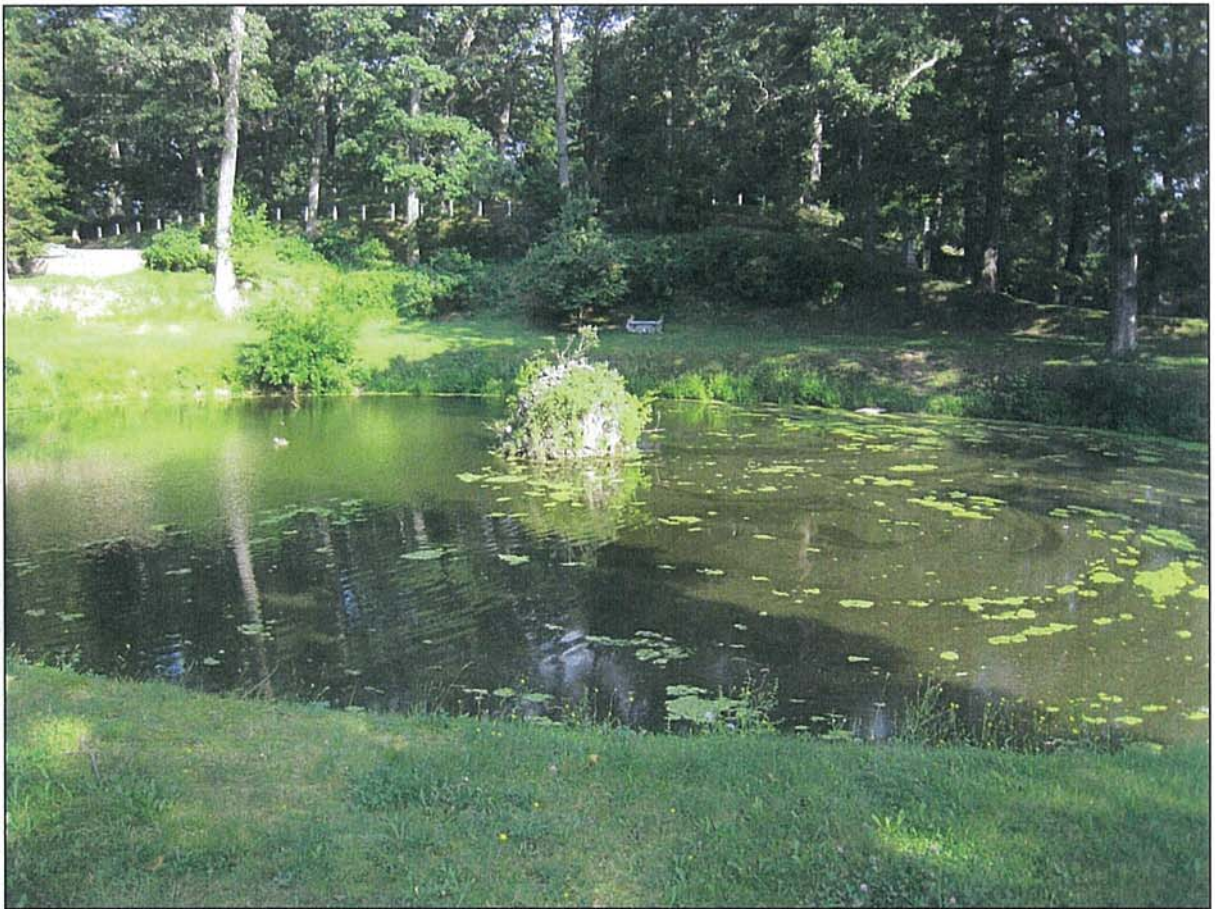
Figure III.30. A stone fountain is sited at the center of the Sylvan Waters to re-circulate water and provide a scenic effect; however, volunteer growth covers much of this central feature. Courtesy Heritage Landscapes. (R-MTH_20080813_4627-Unit2sylvan.jpg)

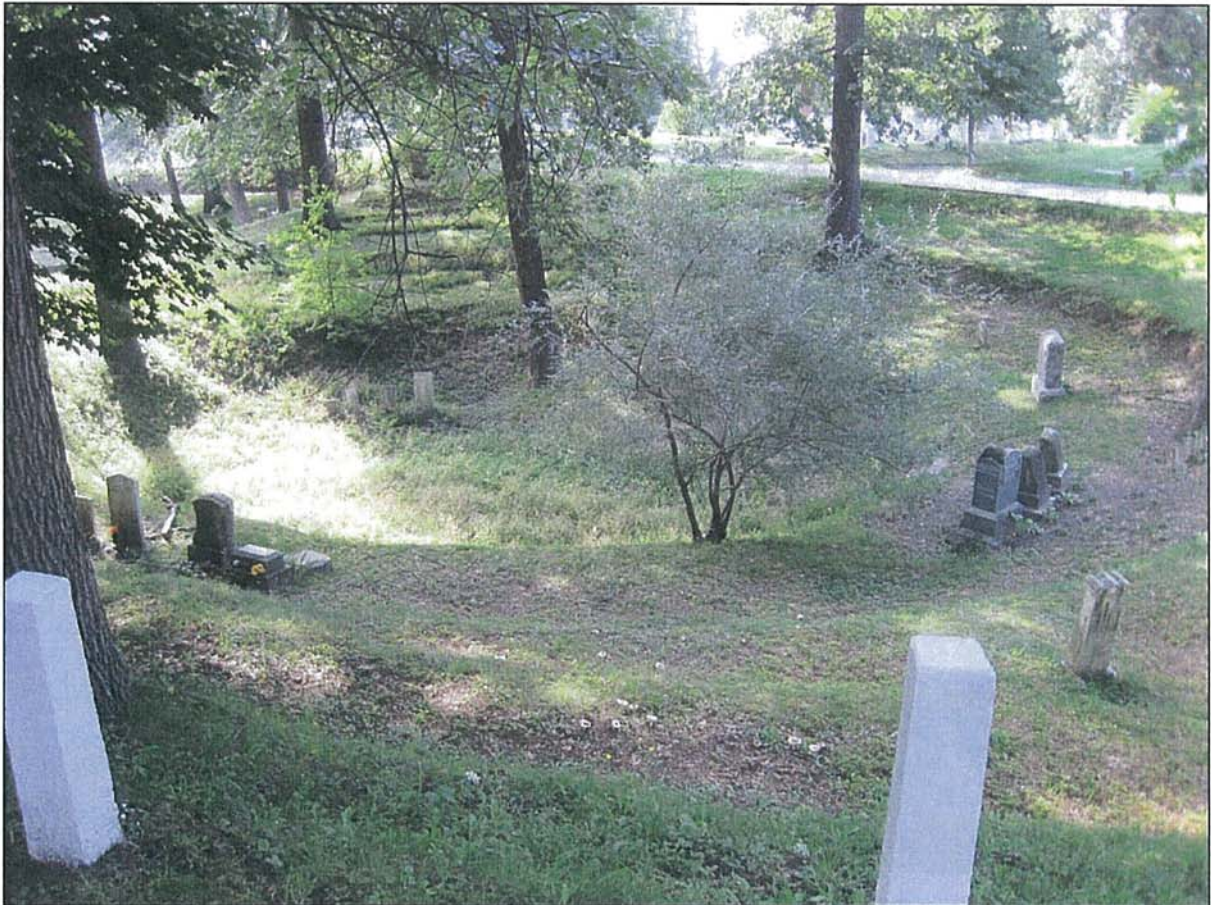
Figure III.31. Three small kettles are located in close proximity to Sylvan Waters; two are directly adjacent, positioned to the north and west with grave stones. Courtesy Heritage Landscapes. (R-MTH_20080813_4623-Unit 2-dry kettle.jpg)

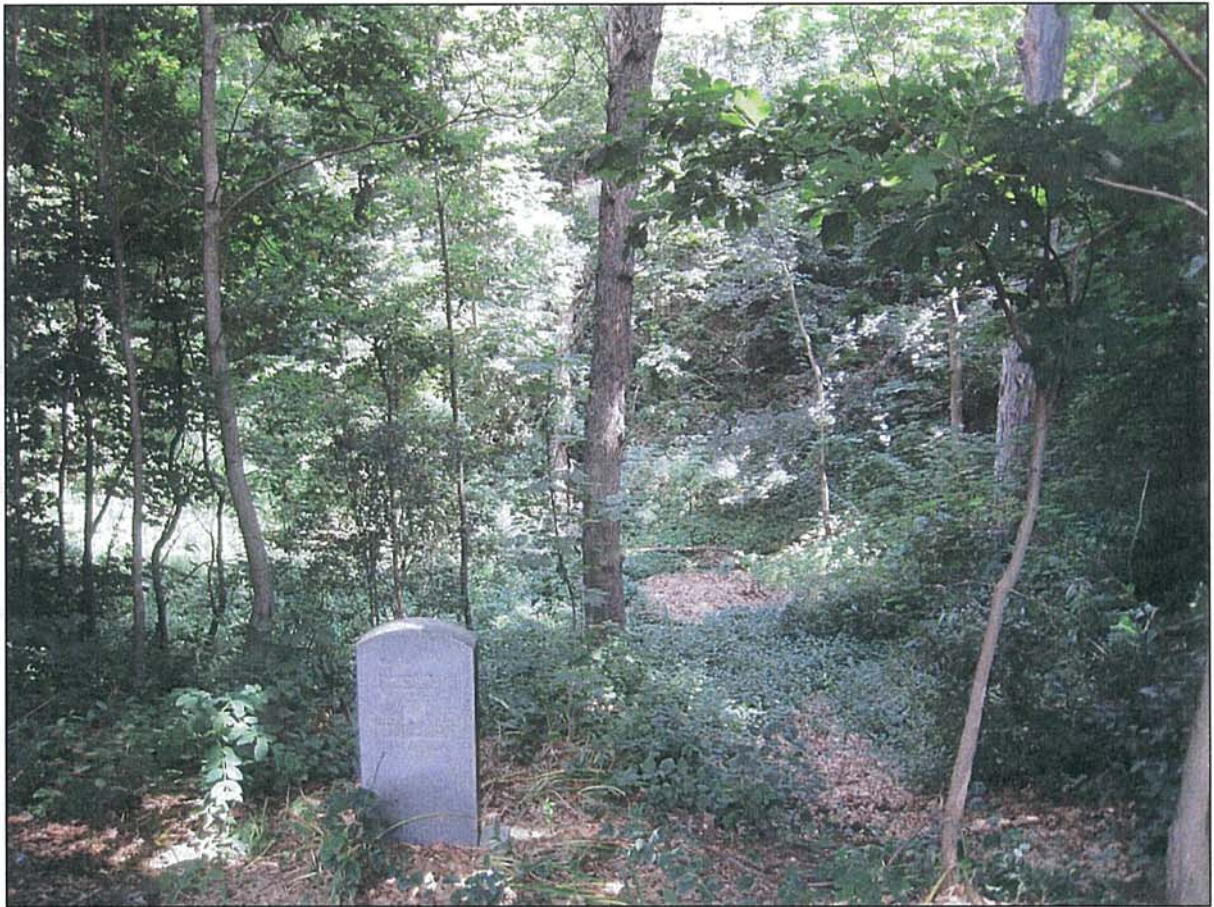
Figure III.32. A kettle located within Section G, in the diamond-shaped area enclosed by Indian Trail and Dell Avenues, is similar in size to Sylvan Waters but degraded with overgrown volunteer vegetation. Courtesy Heritage Landscapes. (R-MTH_20080813_4789-Unit2 Kettle.jpg)

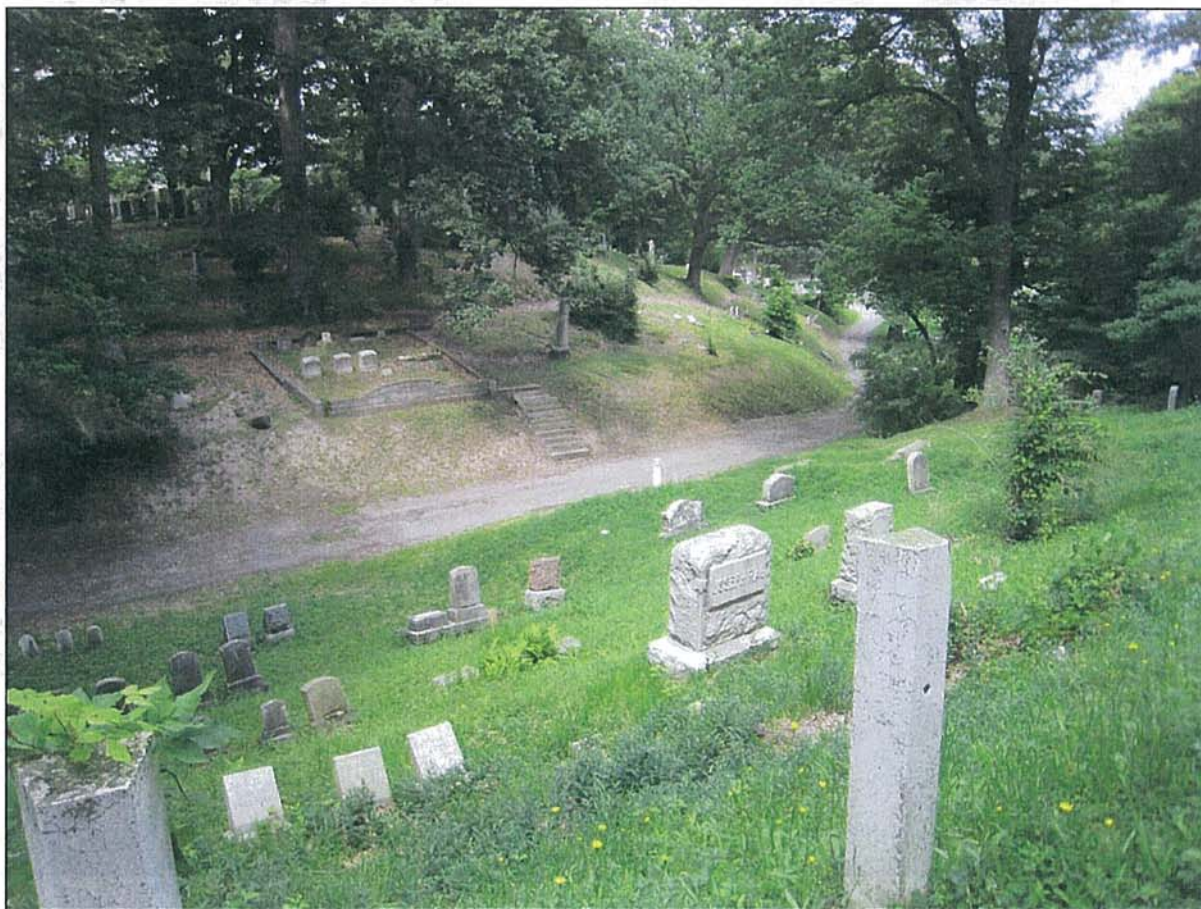
Figure III.33. Stone retaining walls and steps are also found throughout Landscape Area 2, retaining grade and providing access around gravesites and constructed mausoleums. Courtesy Heritage Landscapes. (R-MTH_20080813_4771-Unit2.jpg)
