MOUNT HOPE CEMETERY

CULTURAL LANDSCAPE REPORT

TREE INVENTORY & MANAGEMENT PLAN

LANDSCAPE EXISTING CHARACTER

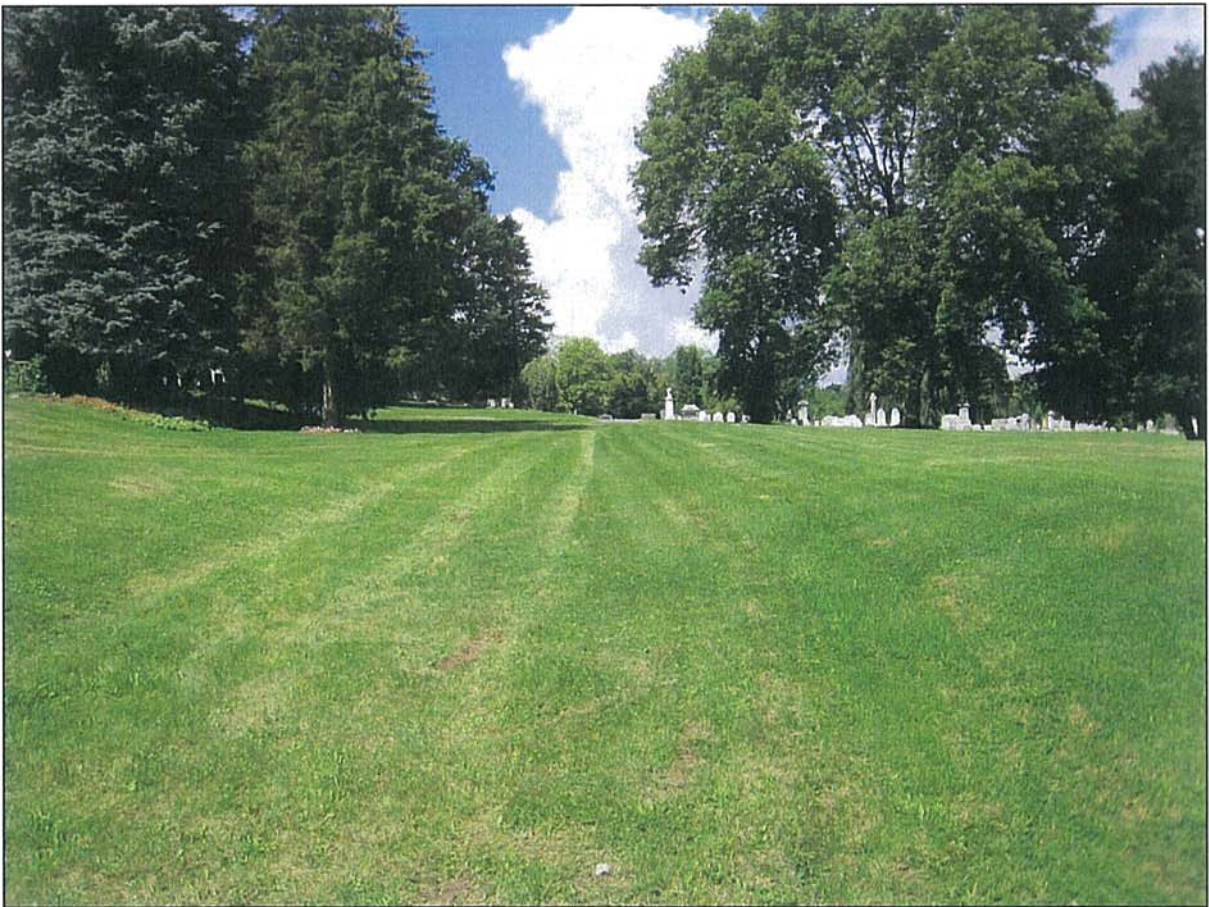
Figure III.34. Toward Mount Hope Avenue, the ground plane is open with no burial plots or drives. Because of the grid-like organization and patterns that characterize the North Cemetery Edge & Maintenance Yard, this area is spatially distinct from the broader cemetery landscape. Courtesy Heritage Landscapes. (R-MTH_20080812_4490-Unit3.jpg)

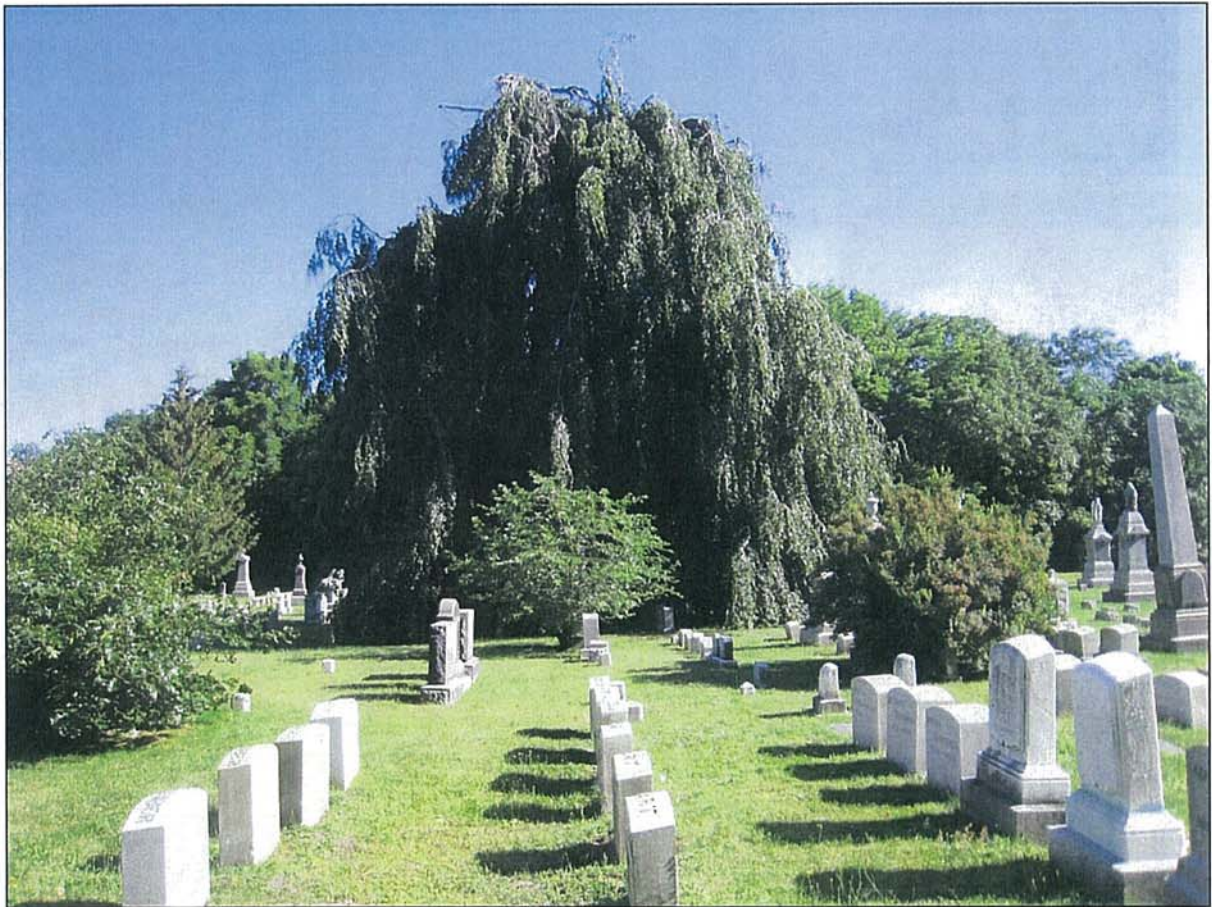
Figure III.36. In the center of Area 3, deciduous, evergreen, and ornamental trees are scattered over a mown turf ground plane. Of particular interest is a mature weeping European beech tree, likely planted during the mid-to-late 19th century. Courtesy Heritage Landscapes. (R-MTH-15Jul08-0024.jpg)

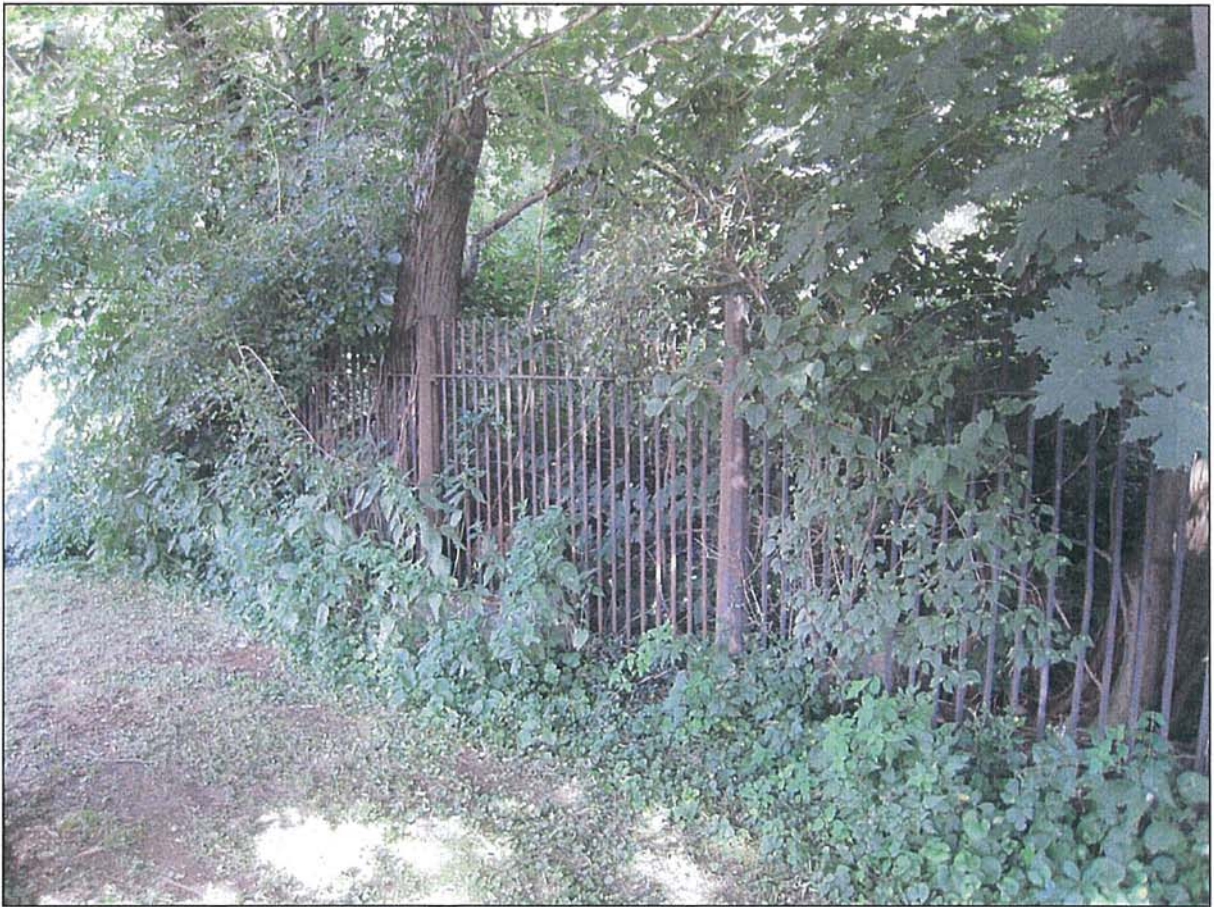
Figure III.37. In Area 3, the iron cemetery fence defines the north edge of the public landscape and separates the main cemetery from the maintenance yard. The section of the northern perimeter fence shown in this image has different cast iron posts than the section of fence along Mount Hope Avenue. Courtesy Heritage Landscapes. (R-MTH_20080812_4497-Unit 3 fence.jpg)

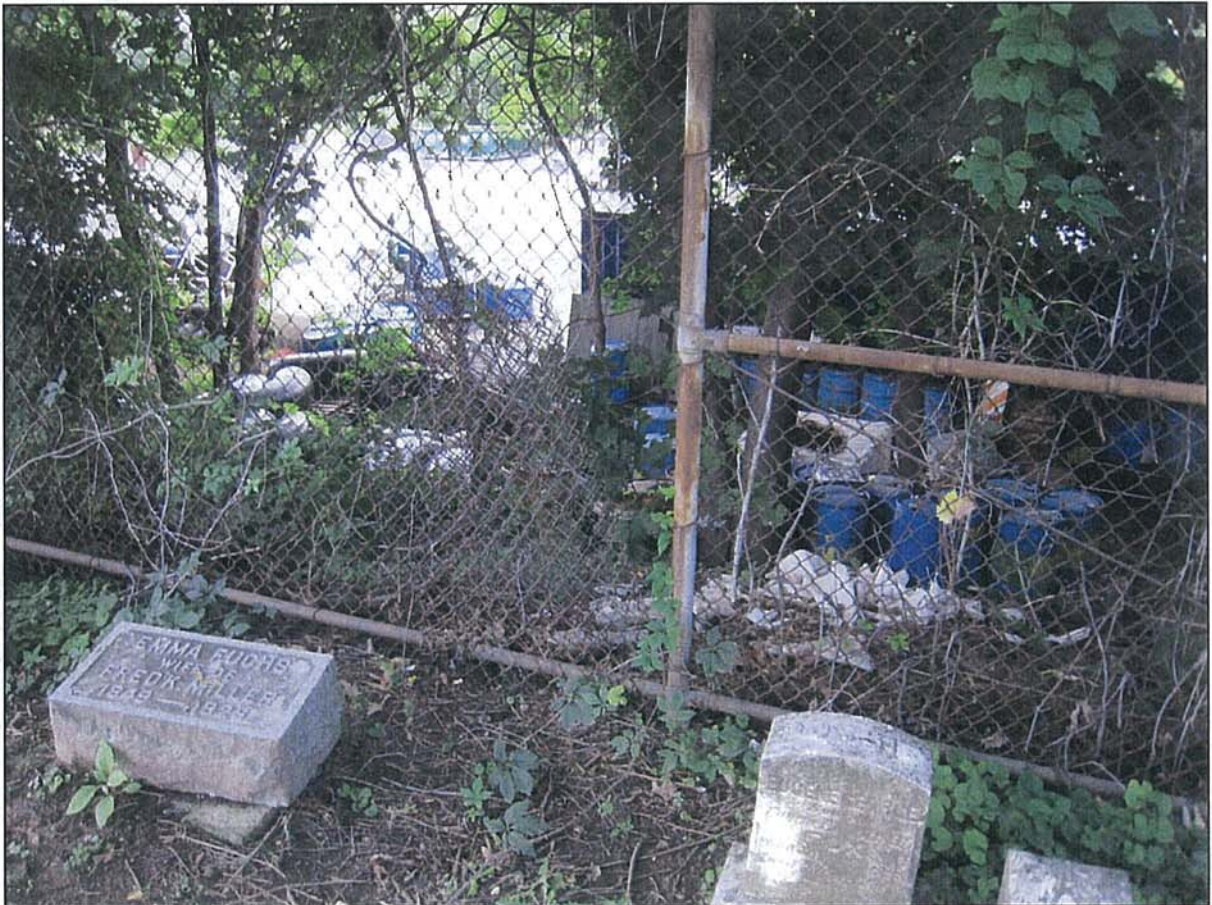
Figure III.38. At the western cemetery edge, chain-link fencing marks the property line and provides a barrier between Mount Hope Cemetery and the adjacent property. Courtesy Heritage Landscapes. (R-MTH_20080812_4502-Unit3-views through.jpg)

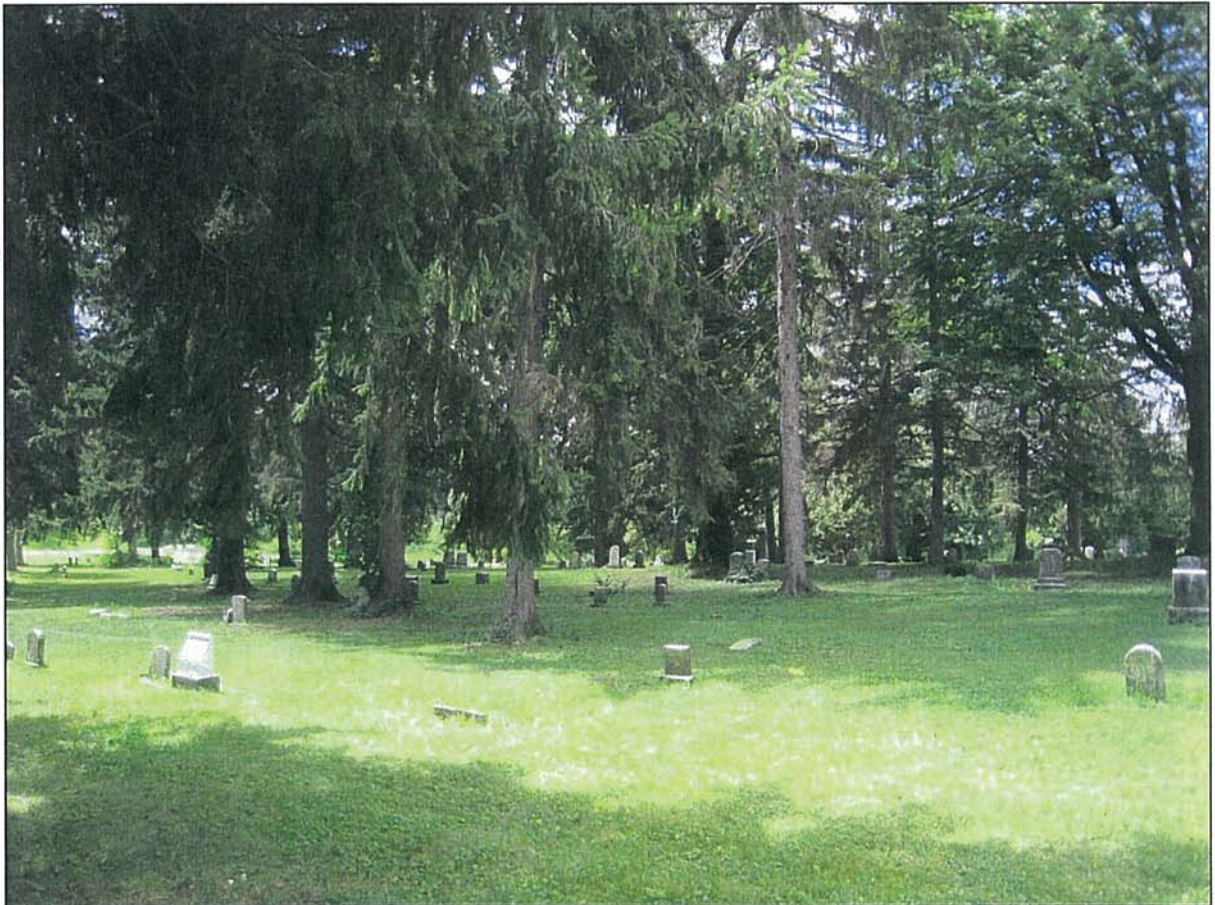
Figure III.40. Vegetation within Landscape Area 4 includes both deciduous and evergreen species, though evergreen species are more dominant in this area than throughout other sections of the cemetery. Courtesy Heritage Landscapes. (R-MTH_20080812_4575-Unit 4 evergreen.jpg)

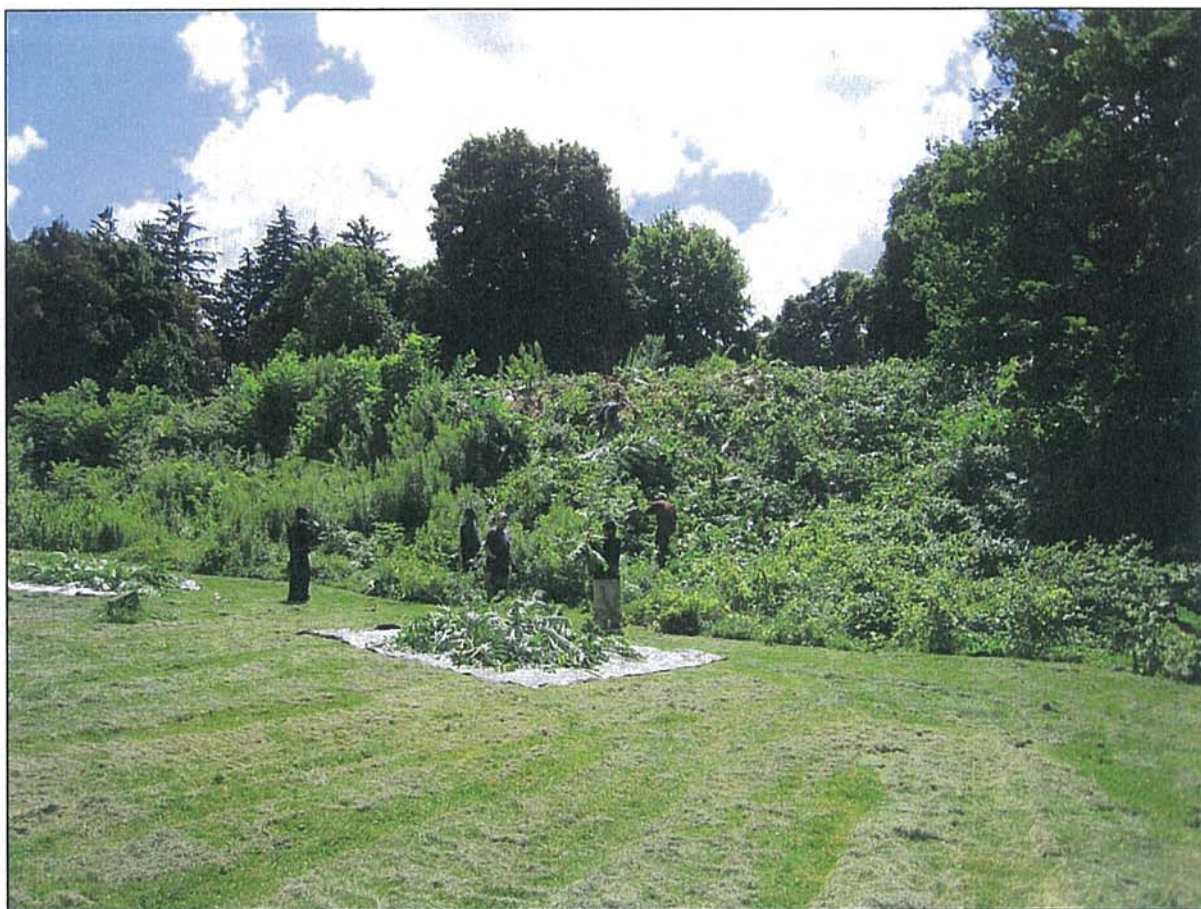
Figure III.41. The steep slopes at the south and west edges of Landscape Area 4 are densely vegetated, primarily with volunteer growth. However, efforts by the City of Rochester in August 2008 have cleared the volunteer growth on the steep southern slope between Landscape Areas 4 and 5. Courtesy Heritage Landscapes. (R-MTH_20080812_4545-city slope-Unit 4-5maintenance.jpg)

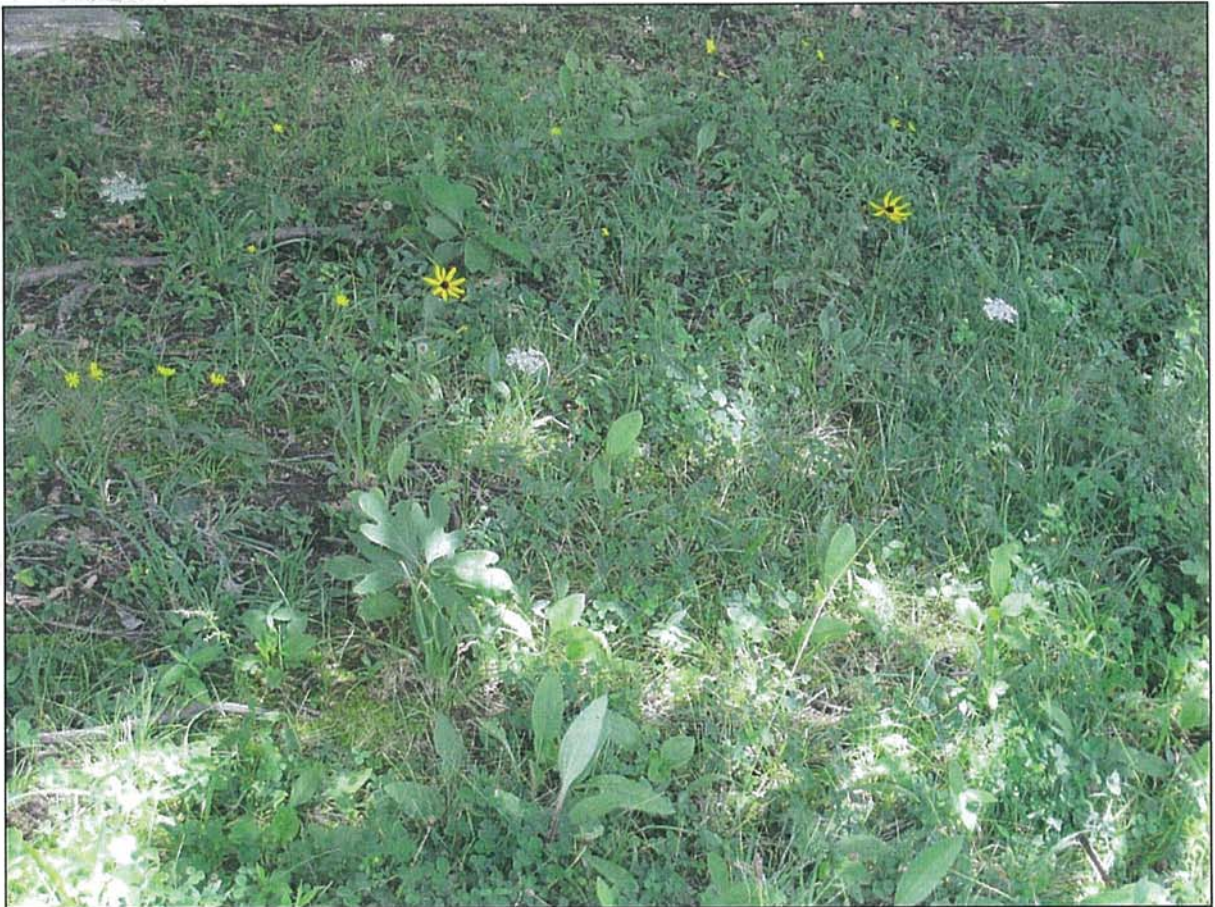
Figure III.42. Ground plane vegetation consists of mown mixed species turf grass in the west and south portions of the area; however, native grasses, flowers, and regenerating oak trees persist in the northeast quadrant of Area 4. Courtesy Heritage Landscapes. (R-MTH_20080812_4573.jpg)

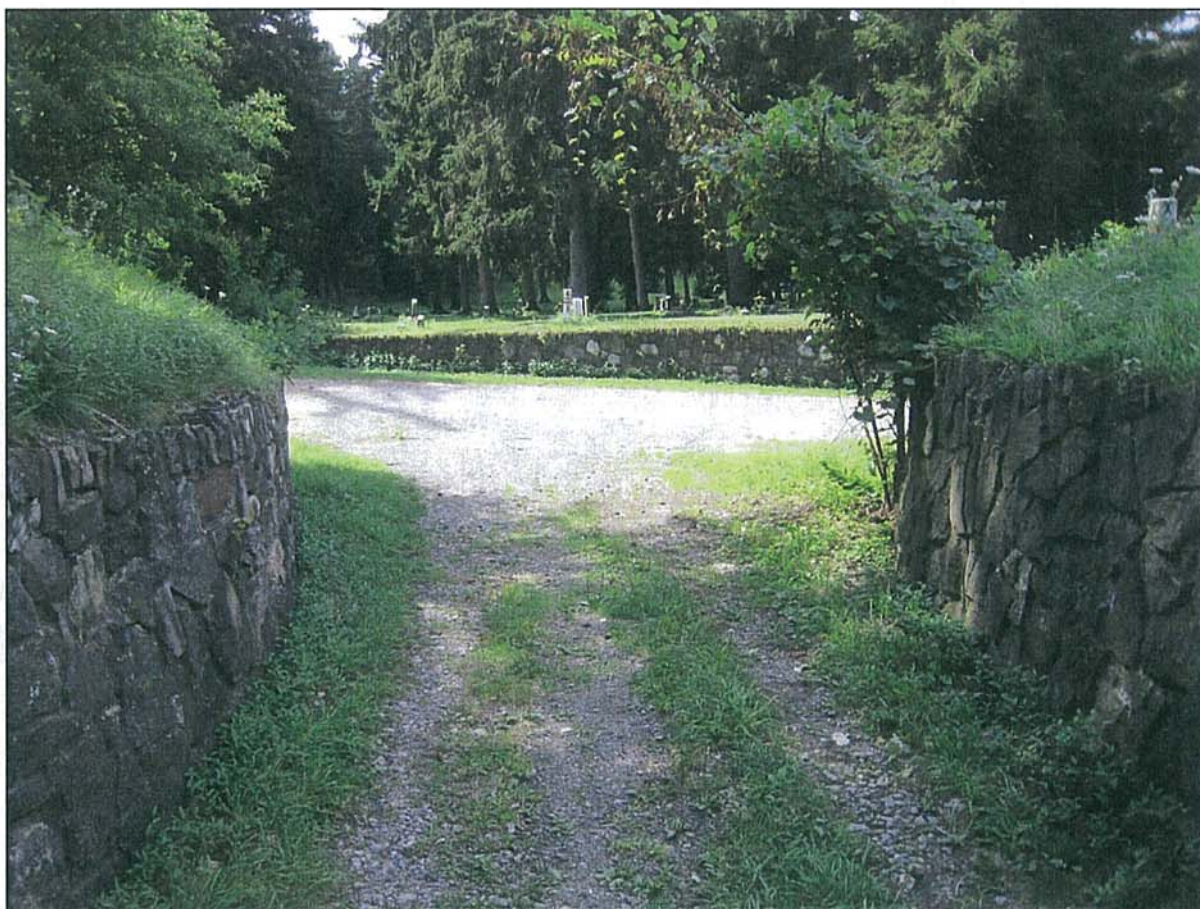
Figure III.43. Near the center of Landscape Area 4, both Pine and Buell Avenues become sunken drives with stone retaining walls and rising surrounding ground planes. Courtesy Heritage Landscapes. (R-MTH_20080813_4692-Unit4.jpg)

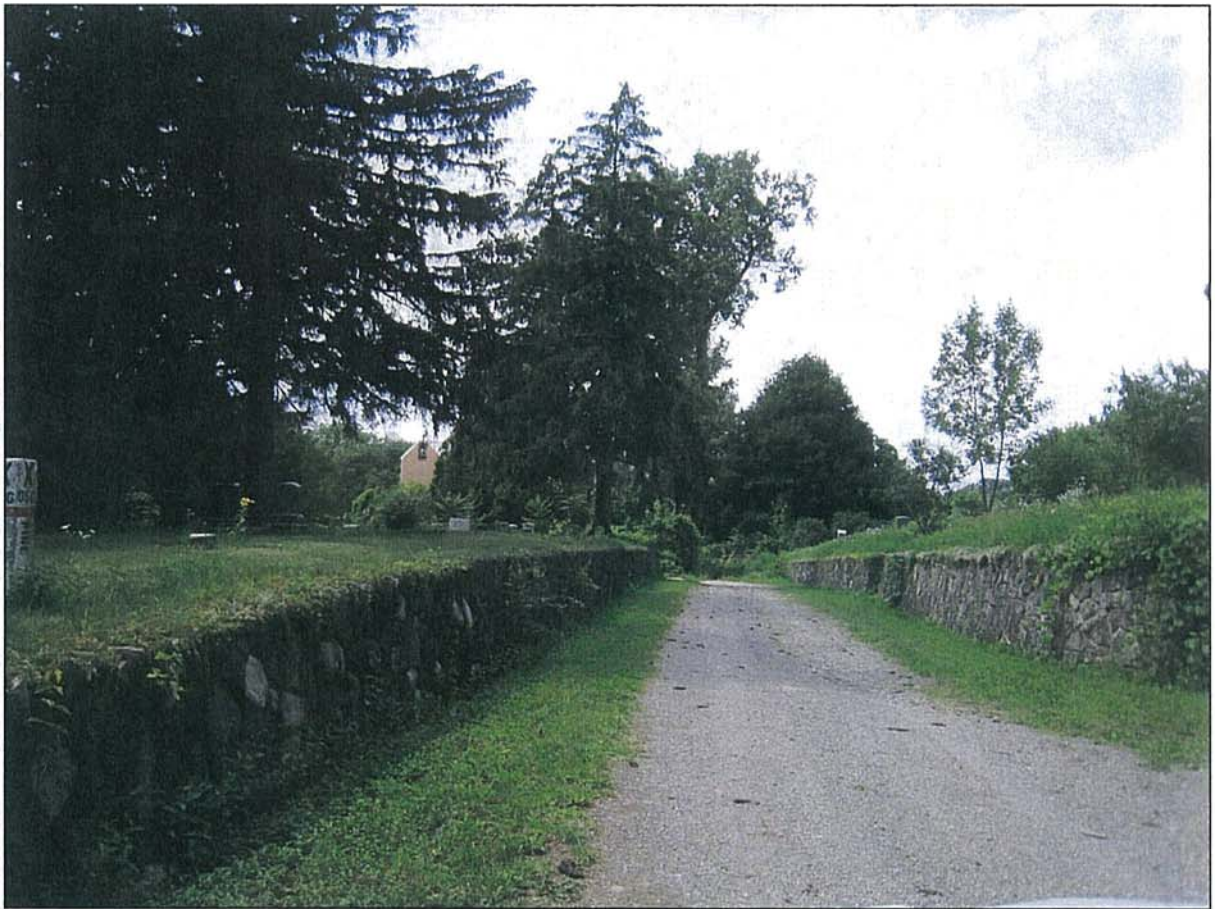
Figure III.44. Near the center of Landscape Area 4, both Pine and Buell Avenues are delineated by adjacent retaining walls and rising ground planes. Courtesy Heritage Landscapes. (R-MTH_20080813_4840-Unit4.jpg)

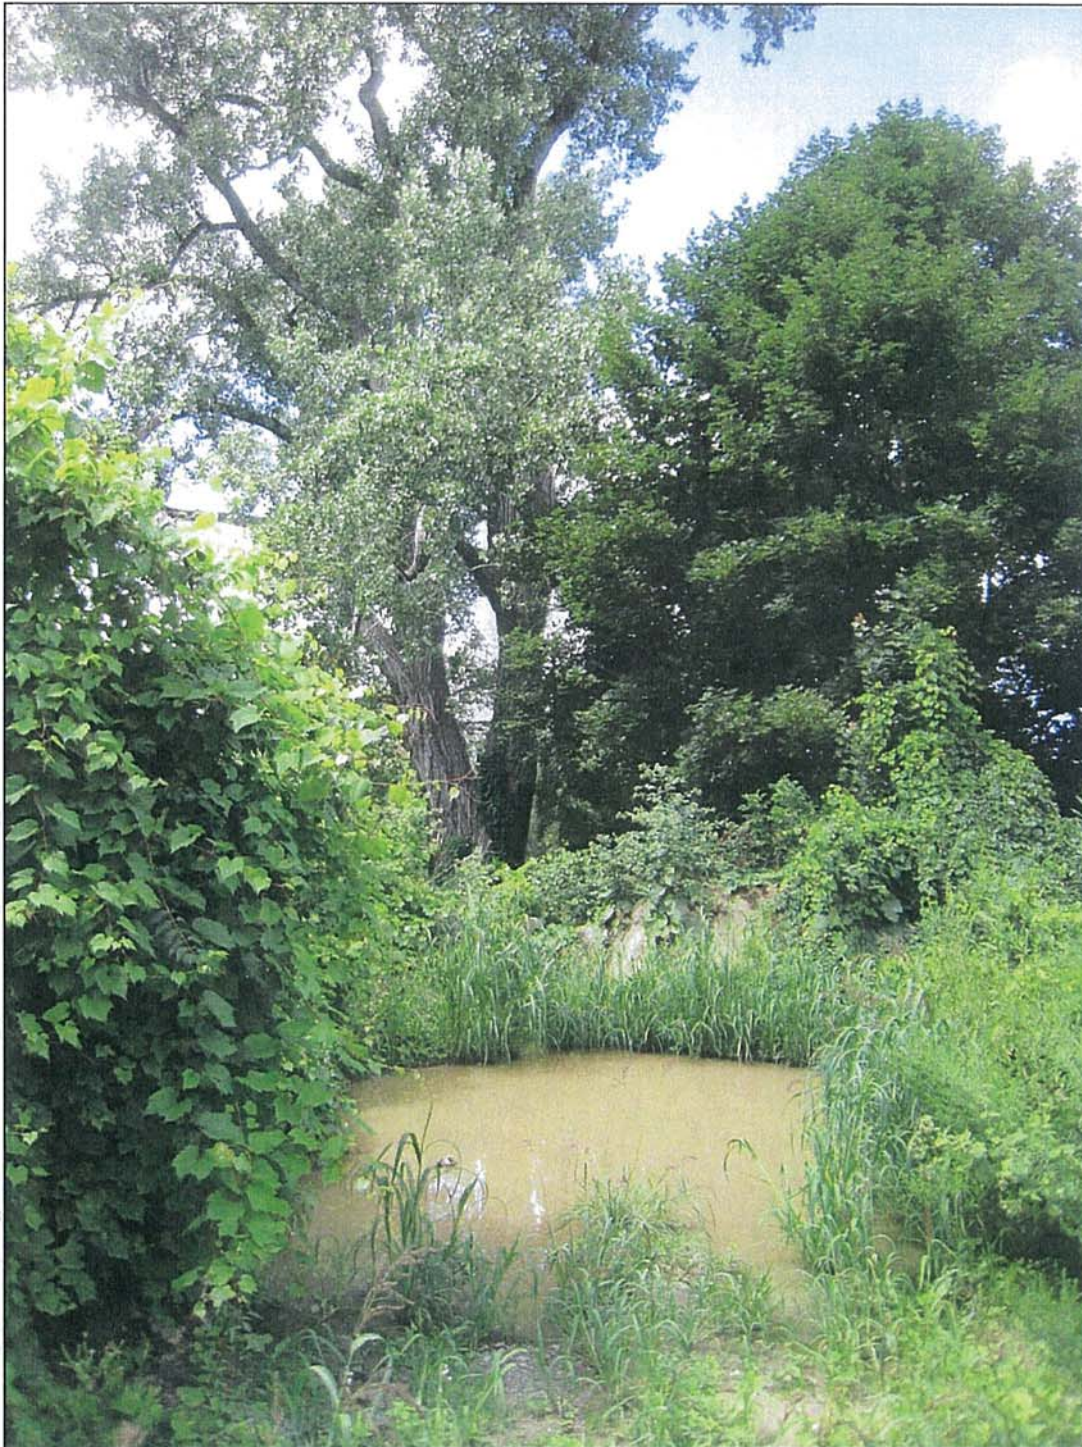
Figure III.45. In Area 4, the road trace at the Pine Avenue elbow-turn exhibits ponding with standing water present during most of the summer. Courtesy Heritage Landscapes. (R-MTH_20080812_4552-ponding former road-Unit4.jpg)

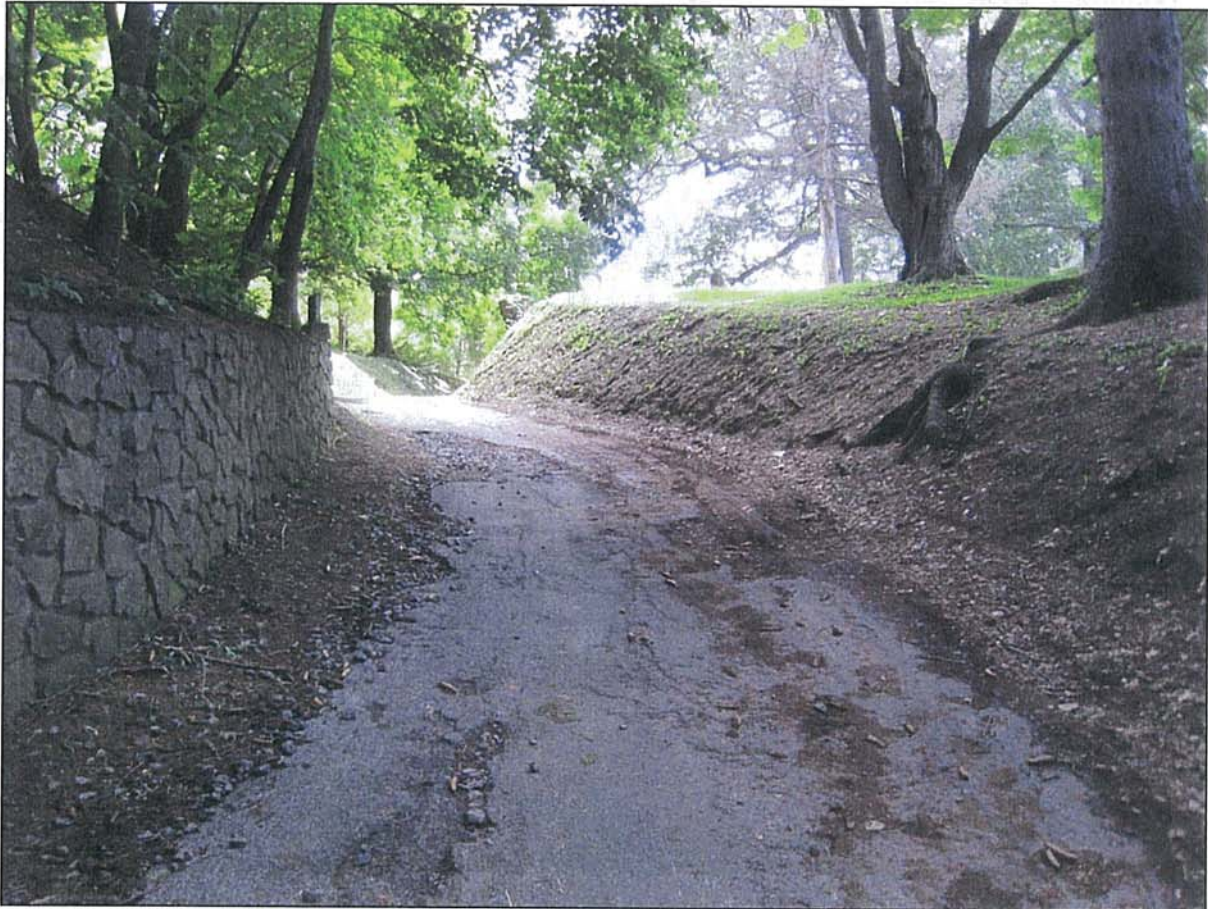
Figure III.47. Views are framed and narrowed along a short sunken segment of Glen Avenue in Area 5, but expand upon approaching Grove Avenue to the south. Courtesy Heritage Landscapes. (R-MTH_20080812_4576-Unit 5 sunken road.jpg)

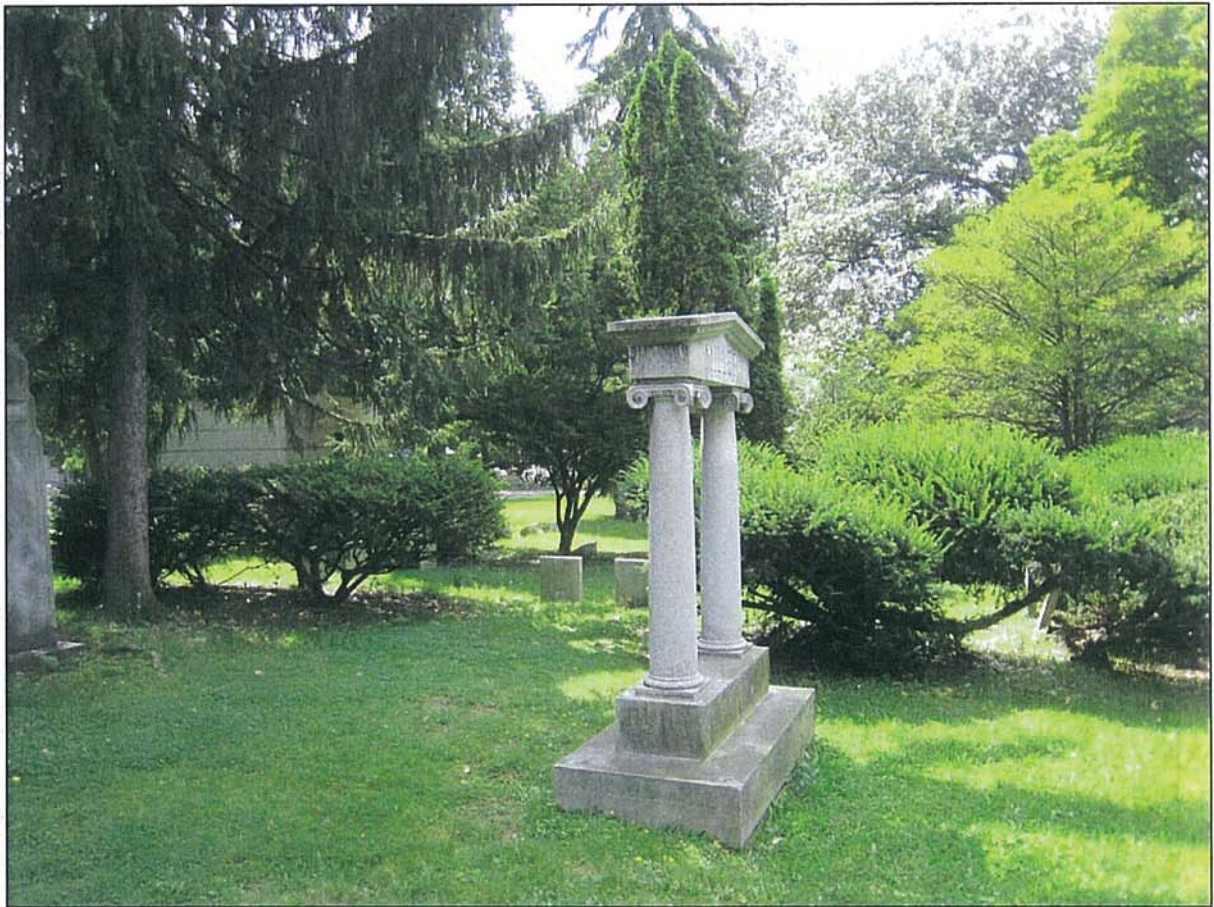
Figure III.48. Patterns of vegetation vary throughout Area 5 with a number of small tree and shrub clusters and rows as well as individual trees found on the sloping ground plane. Courtesy Heritage Landscapes. (R-MTH_20080813_4885-Unit5-yews, cedar.jpg)

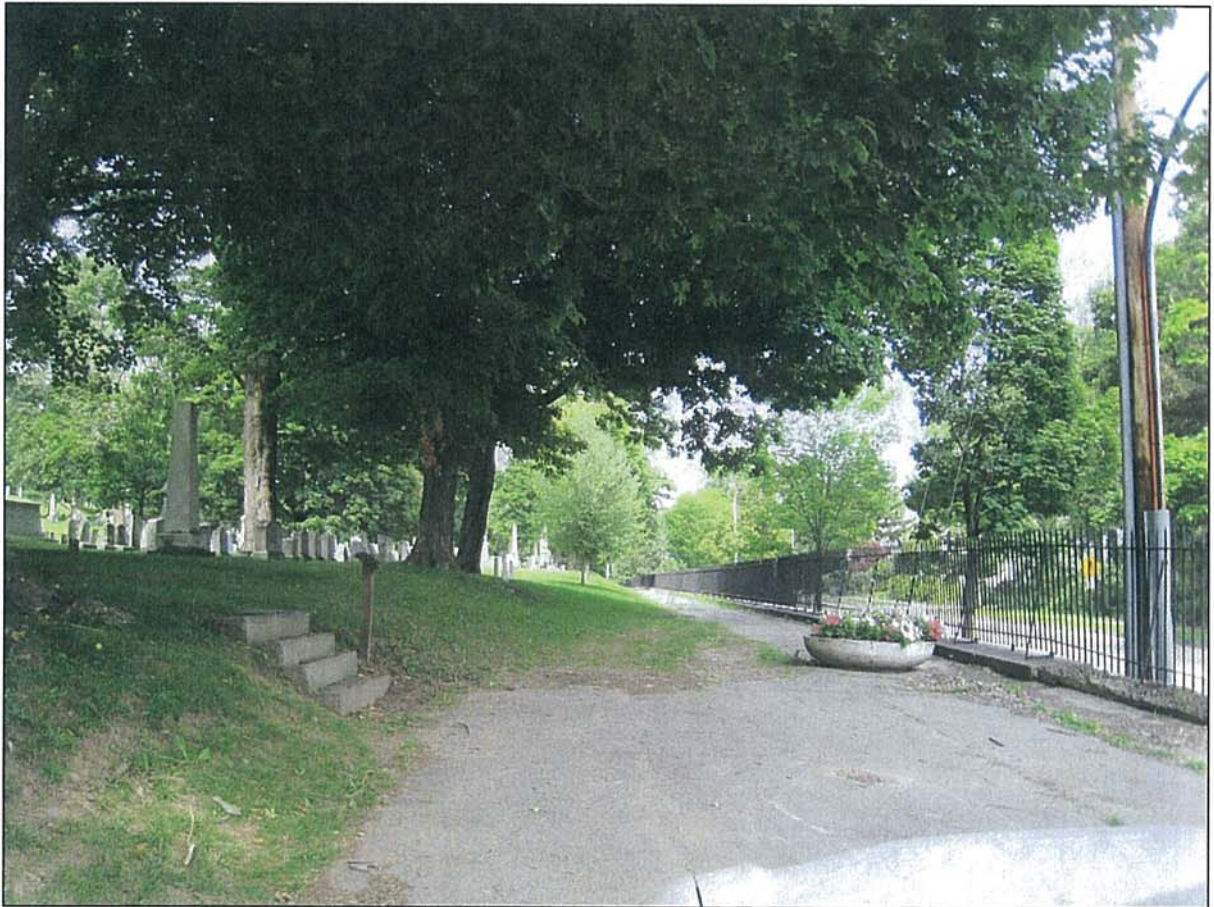
Figure III.50. At its connection with Grove Avenue at the south, East Avenue functions as a drive. The drive extends northeast for approximately 320 feet before narrowing to a 5-foot wide pedestrian path. Courtesy Heritage Landscapes. (R-MTH_20080813_4896-Unit5 East Ave.jpg)

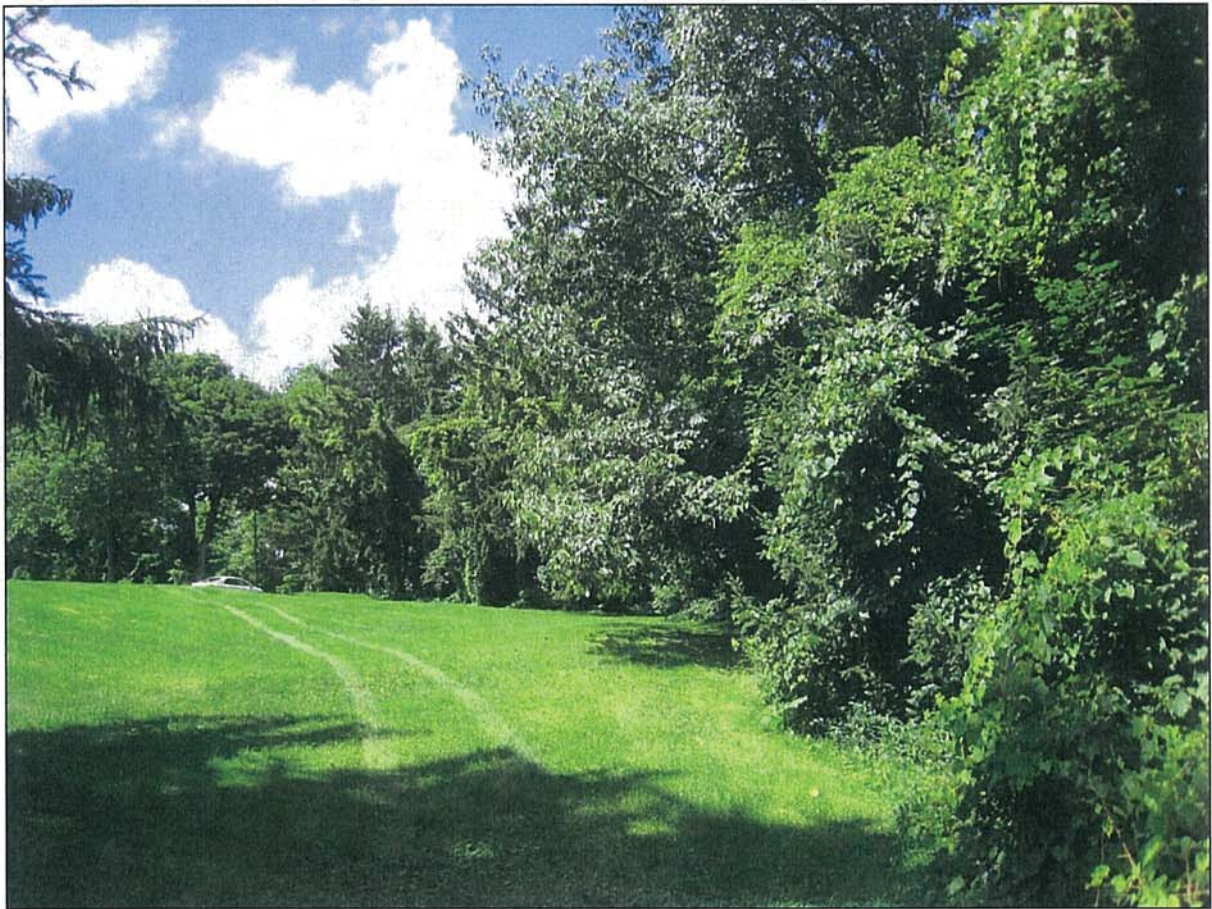
Figure III.52. A trace of Cedar Avenue remains evident near the steep slope between Areas 4 and 5. Maintenance vehicles often use this road trace as a short-cut. Courtesy Heritage Landscapes. (R-MTH_20080812_4540-Unit 5 open.jpg)

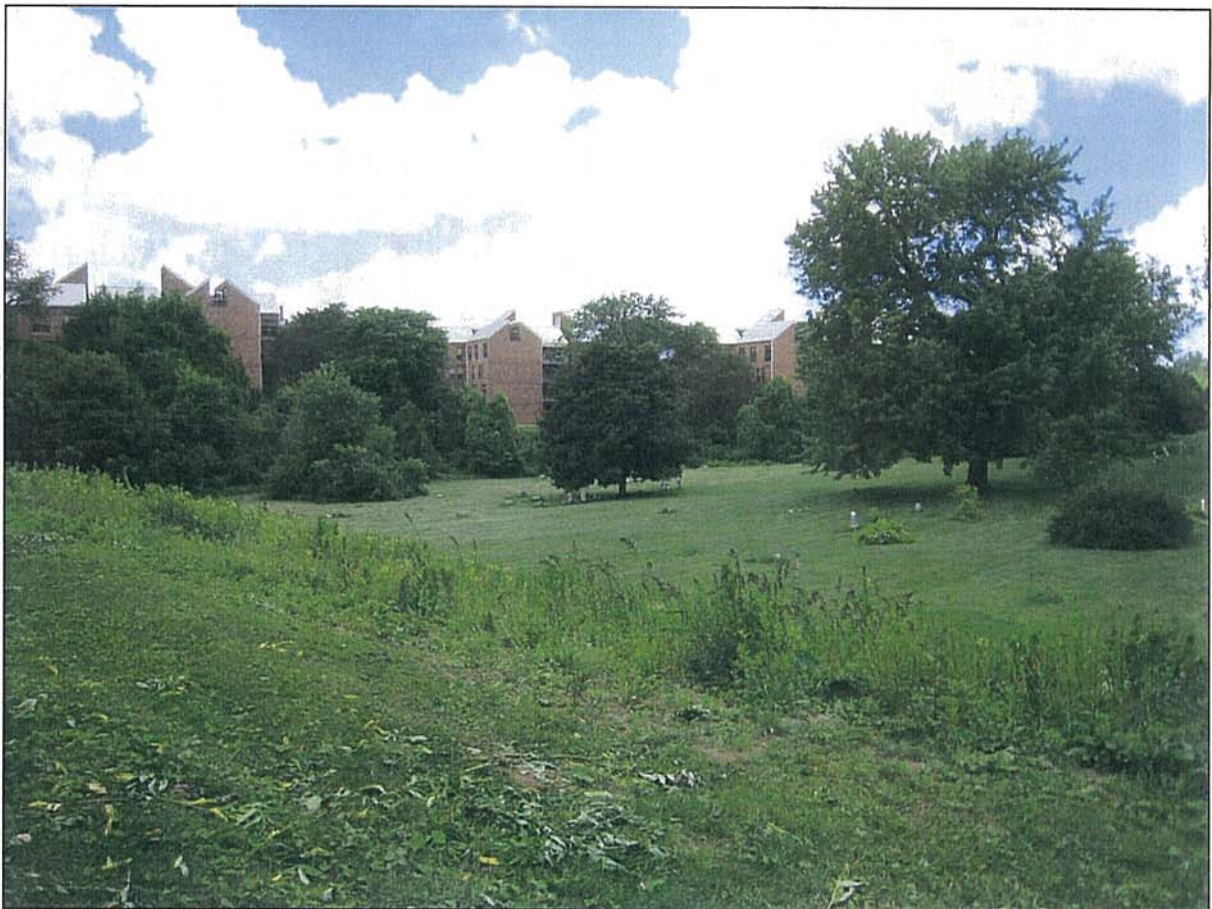
Figure III.53. In Landscape Area 6, dense vegetation creates a barrier between the cemetery and University of Rochester River Campus landscapes, obscuring views into the campus. Courtesy Heritage Landscapes. (R-MTH_20080812_4582-Unit6.jpg)

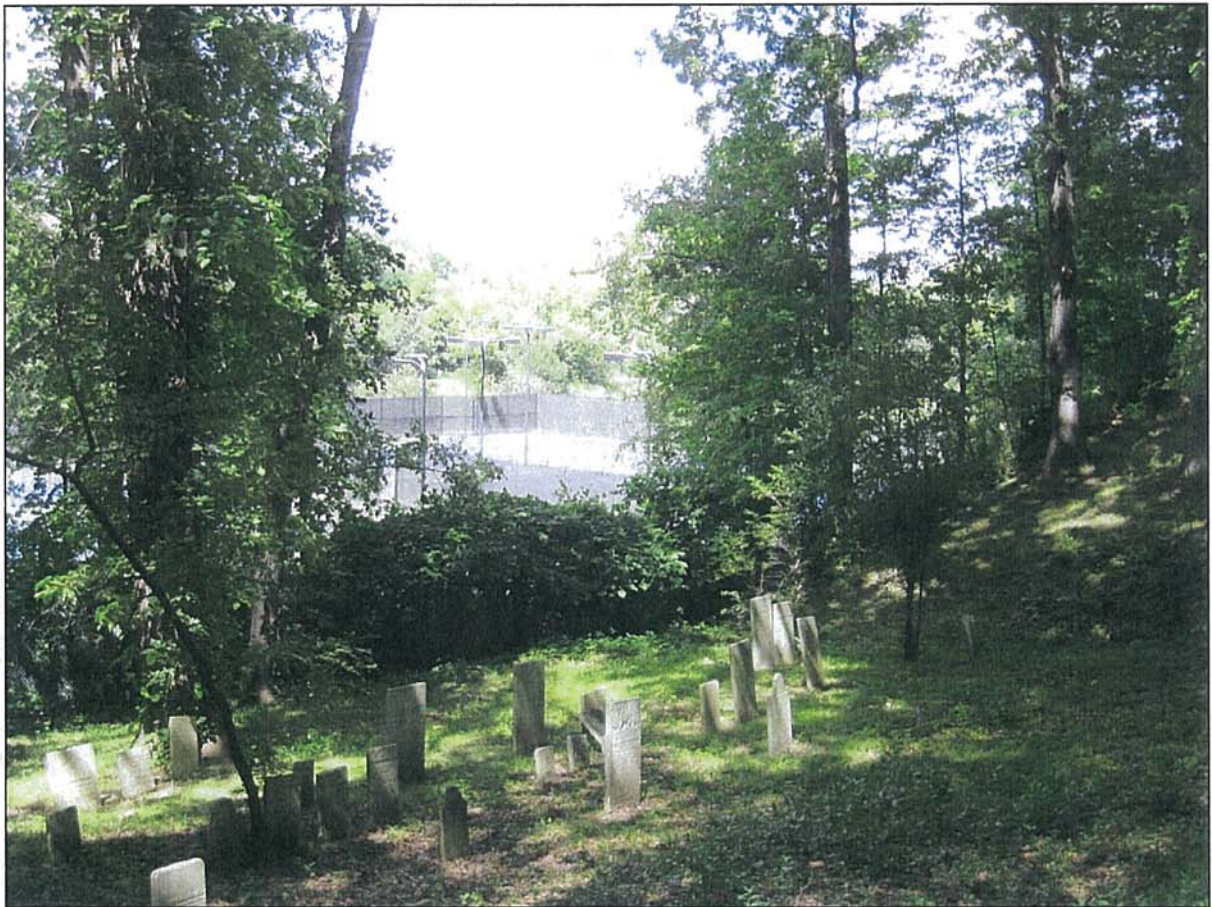
Figure III.54. The open, gently sloping area that fronted on the Genesee River at Area 6 has been replaced with University of Rochester River Campus facilities, including student dormitories, tennis courts, and a large asphalt parking lot. Courtesy Heritage Landscapes. (R-MTH_20080812_4561-views to UR-Unit6.jpg)

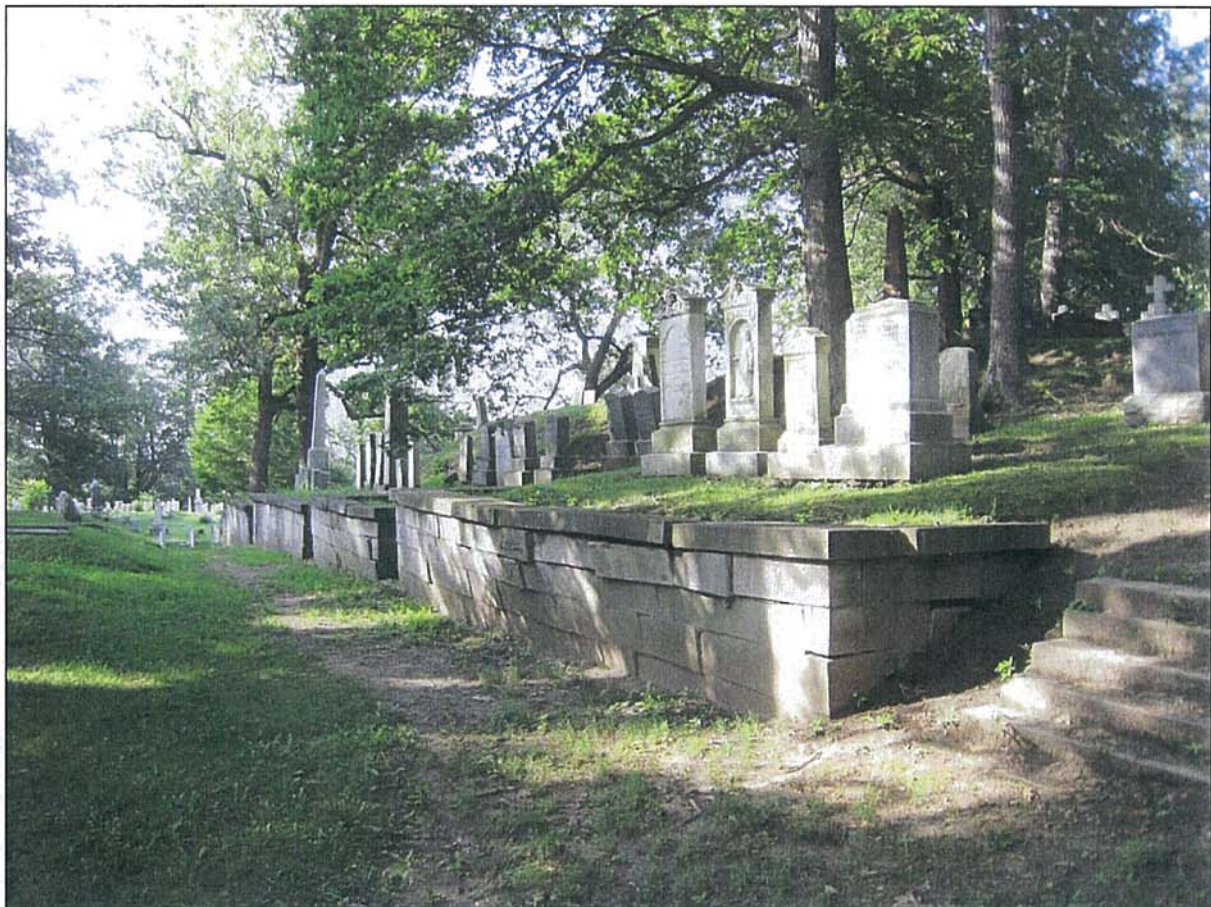
features exhibit deterioration and weathering. (See Figure III.55.) Additionally, historic features, such as stone grave markers, iron fencing, retaining walls, and historic circulation routes, are impacted by other landscape features, particularly vegetation. An appropriate management and preservation strategy needs to be implemented to resolve these issues.

Figure III.55. A considerable number of features remain from the historic cemetery period, but a unified approach for the preservation of Mount Hope Cemetery has not been holistically addressed. A number of features such as this historic retaining wall exhibit deterioration and weathering. Courtesy Heritage Landscapes. (R-MTH_20080813_4620-wall failure-Unit 5.jpg)

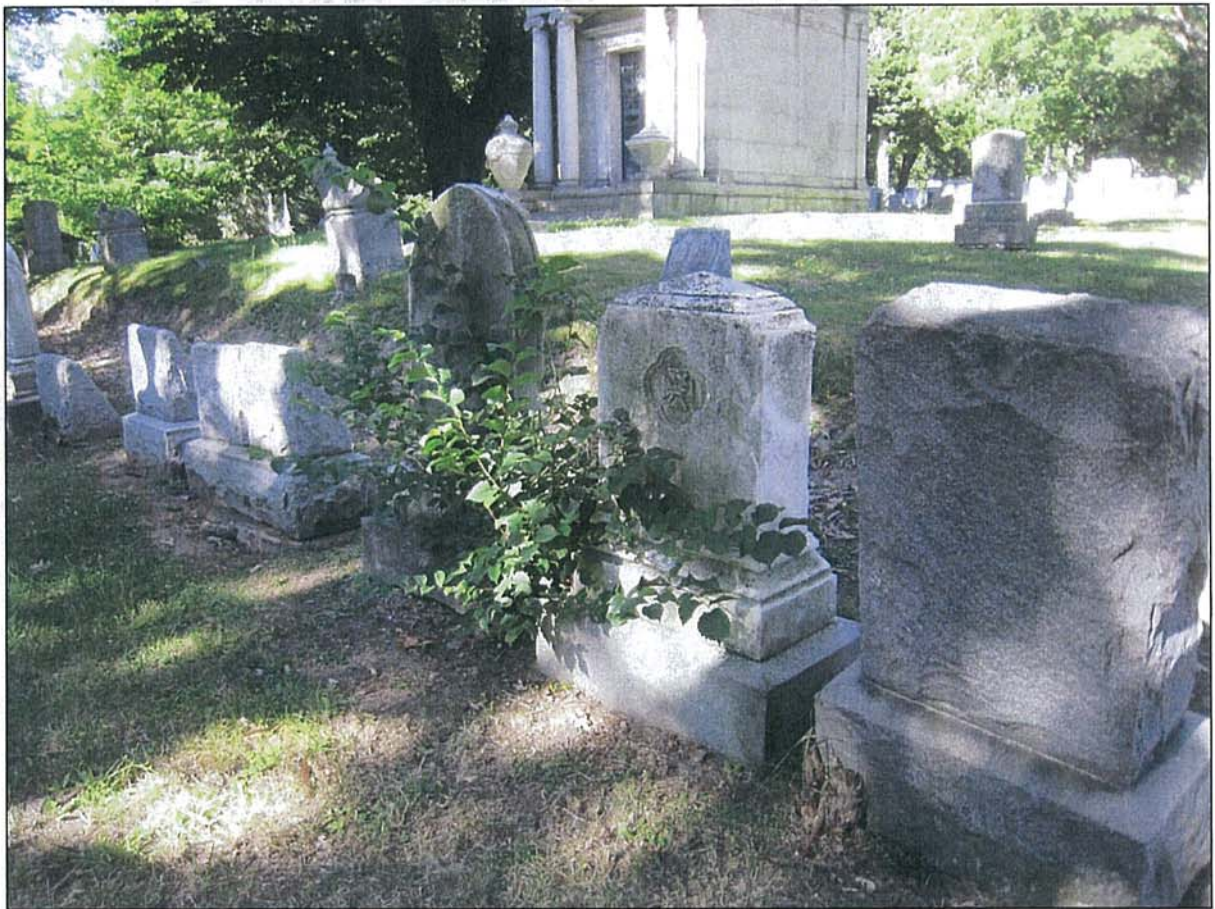
The method of managing a balance between natural and built features is an important issue to address. Several instances where natural features are negatively affecting built features were observed throughout the Mount Hope Cemetery landscape. In particular, some vegetation has grown adjacent to grave markers and monuments, which can cause the stones to shift and break. (See Figures III.56 and III.57.)

Figure III.56. Natural features are negatively affecting built features throughout the Mount Hope Cemetery landscape. In this image, vegetation has grown adjacent to grave markers and monuments, which can cause damage. Courtesy Heritage Landscapes. (R-MTH-15Jul08-0016.jpg)

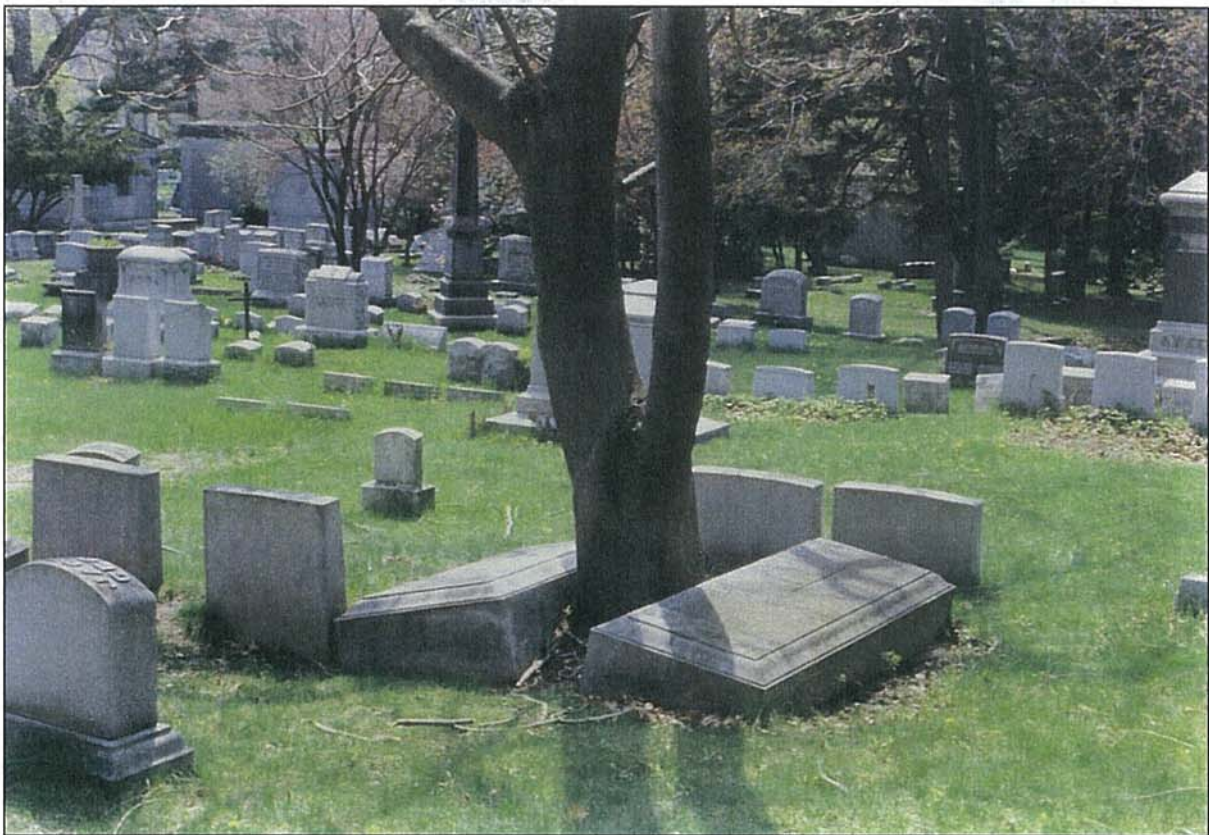
Figure III.57. At Mount Hope Cemetery, the balance between natural and built features must be addressed. In this image, a tree has grown between grave markers, causing the monument stones to shift and break. Courtesy Friends of Mount Hope Cemetery. (R-MTH-FOMH-Tree-Graves-nd.jpg)
