MOUNT HOPE CEMETERY

CULTURAL LANDSCAPE REPORT

TREE INVENTORY & MANAGEMENT PLAN

LANDSCAPE EXISTING CHARACTER

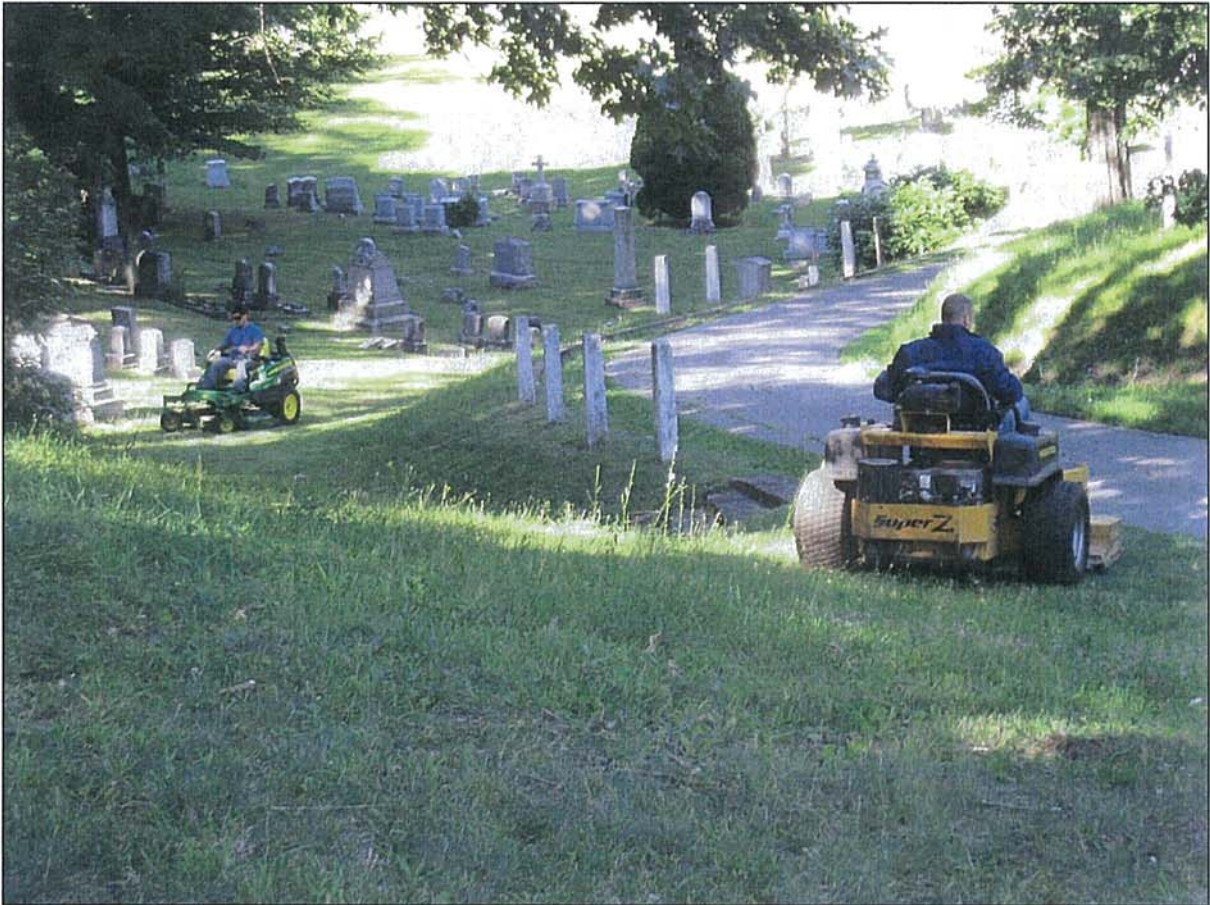
Figure III.58. Maintenance of the cemetery landscape needs to consider historic character and features. Because of the steeply sloping topography, mowing the turf ground plane can be challenging, and maneuvering mowers too closely to these features can cause damage. Courtesy Heritage Landscapes. (R-MTH-15Jul08-0064-mowing.jpg)

Maintenance of the cemetery landscape also needs to consider historic character and features. Because of the steeply sloping topography, mowing the turf ground plane can be challenging. (See Figures III.58 and III.59.) Particular care needs to be taken to ensure the continued integrity of cemetery grave markers and stones and vegetation. Maneuvering mowers too closely to these features can cause damage. Additionally, extra care needs to be taken to ensure the safety of maintenance employees when mowing steep slopes.

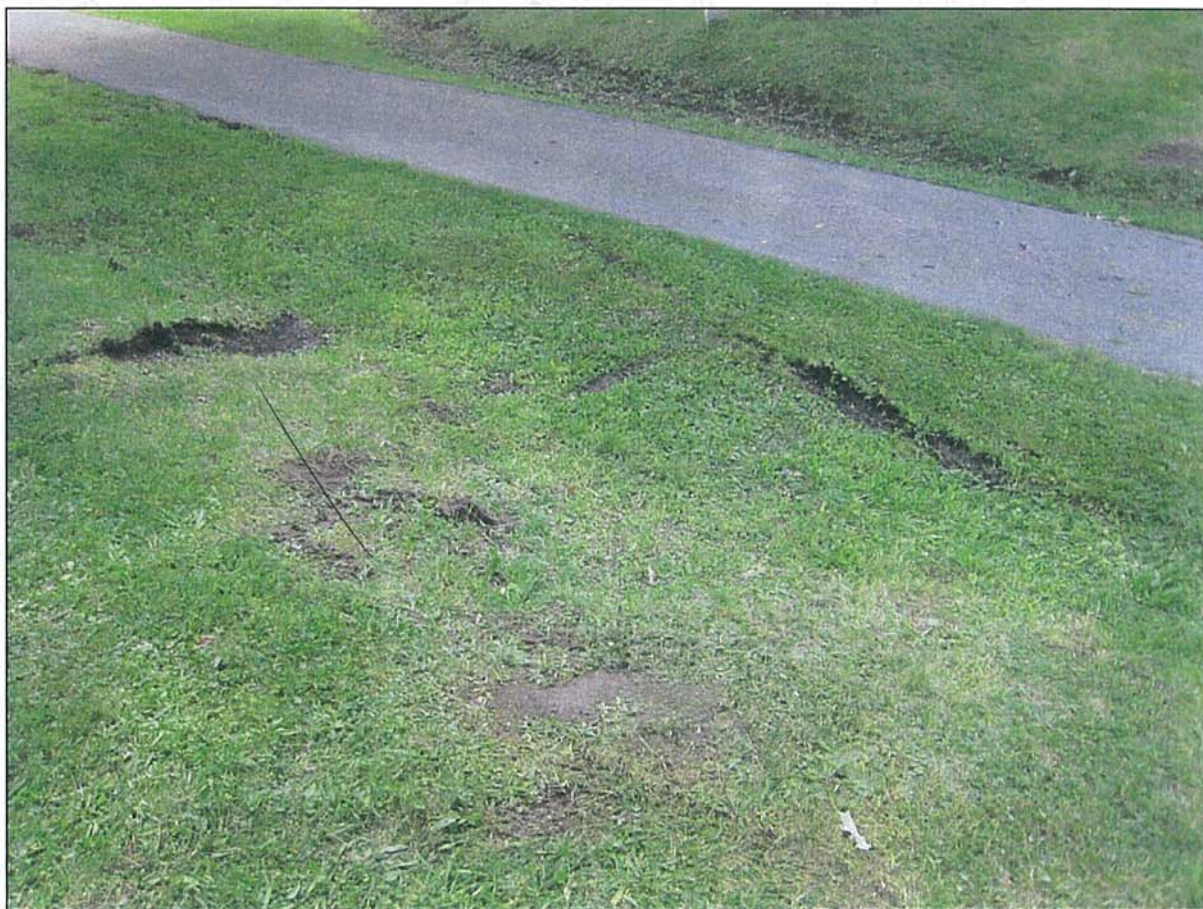
Figure III.59. Particular care needs to be taken to ensure the continued integrity of cemetery grave markers, stones, and vegetation. Courtesy Heritage Landscapes. (R-MTH_20080812_4523-mower damage.jpg)

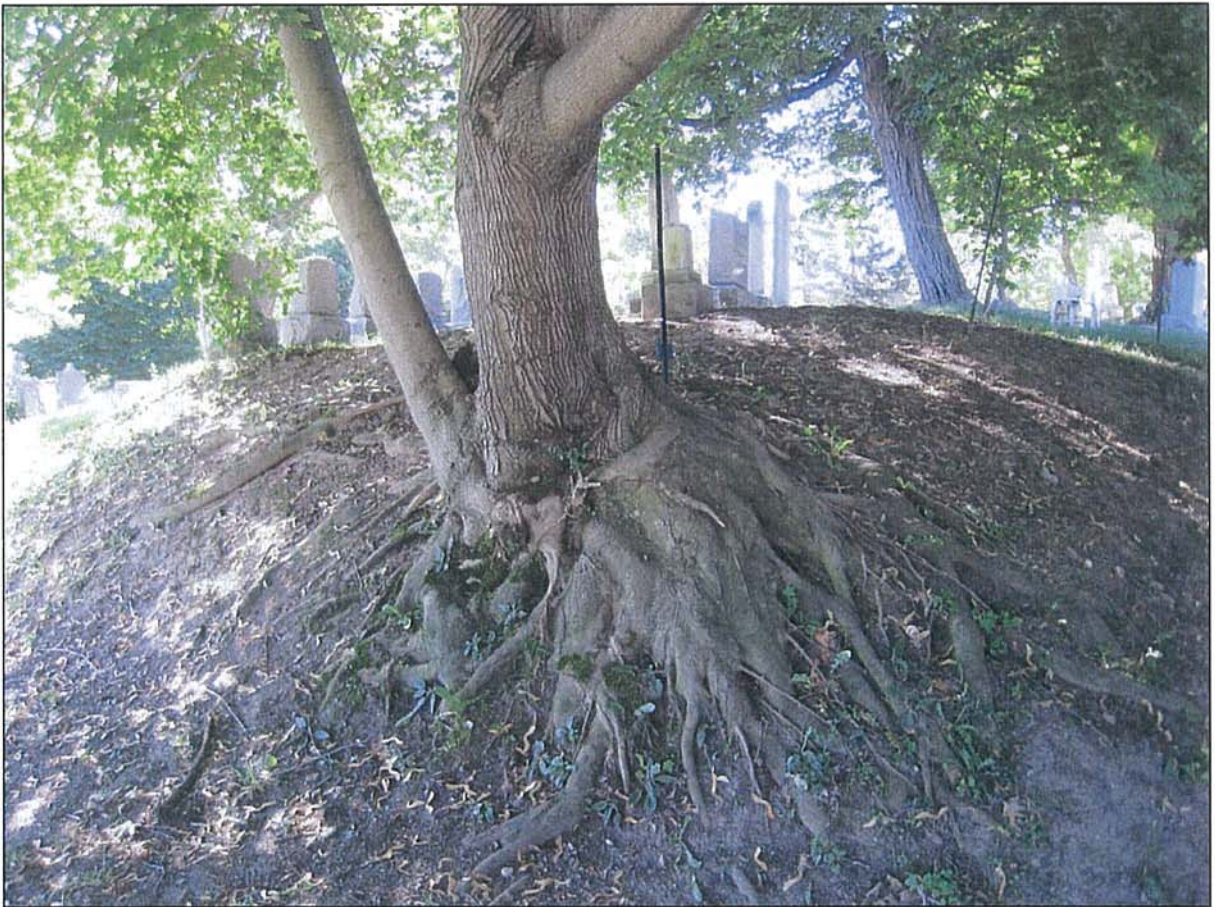
Because of the steep topography, erosion and stormwater management are important existing interrelated issues. Erosion is evident in several locations in Mount Hope Cemetery, most prominently on steep hillsides. A combination of stormwater running down the slopes and site visitors taking shortcuts on short, open hillsides has caused the ground plane to erode in certain areas. In some instances, this is affecting site vegetation. (See Figure III.60.) Management of stormwater and surface runoff also needs to be addressed. Currently, the overland flow of surface runoff down the steeply sloping ground plane contributes to erosion issues. Additionally, stormwater flows along historic circulation features, impacting the extant paving materials. Instances of standing water were also observed during field work sessions. (See Figure III.45.) In order to maintain the unique character and distinct topographic features of Mount Hope Cemetery into the future, appropriate erosion and stormwater control measures need to be implemented.

Figure III.60. A combination of stormwater running down the slopes and site visitors taking shortcuts on short, open hillsides has caused the ground plane to erode in certain areas at Mount Hope Cemetery. In some instances, as in this image, erosion is affecting site vegetation. Courtesy Heritage Landscapes. (R-MTH-15Jul08-0038-erosion.jpg)

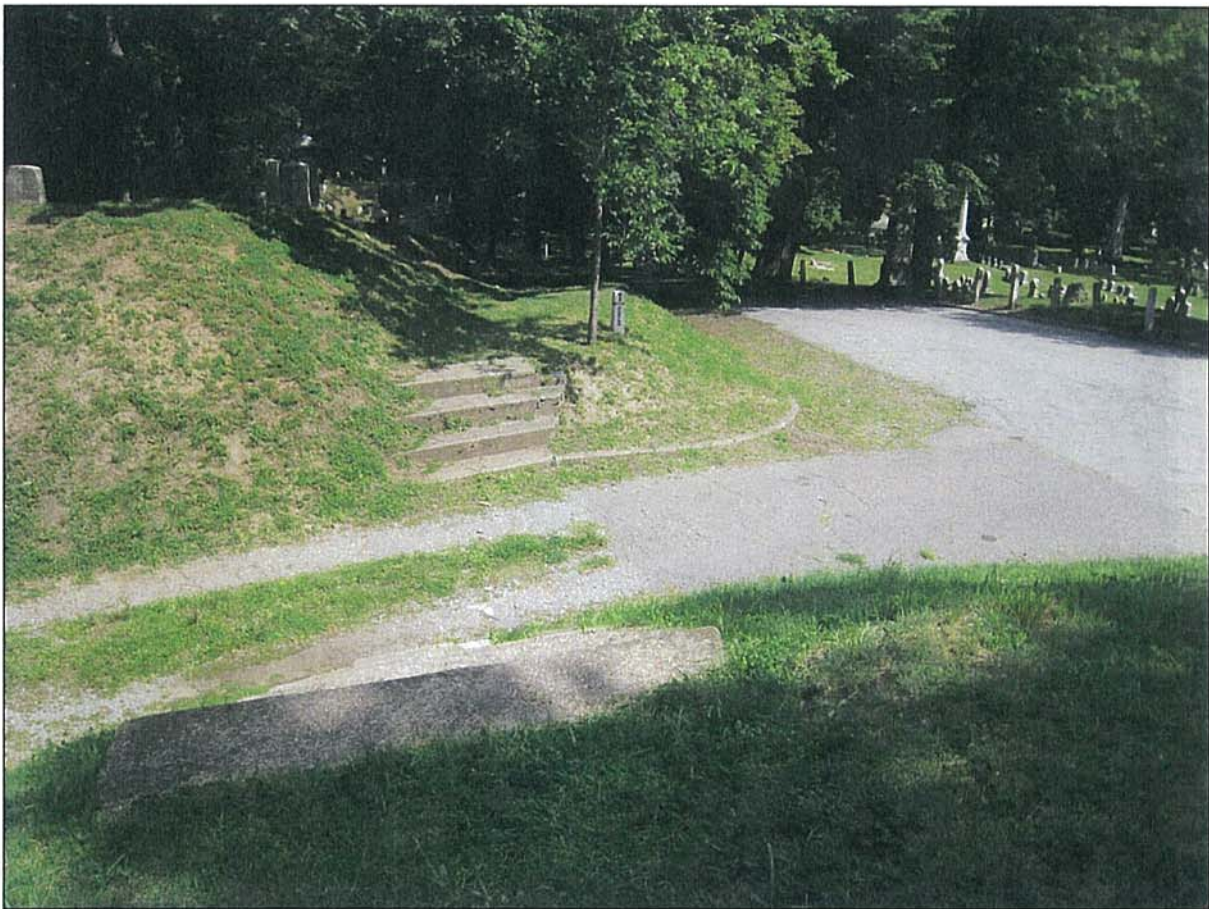
Figure III.61. Because of the steep terrain, steps are important to visitor use and circulation through the cemetery grounds. Safe use of the steps can be improved by lifting and resetting the treads to create a level walking surface. Courtesy Heritage Landscapes. (R-MTH_20080813_4712-steps.jpg)

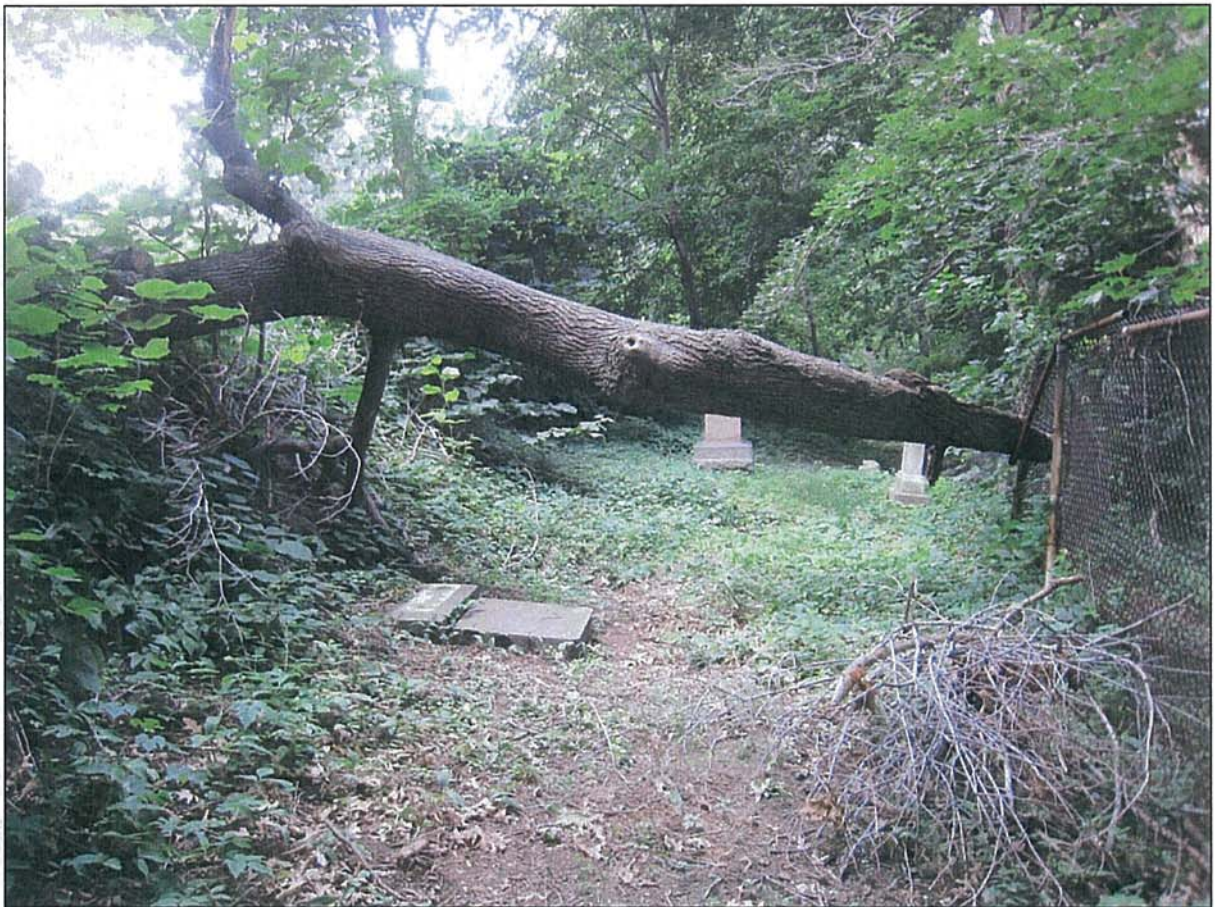
Figure III.62. Trees that are either standing dead or have dead branches in the canopy pose an issue with regard to the safety of users, particularly when declining trees are located near the walking paths. In this image, deadfall blocks a circulation path. Courtesy Heritage Landscapes. (R-MTH_20080812_4513-Unit3-west edge-deadfall.jpg)

Also related to user safety is tree management and path maintenance. Given the extensive visitor use of the entire cemetery landscape, both along defined paths and across burial sections, understanding the condition of trees in the cemetery is important. Trees that are either standing dead or have dead branches in the canopy pose an issue with regard to the safety of users. At least one instance was observed of deadfall blocking a circulation path. (See Figure III.62.) Additionally, leaf litter is deposited on the ground plane, paths, and drives as stormwater drains over them. This can result in slippery and uneven walking surfaces. Pruning of trees near popular use areas can enhance the character and safety of the Mount Hope Cemetery landscape.
