Environmental Management Plan

Center City Courtyard
(Former Rotary Site)

CSD Housing, LLC
642 Kreag Road, Suite 301
Pittsford, NY 14534

LaBella Project No. 2221127

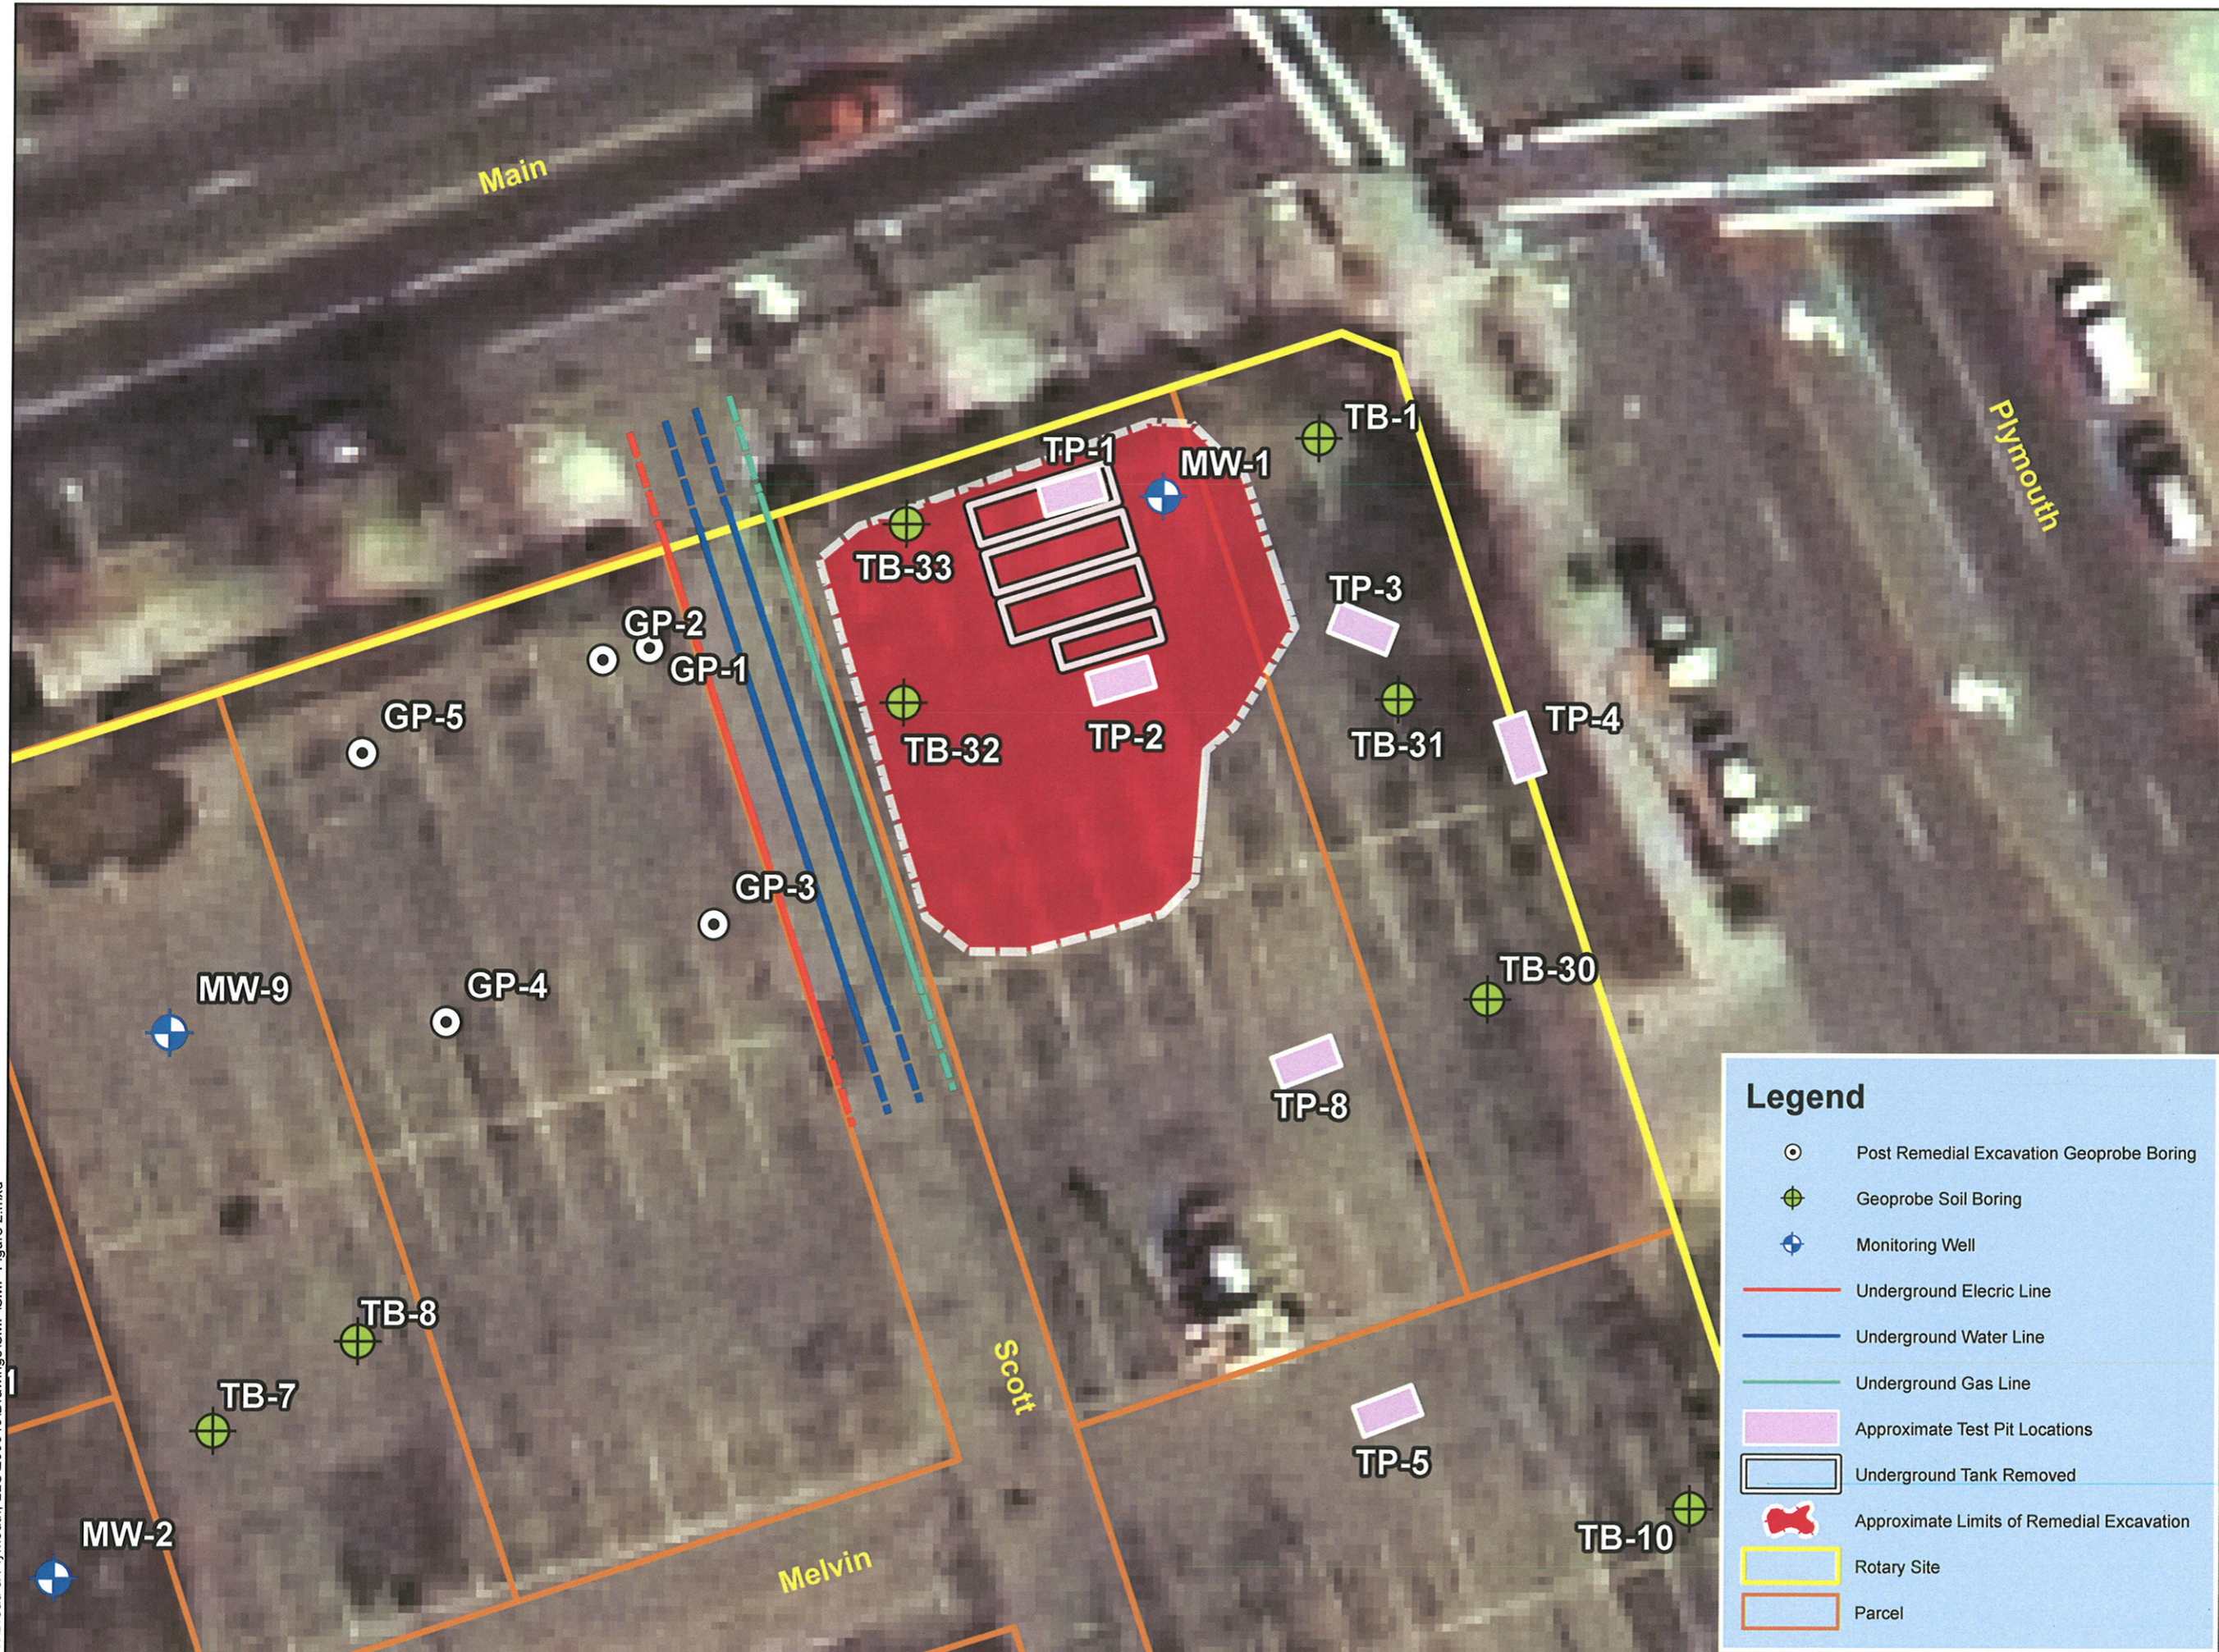
[FIGURE 2]

- Post Remedial Excavation Geoprobe Boring
- ⊕ Geoprobe Soil Boring
- ⊕ Monitoring Well
- Underground Electric Line
- Underground Water Line
- Underground Gas Line
- Approximate Test Pit Locations
- Underground Tank Removed
- ⊕ Approximate Limits of Remedial Excavation
- Rotary Site
- Parcel
