Phase I Environmental Site Assessment

195 Smith Street
Rochester, New York

LaBella Project No. 209056

January 2009

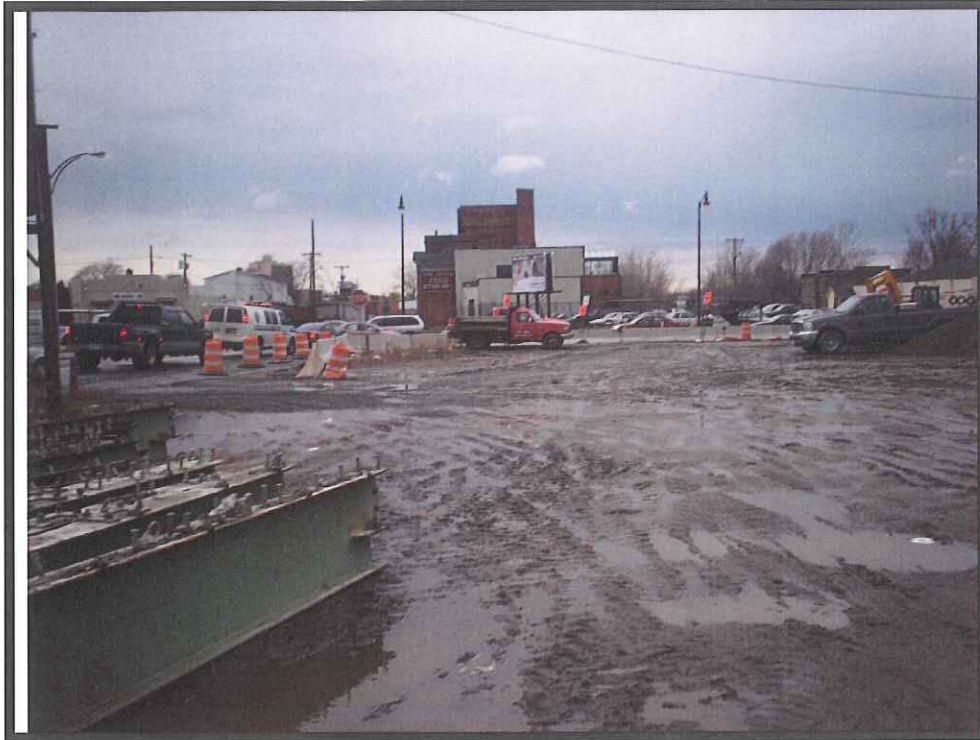
View of the Site looking north.

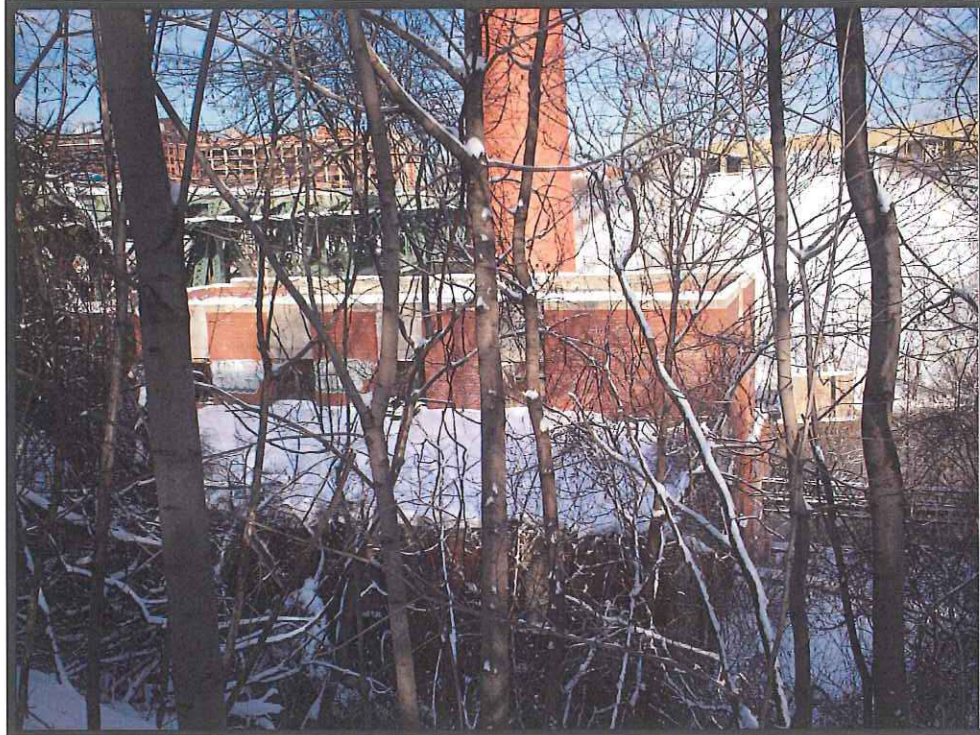
View of the former City of Rochester Incinerator/Garbage Reduction Plant located adjacent to the east of the Site.

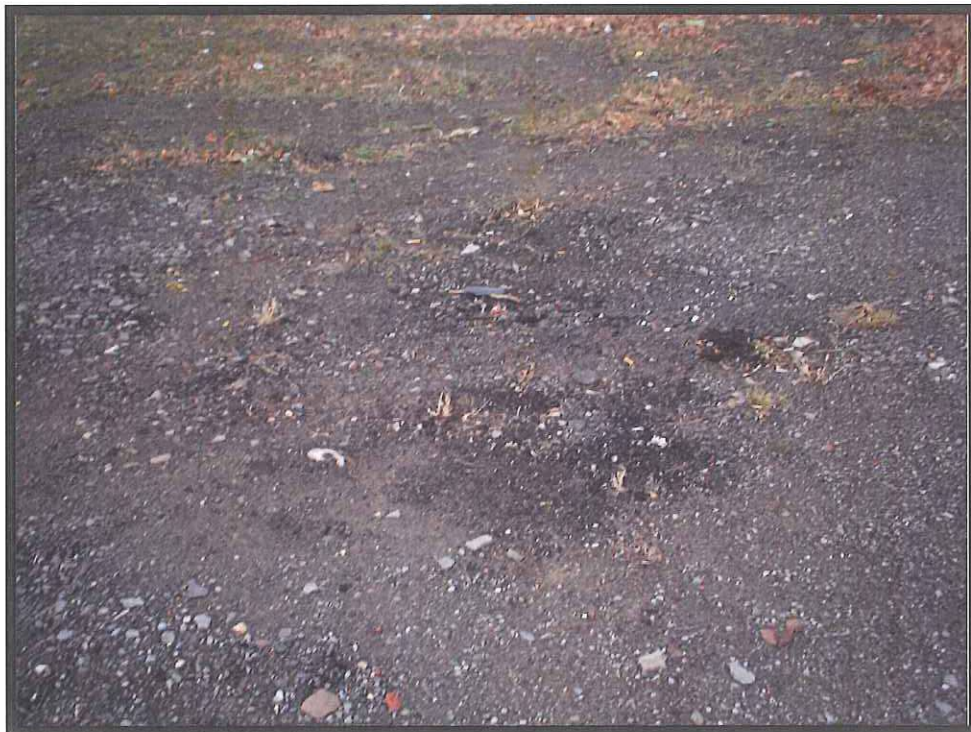
View of surface soil at the Site containing cinders and scrap metal as well as brick, concrete, and coal fragments.

- 2) As detailed in Sections 6.2.8, 6.2.9, and 6.2.10, stained soil, stressed vegetation, and solid waste were observed at the Site during the December 21, 2008 site visit. The stained soil appeared to be due to the high content of solid waste mixed in with the soil including cinders, coal fragments and dust, concrete, brick and scrap metal. The presence of stress vegetation observed appears to be due to the fill material incorporated into the soil as well as the lack of adequate topsoil at the Site. At the time of the site visit, a partially buried railroad track was observed in the soil at the Site. The presence of this remaining track could also indicate the presence or creosote treated historic railroad ties in the subsurface at the Site.

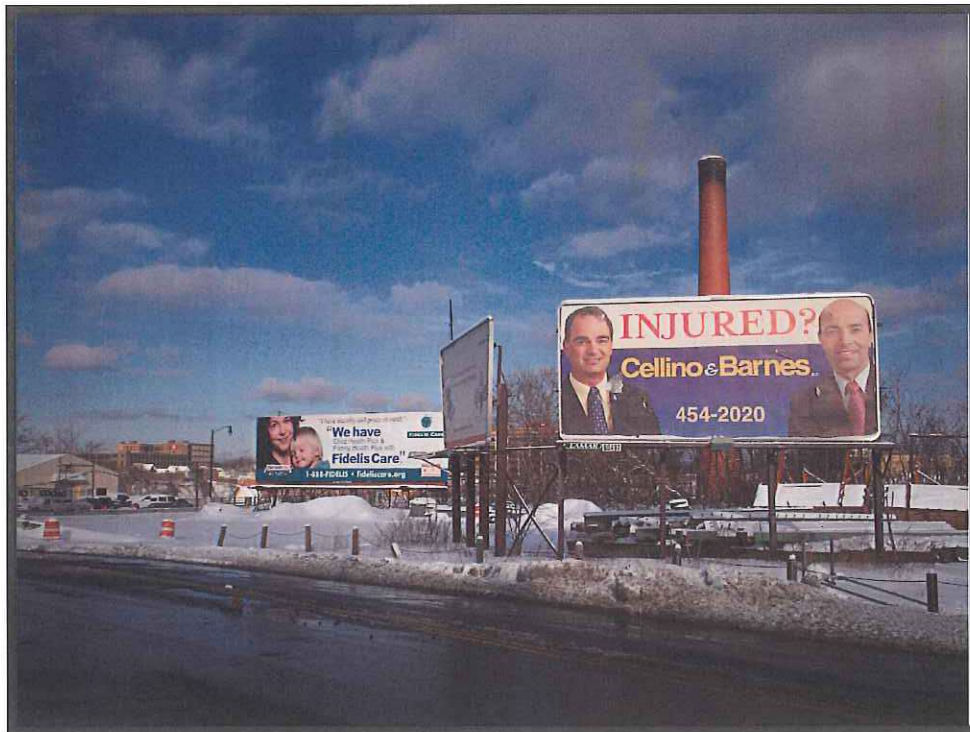
View of commercial billboards in the northern portion of the Site. The northern portion of the Site is also being temporarily used to stage construction materials for the reconstruction of the Smith Street bridge project.

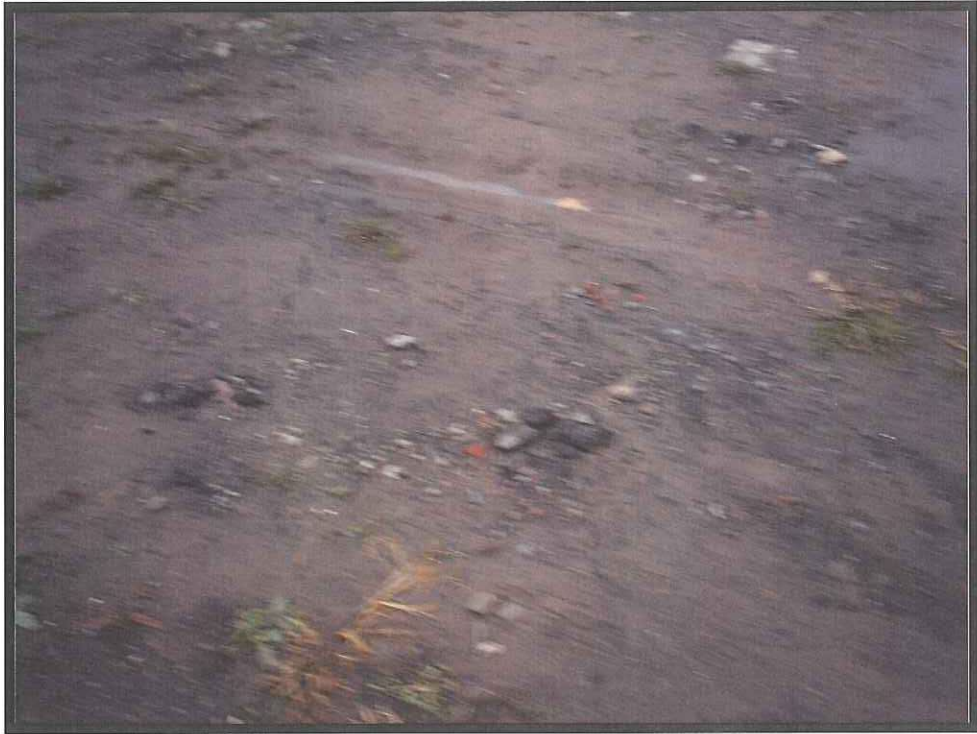
View of a partially buried railroad track at the Site.

It appears that a railroad yard may have been formerly located at and adjacent to the Site. The City of Rochester DEQ and Phoenix Graphics should be aware that railroad ties are commonly treated with chemicals, such as creosote, to prevent the wood from decaying. In addition, railroad ballast often contain elevated levels of heavy metals. These chemicals have been known impact soil and groundwater. There is no readily available information indicating that the railroad tracks adjacent to the Site have impacted the soil and groundwater at the Site.

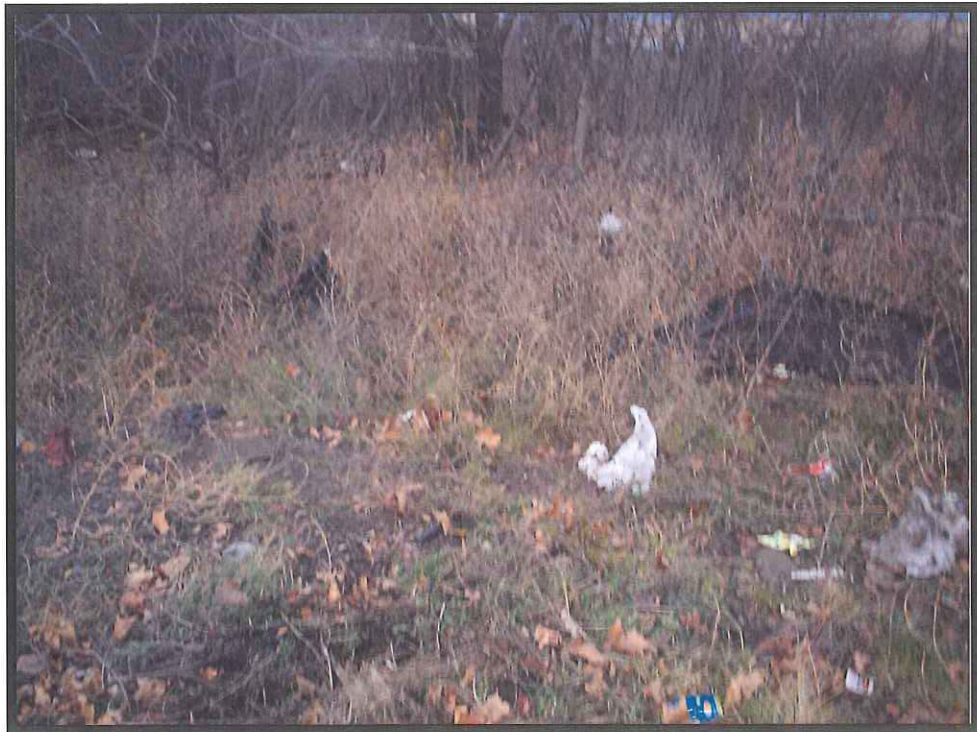
**View of wind blown trash, and construction and demolition debris
(waste asphalt and concrete) at the Site.**

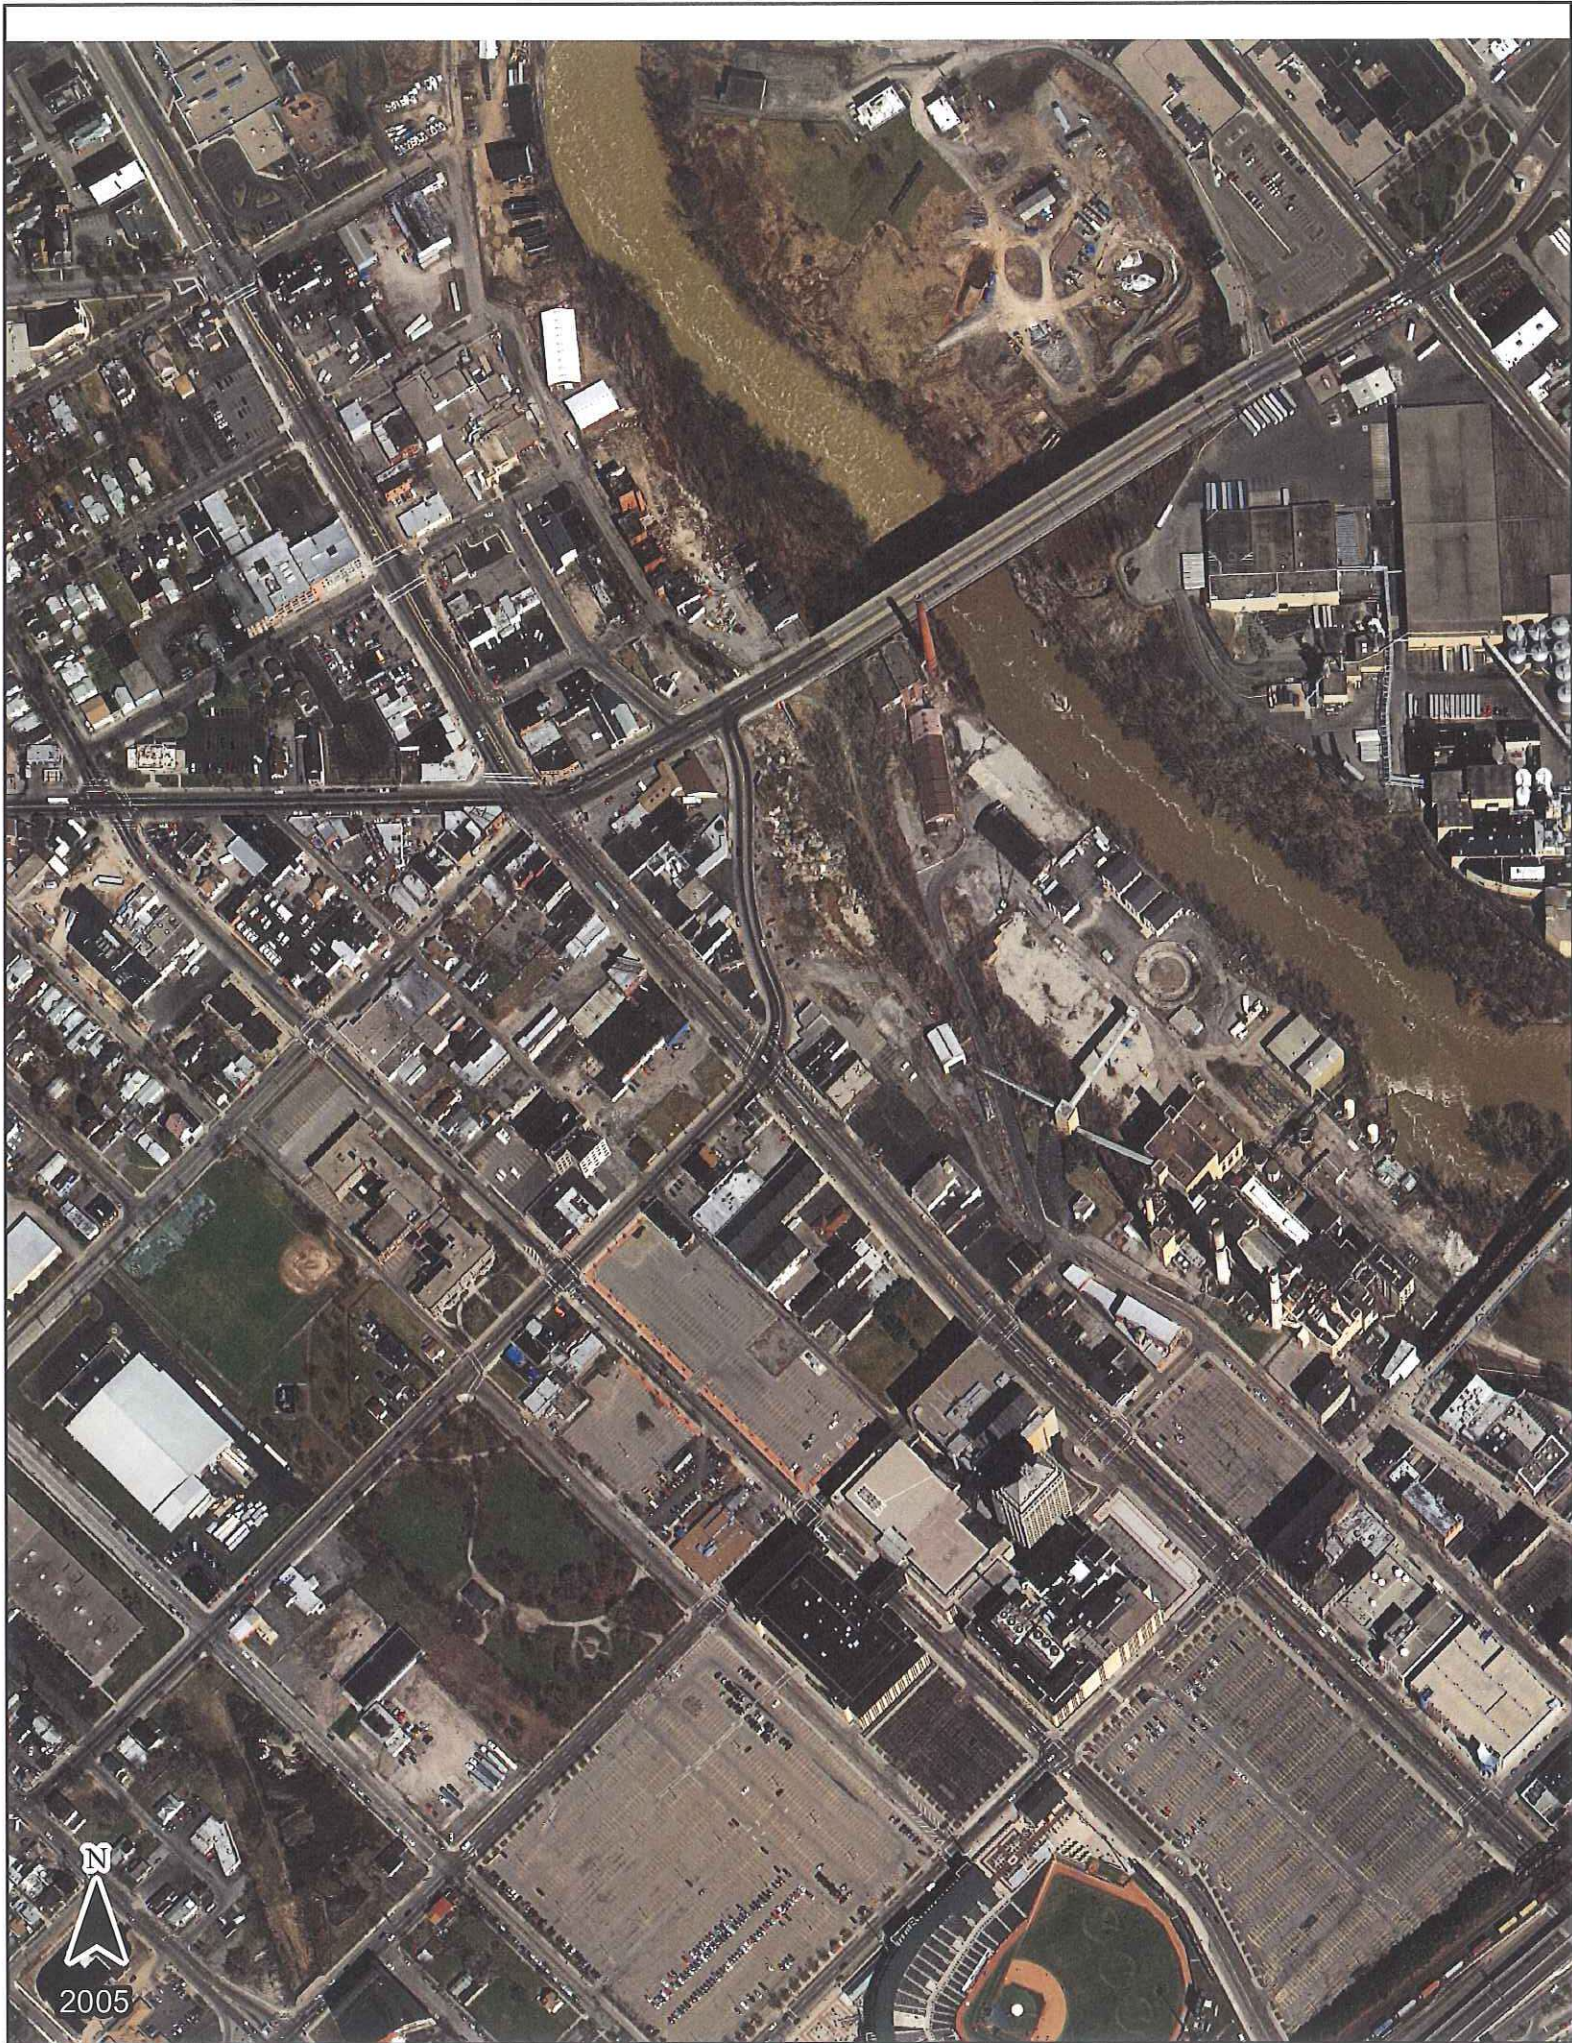
1999 and 2005	The Site appears to be vacant and undeveloped with no structures or railroad tracks visible. C&D debris appears to be staged on-site in the 2005 aerial photograph. No other significant changes were noted relative to the 1996 aerial photograph.
