Phase II Environmental Site Assessment
Preliminary Geotechnical Evaluation with
Environmental Confirmation Sampling

196 Smith Street
Rochester, New York

LaBella Project No. 209126

March 2009

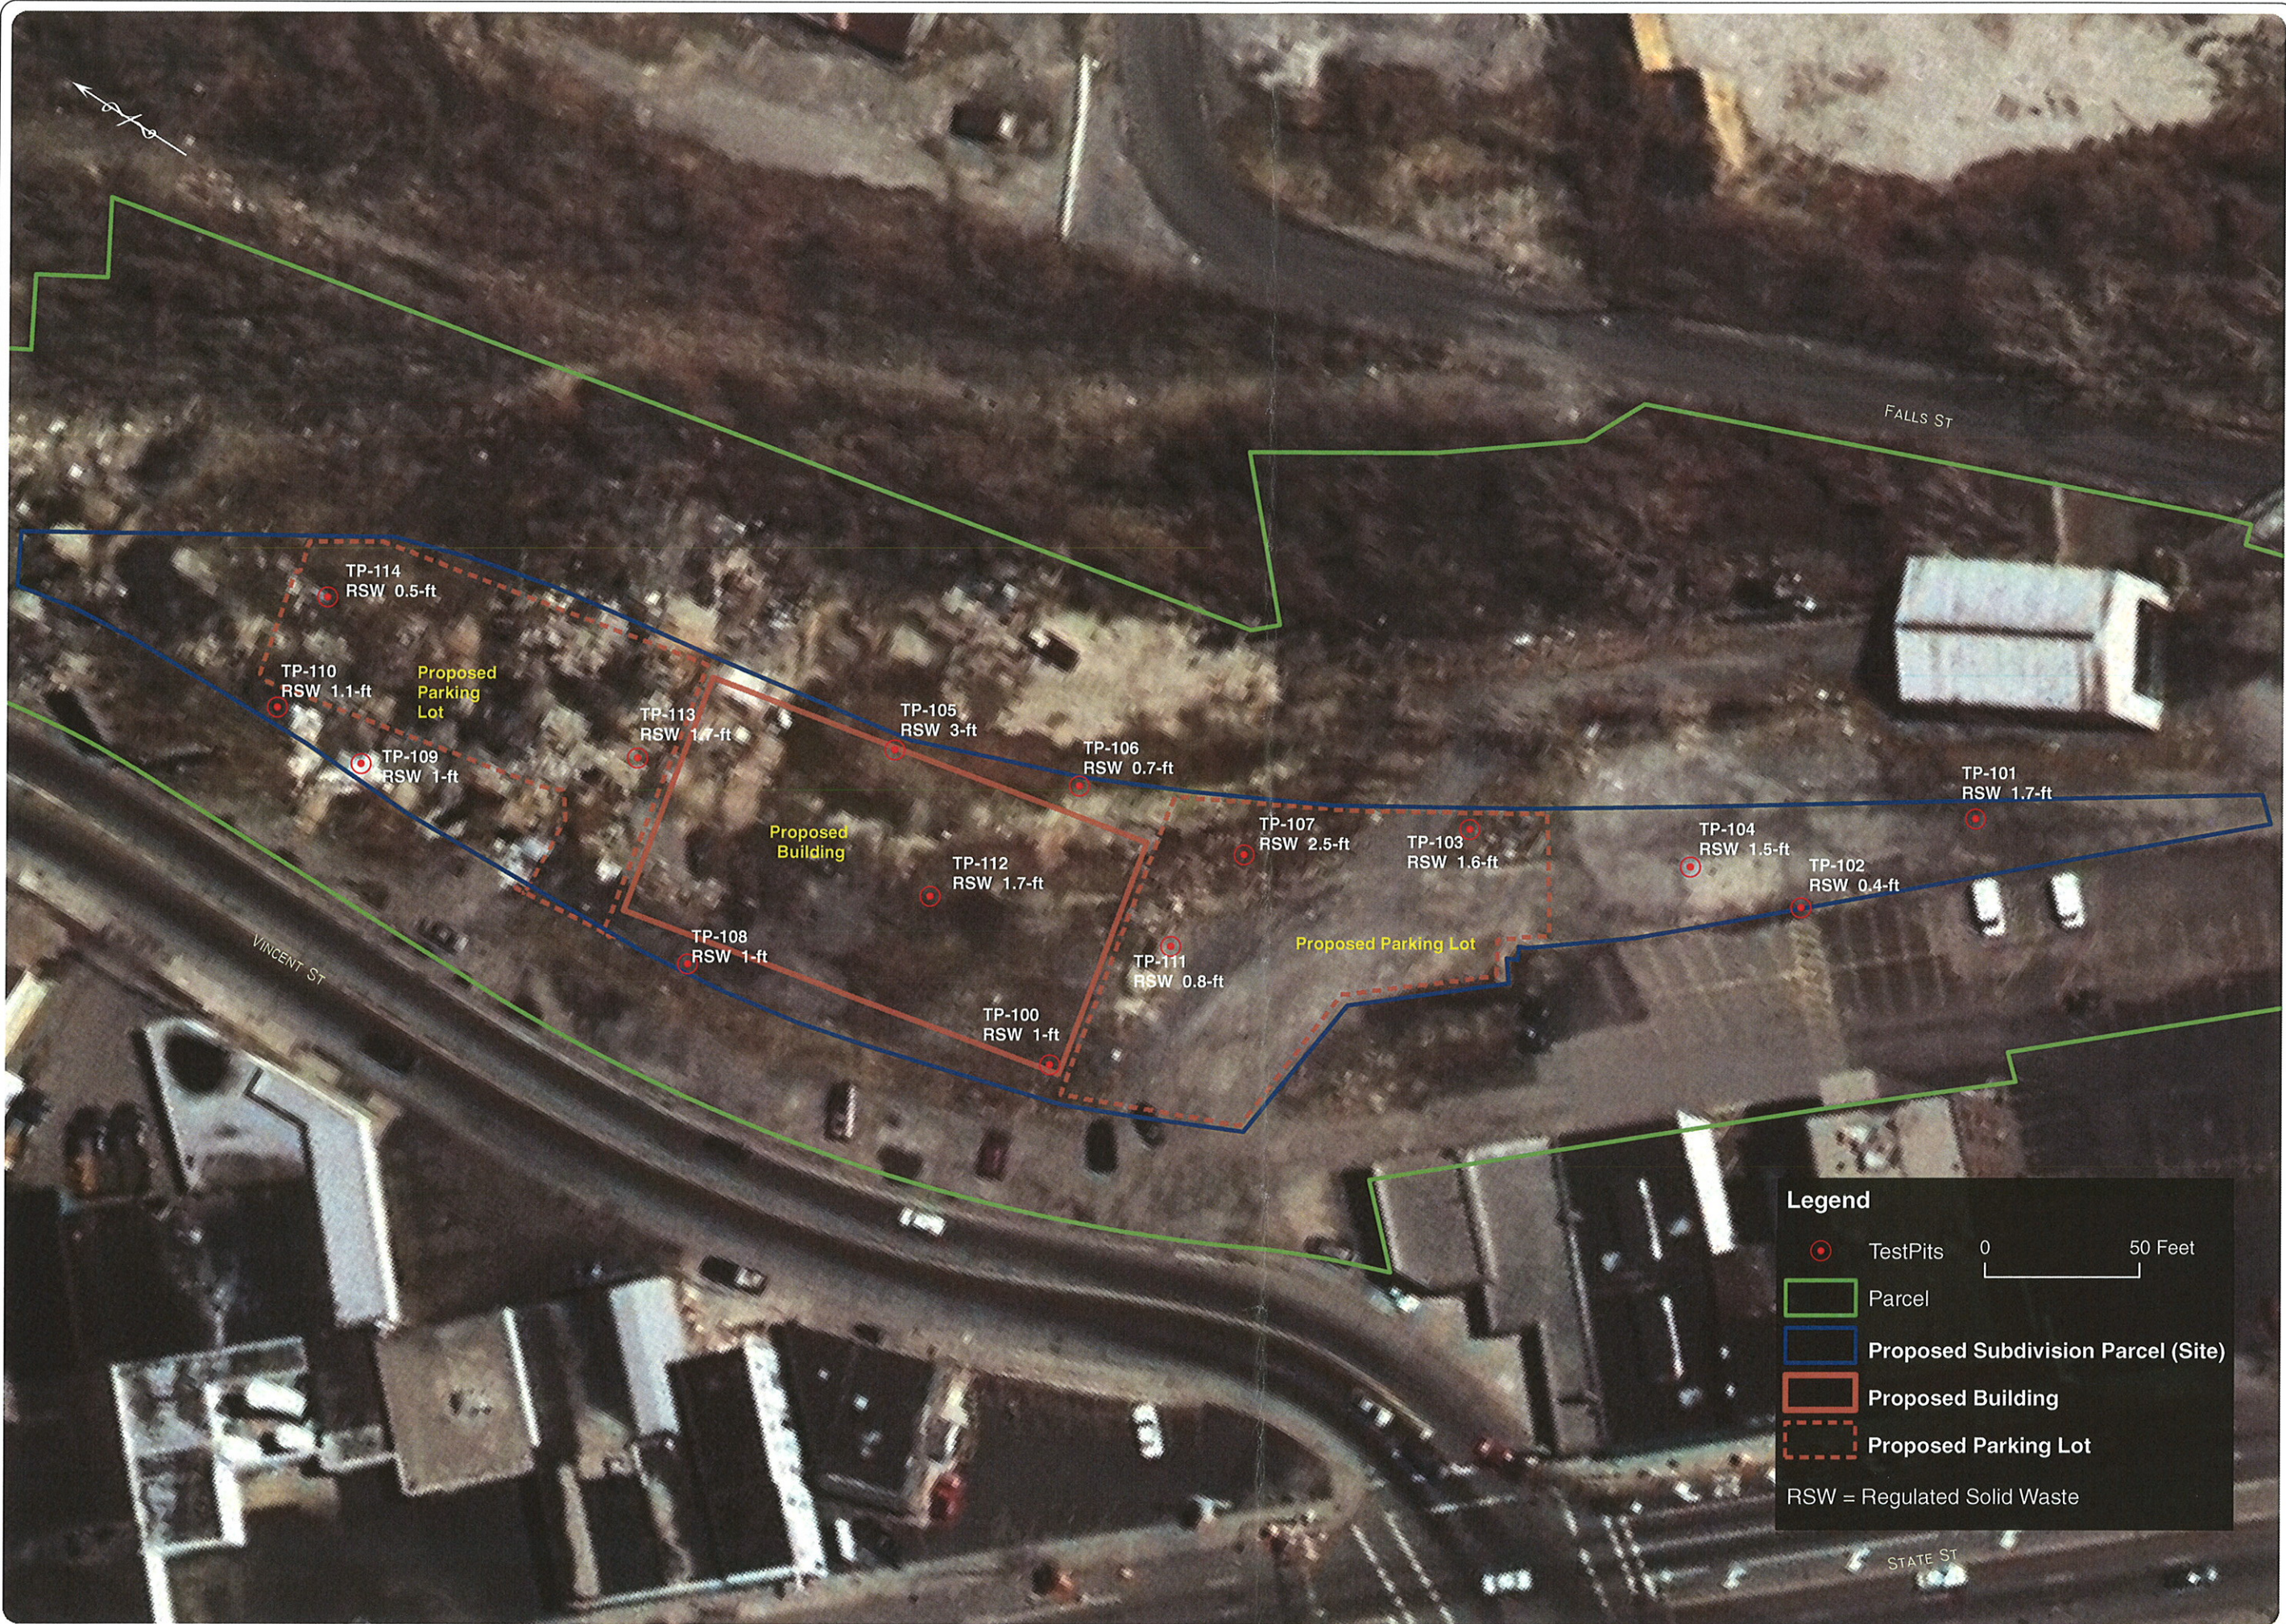
PROJECT/DRAWING NUMBER
 [209126]
[FIGURE 5]

Y:\Rochester_City\209126\Drawings\GIS\Fig 5 SlagContours.mxd - 4/23/2009 @ 3:14:18 PM

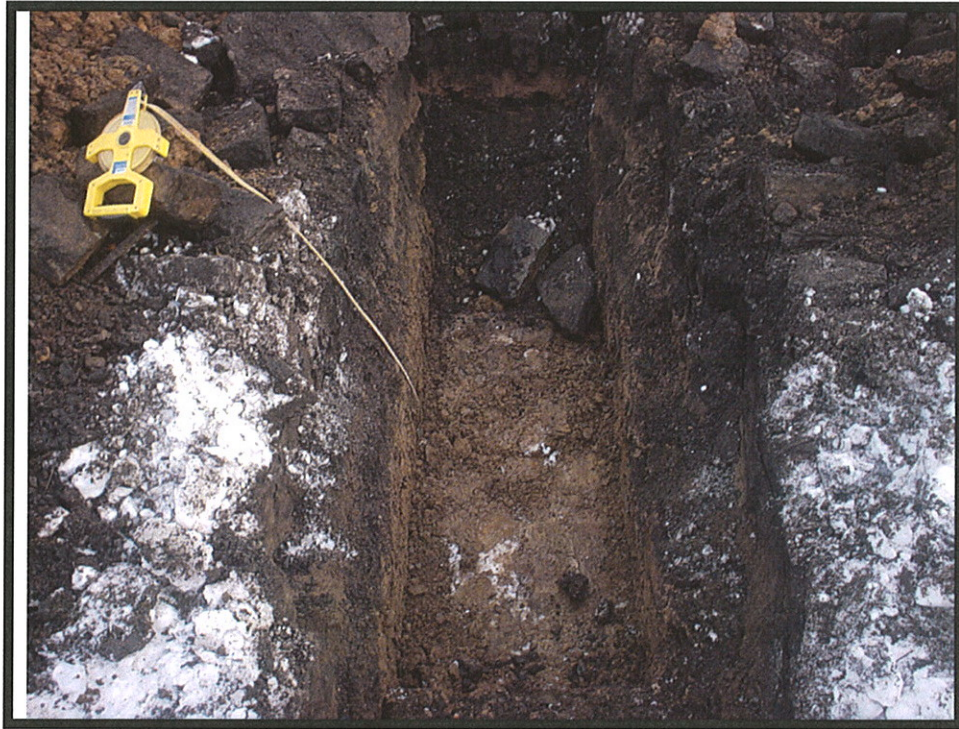
TP-102 was excavated on the southern portion of the Site north of TP-101, in order to evaluate the historic railroad operations that were identified on Sanborn maps for this area. No evidence of impairment was observed in TP-102. Fill materials were encountered in TP-102 from approximately 1.8' bgs to 2.2' bgs. Groundwater was not encountered within this test pit. Bedrock was encountered at approximately 2.7' bgs.

View of the TP-102 showing top of bedrock

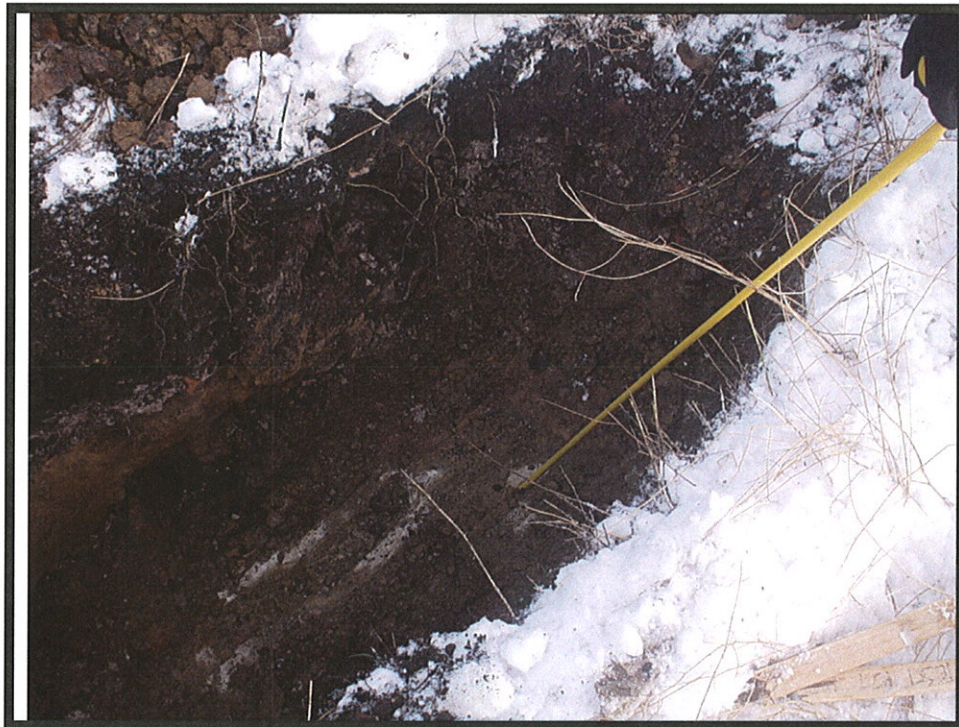
TP-103 was excavated on the southeastern portion of the Site within the proposed parking lot in order to evaluate the historic railroad operations that were identified on Sanborn maps for this area. No evidence of impairment was observed in TP-103. Fill materials were encountered in TP-103 from approximately 0.0' bgs to 1.6' bgs. Groundwater was not encountered within this test pit. Bedrock was encountered at approximately 3.3' bgs.

View of the TP-103 showing excavator scrapes on top of bedrock

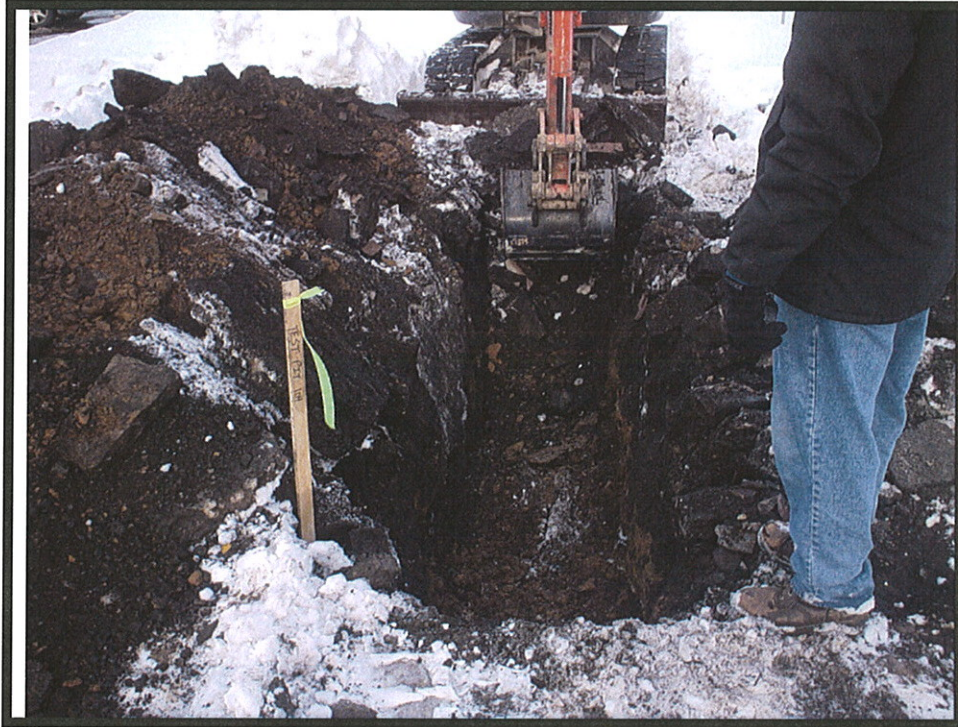
TP-104 was excavated on the southern portion of the Site, in order to evaluate general subsurface conditions on-site. No evidence of impairment was observed in TP-104. Fill materials were encountered in TP-104 from approximately 0.4' bgs to 1.9' bgs. Groundwater was not encountered within this test pit. Bedrock was encountered at approximately 3.0' bgs.

View of the TP-104 showing light brown native soil and weathered bedrock

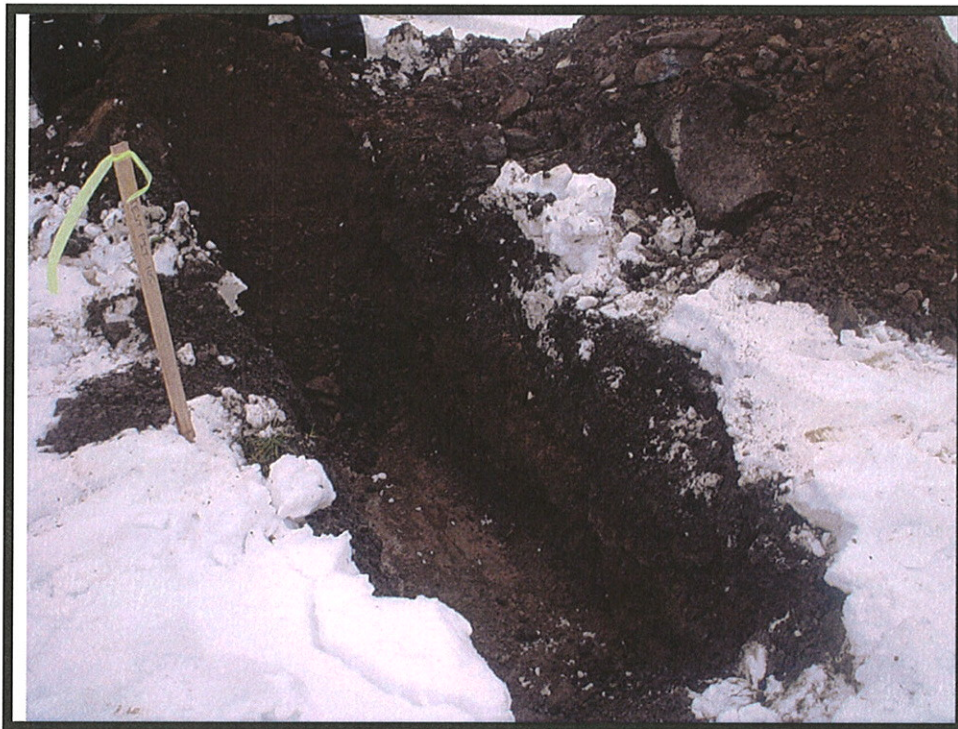
View of the TP-105

TP-105 was excavated on the eastern portion of the Site in the proposed building footprint, in order to evaluate general subsurface conditions on-site. No evidence of impairment was observed in TP-105. Fill materials were encountered in TP-105 from approximately 0.0' bgs to 3.0' bgs. Groundwater was not encountered within this test pit. Bedrock was encountered at approximately 3.0' bgs.

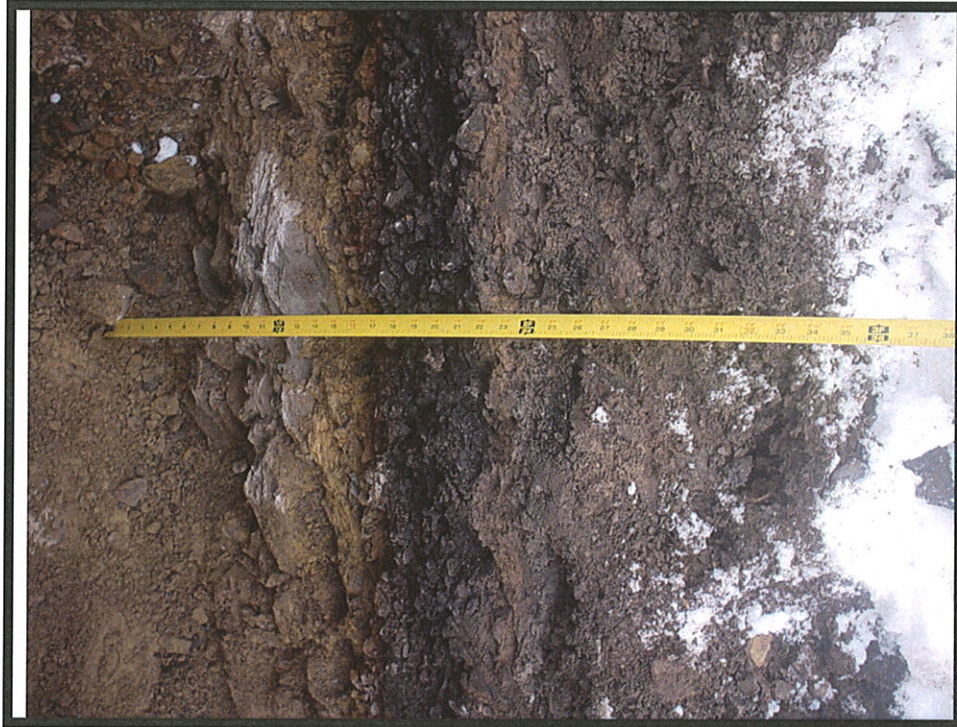
TP-108 was excavated on the northwestern portion of the Site near Vincent Street slightly west of the proposed building footprint in order to evaluate the historic railroad operations that were identified on Sanborn maps for this area. No evidence of impairment was observed in TP-108. Fill materials were encountered in TP-108 from approximately 0.0' bgs to 1.0' bgs. Groundwater was not encountered within this test pit. Bedrock was encountered at approximately 4.0' bgs.

View of the TP-108 showing depth to and thickness of fill materials layer

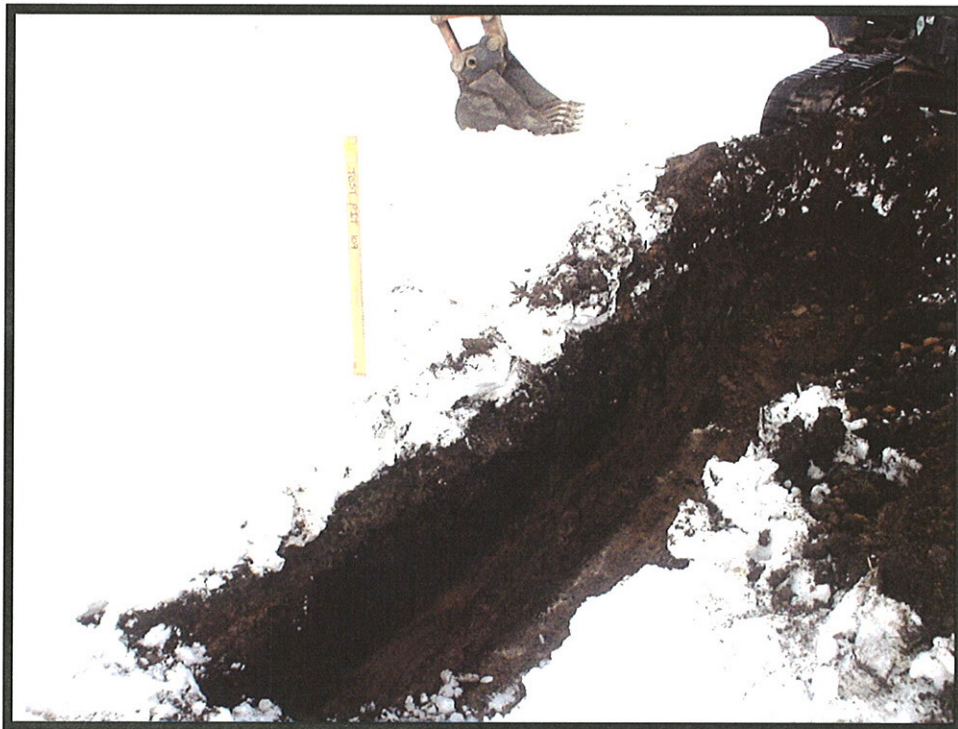
TP-109 was excavated on the northwestern portion of the Site near Vincent Street slightly west of the proposed parking lot, in order to evaluate the historic railroad operations that were identified on Sanborn maps for this area. No evidence of impairment was observed in TP-109. Fill materials were encountered in TP-109 from approximately 0.7' bgs to 1.7' bgs. Groundwater was not encountered within this test pit. Bedrock was encountered at approximately 3.2' bgs.

View of the TP-109 showing fill materials layer and native soil layer

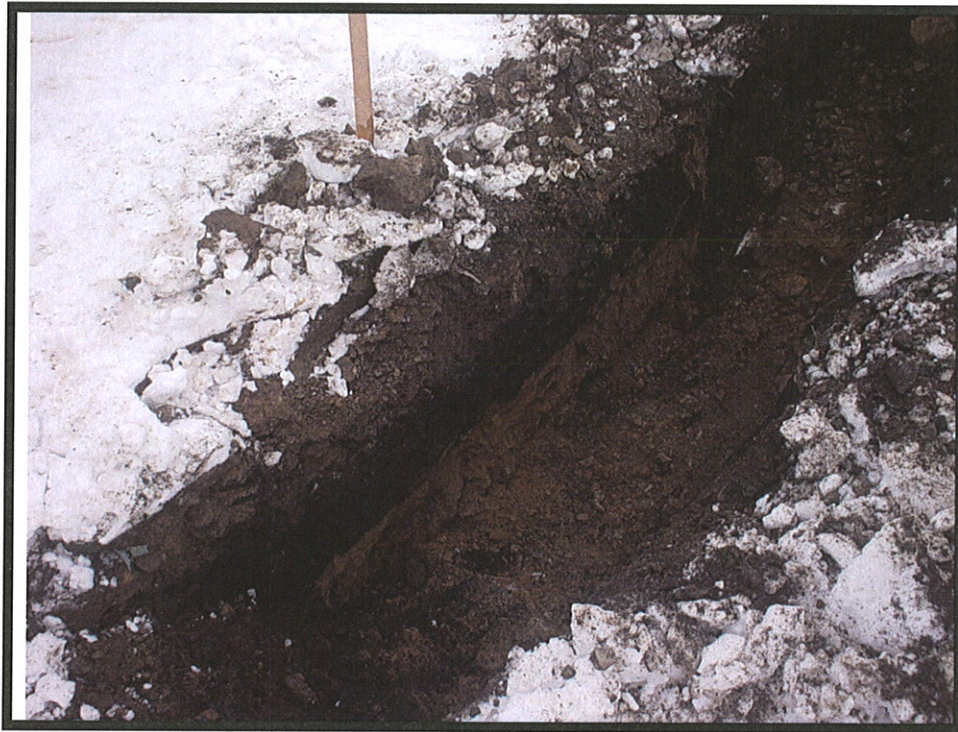
TP-110 was excavated on the northwestern portion of the Site near Vincent Street slightly north of TP-109 and west of the proposed parking lot, in order to evaluate the historic railroad operations that were identified on Sanborn maps for this area. No evidence of impairment was observed in TP-110. Fill materials were encountered in TP-110 from approximately 0.6' bgs to 1.7' bgs. Groundwater was not encountered within this test pit. Bedrock was encountered at approximately 2.9' bgs.

View of the TP-110 featuring shallow depth to top of bedrock

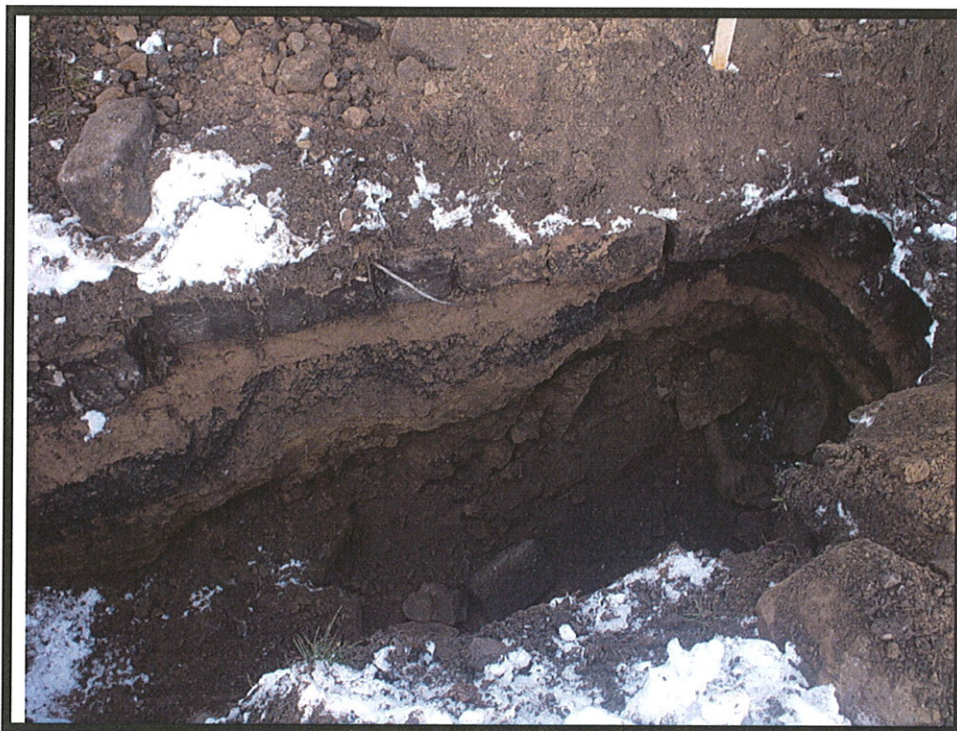
TP-111 was excavated on the central portion of the Site within the proposed parking lot, in order to evaluate general subsurface conditions on-site. No evidence of impairment was observed in TP-111. Fill materials were encountered in TP-111 from approximately 2.0' bgs to 2.8' bgs. Groundwater was not encountered within this test pit. Bedrock was encountered at approximately 6.0' bgs.

View of the TP-111 featuring pavers of former roadway underlain by coarse sand, fill materials layer, and native soil

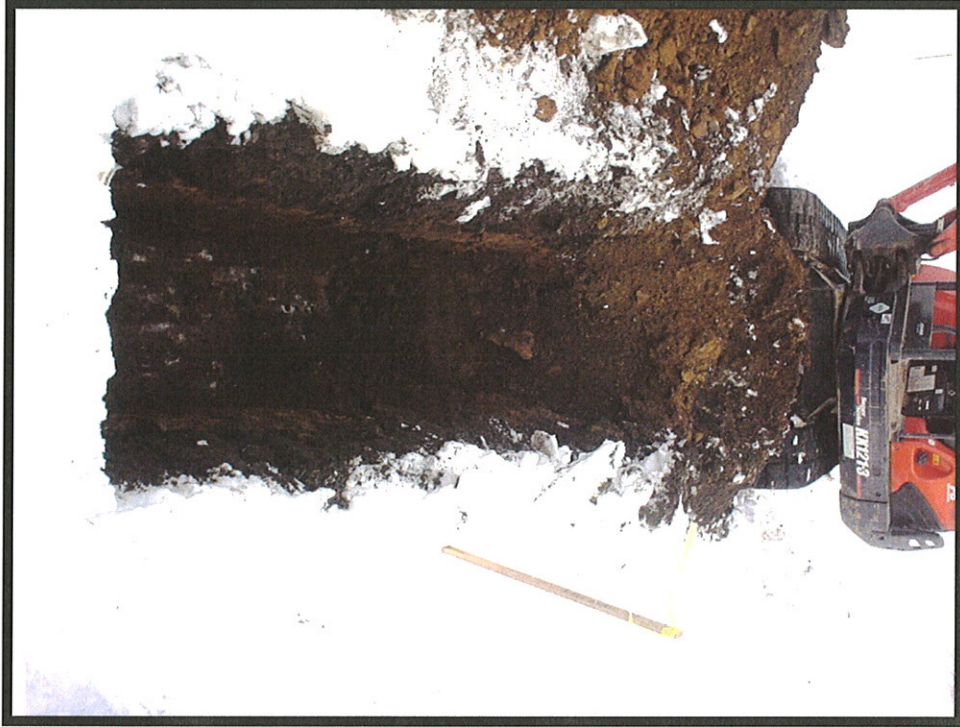
TP-112 was excavated on the central portion of the Site within the proposed building footprint, in order to evaluate general subsurface conditions on-site. No evidence of impairment was observed in TP-112. Fill materials were encountered in TP-112 from approximately 0.0' bgs to 1.7' bgs. Groundwater was not encountered within this test pit. Bedrock was encountered at approximately 4.9' bgs.

View of the TP-112 showing top of bedrock

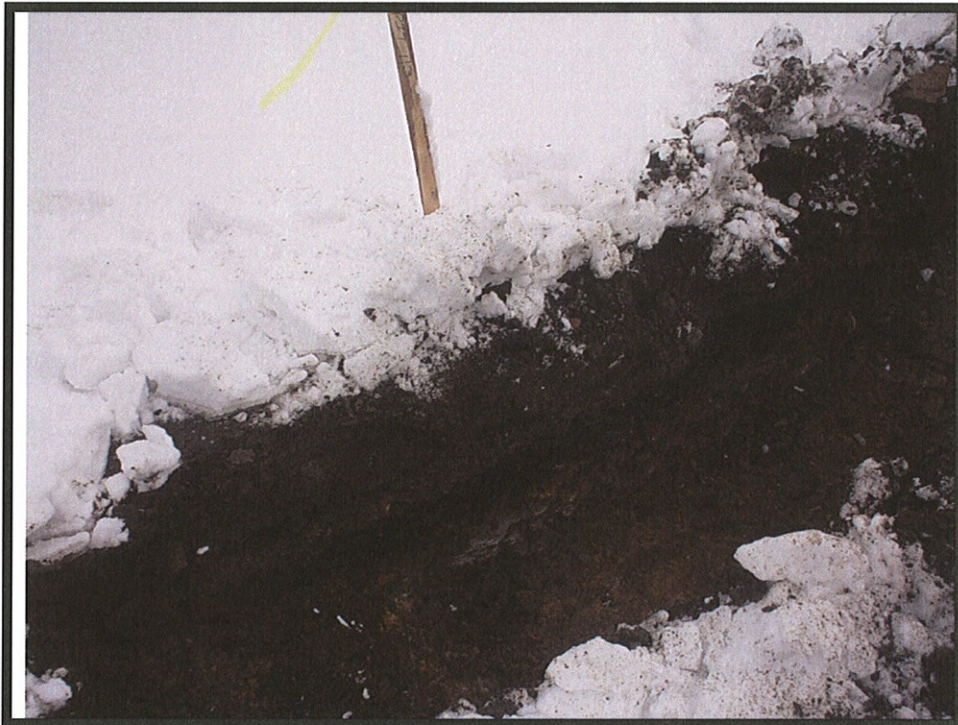
View of the TP-113

TP-113 was excavated on the central portion of the Site within the proposed parking lot, in order to evaluate general subsurface conditions on-site. No evidence of impairment was observed in TP-113. Fill materials were encountered in TP-113 from approximately 0.0' bgs to 1.7' bgs. Groundwater was not encountered within this test pit. Bedrock was encountered at approximately 3.0' bgs.
