**Re: Rochester Steel Treating Works (C828210)
962, 966, and 972-974 East Main St., Rochester, Monroe County
Remedial Investigation/Remedial Alternative Analysis Work Plan, December 2018**

**REMEDIAL INVESTIGATION/REMEDIAL ALTERNATIVES ANALYSIS
WORK PLAN
962, 966,972-974 EAST MAIN STREET
ROCHESTER, NEW YORK
NYSDEC SITE NUMBER: 828210**

Prepared by: Day Environmental, Inc.
1563 Lyell Avenue
Rochester, New York

Project No. 5491R-18

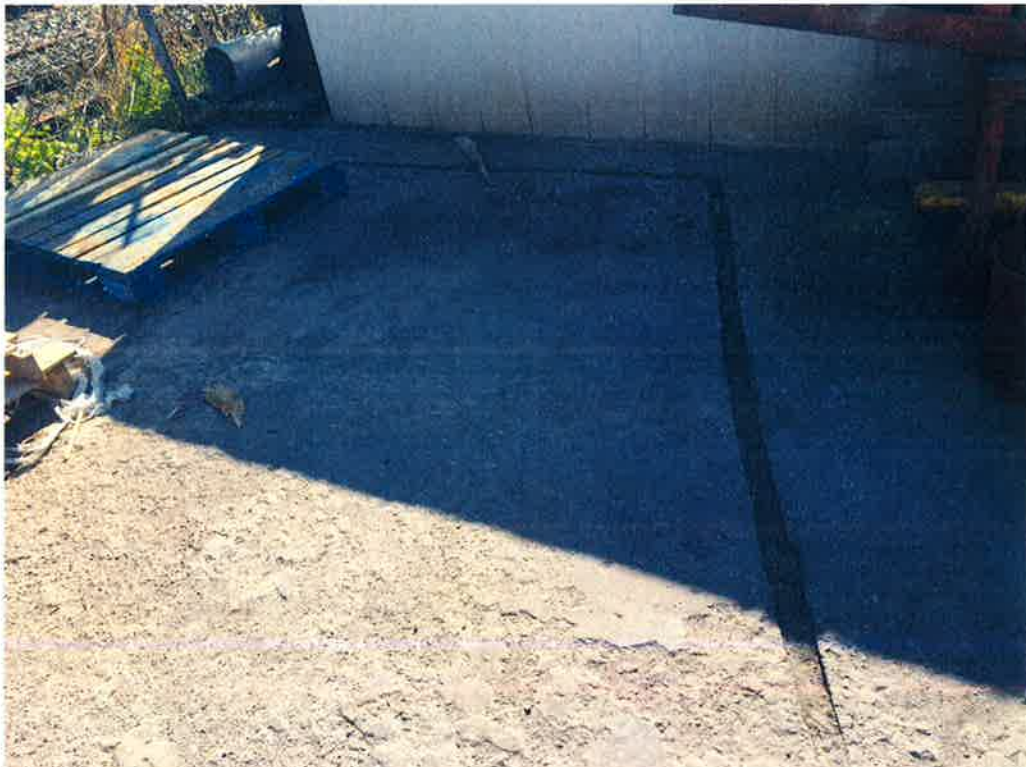
View of a cut in the concrete on the northern exterior portion of the assessed property used for drainage to the adjoining property to the east (i.e., railroad), looking southeast.

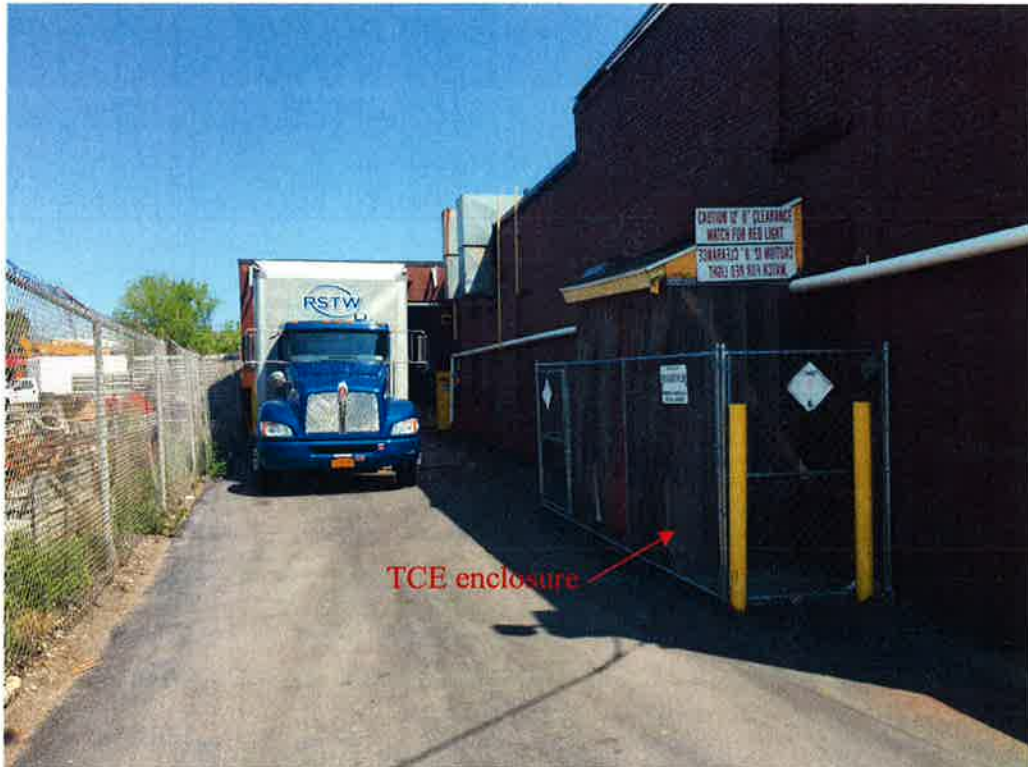
View of the western exterior portion of the assessed property, looking north. Note the enclosure for TCE tanks.

- TCE ASTs that are located on the western exterior of the building on the Site. [Note: At the time of the Phase I ESA (i.e., 2016) two 110-gallon TCE ASTs were located on the western exterior of the Site building. On June 18, 2018, the two 110-gallon TCE ASTs were removed and replaced with one 175-gallon TCE AST.] In addition, a TCE degreaser is located in the southwest interior of the building, and a TCE degreaser was reportedly formerly located east of the current TCE degreaser.
- Hazardous waste, including TCE, that was generated and stored within a 90-Day Storage Area located in the building at the Site.

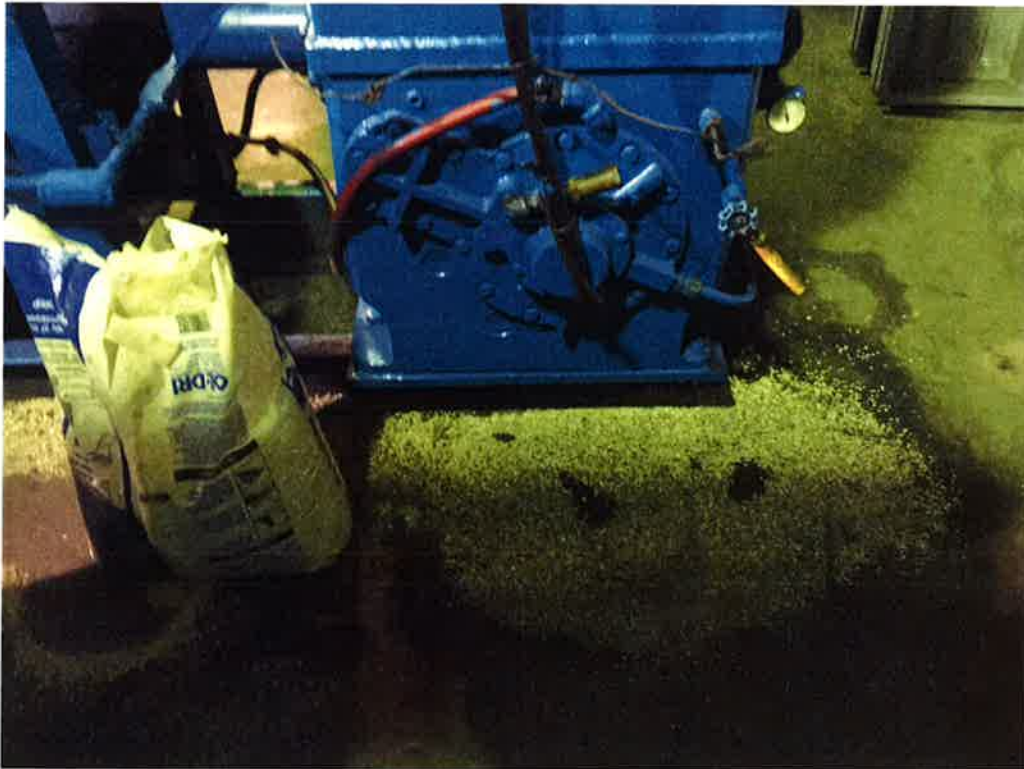
View of spillage of condensed oil and absorbent material located on the concrete floor of the new vacuum room (i.e., on the eastern interior portion of the assessed building).

- Various spills and stains (assumed to be petroleum in nature) that were observed on the concrete floor areas in the locations of the vacuum furnaces in the eastern portion of the building at the Site. The spills were reportedly related to leakage of a pumping system in the vacuum furnace that collects evaporated oil.

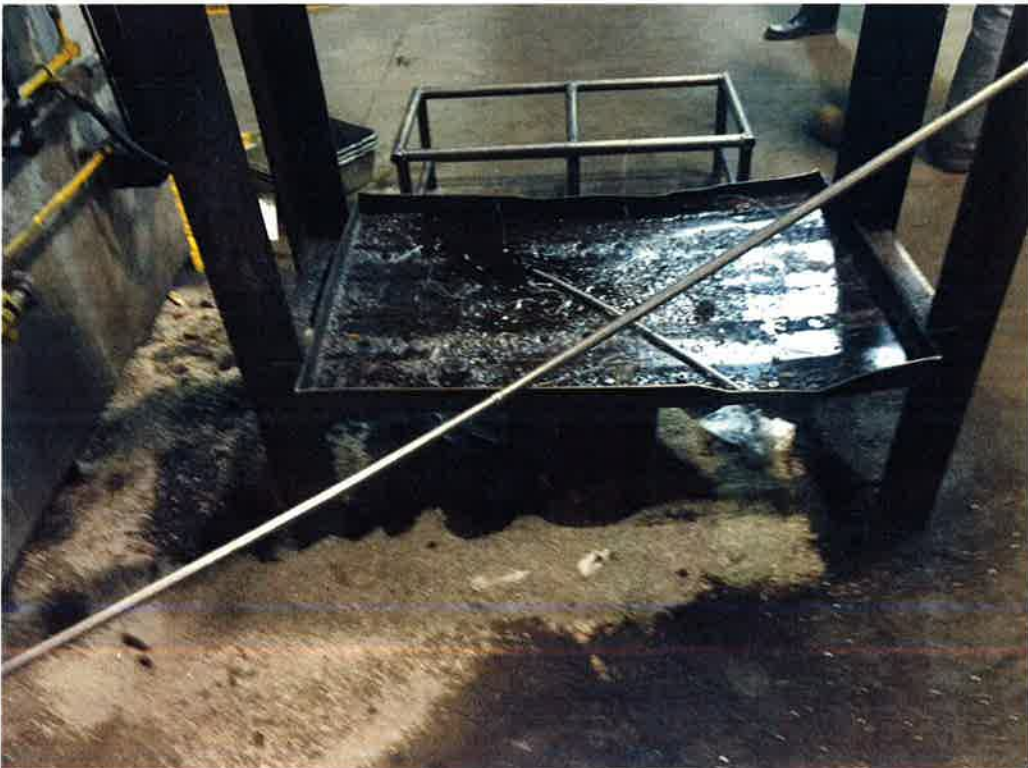
View of spillage of quench oil and absorbent material in the original manufacturing area (i.e., on the western interior portion of the assessed building).

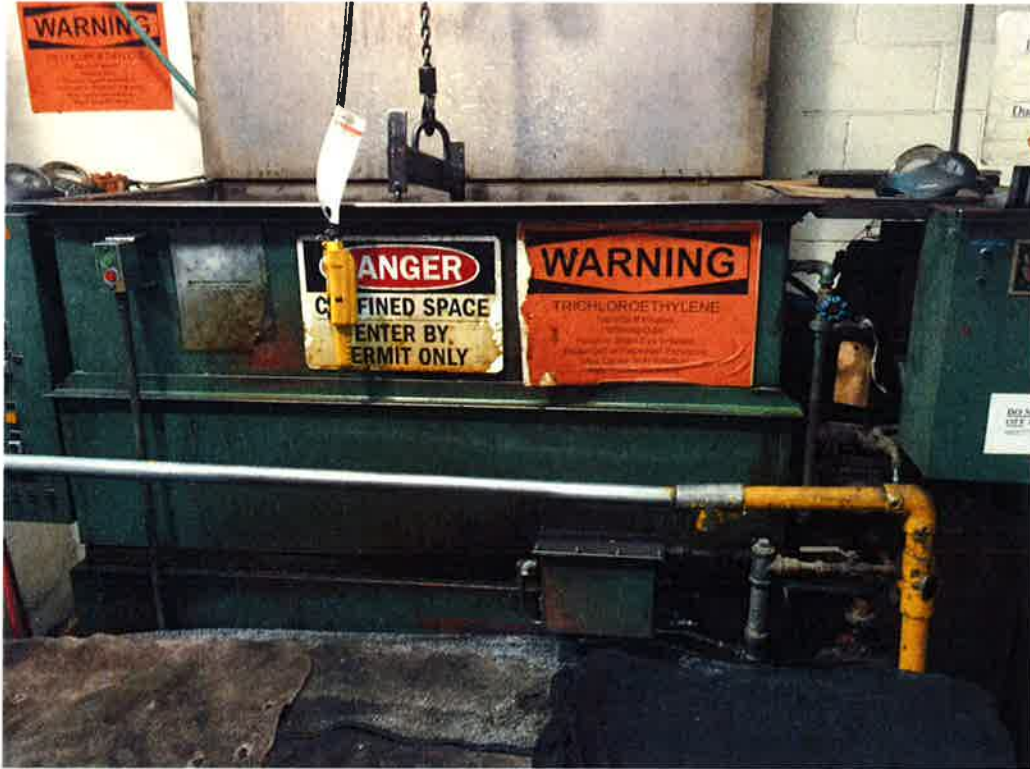
View of the TCE degreaser (i.e., on the southwest interior portion of the assessed building).

Reportedly, a TCE degreaser was historically located in the approximate location of monitoring well MW-A, from approximately 1959 until approximately 1972. In addition, an associated TCE AST was reportedly located south of the former TCE degreaser. Chlorinated VOCs (i.e., TCE and associated degradation products) may have been released from the location of this historic degreaser and/or the former TCE AST.

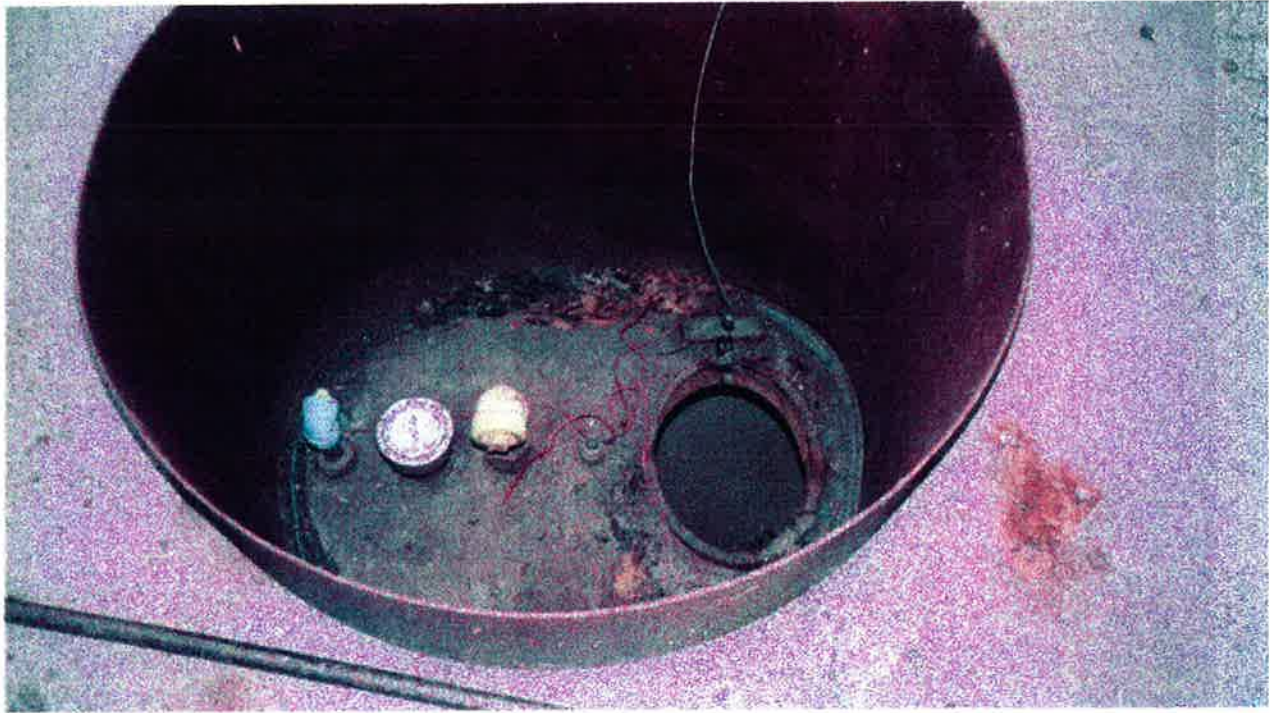
Methanol UST with pressure cover removed

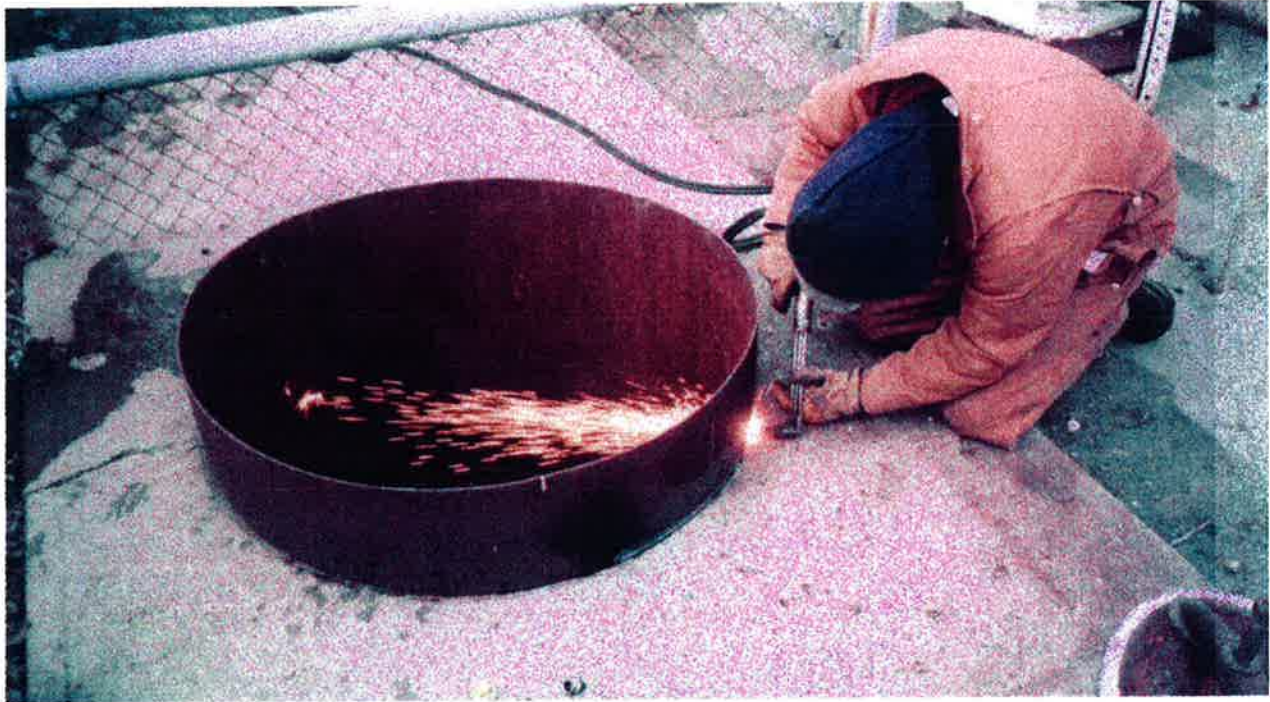
Methanol UST manway riser being removed (pressure cover at bottom right)

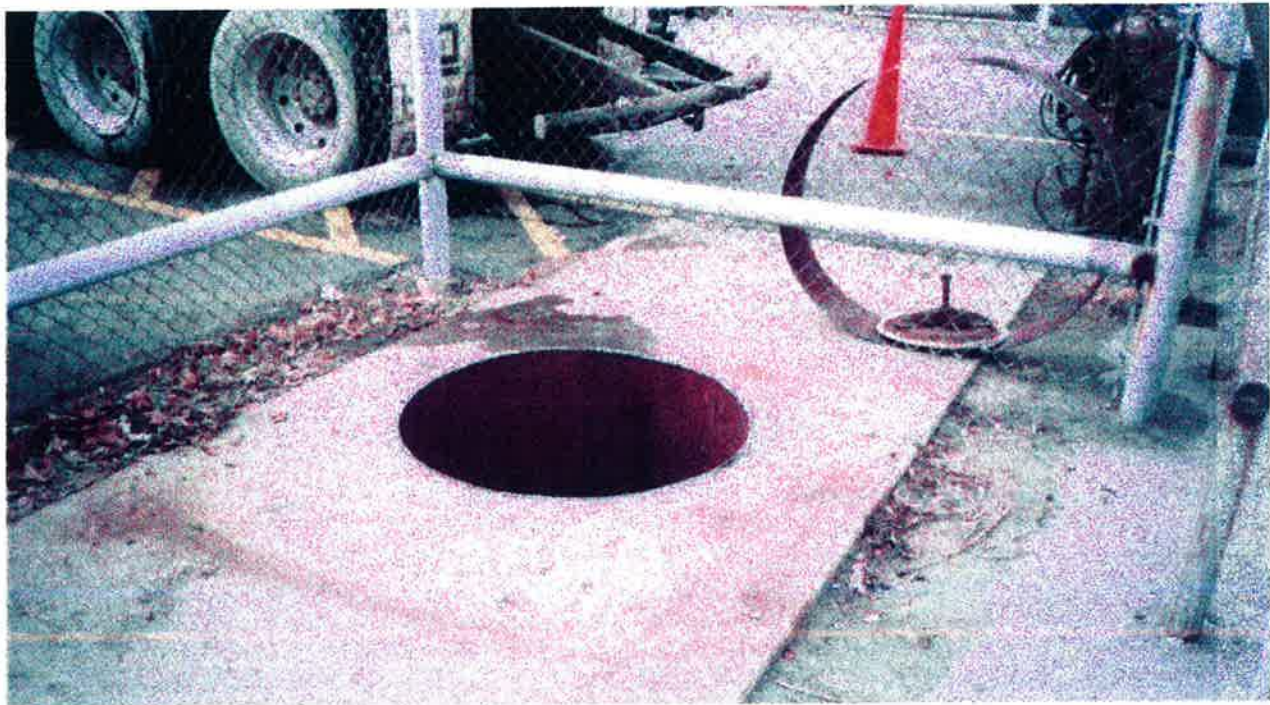
Manway riser removed (upper right) prior to filling UST

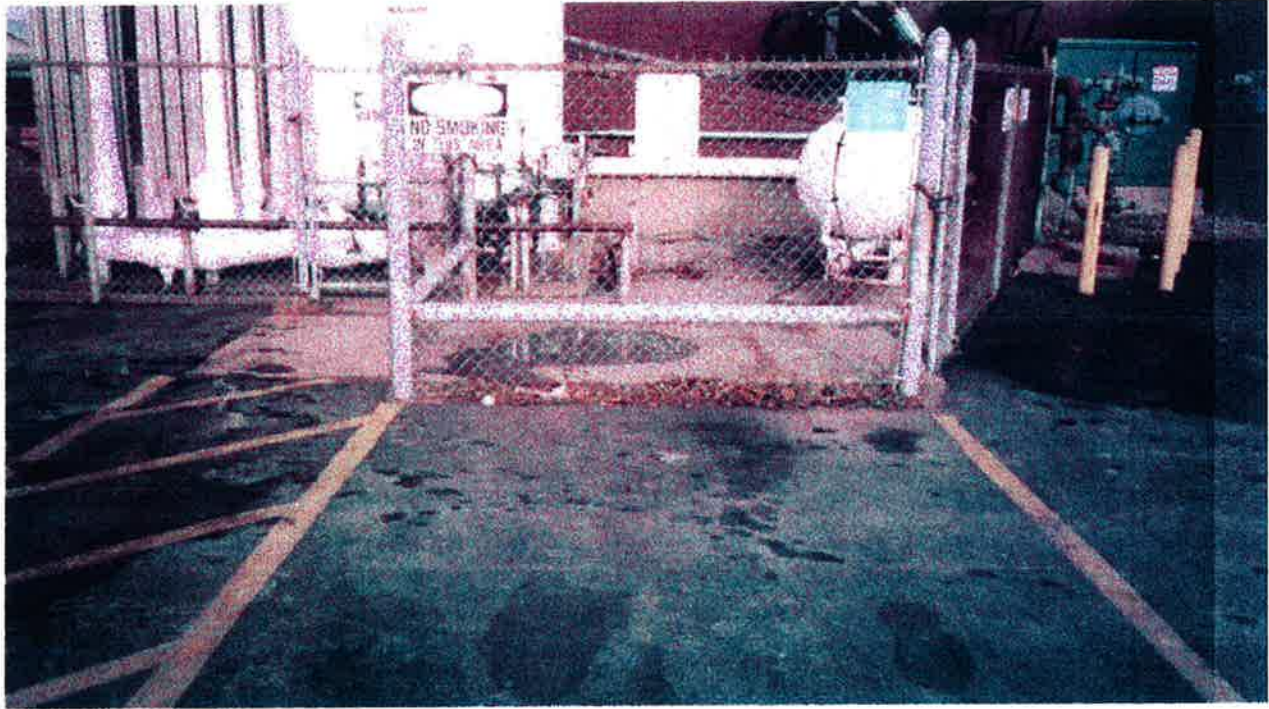
Methanol UST after filling with K-Crete
