REMEDIAL INVESTIGATION/FEASIBILITY STUDY REPORT

**OBI, LLC PROPERTIES
245-265 HOLLENBECK STREET, 271 HOLLENBECK
STREET, AND 50 BALFOUR DRIVE
ROCHESTER, NEW YORK 14621-3257
NYSDEC SITE NO. 828188**

Prepared By: Day Engineering, P.C.
1563 Lyell Avenue
Rochester, New York 14606

Date: August 24, 2017 (Revised November 26, 2019)

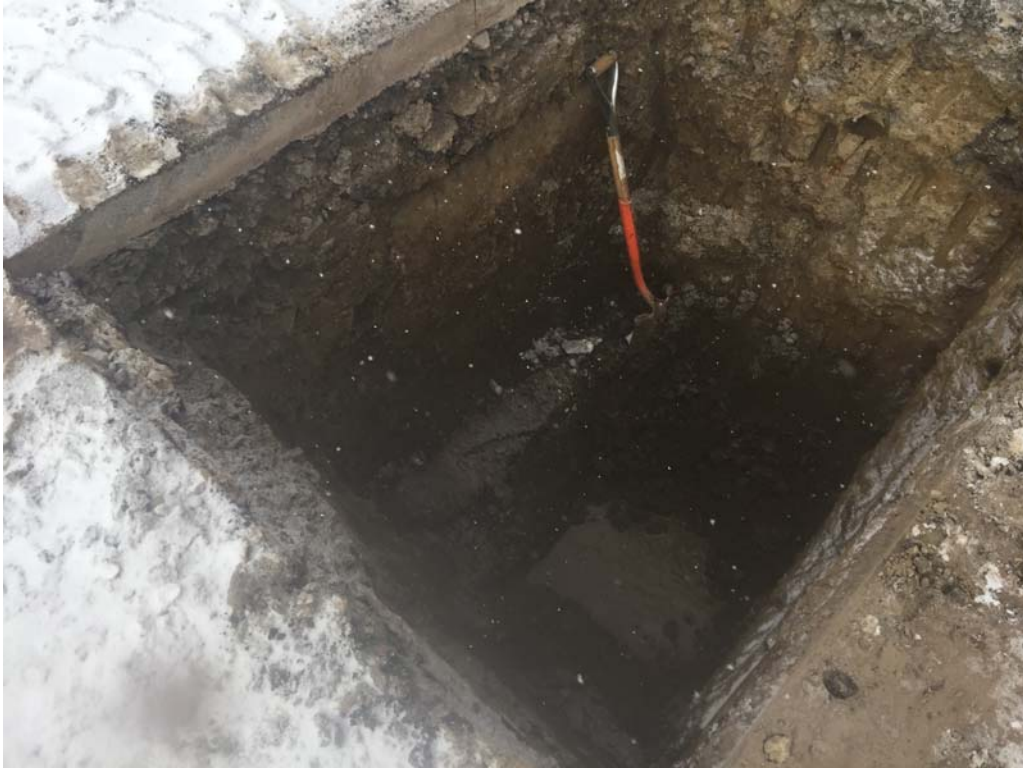
Excavated area of damaged sewer line (i.e., original location of MW-19)

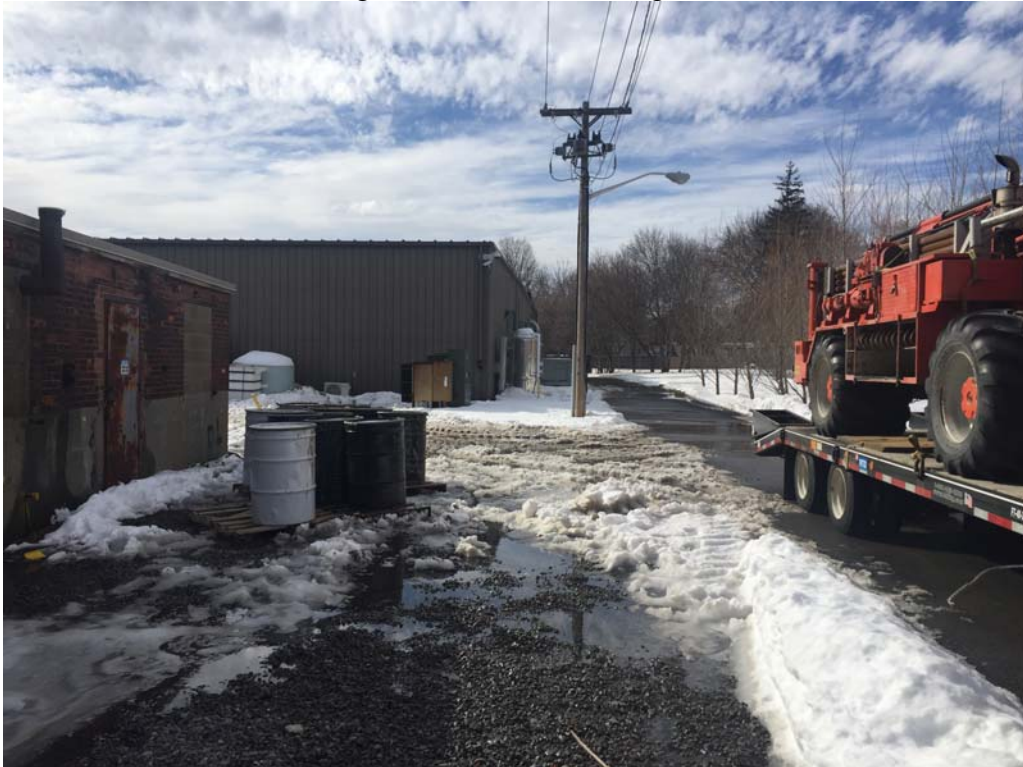
North portion of site as Applus demobilizes, looking west
