Tuesday, December 11<sup>th</sup>, 2007

Mr. Dominick Caroselli  
Vice President of Residential Development  
Anthony J. Costello & Son Development  
One Airport Way, Suite 300  
Rochester, New York 14624

## Forensic Building Science and Microbiological Investigative Executive Summary Former Iola Campus in Rochester, New York

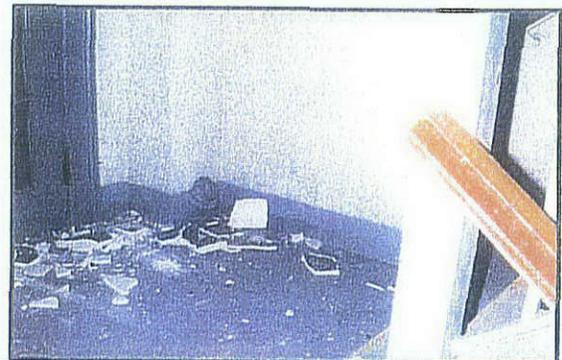
**Building Science and Microbiological Investigation** – This structure is clearly in the best condition of the remaining buildings. Recent renovations have improved the overall condition and performance of this assembly. The roof and all structural elements appeared to be in good condition. However, extensive <sup>(1,2)</sup> mold growth was observed in the basement due to a combination of moisture migration through the front foundation leading to relatively minor flooding and a high humidity. There is approximately 680 ft<sup>2</sup> of mold growth estimated in the building. The scope of mold impacted building materials includes (but is not limited to) 5/8" gypsum wallboard, plaster and carpet. The concentration of airborne mold spores is 3,099 spores/m<sup>3</sup>.

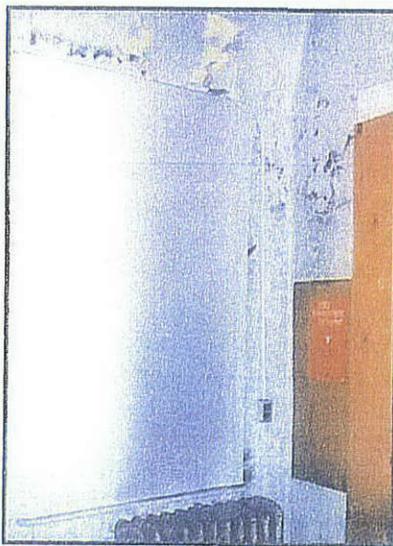
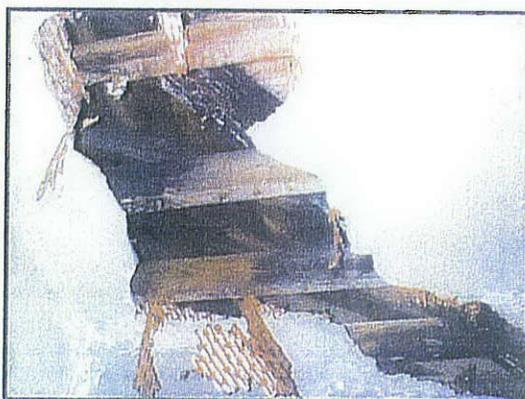
**Building Science and Microbiological Investigation** – Portions of the structure have been impacted by water damage and the subsequent growth of extensive <sup>(1,2)</sup> mold contamination. The sources of moisture that promoted the growth of mold include a combination of roof leaks, moisture migration through the floor slab and a high relative humidity level combined with a lack of air circulation. The

3" floor slab has heaved in several locations. An inspection of the roof framing illustrated the growth of wood rot fungi and deteriorated wooden members due to chronic roof leaks. The roof on the east side of the structure has failed and is supported to prevent collapse. There

is approximately 220 ft<sup>2</sup> of mold growth estimated in the building. The scope of mold impacted building materials includes (but is not limited to) plaster, wooden roof framing, wooden doors and wooden window/door trim. The concentration of airborne mold spores is 13,455 spores/m<sup>3</sup>.

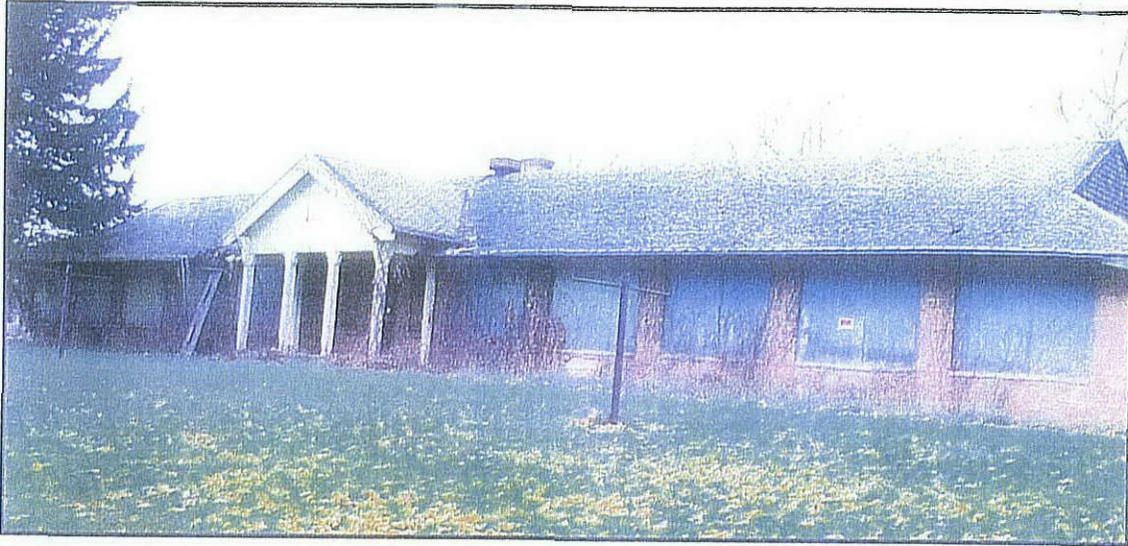
**Building #4 – Monroe County Storage and former Iola Dormitory**

**General Structural Description** – The 4,840 ft<sup>2</sup> structure faces north on Iola Circle Drive. This single story timber and wood framed structure was constructed in 1911. There are 12 rooms and a large open L-shaped rear area. It has a brick façade with a slab-on-grade foundation. Interior wall construction includes concrete block and plaster with metal lath supported by a combination of wood/brick columns. There is a conventional wood framed roofing assembly. Floor finishes include concrete and 9" asbestos-containing vinyl floor tile. The building is heated by radiant heat.

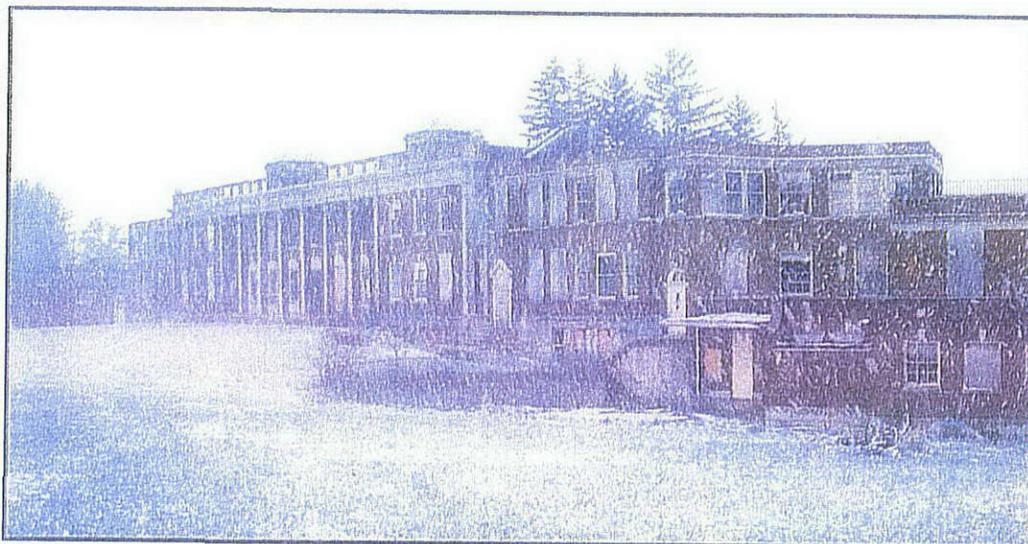
**Building #5 – Monroe County Traffic Control and former Iola Children's Building**

**General Structural Description** – The 64,430 ft<sup>2</sup> irregular shaped structure faces northwest and is located on Iola Circle Drive. This two and three story structure was constructed in 1926 and has been reportedly vacant since 2000. It has a brick façade with a finished basement and unfinished sub-basement. Interior wall construction includes concrete block, plaster with metal lath and ½ - ⅝" gypsum wallboard on steel/wooden studs. The floors are constructed with concrete forms on open web steel joists with additional steel column/beams for structural support. Floor finishes include concrete, hardwood, vinyl floor tile, ceramic tile and carpet. The building is heated by radiant heat.

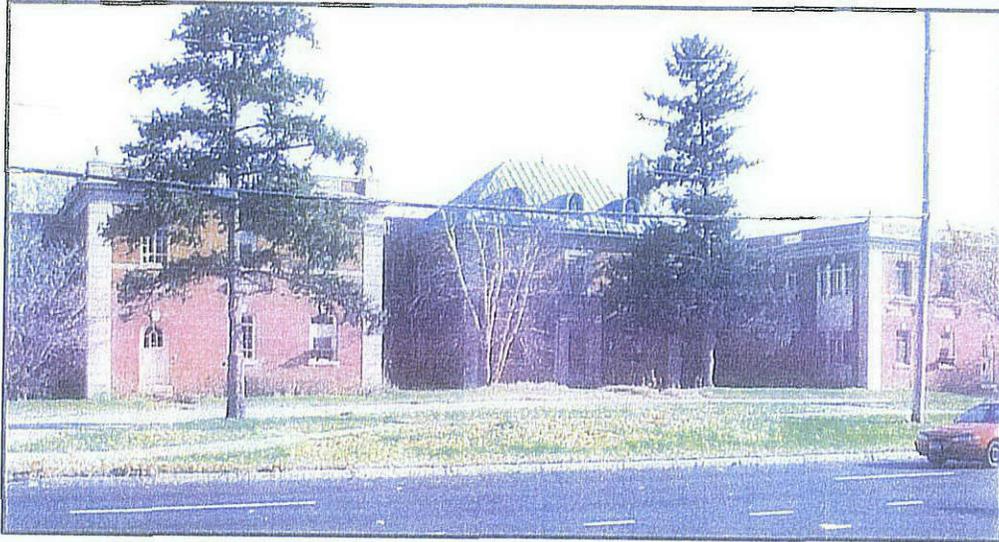
**Building #7 – Monroe County Office Records Storage and former Iola Staff Home**

**General Structural Description** – The 10,900 ft<sup>2</sup> E-shaped structure faces west and is located on the corner of East Henrietta Road and Iola Circle Drive. This two story structure was constructed in 1931. It has a brick and clay tile façade with an unfinished basement. There are 13 caged holding cells and several storage areas in the basement, 20 rooms on the first floor and 20 rooms on the second floor. There are two stairwells located at each end of the building and one central stairwell. The foundation walls and floor are constructed using poured concrete. Interior wall construction includes concrete block, plaster with metal lath and 5/8" gypsum wallboard on steel studs. The floors are constructed with concrete forms on open web steel joists with steel column/beams for structural support. Floor finishes include concrete, vinyl floor tile, ceramic tile and carpet. The building is heated by radiant heat.

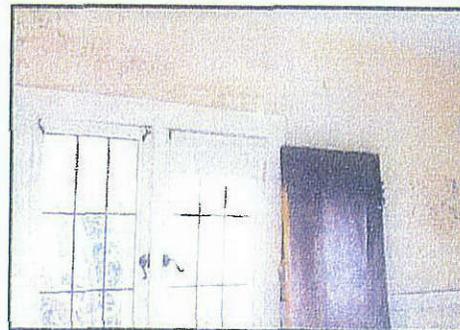
**Building Science and Microbiological Investigation** – The entire basement and significant portions of the remainder of the residence have been impacted by water damage and the subsequent growth of extensive <sup>(1,2)</sup> mold contamination. The mold growth in the basement has occurred due to a high humidity level (vapor migration through the foundation and flooding) combined with a lack of air circulation. The growth on the upper floors has been caused by a combination of humidity migrating from the basement, plumbing leaks and roof leaks. There is approximately 1,650 ft<sup>2</sup> of mold growth estimated in the building. The scope of mold impacted building materials includes (but is not limited to) ½" gypsum wallboard, plaster with wooden lath, wooden planking, asbestos-containing pipe wrap and carpet. The concentration of airborne mold spores is 23,288 spores/m<sup>3</sup>.

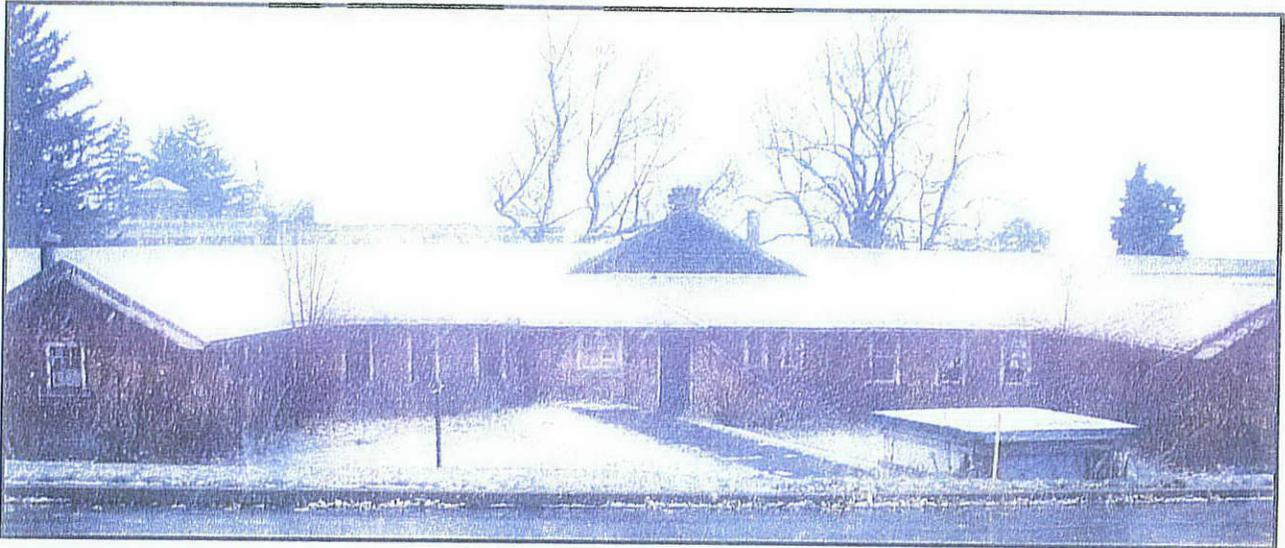
**Building #9 – Monroe County Bridge Maintenance Storage and former Iola Dormitory**

**General Structural Description** – The 5,620 ft<sup>2</sup> structure faces northwest on Iola Circle Drive. This single story timber-framed structure was constructed in 1911. It has a brick façade with a slab-on-grade foundation and a smaller 770 ft<sup>2</sup> central basement. There is a central basement stairwell. The foundation walls and floor are constructed using poured concrete. Interior wall construction includes concrete block, plaster with wooden lath and 5/8" gypsum wallboard on wooden studs. The floor is constructed with a 2½" wooden tongue-and-groove plank sub-floor on 2"×10" wooden joists above the basement. Floor finishes include concrete and 2" hardwood. The building is heated by radiant heat.

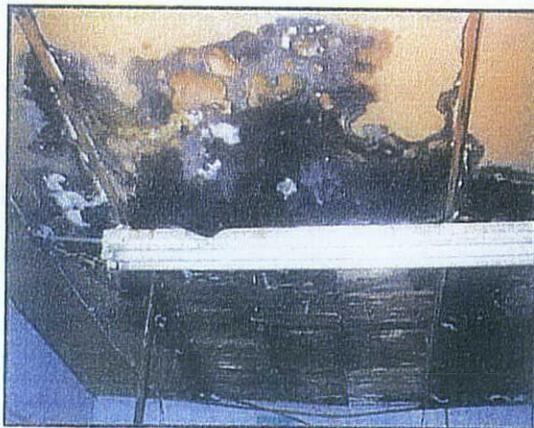
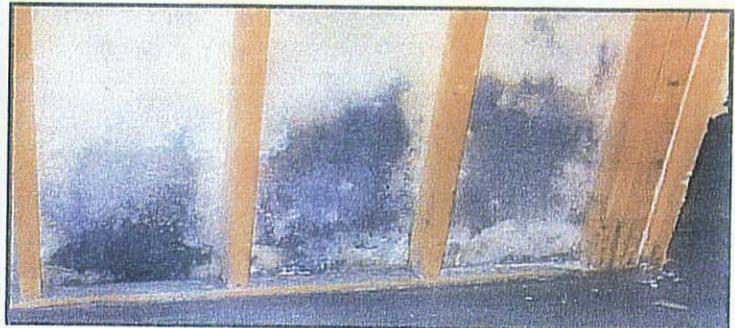
**Building Science and Microbiological Investigation** – Portions of the first floor have been impacted by water damage and the subsequent growth of extensive <sup>(1,2)</sup> mold contamination. The mold growth has occurred due to a combination of high humidity combined with a lack of air circulation, moisture migration through the basement walls, plumbing leaks and roof leaks. There is approximately 226 ft<sup>2</sup> of mold growth estimated in the building. The scope of mold impacted building materials includes (but is not limited to) 5/8" gypsum wallboard, plaster, wooden planking, 2"×10" wooden joists, cellulose-based ceiling tiles, pressboard sheathing and hardwood flooring. The concentration of airborne mold spores is 10,488 spores/m<sup>3</sup>.

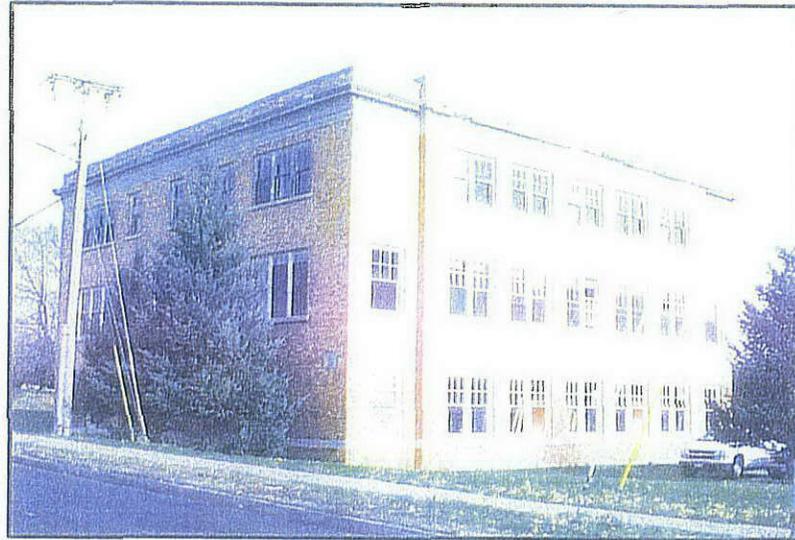
**Building #10 – Monroe County Road Maintenance and former Iola Service Building**

**General Structural Description** – The 12,675 ft<sup>2</sup> square building is located on the corner of East Henrietta Road and Stan Yale Drive. This three story structure was constructed in 1924. There are nine rooms on the first floor including a large working bay and a shower/locker area, 14 rooms on the second floor and 24 rooms on the third floor. There are stairwells located on the west and east sides of the building. The original structure had a 210 ft<sup>2</sup> centrally sunken roof with clerestory windows to provide central lighting and ventilation. This feature has been subsequently covered with 3/4" plywood and 2"×10" wooden joists. It has a brick façade with a slab-on-grade foundation. Interior wall construction includes concrete block, brick, plaster with metal lath and 5/8" gypsum wallboard on steel studs. Floor finishes include cast-in-place concrete ("T-Beam" construction), vinyl floor tile and carpet. The structure is supported by a combination of steel/concrete beams and columns. The building is heated by a combination of radiant heat (primarily) and forced-air furnace.
