GENESEE VALLEY PARK WEST

MASTER PLAN

EXISTING PARK CONDITIONS

City of Rochester

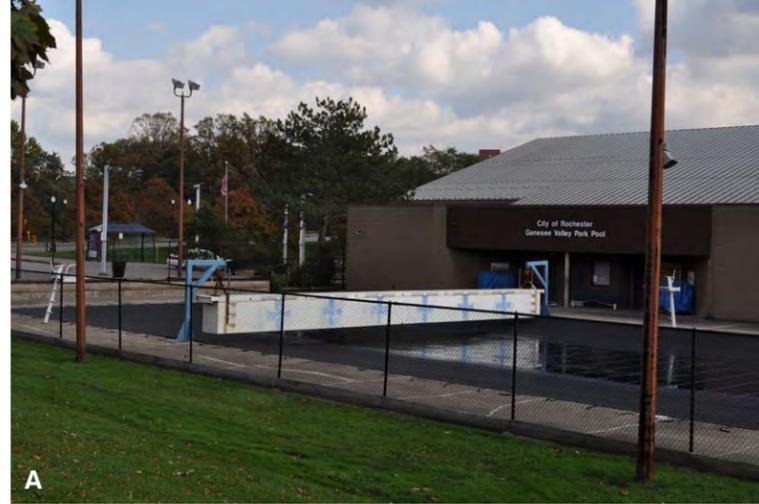
A

- A. View of outdoor pool from primary parking lot for Sports Complex.
- B. Entry area to Sports Complex from bus/exit loop drop-off.
- C. Turf area between parking lot and fenced pool area functions as spectator seating for swim events. There is no formal exterior family seating area within the pool space.
- D. View from entry to Sports Complex to bus loop.
- E. View of building exterior (ice rink) from Genesee Riverway Trail and Genesee River.
- F. Island in parking lot is not conducive to tree growth.

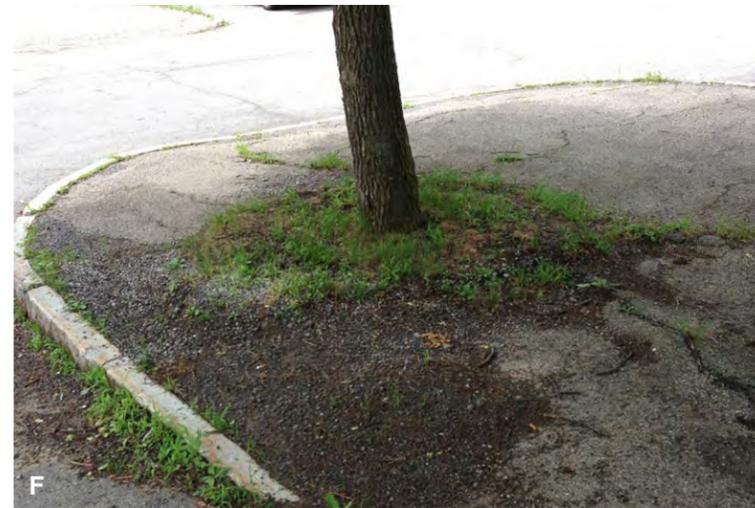
F

The overall site and parking areas appear to be in poor condition with severe asphalt deterioration, tree-planted landscaped islands paved with asphalt (undermining tree health), unclear parking delineation, poor separation of vehicular and pedestrian paved areas (limited curbed areas). The parking lot does appear to have adequate drainage and lighting. The amount of parking adjacent to the Sports Complex appears to successfully serve current typical needs outside of large events. The western-most parking area is leased to the University of Rochester during the school year for faculty and staff parking.

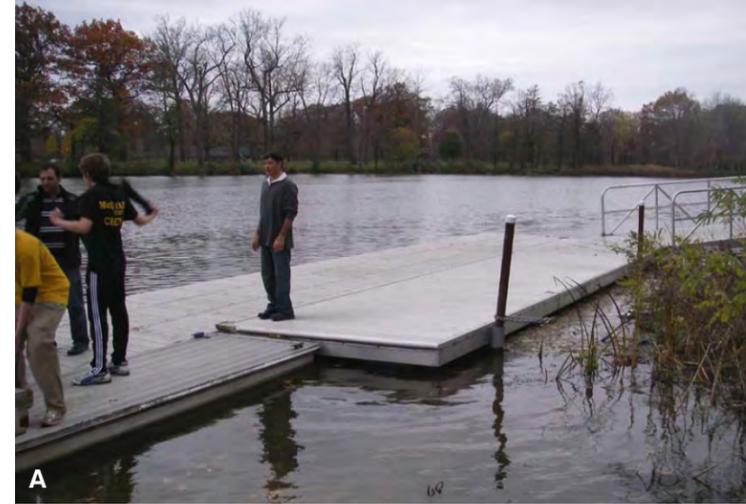
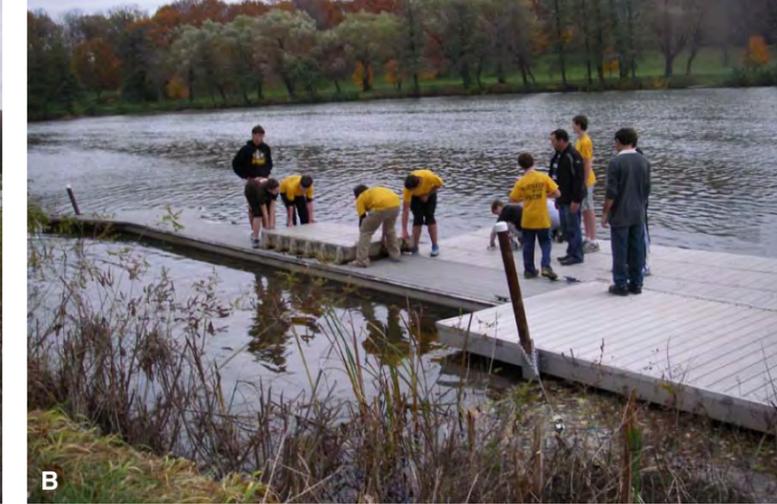
A. Privately Owned Rower Docks

Pin & Pile System Insufficient: Pin and pile dock anchoring installations appear to provide insufficient capacity for the quantity and/or size of the anchored docks and show signs of undesirable movement. Periods of high velocity river current may undermine pilings or pull docks from anchoring.

Debris: Docks are not adequately protected from vegetation and other large floating debris, such as logs and ice floe (for docks that remain in water during winter).

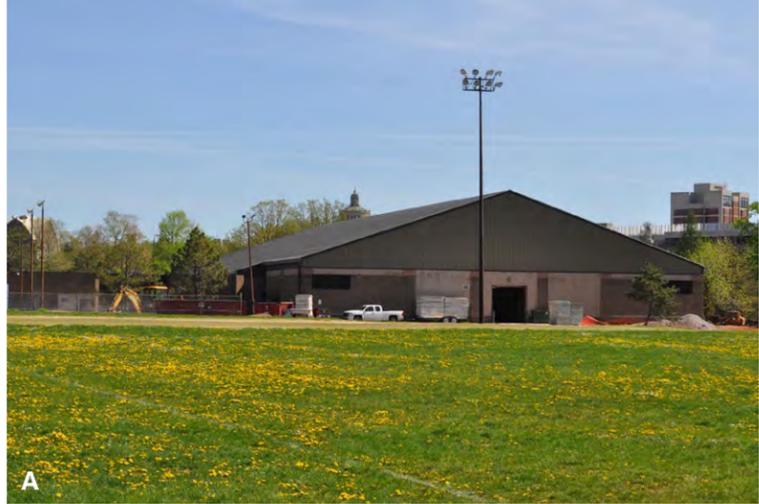
A.

The architectural massing and style of the Ice Rink structure is inconsistent with the character expected of an historic Olmsted-designed park. It's highly visible from many areas within both the east and west sides of Genesee Valley Park.

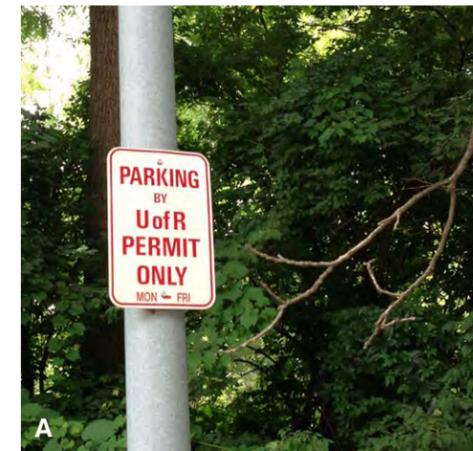
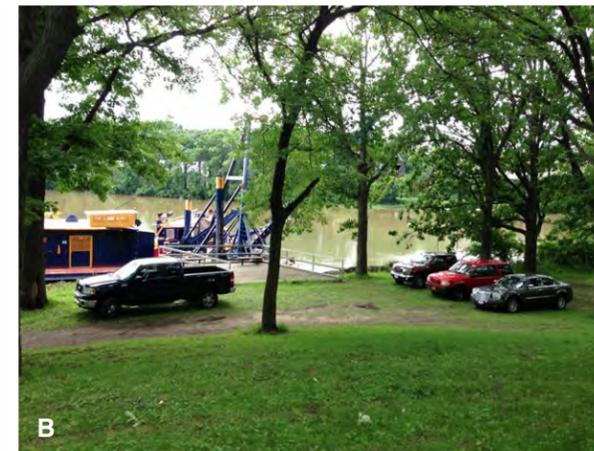
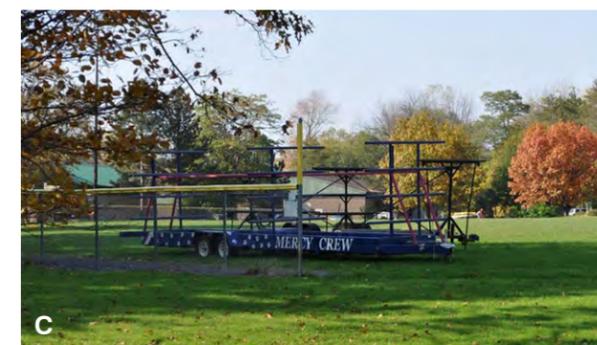
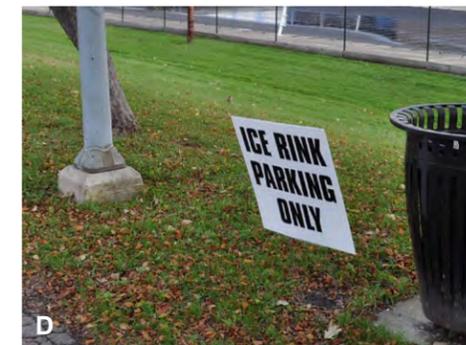
- The western-most parking lot at the park’s Sports Complex is signed as parking for the University of Rochester only, under lease from the City.
- NYS Canal Authority employees park vehicles within the white oaks at the foot of the “Olmsted” pedestrian bridge. The land is owned by the State but functions as park land. The Canal Authority also parks dredging equipment at the site. This equipment significantly impacts the scenic quality of the river and overall Genesee Valley Park.
- Genesee Waterways Center users park trailers within the lawn area / outfield of Ball field #4. The field is also used for sports tourism event parking, which causes damage to the playing surface.
- Presumably due to University of Rochester employees or students parking in the park (outside of designated areas) many temporary signs are used to notify vehicles.

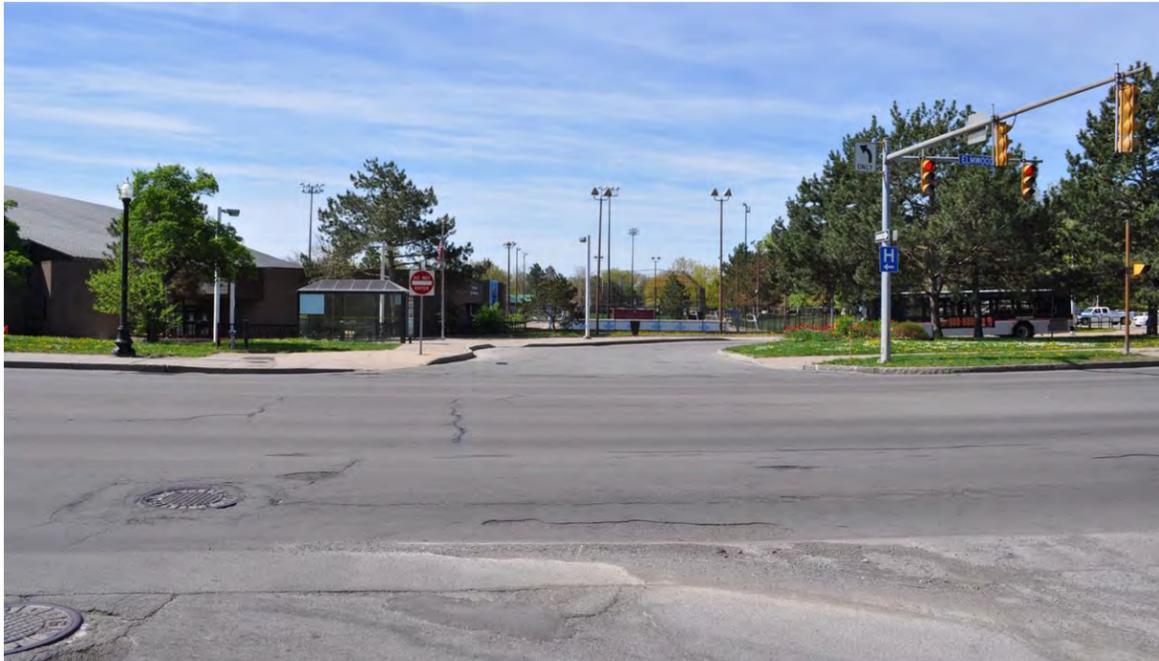
ELMWOOD AVE
ENTRANCE

The Elmwood Avenue exit functions as the primary entry and visual "facade" of the park. It clues potential users onto the quality of the experience that the park may offer and directly influences potential use. The park's potential historic character and recreational opportunities are poorly representable at the entry from Elmwood Avenue.

Buses queue at the Elmwood Avenue entry/exit loop at the park. More than 100 buses per day use the turning loop and often queue further to the south near the waterways center due to inadequate bus area and a poorly design park entry.

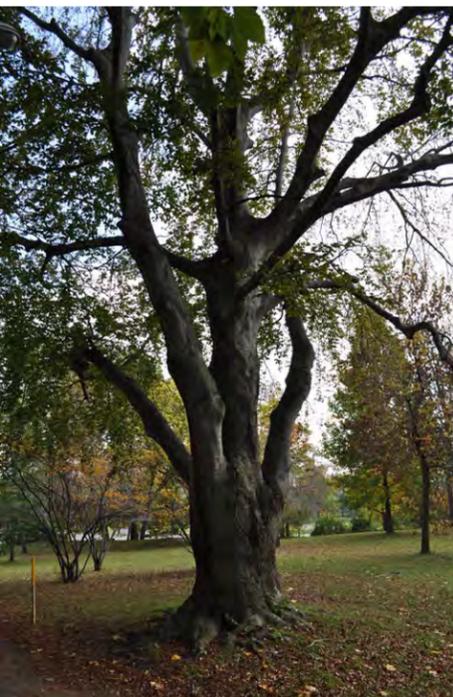
One of several significant European Beech trees within the wooded picnic grove.

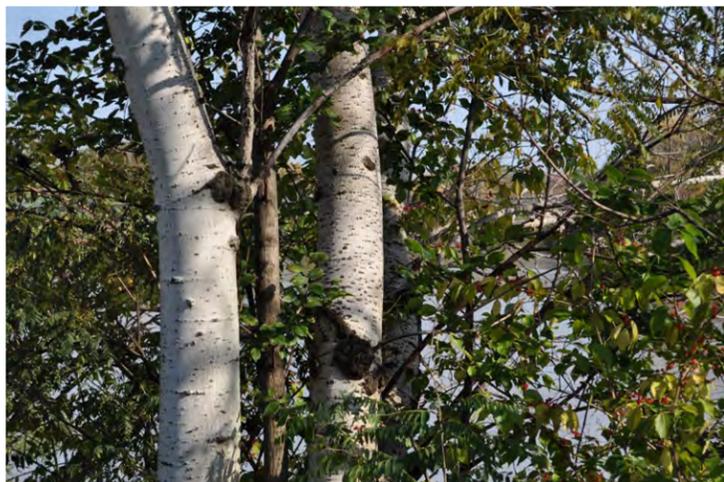
American White Birch located along the river edge, north of Ballfield #6. *Betula papyracea* is one of several tree species planted along the river in the Olmsted firm planting lists. However, very few White Birches appear to remain along the river - long since crowded out by understory brush and more aggressive tree species.

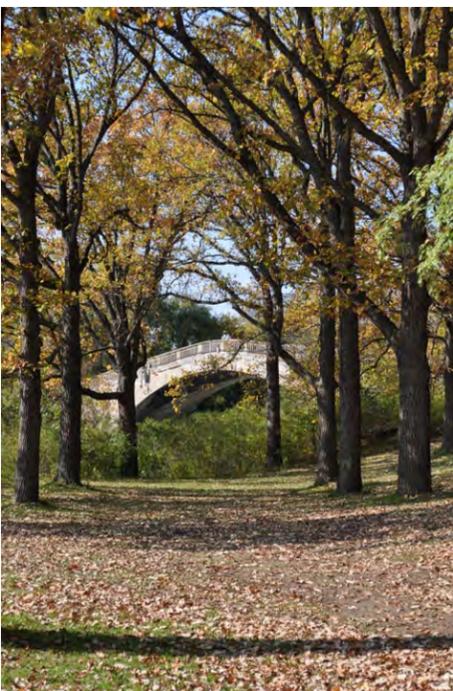
White oaks planted around 1920 in glade near the canal confluence. Pedestrian bridge in background.
