Garage Inspection & Rating Program

Mortimer Street Parking Garage

October 1st, 2019

EXECUTIVE SUMMARY

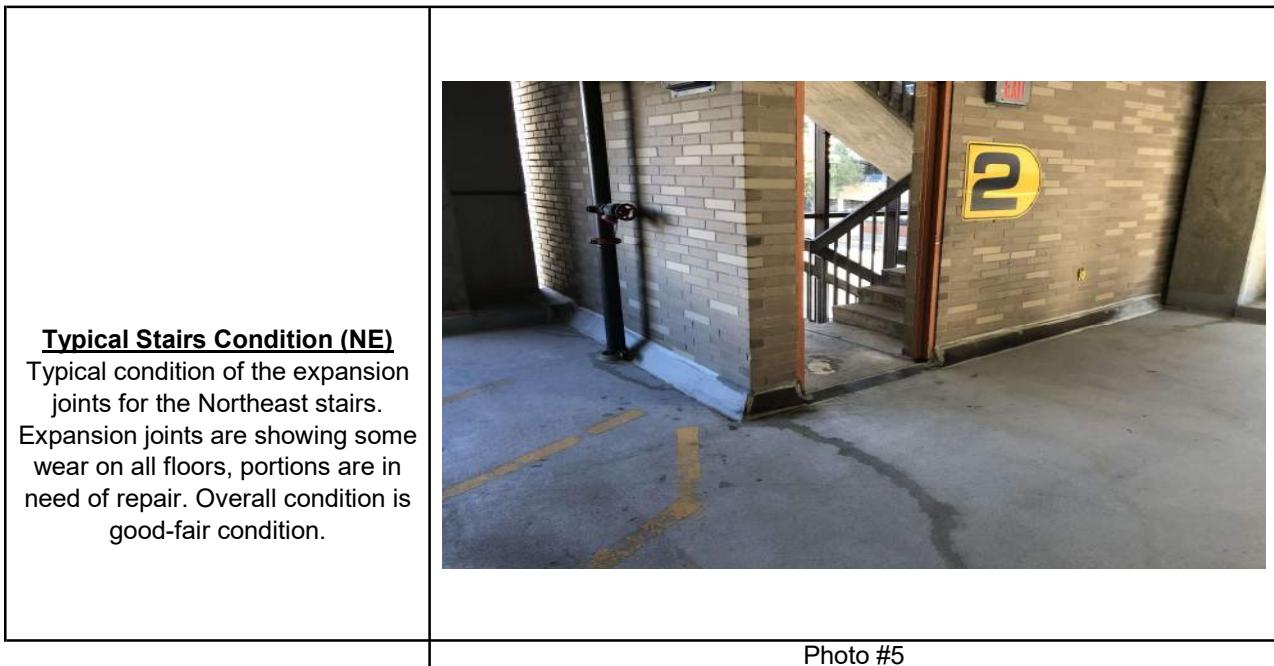
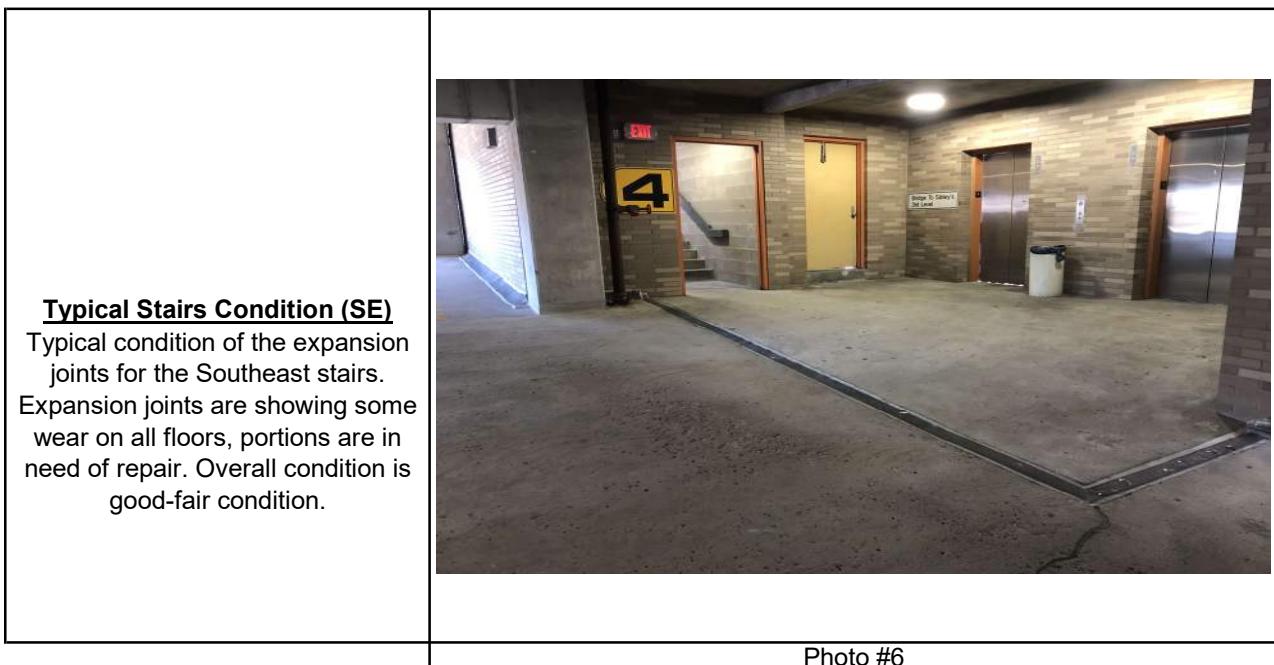
<u>Expansion Joint Case 1</u> Major repair need for roof expansion joint of Southeast stairs, multiple feet of failed material.
