High Falls Overlook

Feasibility Report

City Project No. 19324

City Project No. 19324
December 2021

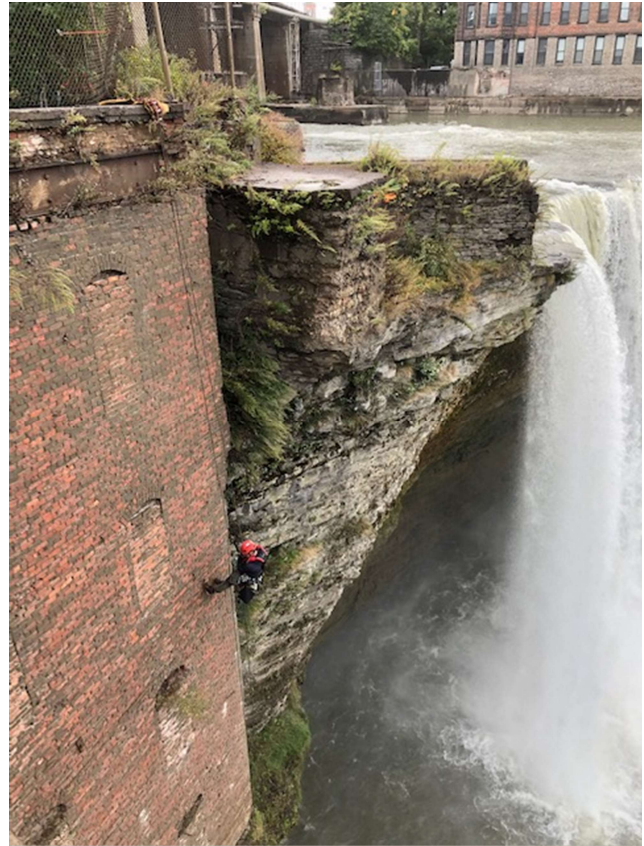
Figure 6 - Vertical Access team rappelling from Station No. 4

Vertical Access utilized their expertise in building inspections and rope access techniques to provide a hands-on inspection of the exterior of the building that would have otherwise been impossible. With the use of site-specific rigging systems, they rappelled down the face of the building in several locations. During these investigations, cracking was observed in all accessible facades, with significant cracking (greater than 1 inch wide) at several locations. Bulging and loose brick were also identified in all facades. In all, the exterior masonry was determined to be in poor condition with large areas of instability and twenty Priority 1

conditions, which represent poor conditions and the most concerning structural deficiencies. According to the report, “Poor condition refers to a system, material, or item that has lost most of its intended structural, waterproofing, or aesthetic function.” In summary, Vertical Access found that *“the masonry was in poor condition exhibiting displacement, vertical crack systems and sections of unsecured masonry that may call into question the structural integrity of the former Station 4 structures.”*

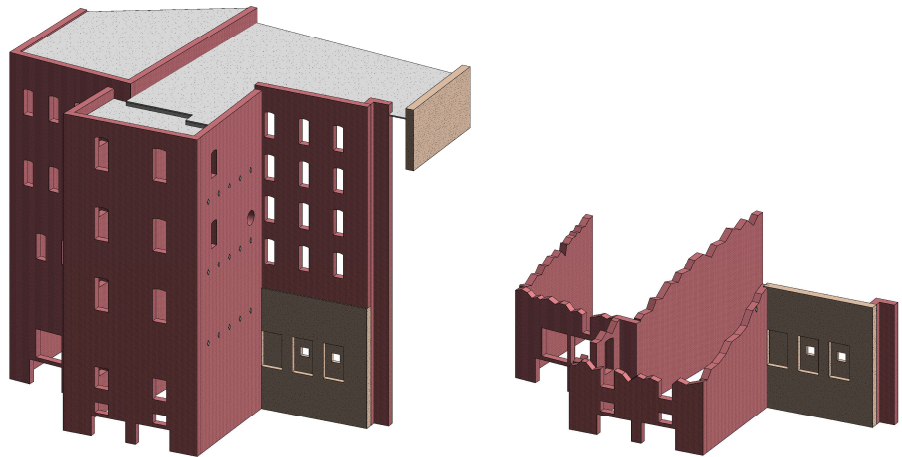
Figure 16 – Model of Existing Station No. 4 (left) and Potential Remnant (right)

Demolition would entail removal of the upper, brick portion of the structure, potentially down to the existing stone foundation. The brick, concrete, steel, and wood materials demolished would be removed from the site. With the existing foundations left in place, consideration should be given to leaving the bottom 20 feet of the building in place as a representative historical remnant of the existing structure.

Demolition would eliminate the uncertainty of when and how portions of the building may collapse over time. The foundation and remnant to be left in place would continue to deteriorate but sudden and significant collapse of the remaining structure would be unlikely.

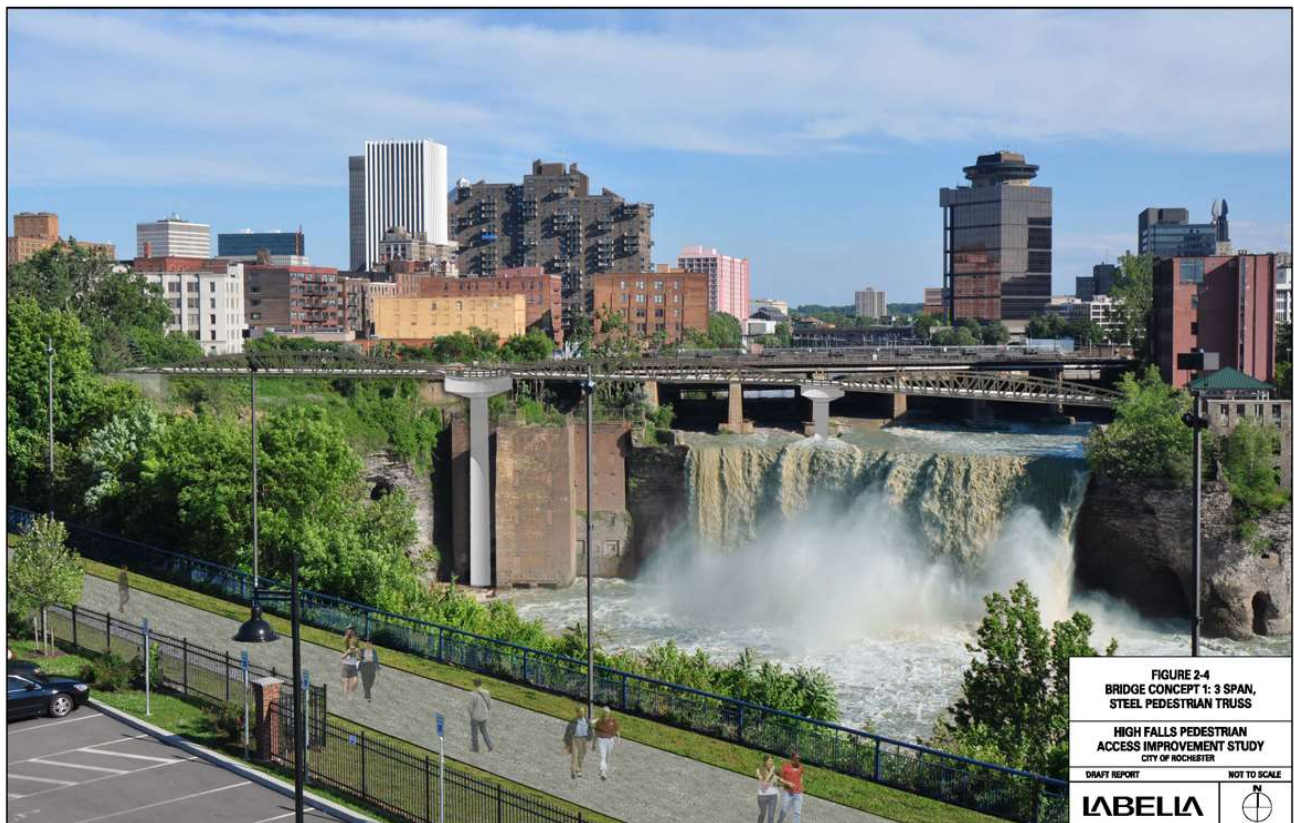
Figure 17 - Visualization from 2015 Report showing Pier concept.

A second option for a replacement viewing platform would be supported by a pier that could extend up from the lower river level. Further investigation of this option was not undertaken during this study as the aforementioned 2015 Study considered several similar approaches. Regarding the construction of the pier depicted in Figure 17, the 2015 Study noted: “Pier 2 would be founded northeast of Station 4, adjacent to the building, and be approximately 135’ tall. [The pier] would be concrete and founded on rock sockets drilled into the rock.” Refer to that study for addition feasibility information and costs.
