High Falls Overlook

Feasibility Report

City Project No. 19324

City Project No. 19324
December 2021

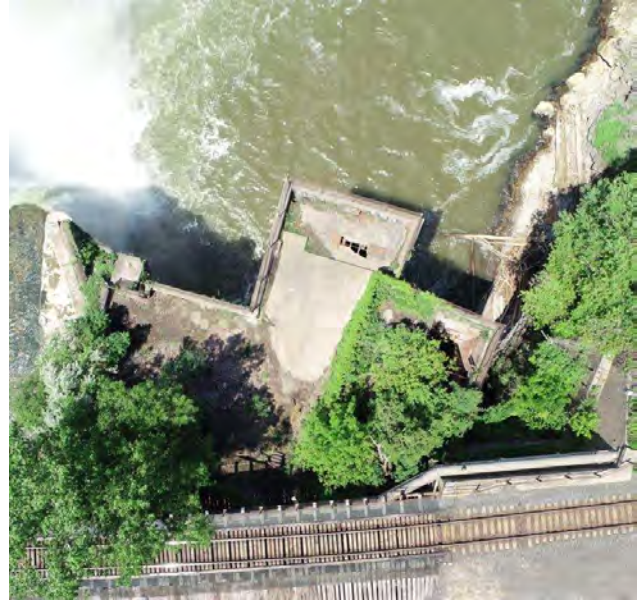
Figure 3 - Drone photo of Station No. 4

almost a year, a team of expert consultants gathered the data required to determine the condition of the primary structural elements: foundations, masonry walls, interior framing supports, and rock face. *Upon compilation and review of all the data, it was determined that re-use of the structure, either through rehabilitation or replacement, was infeasible due to the poor condition of the structure and the costs and safety hazards to undertake the extensive improvements required. As such, it is recommended that the structure either remains as is or is demolished.*

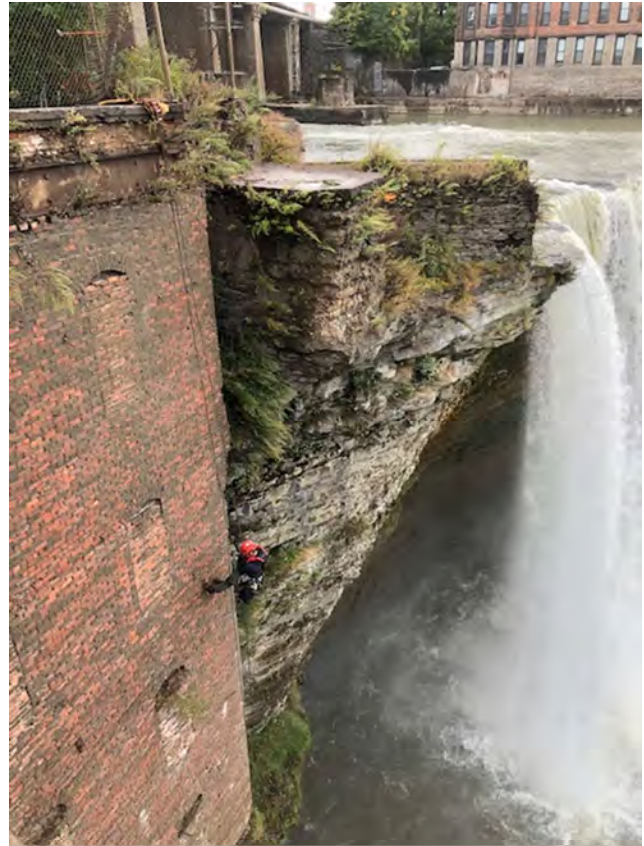
Figure 6 - Vertical Access team rappelling from Station No. 4

Vertical Access utilized their expertise in building inspections and rope access techniques to provide a hands-on inspection of the exterior of the building that would have otherwise been impossible. With the use of site-specific rigging systems, they rappelled down the face of the building in several locations. During these investigations, cracking was observed in all accessible facades, with significant cracking (greater than 1 inch wide) at several locations. Bulging and loose brick were also identified in all facades. In all, the exterior masonry was determined to be in poor condition with large areas of instability and twenty Priority 1

conditions, which represent poor conditions and the most concerning structural deficiencies. According to the report, “Poor condition refers to a system, material, or item that has lost most of its intended structural, waterproofing, or aesthetic function.” In summary, Vertical Access found that *“the masonry was in poor condition exhibiting displacement, vertical crack systems and sections of unsecured masonry that may call into question the structural integrity of the former Station 4 structures.”*

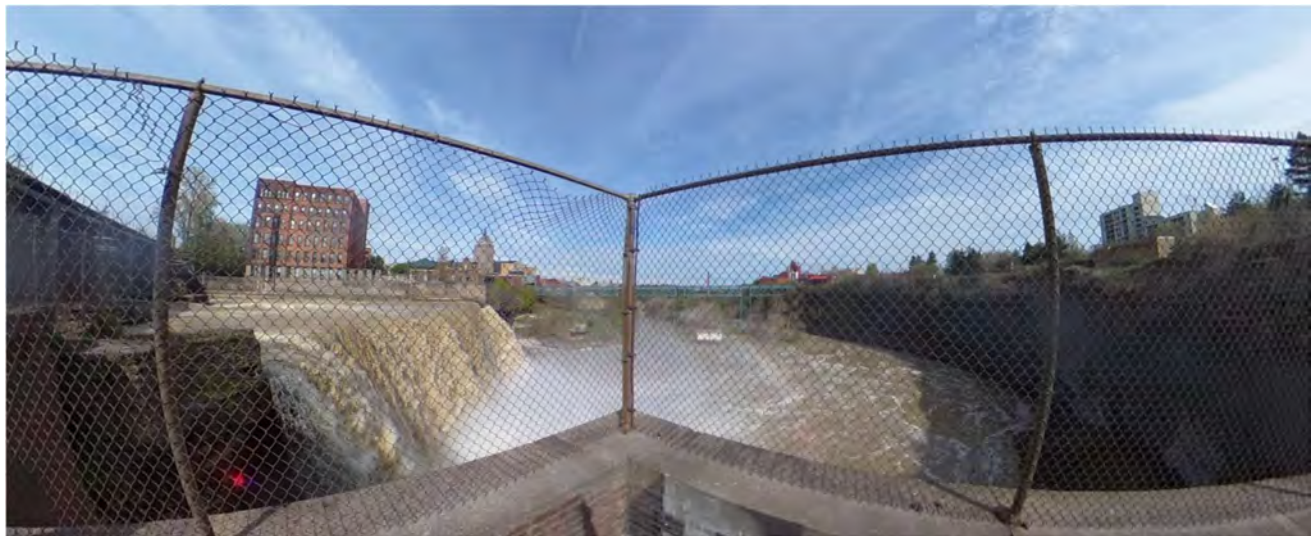
Figure 8 - Scenic View from atop Station No. 4

Atop Station No. 4, the preferred viewing locations were at either the northernmost point (closest to the building edge) or westernmost point (closest to the falls). The closer to the railway that one progressed, the views were considered less desirable, reinforcing that the full tourist overlook effect would require viewing locations that were as far north as possible.

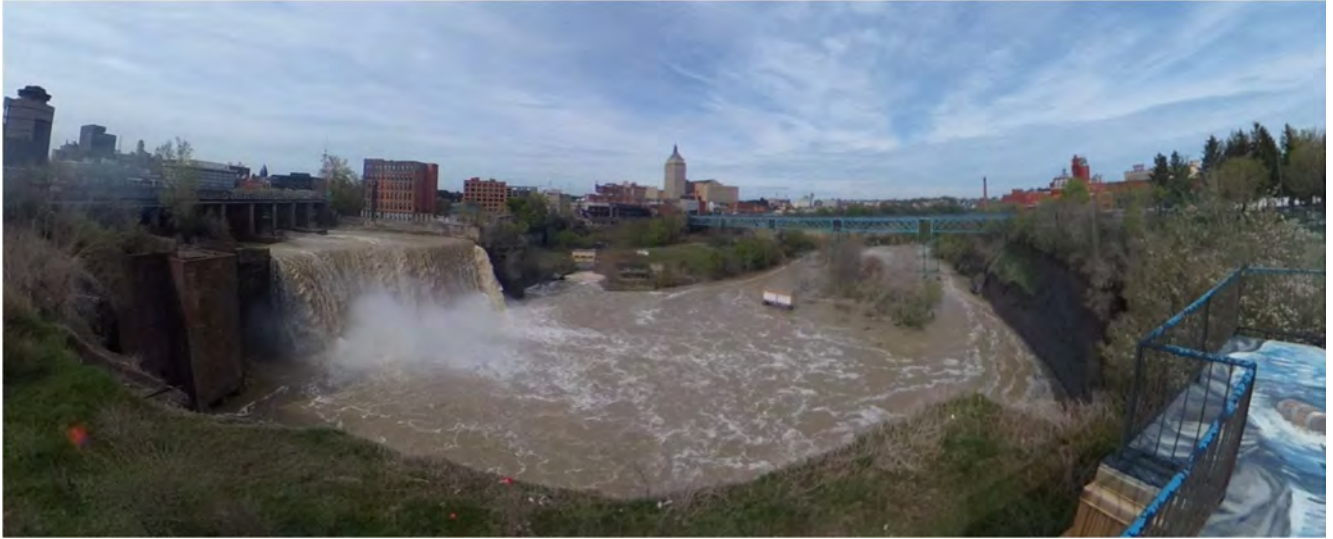
Figure 10 - Scenic View from High Falls Terrace Park Overlook

Views from the Pont de Rennes Bridge and High Falls Terrace Park Overlook (also referred to as the High Falls Terrace Platform) were ranked by the Project Advisory Committee as similarly or more impressive than the views from atop Station No. 4.

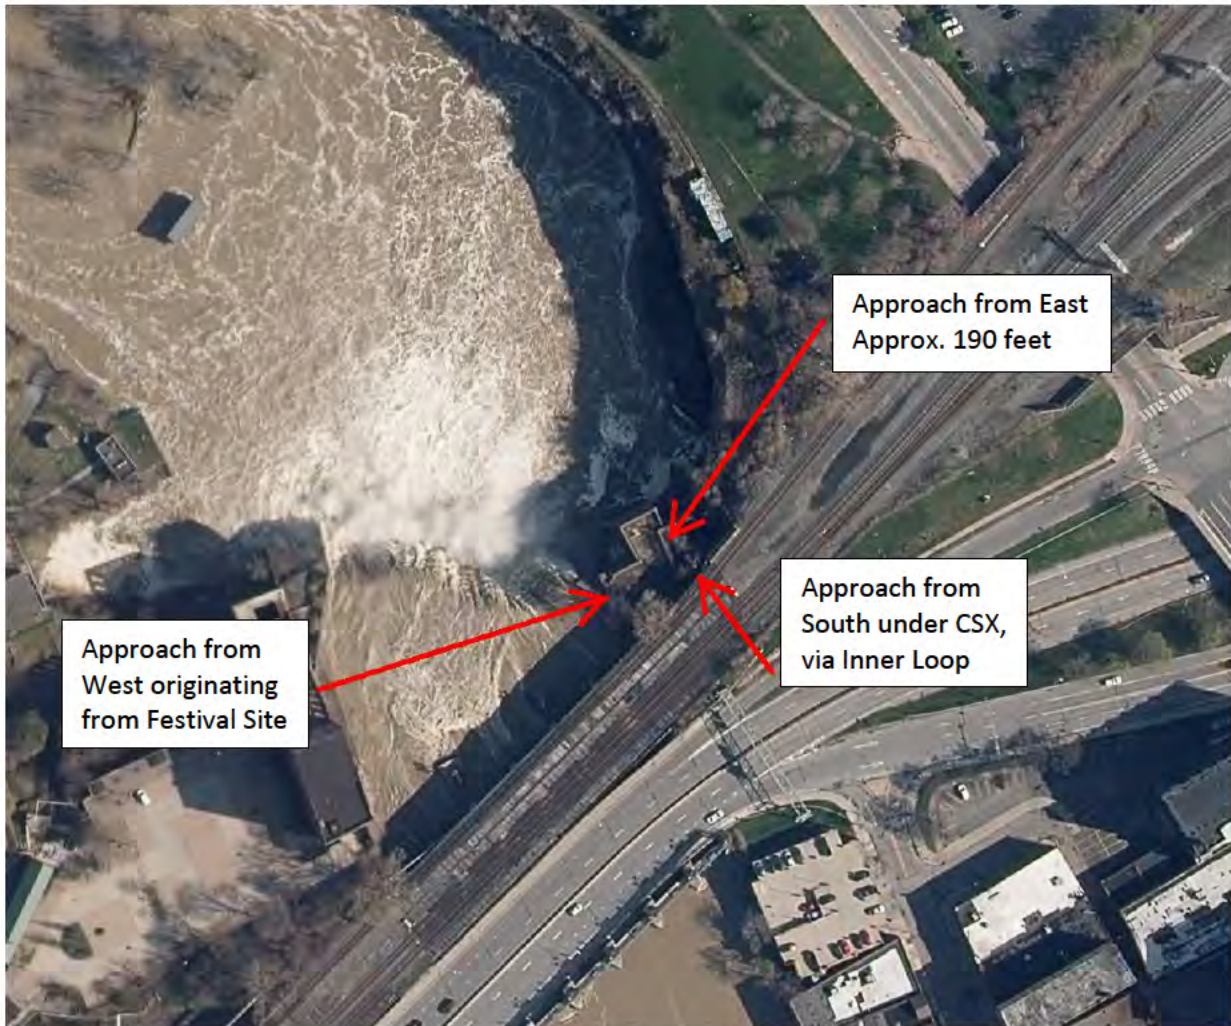
Figure 11 - Access Approaches

Pedestrian access to the potential platform was evaluated from three approaches: 1. from High Falls Terrace Park to the east, 2. From the former High Falls Festival Site to the west, and 3. from the Inner Loop under the CSX railway bridge.

The nearest point of the cliff to the east is separated from the center of the structure by approximately 65 feet horizontally and more than 30 feet vertically. After visual inspection and review of the cliff scan data, it was determined that any bridge abutment would need to originate at a significant distance from the cliff due to the condition of the rock face and degree of undermining evident at this location. In addition, CSX right of way restrictions would force the pedestrian access point further to the north from this most proximate location.

The structure is currently accessed via an access easement that extends from the Inner Loop right of way under the CSX Railway. The existing access is unimproved, consists of a dirt path at a slope of approximately 17%, and is open to the CSX railway above without debris protection or drainage. Historic retaining walls that likely contained the former raceway are intact though in fair to poor condition. An improved approach would include renovation of this entire area – including a series of ADA ramps, walkways & stairs with railings, overhead debris protection, lighting, and informational signage. This would require significant coordination and approval by CSX, including

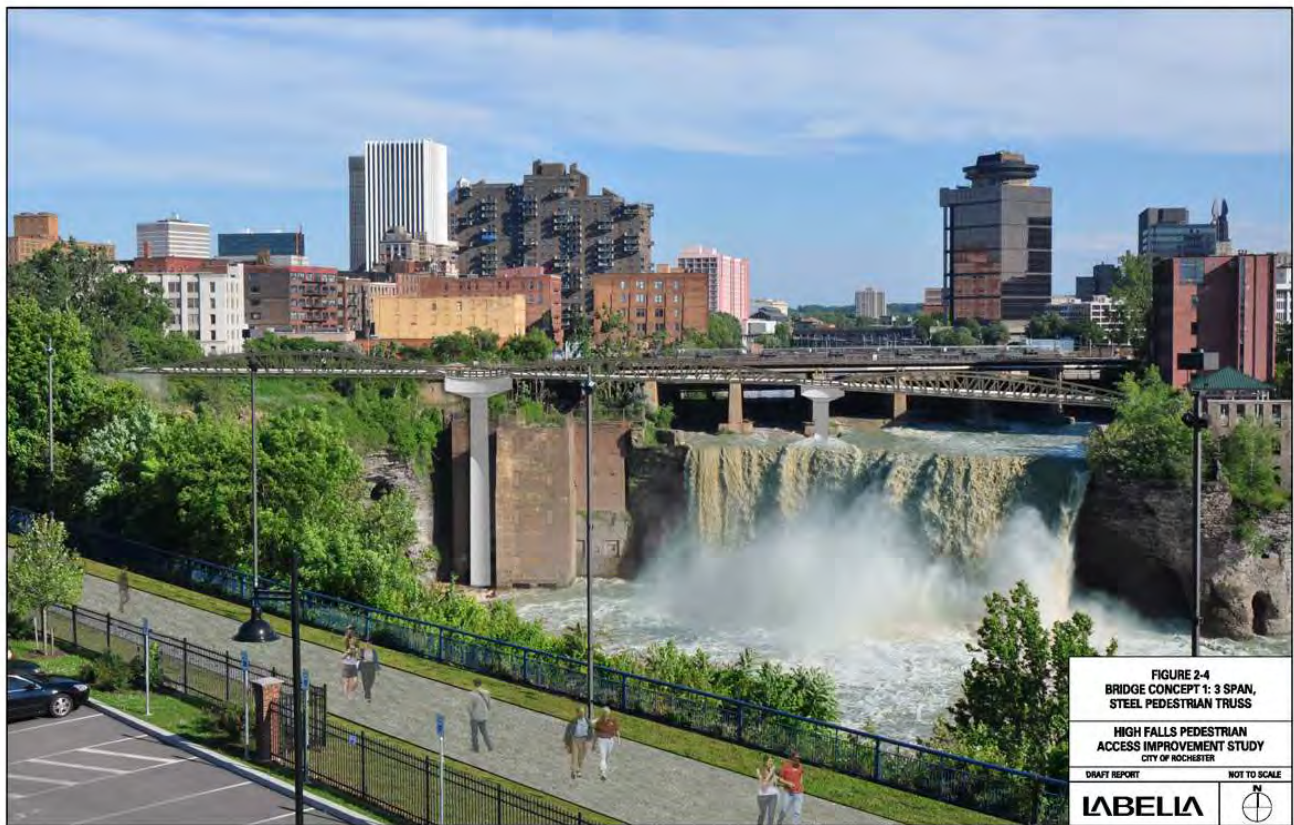
Figure 17 - Visualization from 2015 Report showing Pier concept.

A second option for a replacement viewing platform would be supported by a pier that could extend up from the lower river level. Further investigation of this option was not undertaken during this study as the aforementioned 2015 Study considered several similar approaches. Regarding the construction of the pier depicted in Figure 17, the 2015 Study noted: “Pier 2 would be founded northeast of Station 4, adjacent to the building, and be approximately 135’ tall. [The pier] would be concrete and founded on rock sockets drilled into the rock.” Refer to that study for addition feasibility information and costs.
