# Preliminary Structural Condition Report

For  
Iola Campus  
Buildings 1, 2, 4, 5, 7, 8, 9 and 10

Date of Inspections: November 20, 2007 & November 27, 2007  
Date of Report: December 19, 2007

Re: Iola Campus  
Buildings 1, 2, 4, 5, 7, 8, 9 and 10

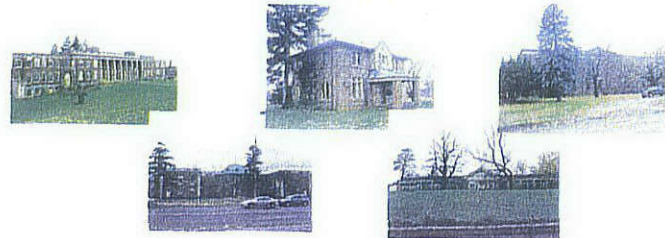
This section of the report addresses the structural condition of the following vacant buildings located in the Iola Campus. The campus is located in the corners of East Henrietta and Westfall Roads in Rochester, N.Y. The buildings were constructed between 1911 to 1931.

- Building 1 Nurse's Quarters
- Building 2, Dormitory
- Building 4, Dormitory
- Building 5, Children's Building/County Building
- Building 7, Staff Home
- Building 8, Supervisor's Home
- Building 9, Dormitory
- Building 10, Service Building
