The Master Plan Strategy for Manhattan Square Park

A strategy for community building & reinvestment in the Center City

Briefing Document Deliverable 4:

Prepared for:
The City of Rochester, New York
Department of Parks, Recreation and Human
Services

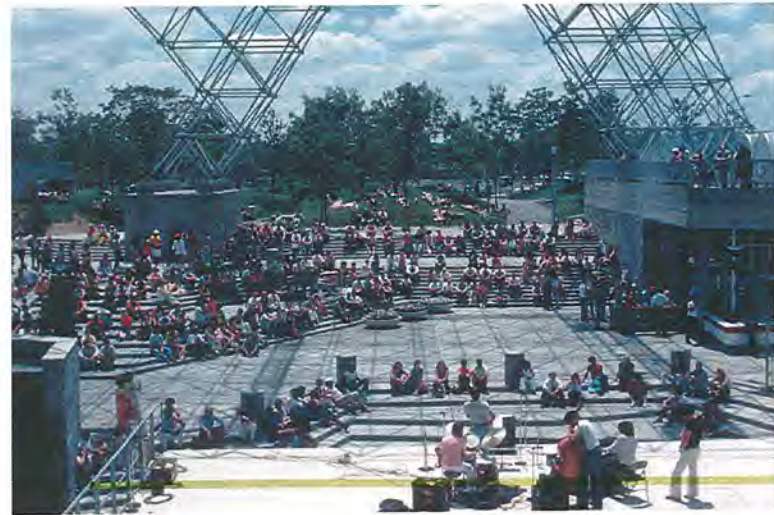
The central plaza space is approximately 17 feet below street level and is often referred to as 'the pit'. To enliven this space a mural has been painted on the extensive west facing concrete retaining walls. The central plaza with its many terraces and

stairs functions as an outdoor amphitheater and accommodates City sponsored events including first night celebrations and summer concerts. The existing ramp does not comply with current ADA regulations and is primarily used for truck delivery access to the multi use building.

The Central Lower Plaza, conceived as the celebratory space, houses the fountain which is non operational, and the multi-use building. The concrete fountain structure is impressive in its mass and very steep by today's standards with many tiered basins. A narrow stair winds around the fountain and provides connection to Court Street and to the upper meadow/field. Views into the park from this stair are discontinuous and interrupted by level changes, raised fountain basins and the space frame footings. The lower fountain basin is used to accommodate the temporary performance stage for concerts and is erected annually by operations personnel.

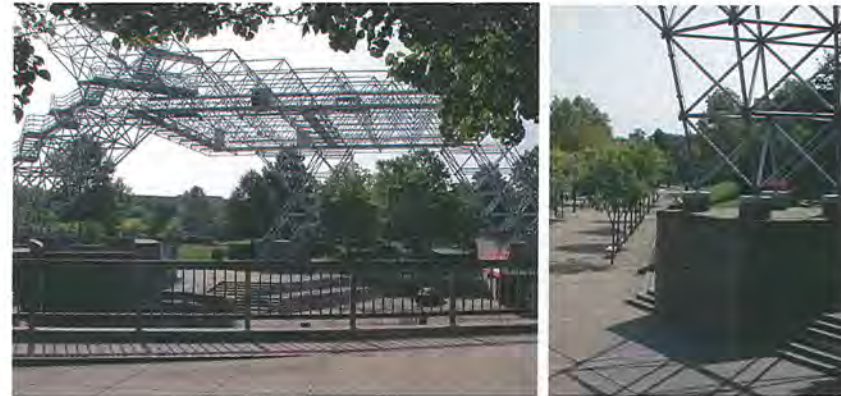
Space Frame Footing

The tops of the upper members of the space frame are beginning to rust. Complete sanding of rusted areas, a more detailed inspection of the anchor bolts and bearings, and the priming and painting of the entire structure will be required in the near future to avoid further deterioration. The electrical panel boards of the space frame are in a serious state of disrepair and temporary wiring methods are visible. Lamp sockets of the Space Frame

are exposed and are a safety hazard to maintenance personnel and the public.

The Space Frame: The aluminum space frame creates an open canopy over the central celebratory performance plaza space and originally accommodated the color change lighting for the

fountain now used to light the temporary performance stage. Outfitted with stairs and viewing balconies, the structure provides high views of the surrounding neighborhood. The structure has been known to sway back and forth when loaded with pedestrians and has been closed to the public for many years. The massive concrete foundations, 12 by 12 feet, which in some cases rise some 15 feet above grade, appear in good condition. These are often cited as blocking views within the park and during performances.

While the space frame introduces an interesting sculptural element within the park and could be retained, repaired, repainted, and possibly reopened to the public, retention has tremendous limiting implications to the re-design of the central plaza space due to the massive footings. These also limit design flexibility concerning an addition to the multi-use building. For these reasons, and due to community feedback on the three design interventions proposed within the central plaza, two of which retained the space frame, the long-term recommendation of the master plan strategy is removal of the space frame and footings.

Recommendations: *The space frame should remain closed to the public with clear-posted signage. Any plans for significant loading including the temporary re-opening the structure to the public or the addition of new stage lighting should be incorporated into a second stage evaluation to include an in depth structural investigation.*

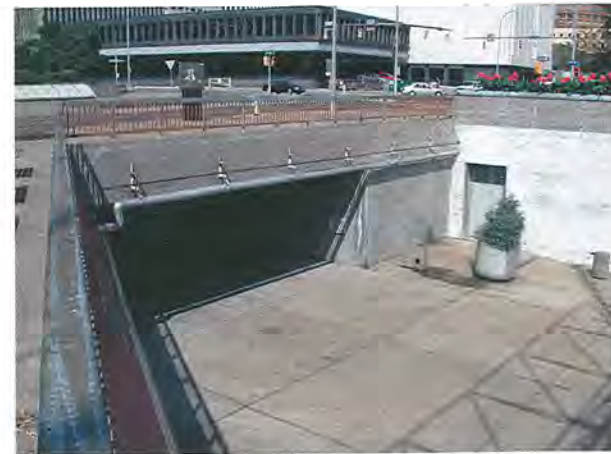
The Tunnel: The tunnel beyond the recess, has been temporarily closed with concrete block walls and the full extent of the tunnel was not inspected.

Recommendations: *The tunnel should be closed to the public for reasons of safety and could be utilized as a storage area for park furnishings, etc. In addition, the City may wish to pursue discussions with RG&E to relocate the utility electrical equipment to a secure and accessible area within the tunnel area.*

Immediate Action: *The electrical conduit feeding the lighting in the tunnel has disintegrated due to corrosion and requires immediate repair.*

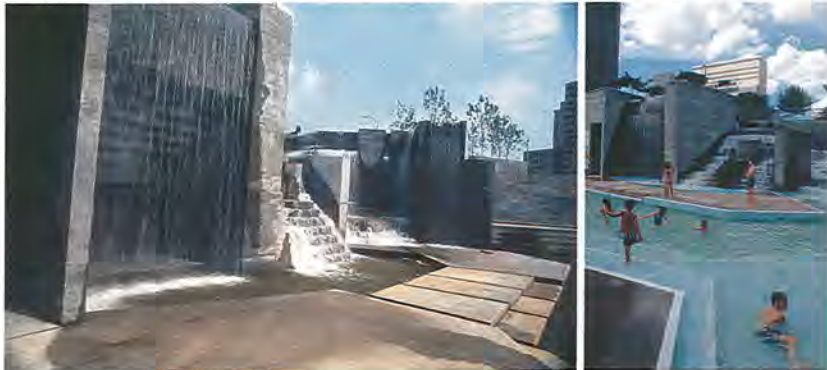
The Fountain: The fountain was opened in 1975 and shutdown in 1995 due to operational difficulties, and liability concerns related to bathing and climbing during non-operational hours. The structure appears sound with visible cracks likely cause by uneven concrete thickness and water penetration.

The mechanical system is very complex incorporating a lot of motorized valves and automatic devices that required constant maintenance. The system was designed to function all winter originally incorporating a heating and ice-melting system that leaked, functioned improperly, and was shut down.

The fountain was never in use beyond November and the automatic timers to turn the fountain on during the day were not used in favor of manual activation to ensure problems associated with start up surge could be managed. The two main pumps could not be turned on at the same time due to surge and displaced water volumes leading to a significant drop in pool

water levels. This problem was caused by overnight water loss due to overflow and leakage. Surge was controlled by adding water at startup.

Many Components of the mechanical system have been replaced, repaired and/or modified. The two main 125hp pumps and the smaller sump pumps were repaired due to flooding of the pump room. The filtration system was inadequate and a large quantity of bromide chemical was added to maintain water quality. The system was flushed and refilled weekly requiring maintenance personnel to crawl into the wet suction chamber to remove and clean the filter screens.

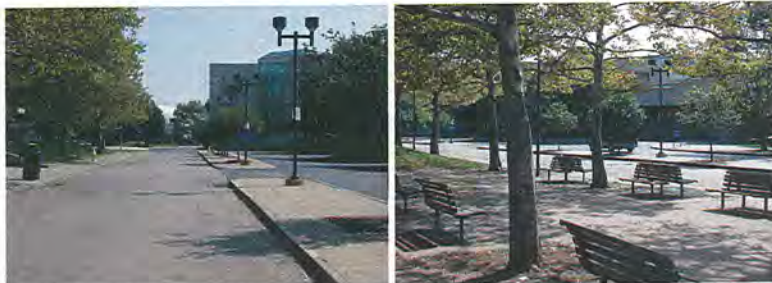
Manhattan Square Drive is the primary delivery street bringing people and services to the park. This is a one way street built adjacent to the Strong Museum’s buss loading facility and the parallel public and private drives at Chestnut street present a confusion situation to visitors. The system is particularly confusing where it merges at the suburban style concrete island providing access to museum parking. The Plane trees along Manhattan Square Drive are amongst the park’s best landscape features.

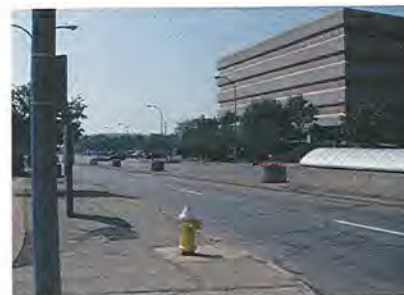
Chestnut Street is a four-lane cross-section with a wide concrete central median and suburban style turning islands at the Court/Chestnut intersection. This intersection has been designed for the efficient movement of cars and through flow turning movements that create a very unsafe situation for pedestrians wishing to use or access the park.

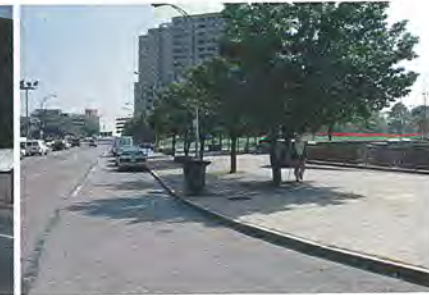
Court Street is a four lane cross-section with parking along both curb edges and provides one way movement east to the Broadway intersection where it joins the other one way pair at Broad street to provide access to and from the inner loop. The Broadway intersection at Manhattan Square Drive with its center-dividing median is very wide and formidable in terms of pedestrian use to and from the park.

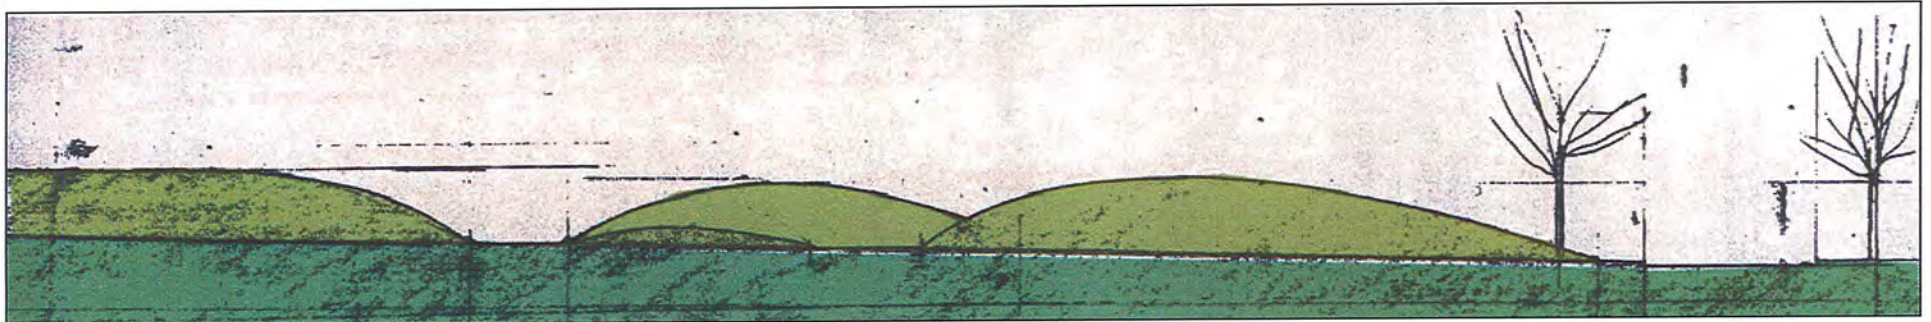
Lawrence Halprin's Design Sketch of the Berm Garden

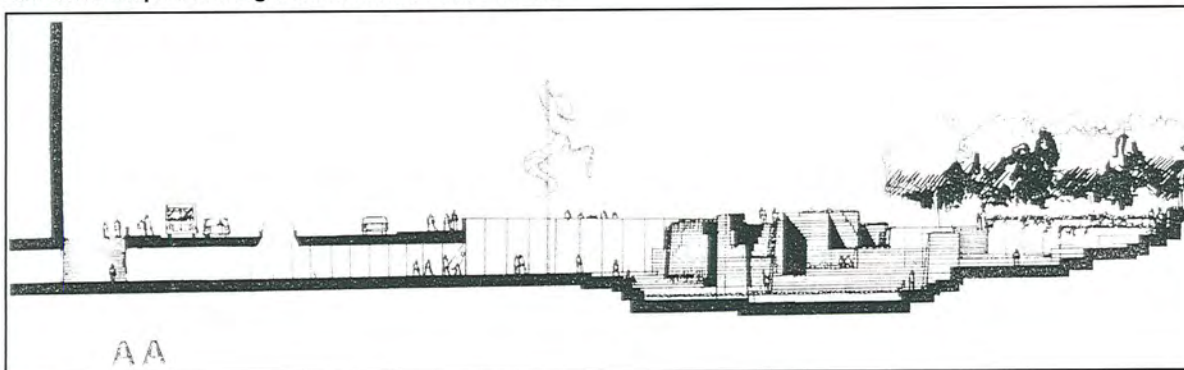
Section through Chestnut showing elevational separations

The park is isolated from its context by grade changes and physical barriers

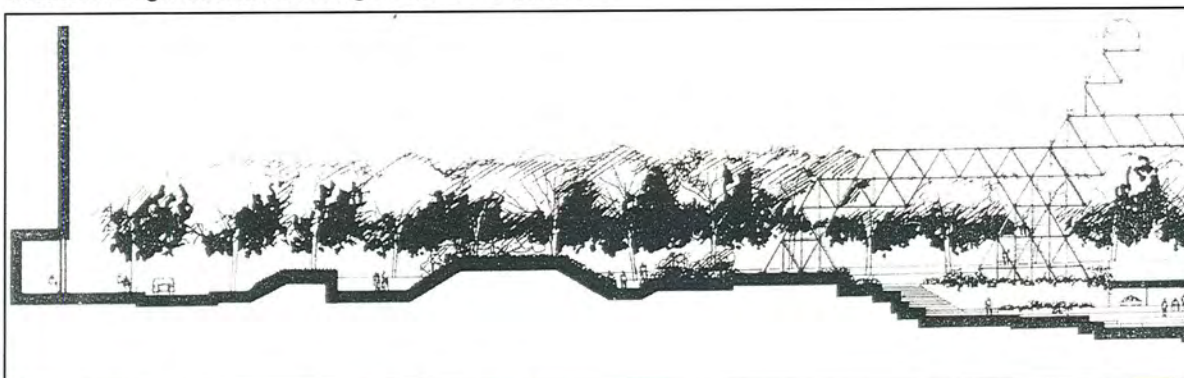
Section through South Berm illustrating visual and physical barriers

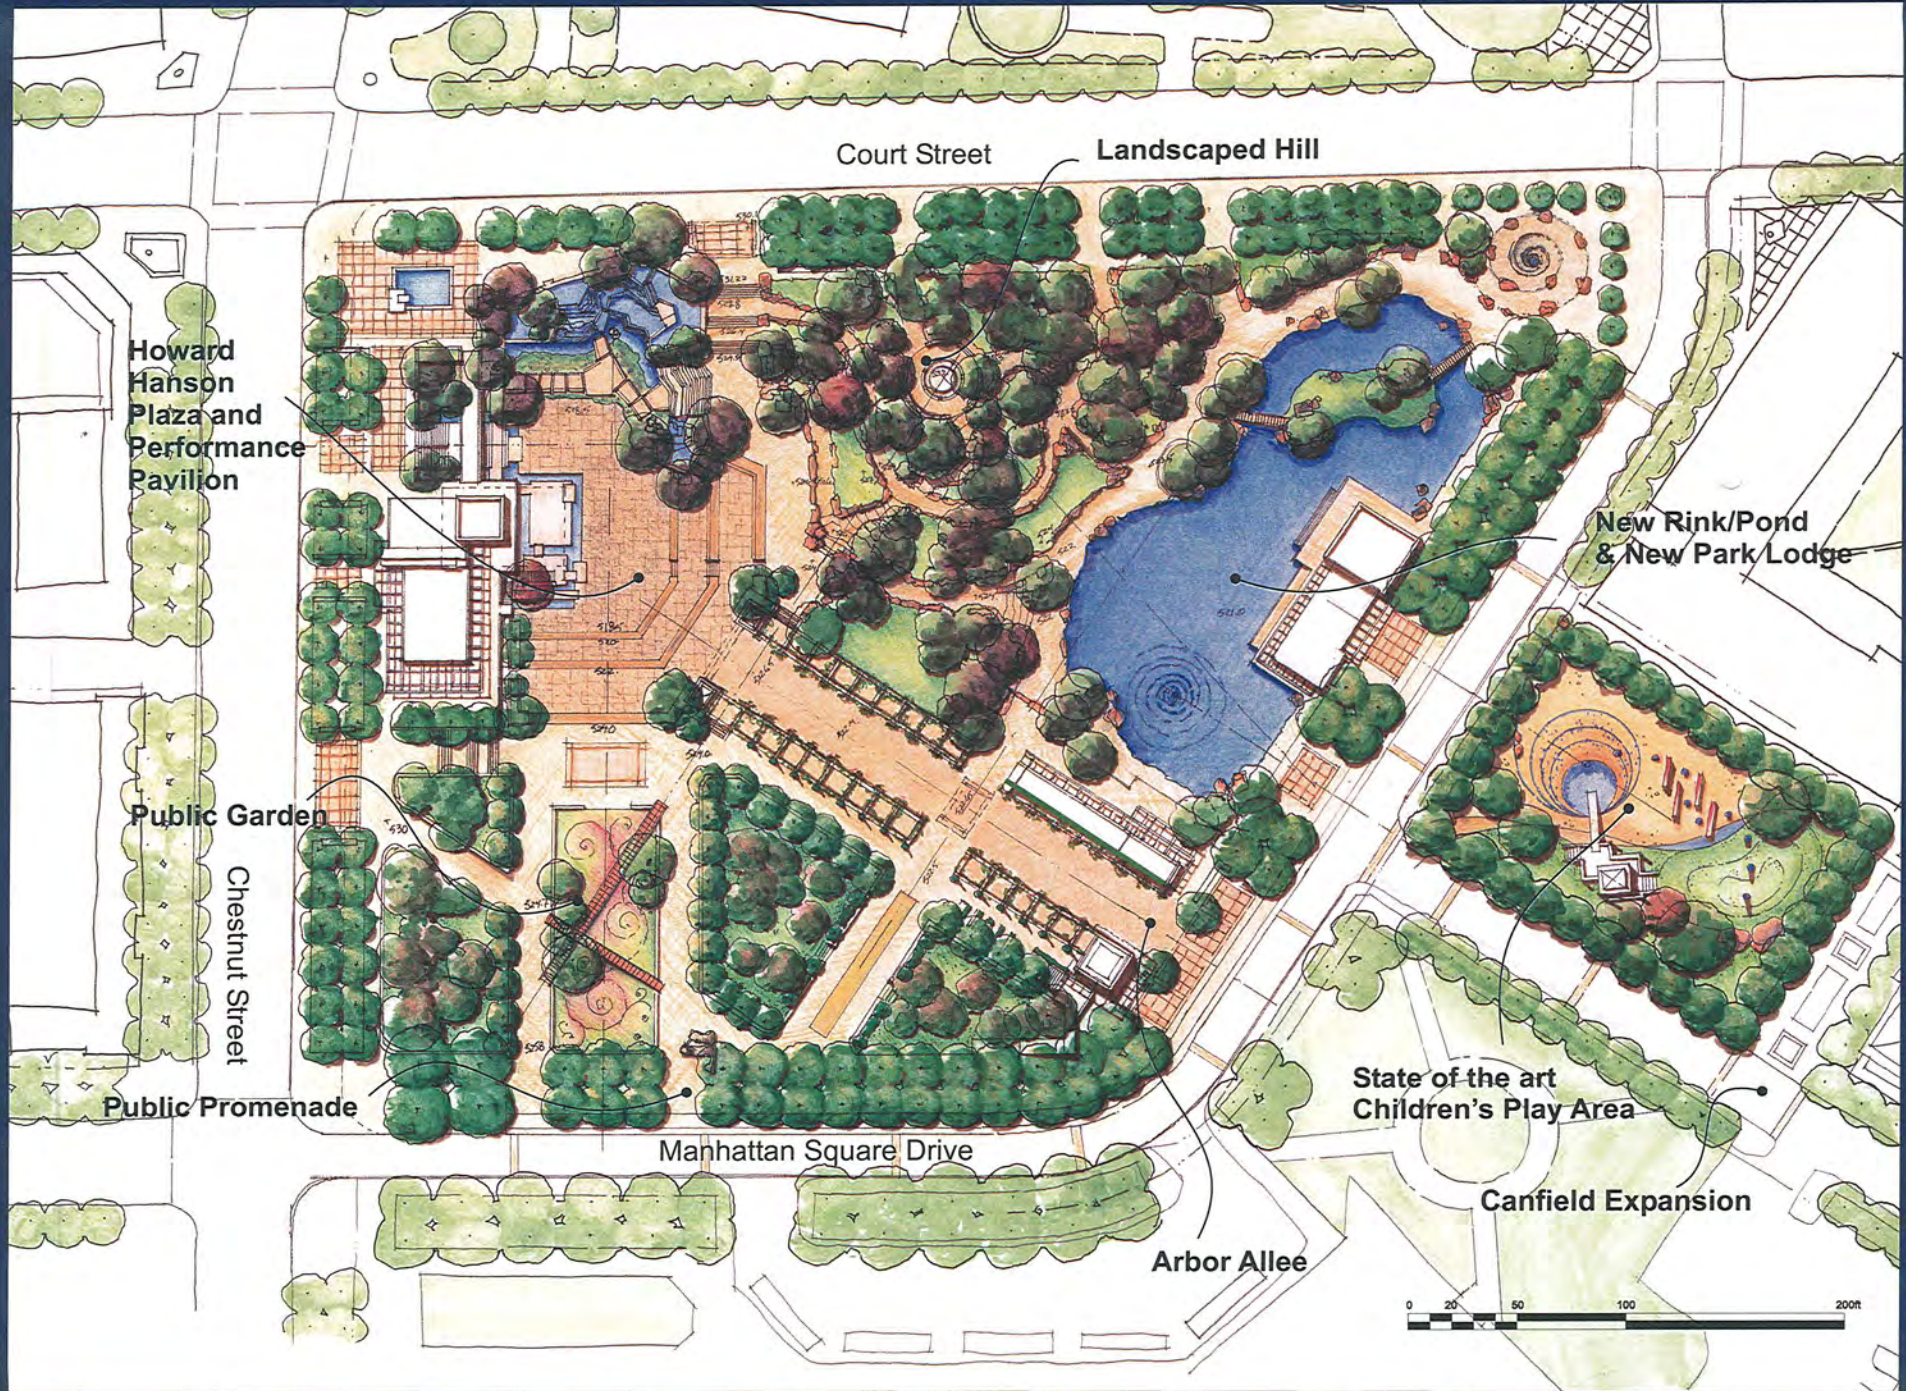
Recommended Master Plan

The former open playing field will be transformed as a **Terraced Landscaped hill** providing a lovely landscape setting for the rink and pond. Reworking and softening the abrupt grade transitions in this area will result in stronger visual and physical connections between recreational and cultural program areas. The hill will be developed as a tree arboretum, and shallow stone and grassed terraces will provide additional event seating overlooking the amphitheater space.

The Halprin Fountain will once again bring water into the lower plaza area, helping to animate the space and creating a stunning setting for the development of a sculpture court featuring the City's growing collection of public art.

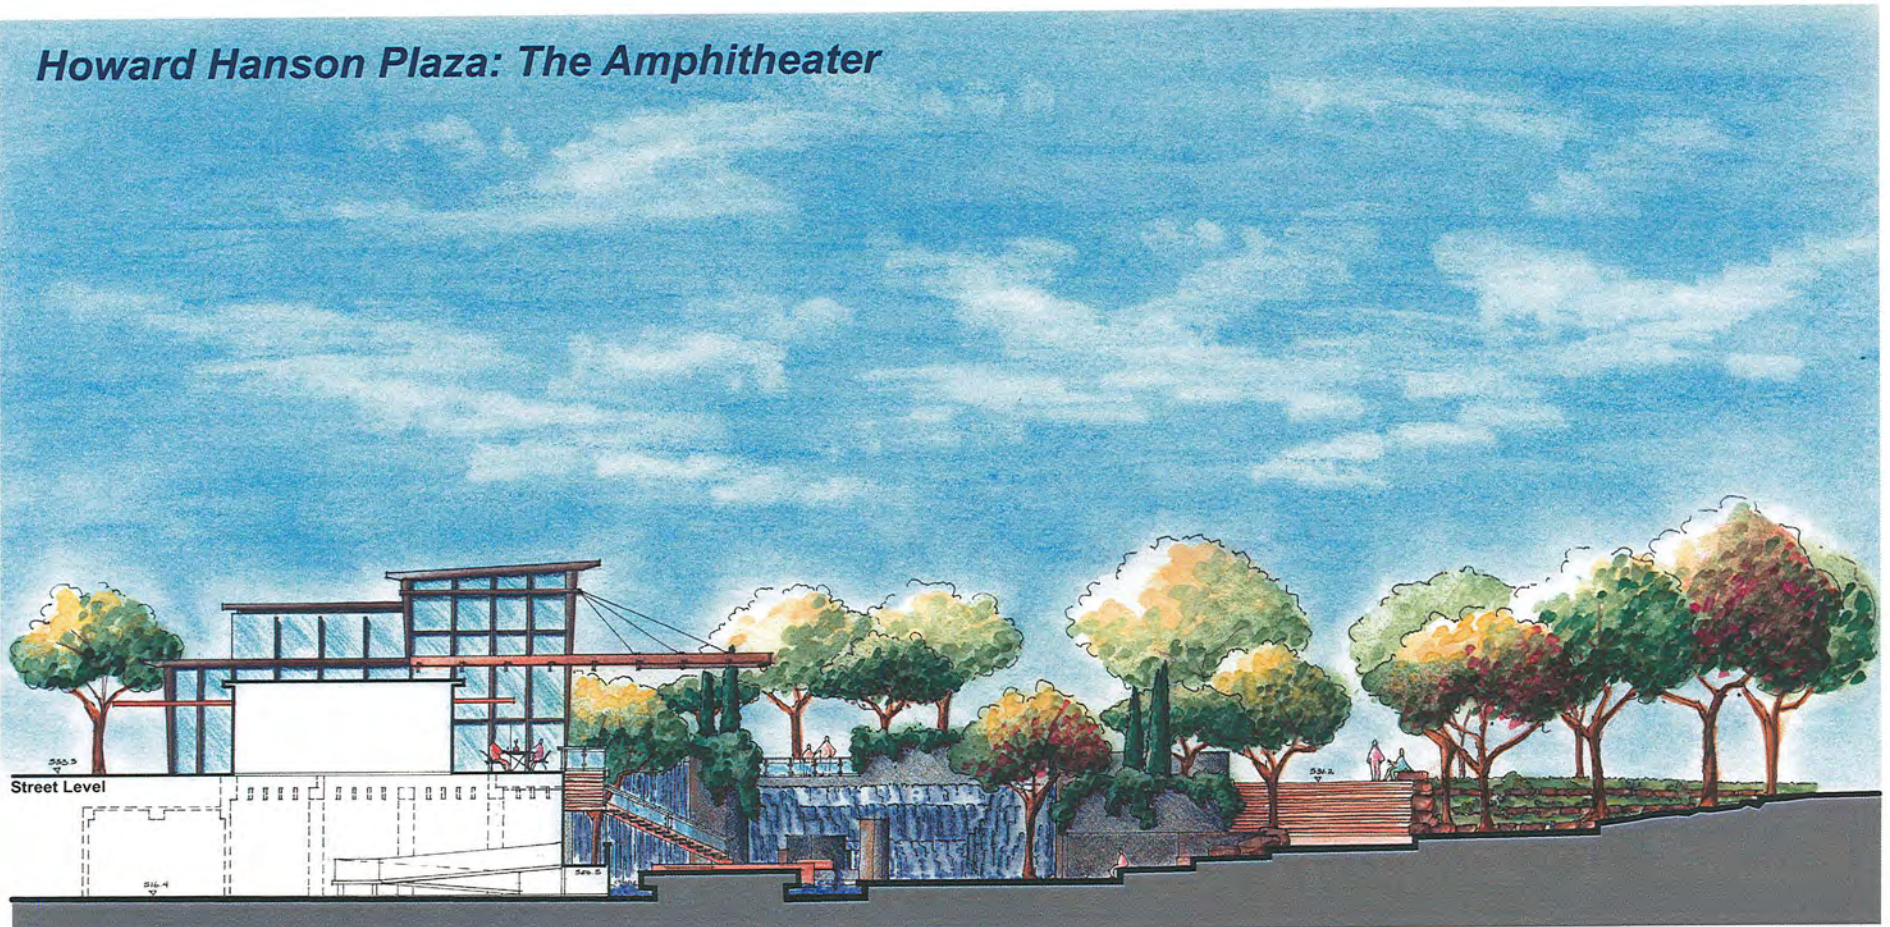
Howard Hanson Plaza: The Amphitheater

The former 11 foot vertical east wall may be saw cut and integrated within the amphitheater design as the third stepped terrace above the amphitheater's lowest level. The existing narrow Court Street stair should be retained, widened by 12 feet and re-clad or re-surfaced to unify this element within material palette selected for the park. Selected large caliper specimen trees will be located around the perimeter of the amphitheater space and to the back of the water stage to provide interest and shade while ensuring clear views to the performance area. Feature lighting highlighting the performance pavilion, stage and water fountain as well as and general night lighting must be carefully integrated within the amphitheater space and enhance the theatrical experience.

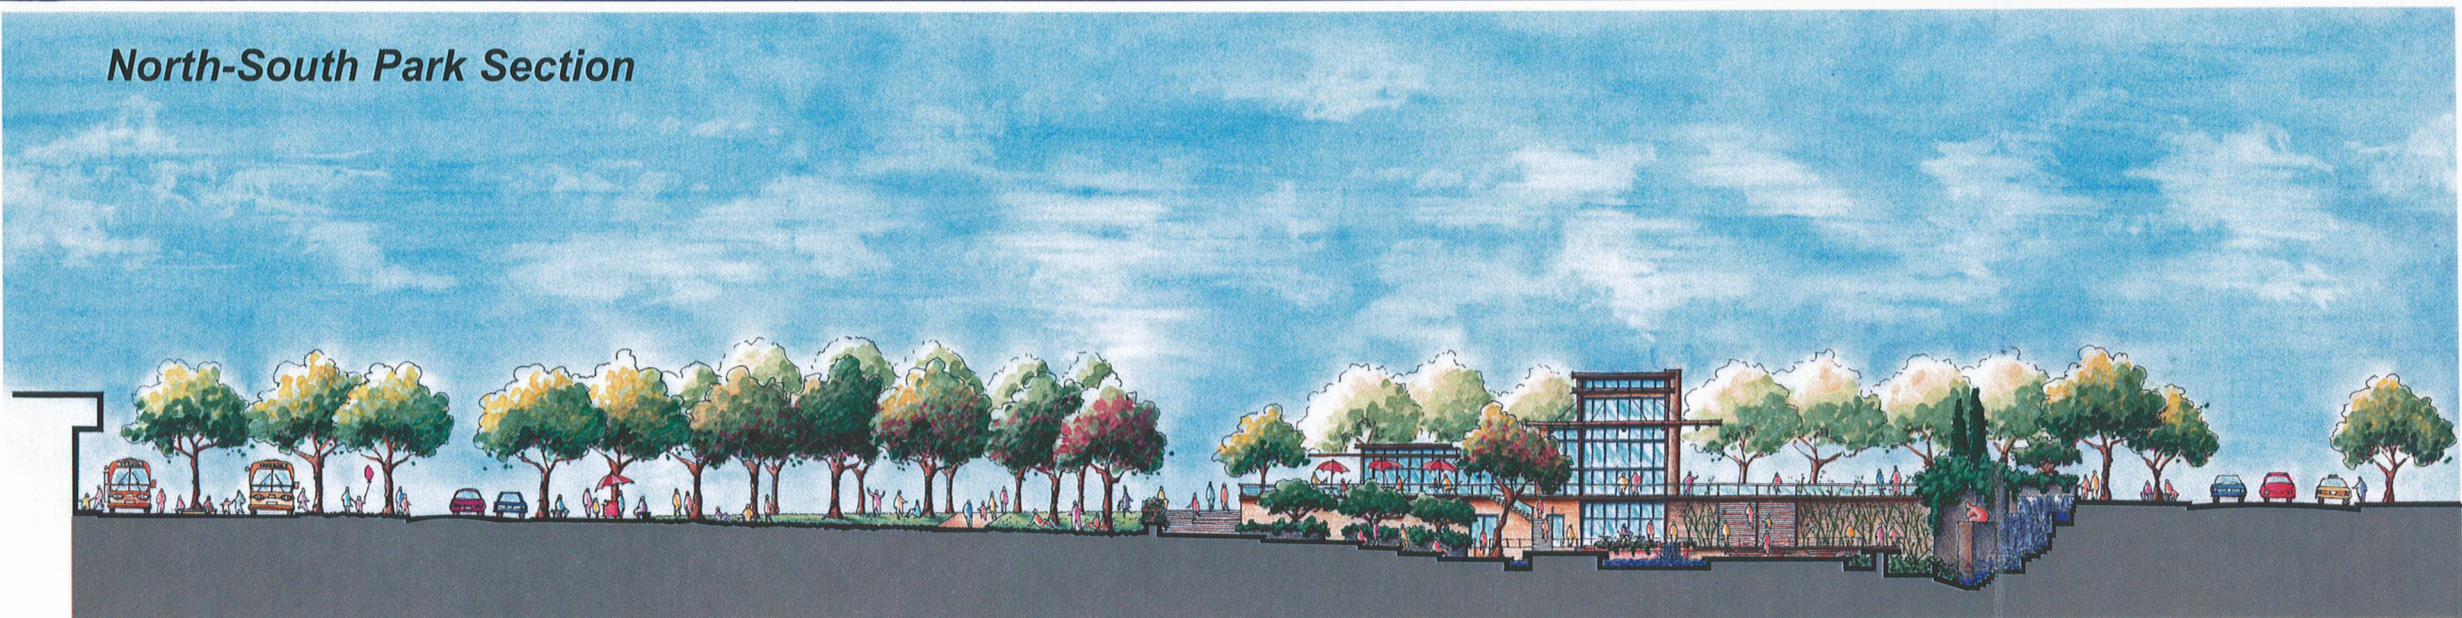
North-South Park Section

Design Intent: The former South berm garden will be redesigned as a simple, elegant open landscape and lawn defined by wide sidewalks, tree plantings, benches and /or seating walls and permitting clear, open and expansive views from Manhattan Square Drive to the amphitheater space framing the fountain view from Manhattan Square Drive. The re-design of this program area will enhance the interface between the park and the Strong Museum, and provide flexible, multi-use space for passive leisure activities, outdoor receptions and exhibits, and picnicking. As a successive improvement phase, the central lawn can be replaced with a

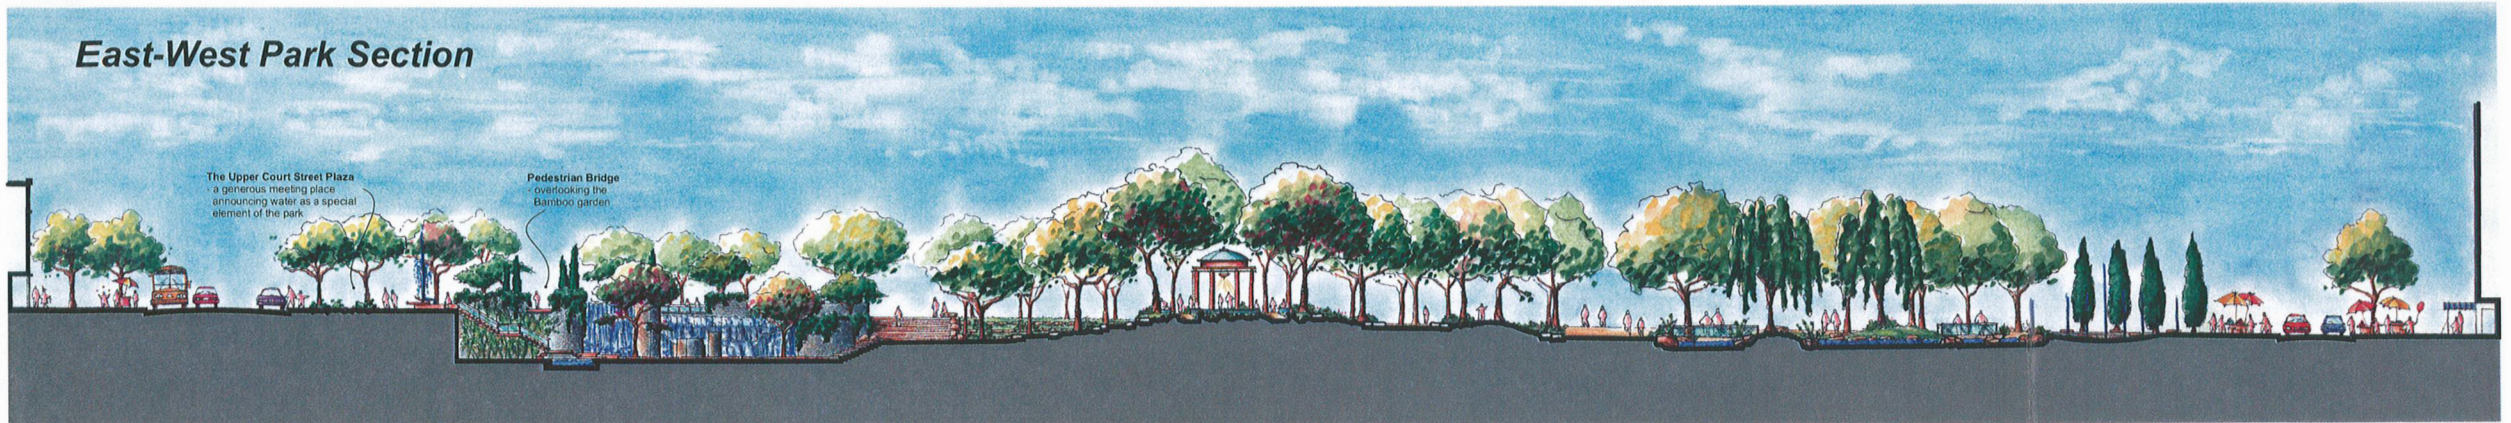
East-West Park Section

The Upper Court Street Plaza
- a generous meeting place
announcing water as a special
element of the park

Pedestrian Bridge
- overlooking the
Bamboo garden

Chestnut Street Interface and Streetscape Improvements

Halprin Fountain and Sculpture Court

- The Space frame and footings will be removed and the former 11 foot vertical east wall of the central plaza will be saw cut and integrated within the amphitheater design as the third stepped terrace above the amphitheater's lowest level.
- The terraces of the hill will accommodate spectator viewing of all areas of the park and expand the park's ability to accommodate large events both within Howard Hanson Plaza, and within the pond and rink area.
- The terraces will function an extension of the amphitheater utilizing large boulders and rocks to create a series of retaining walls supporting sloped paths, wide steps and terrace areas.
- The landscape of the hill will be developed as an arboretum featuring indigenous as well as unique hardy

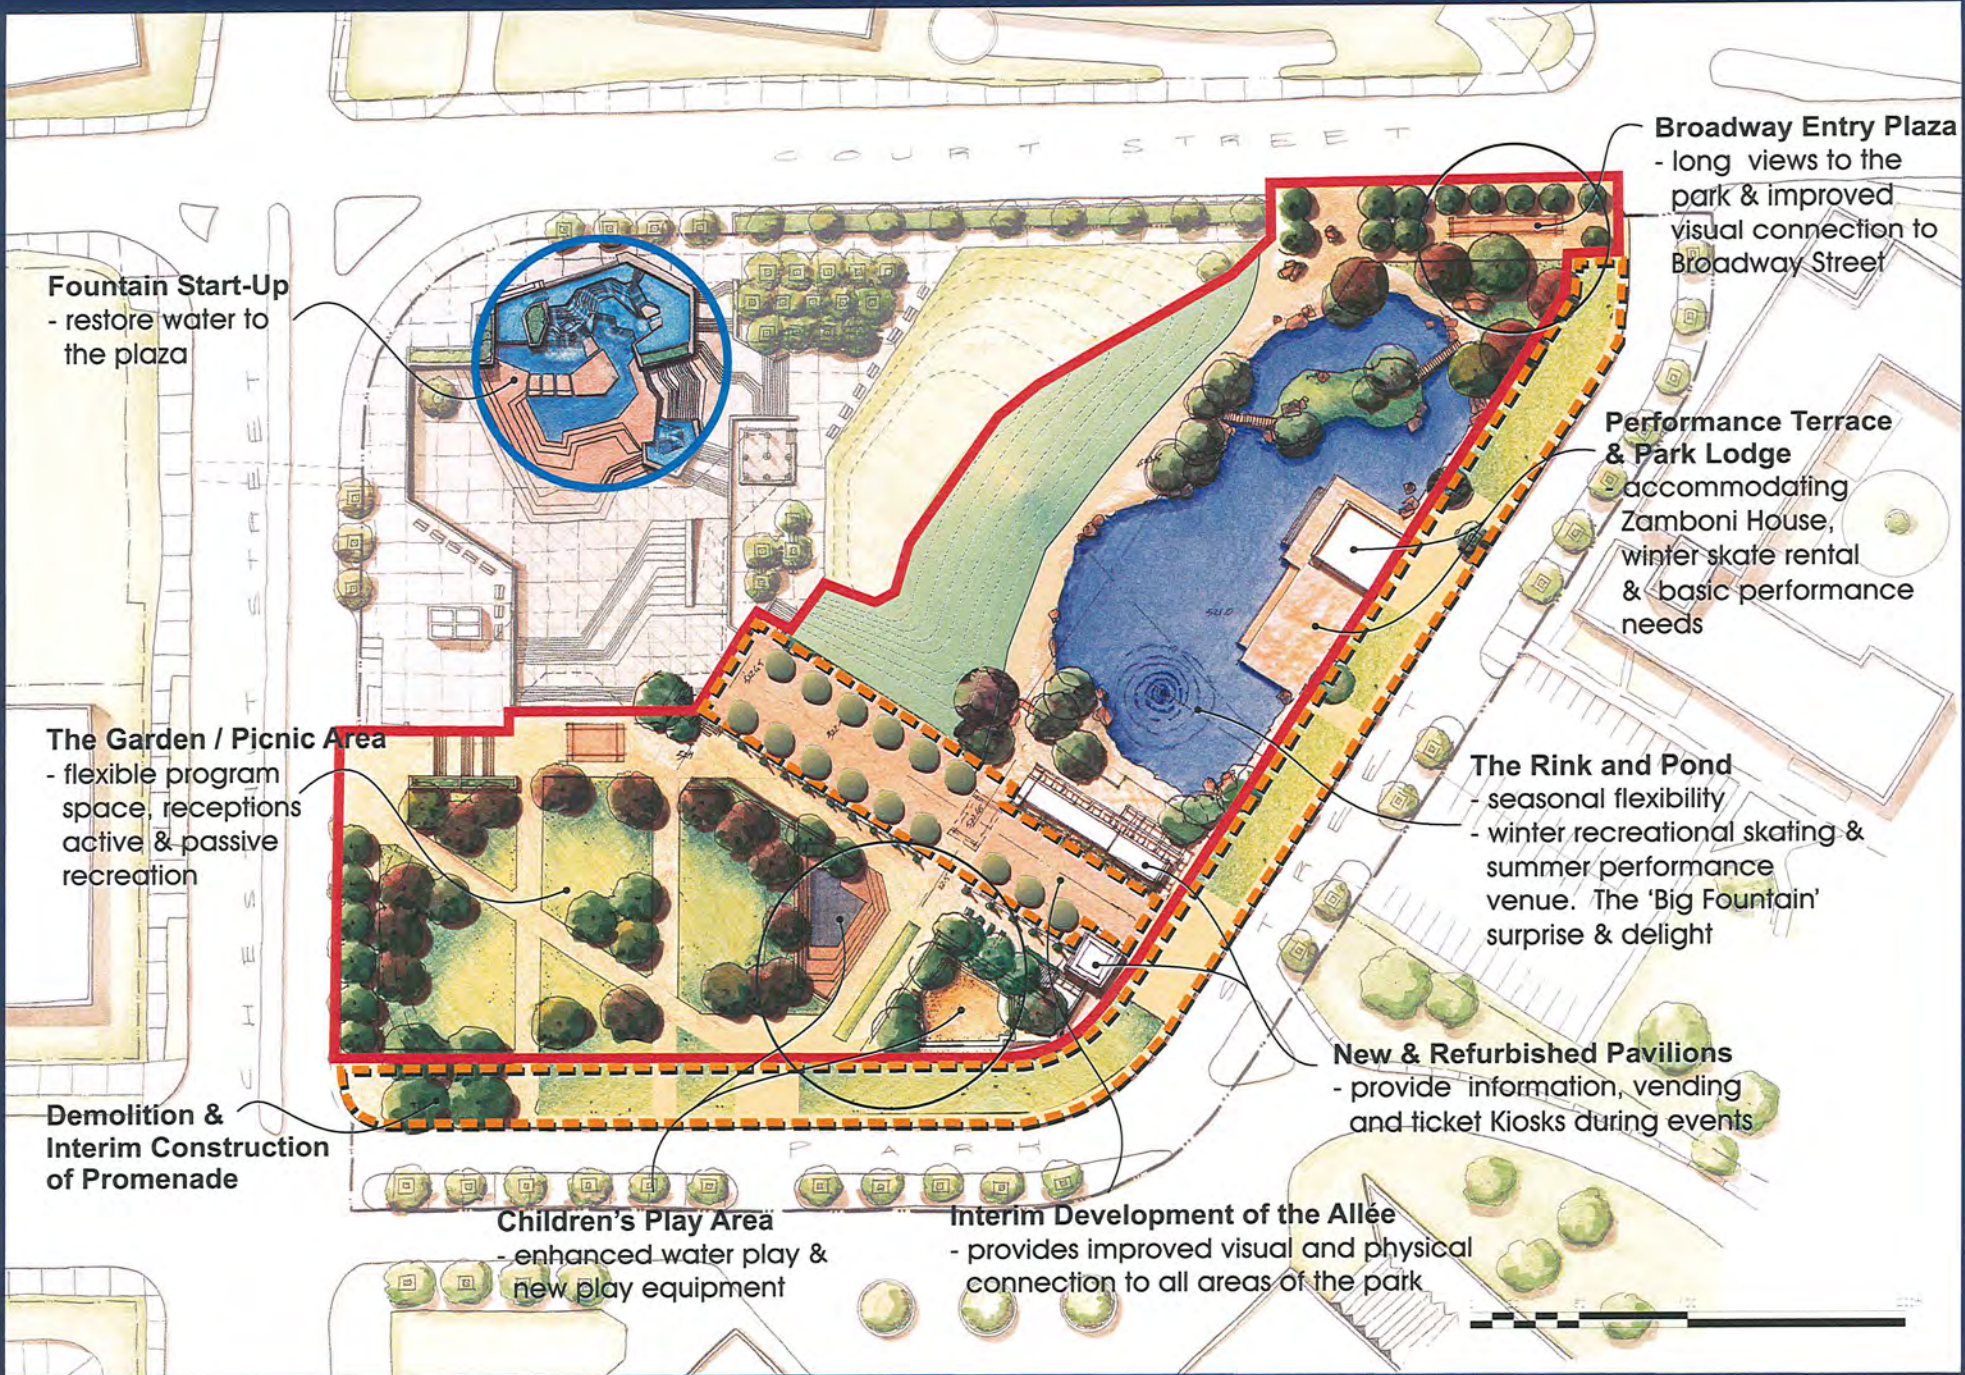
Recommended Master Plan Strategy - Phase One

Fountain Start-Up
 - restore water to the plaza

The Garden / Picnic Area
 - flexible program space, receptions active & passive recreation

- **Interim/partial development of the Garden and Picnic Area** involving the removal of existing berms and hard surface areas (steps to remain) replaced with flat lawns, walkways and new landscaping permitting open views to the fountain area below and to the Strong Museum building.

- **Full development and completion of improvements to the existing Children's Play Area** to include demolition of select concrete structures and berms, new fencing, new play equipment, and improvements to the water court.

- **Interim Fountain Start up.** While the Fountain will not be restored or re-profiled in this phase, an allocation has been established to make operational portions of the fountain and to prevent swimming and eliminate concerns over liability by filling the lower basin with boulders and river rock. This interim condition will restore water to the fountain during the summer months

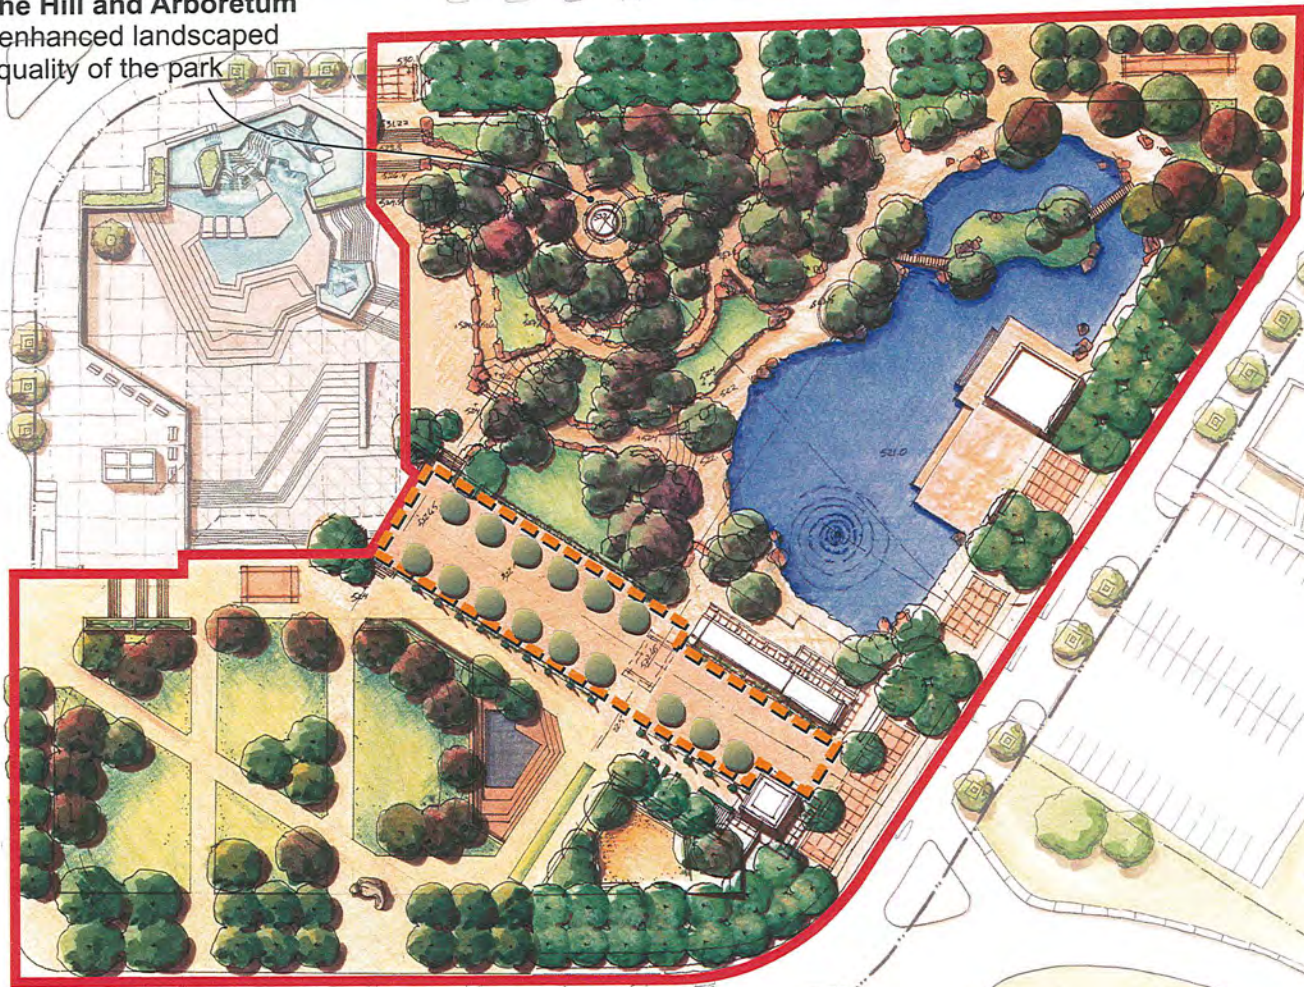
Recommended Master Plan Strategy - Phase Two

The Hill and Arboretum
- enhanced landscaped
quality of the park

**Full Development
of The Promenade**
- improved public
interface & flexible
Program space -
street markets &
festivals
