**CSXT RIVER STREET DERAILMENT PROJECT**

**SITE MANAGEMENT PLAN  
RIVER STREET  
ROCHESTER, NEW YORK**

REVISED JUNE 2012

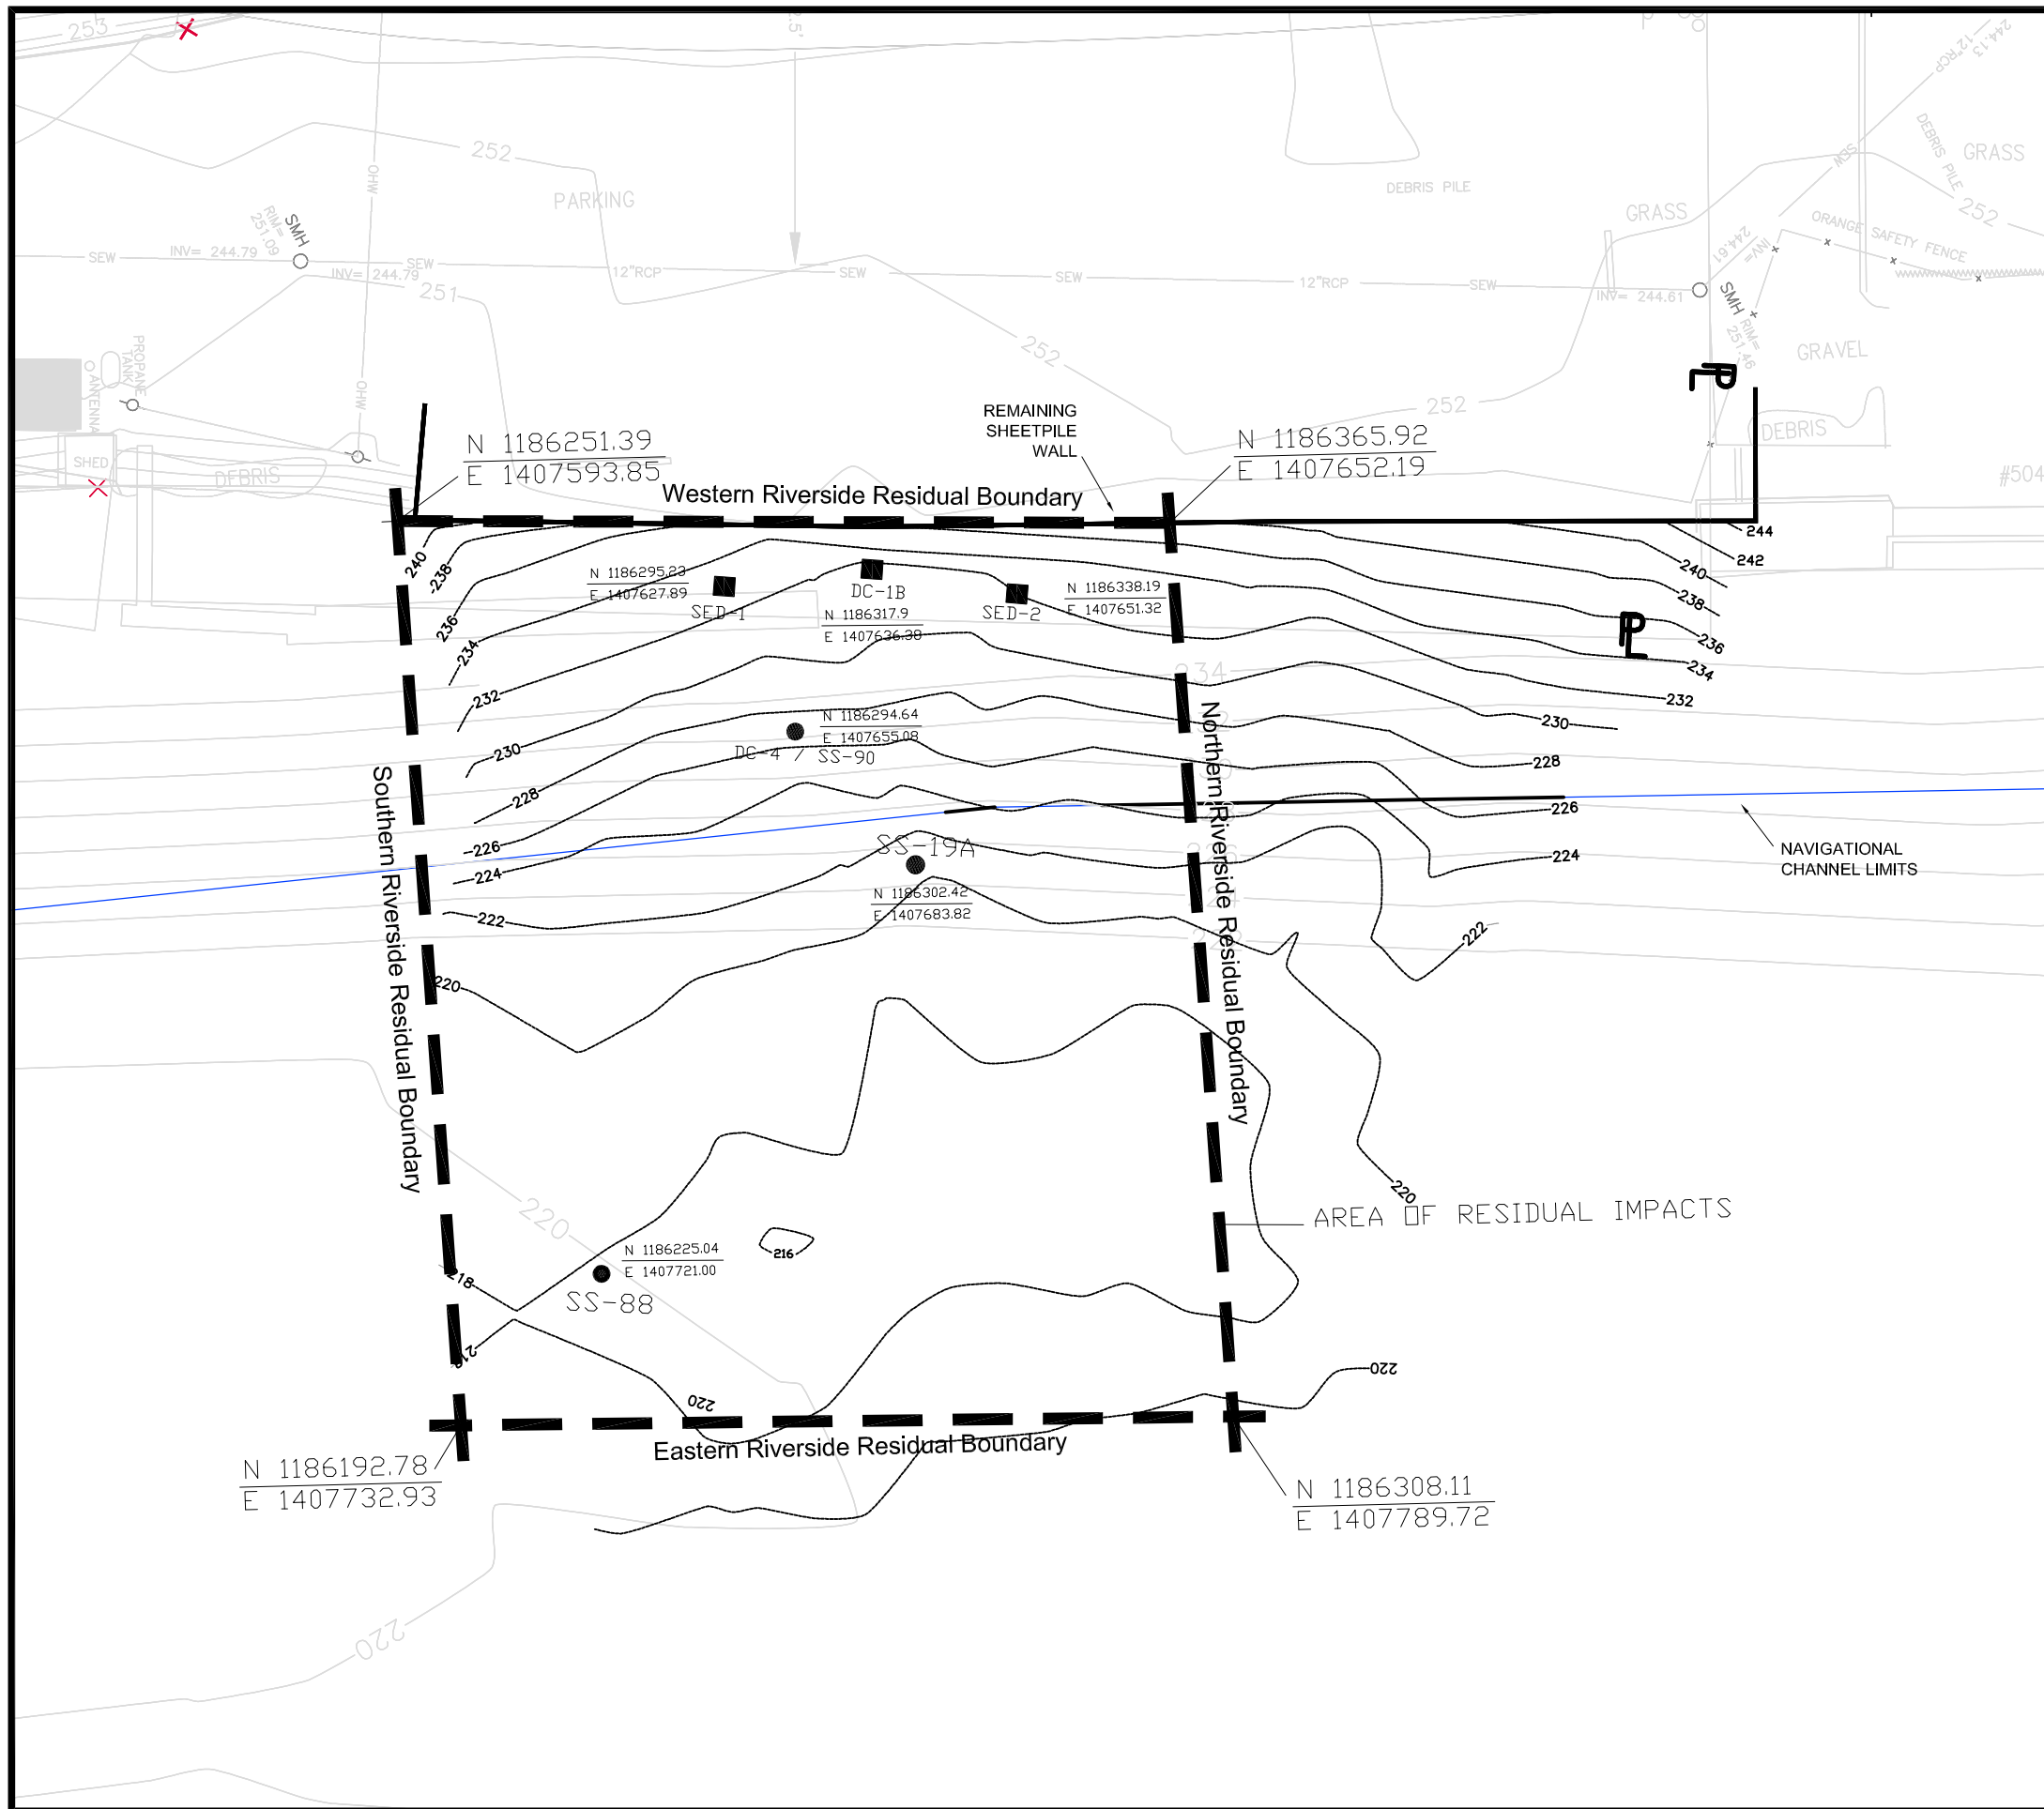
**TITLE:** FIGURE 2  
 RIVERSIDE SITE RESIDUAL BOUNDARY MAP

**Table 1** identifies the sample identification numbers and the corresponding historical analytical results of the locations that exhibited exceedances during the post dredging April 2005 monitoring event. **Figure 2** illustrates the locations of the exceedances and the Riverside Site Residual Boundary.

The dredging IRM removed the impacted sediments to the extent feasible, and in doing so, removed the vast majority of the impacted sediments. The residuals are limited in nature to hot spots within the Riverside Site Residual Boundary depicted in **Figure 2**. Moreover, the IRM was completed in such a manner that future activities conducted in the river should not be adversely affected by the residuals from the 2001 CSXT derailment. The remaining methylene chloride is not expected to be resuspended during USACE maintenance dredging activities (because the sediments are below the specified dredge depth of 221.3' IGLD85) and is not of sufficient quantity to be detectable in the Genesee River water column as demonstrated by the analytical results. However, if the USACE dredging limits are revised or if future development activities

Based on initial IRM closure sediment sampling, two of the 10 closure sample locations exhibited concentrations that exceeded the site-specific cleanup levels of 773 ug/kg for acetone and 1,133 ug/kg for methylene chloride. Closure samples DC-4 and DC-8 were identified as being above the cleanup levels at 24,000 and 1,900 ug/kg methylene chloride, respectively. DC-4 is located outside the navigational limits and will not be disturbed by current USACE maintenance dredging protocol. Also, DC-4 is at an elevation of 218.3 feet IGLD85 that is only 0.4 feet above the 217.9 feet IGLD85 target and within the specified +/- 0.5 foot construction tolerance. Closure sample DC-8 is located within the channel limits, but at a depth three feet below the USACE dredge elevation (221.3 feet IGLD85). Therefore, the residual methylene chloride contained in the sediment should not be disturbed by current USACE maintenance dredging protocol. Also, DC-8 exhibited a methylene chloride concentration that was within the same order of magnitude as the 1,133 ug/kg site-specific cleanup level.

DC-4/SS-90, DC-8/SS-89, and SS-88. Samples DC-4/SS-90, SS-19A and SS-88 were identified as having elevated concentrations of methylene chloride. As stated above, DC-4/SS-90 is outside of the navigational channel limits. Its concentration of 2,400 ug/kg, was also a full order of ten magnitude lower than that detected in the October 2004 closure sample. Although sample SS-19A is within the navigational limits, like DC-8/SS-89, it is located below the USACE dredging limit (221.3 feet IGLD85) at an elevation of 220.7 feet IGLD85. Further, additional dredging in the vicinity of SS-19A is unlikely, as the area of SS-19A must be maintained at a 4H:1V slope to ensure upland stability of the riverbank. The sample collected at the two feet depth interval at SS-88 did not meet the 1,133 ug/kg site-specific cleanup level. However, the upper sample collected at SS-88, 0.5 feet below the sediment surface, met the level. The elevated sample from SS-88 is at an elevation of 217 feet IGLD85 which is 4.3 feet below the USACE maintenance dredge depth of 221.3 feet IGLD85.

If development, maintenance dredging, or any other type of work is planned within the Riverside Site Residual Boundary identified on **Figure 2** which has the potential to disturb sediment, then it is necessary to contact Bill Parry, CSXT, Manager Environmental Remediation at 1-518-767-6049.
